October 1968
Interim Report
M & R No. 636392-4
D-4-37

DYNAMIC TESTS OF SHORT SECTIONS OF

CORRUGATED METAL BEAM GUARDRAIL

SERIES XIII

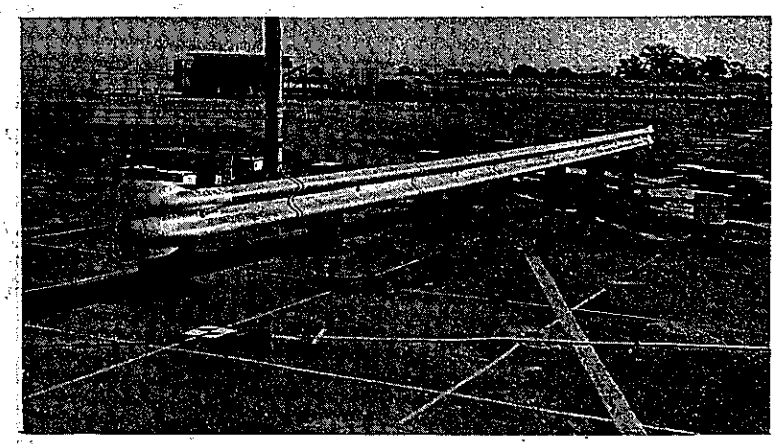
Figure 1

The installation for Test 131 consisted of a 37.5-ft free standing section of unanchored guardrail (Figure 1). This test installation was similar to many operational installations currently installed along California highways

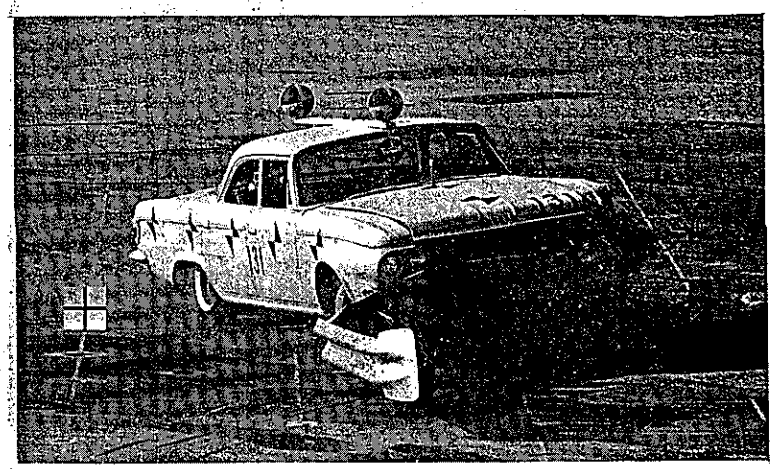
Figure 2

The test vehicle in Test 131 impacted the barrier near the center post at 63 mph/25 deg. The beam pocketed almost immediately upon impact (Figure 2), was pulled free of all but one of the posts, and was dragged, intact, by the vehicle as it penetrated through the installation with only a 3-deg change in direction, Plate A (Appendix).

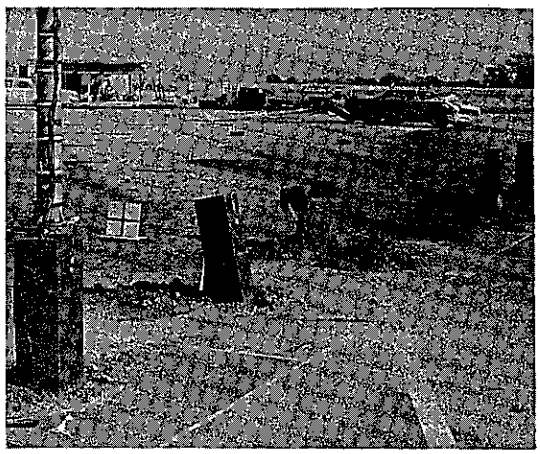
Figure 3

All beam sections, posts, and block-out blocks were damaged (Figure 3). The vehicle sustained major front end damage and was considered a total loss (Figure 4).

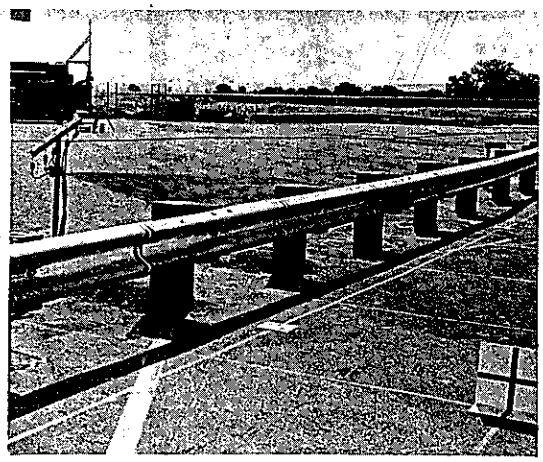
Figure 5a

The test vehicle in Test 132 impacted the barrier 2-ft downstream of post 4 at 61 mph/25 deg. As in Test 131, the beam was pulled free from the posts and dragged, intact, by the vehicle as it penetrated through the barrier with a 6-deg redirection angle, Plate B (Appendix). The additional barrier length was still not sufficient to prevent a repeat of the failure experienced in Test 131. The number of posts in a 62.5-ft section of guardrail was insufficient to develop the combined beam-to-post strength required to resist the axial load imposed by a severe impact.

Although the over-all results of this test would probably not have been significantly different had round cut or rectangular plate washers been used under all bolt heads, it is notable that six out of the seven bolts without washers pulled through the metal beam. The transfer of the high axial load to the posts prior to the "pull through" failures was evident in that ten of the eleven posts were split.

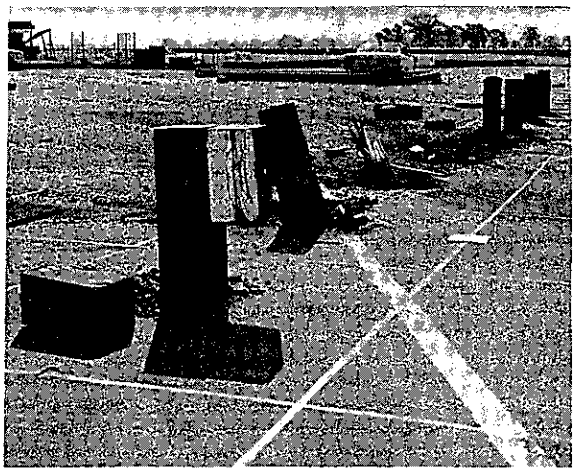
Figure 6

All beam sections, posts, and block-out blocks were damaged (Figure 6).

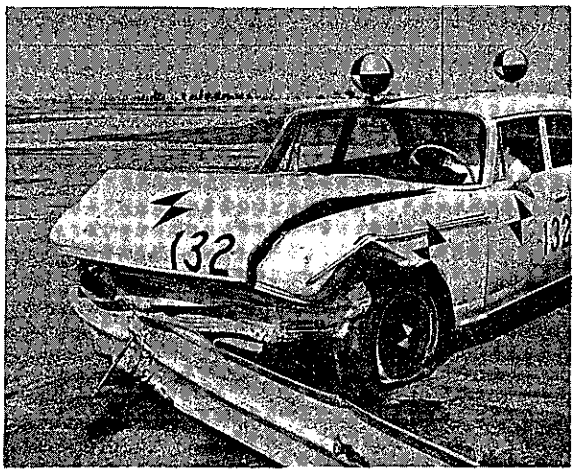
Figure 7

The vehicle sustained major front end damage and was considered a total loss (Figure 7).

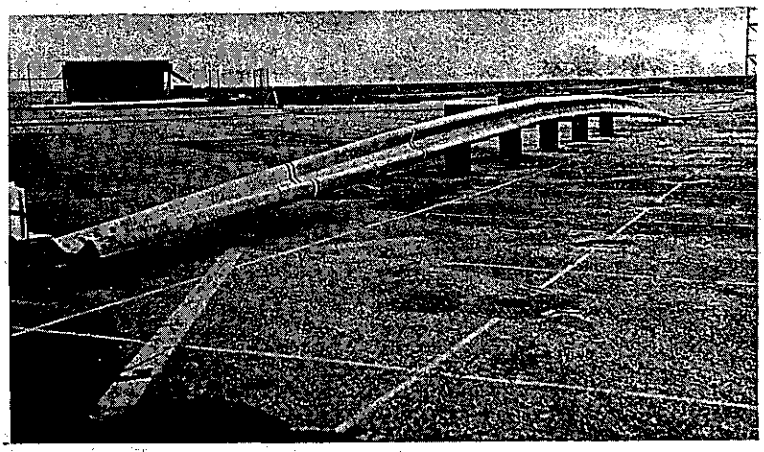
Figure 8

The first guardrail end anchorage design tested was developed by the Texas Highway Department and is referred to as the "Texas Twist". The test installation for Tests 133 and 134 consisted of a 62.5-ft section of guardrail with 18-ft 9-in. of the beam section at each end twisted 90 deg axially, bent down and bolted to fabricated steel posts cast in 18-in. diameter by 5-ft deep cylindrical concrete footings, Exhibit 3 (Appendix). There was no intermediate support in the sloping end sections between the concrete footing and the first post. The center 25-ft of the installation conformed to the California standard 27-in. high metal beam guardrail with round cut washers installed under the heads of all through bolts (Figure 8).

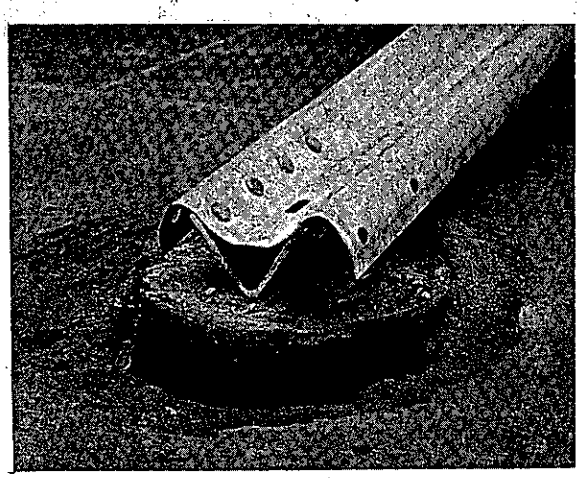
Figure 9

All beam sections were damaged as were two block-out blocks and one post. There were no bolt pull through failures. A 1/3-in. wide crack was opened in the downstream concrete footing which was displaced approximately 1/2 in. toward impact. The upstream concrete footing was displaced 2 1/2 in. toward impact (Figure 9) indicating the high tensile force transmitted by the guardrail beam.

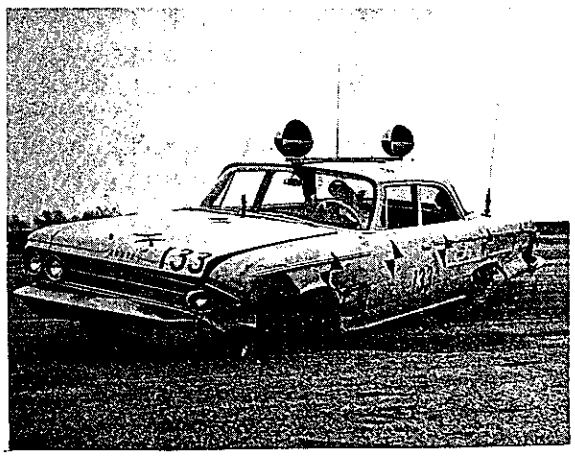
Figure 10

The vehicle sustained moderate damage as shown in Figure 10.

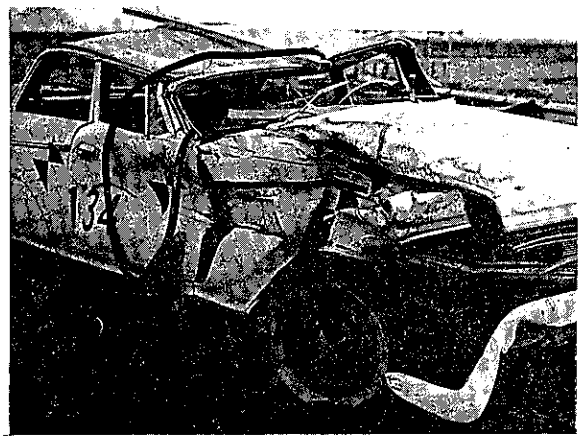
Figure 12

The end section of beam was destroyed and one post and block-out block shattered (Figure 11). The vehicle sustained major front, side, and top damage, and was considered a total loss (Figure 12).

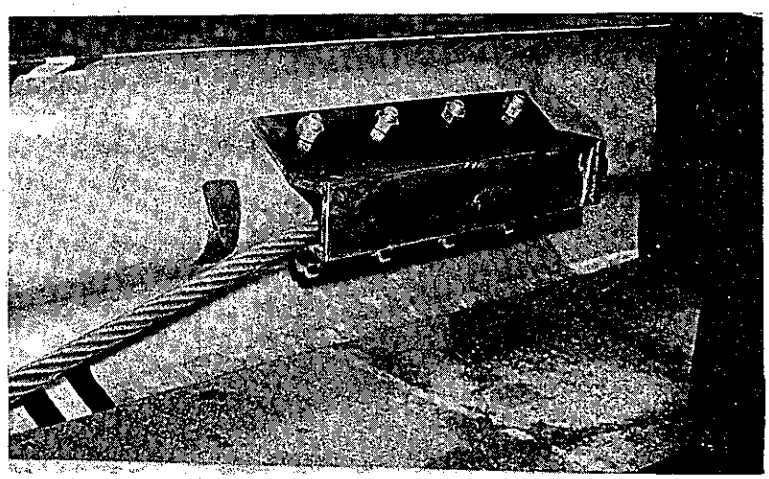
Figure 13

The test installation consisted of a 50-ft length of corrugated metal beam guardrail constructed on a parabolic flare. In order to reduce the lever arm effect of the axial force acting about the posts, block-out blocks were not installed on the end posts and 4-in. thick blocks were used on the posts next to the end. Round cut washers were used under all bolt heads. Each end section of the beam was secured with a 3/4-in. steel cable (breaking strength 21.4-tons) attached to the beam with a special fitting between the first and second posts (Figure 13).

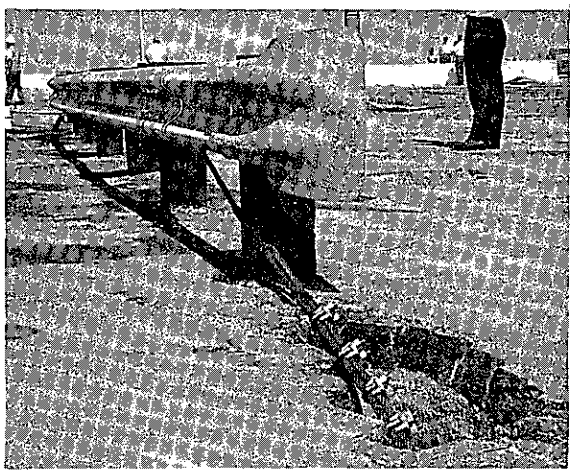
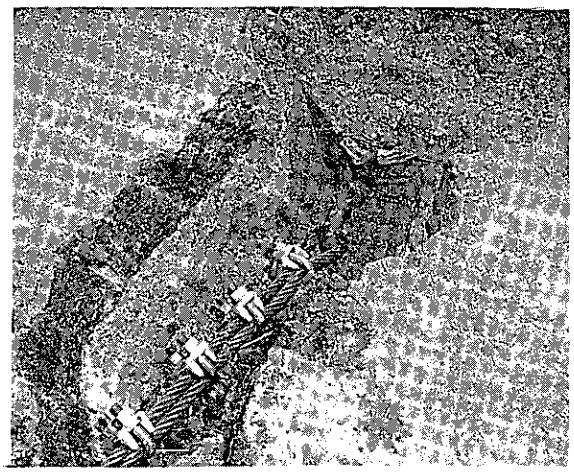
The other end of each cable was clamped to a 1 1/4-in. eye bolt attached to a steel 8 WF 17 section cast in an 18-in. dia by 5-ft deep cylindrical concrete footing (Figures 14 and 15).

The magnitude of the impact force transmitted from the beam into the cable end anchors was indicated by displacement of the upstream concrete footing 3/4 in. and of the downstream footing 1/2 in., both toward impact. The beam was warped slightly where the cable connection fitting was attached, indicating that it was under substantial load through impact.

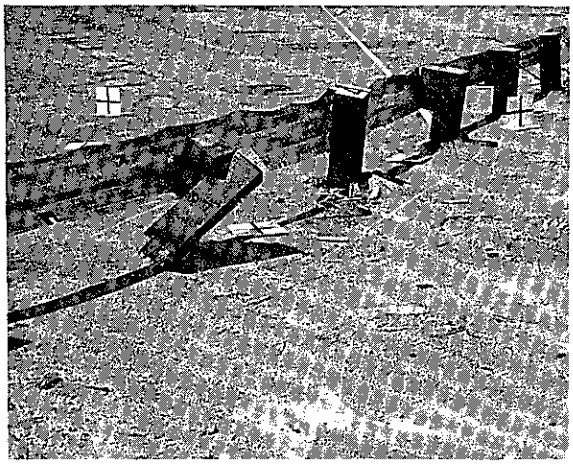
Figure 16

All beam sections were damaged. There were no bolt pull through failures although two block-out blocks crushed and one post was broken (Figure 16). The vehicle sustained moderate front end damage (Figure 17).

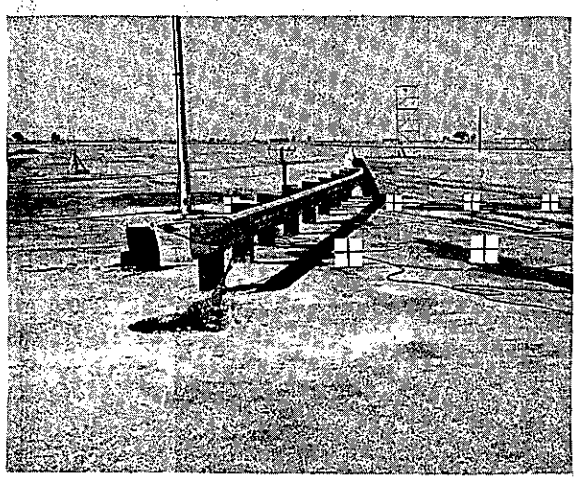
Figure 18

The success of the cable anchor in providing adequate beaming strength to a short section of guardrail prompted Test 136 where it was used to anchor the upstream end of a bridge guardrail approach flare. The test installation for Test 136 consisted of a 53-ft section of metal beam guardrail with the initial 12 ft at the downstream end constructed with enough curvature that the remaining 41 ft could be installed on a straight line thus forming a 4-ft offset from the face of a simulated bridge end post (Figure 18). The metal beam at the downstream end was secured to the nonreinforced concrete simulated bridge end post with two 1-in. dia high strength bolts. The bolts were inserted through 1-1/8 in. dia holes bored through the concrete. An 8- by 12- by 18-in. wood block-out block was placed between the guardrail beam and the concrete (Figure 19).

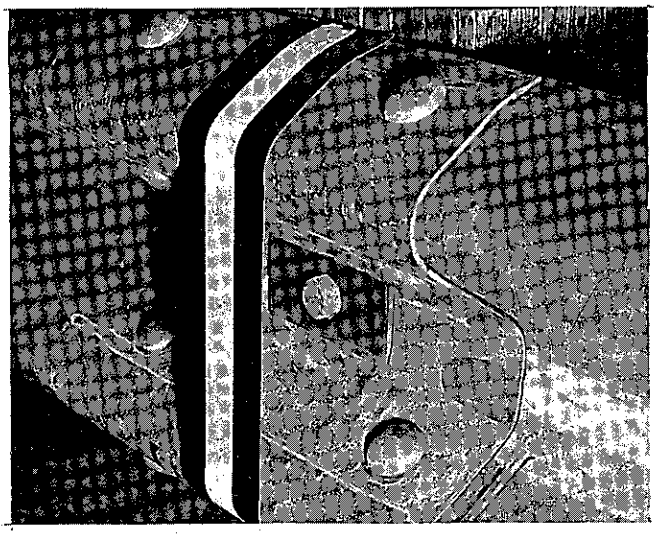
Figure 20

The upstream end of the metal beam guardrail was anchored with the cable anchor design tested in Test 135. Data from the preceding tests indicated that the use of round cut washers under the heads of the through bolts did assist in preventing bolt pull through failures. It was also evident that when the guardrail beam is adequately anchored, as in Test 135 the probability of bolt pull through failures or post splitting is minimized under those impact conditions. However, under a more severe impact it is conceivable that even with round cut washers, bolt pull through failures could occur. Consequently, it was decided that for Test 136 the round cut washers would be replaced with a 3- by 1-3/4- by 3/16-in. steel plate washers to provide additional bearing surface under the through bolt heads (Figure 20).

8. The results of this series indicate that washers placed under the heads of the through bolts in the metal beam to post connection are effective in minimizing bolt pull through failures. The California Division of Highways now uses 3- by 1 3/4-in. by 3/16-in. rectangular plate washers under the head of the through bolts.

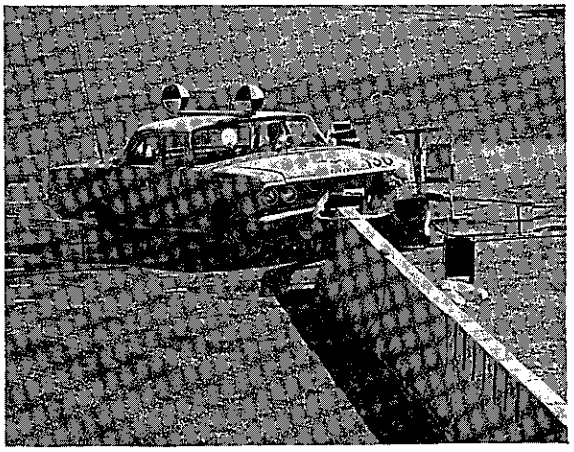
Figure 21

The test vehicle in Test 136 impacted the barrier 18-ft upstream of the simulated bridge end post at 60 mph/33 deg. pocketing the beam severely (Figure 21).

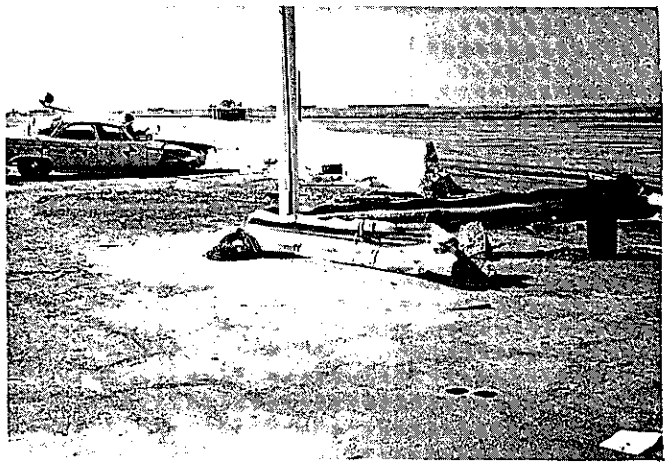
Figure 22

As the vehicle was being redirected (approximately 12 deg) the concrete end post failed through the connecting holes, allowing the guardrail beam to pull free, thus permitting the vehicle to penetrate the barrier. As the vehicle progressed through impact, the right front wheel struck the end of the concrete end post throwing the vehicle into a violent counter clockwise roll-over. The vehicle came to rest 45 ft beyond impact in a regained upright position (Figure 22), Plate F (Appendix).

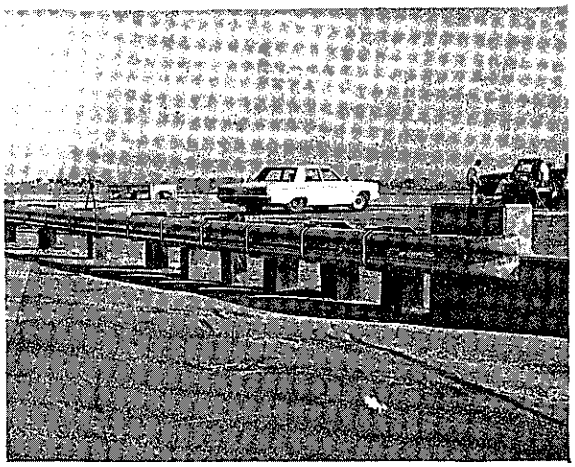
Figure 24

design details of the then current California Division of Highways Standard Plans, Exhibit 2 (Appendix). A 50-ft section of metal beam guardrail was constructed on a straight line with the upstream end offset 4 ft from the projected face of the bridge end post (Figure 24). The same cable anchorage installation used in Test 136 was employed to anchor the upstream end, Exhibit 1 (Appendix).

Finally, to minimize the pocketing noted in Test 136 and to provide improved transition from the semi-flexible metal beam guardrail to the rigid concrete bridge rail, the guardrail post spacing near the concrete bridge end post was decreased to 3-ft 1-1/2-in. Also the three timber guardrail posts nearest to the bridge rail end were 10- by 10-in. rather than the standard 8- by 8-in. posts. Steel plate washers were used on all through bolts as in the preceding Test 136.

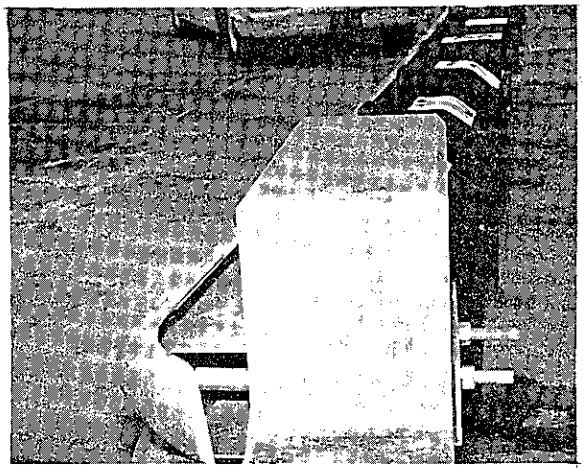
Figure 25

The block-out block between the guardrail beam and the concrete was fabricated of 1/4-in. steel plate rather than the wood block used in the preceding test (Figure 25). This was done to add rigidity to the system and prevent the crushing of the block.

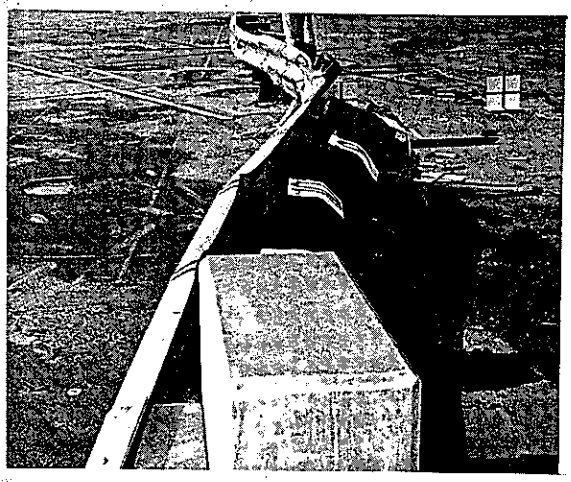
Figure 26

there were no bolt pull through failures. The guardrail beam sustained a permanent lateral deflection of 2.1 ft (Figure 26).

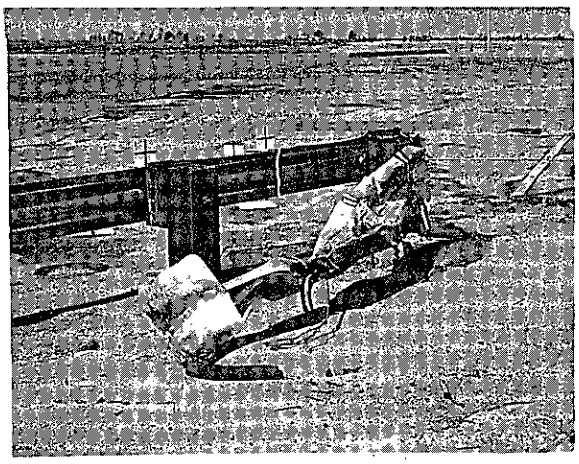
Figure 28

The first two posts were broken off at ground level and completely shattered. The end 12-ft of metal beam guardrail was twisted and doubled back around post 3 which was

deflected laterally 0.7 ft. The remainder of the barrier was intact with no significant movement or damage (Figure 28). There were no bolt through failures. This again illustrates the effectiveness of the plate washers, which have subsequently been adopted as a California standard for use on guardrailing.
