State of California
Department of Public Works
Division of Highways
Materials and Research Department

DYNAMIC TESTS OF SHORT SECTIONS OF CORRUGATED METAL BEAM GUARDRAIL

Presented at the 48th Annual Meeting
of the Highway Research Board

January 1969

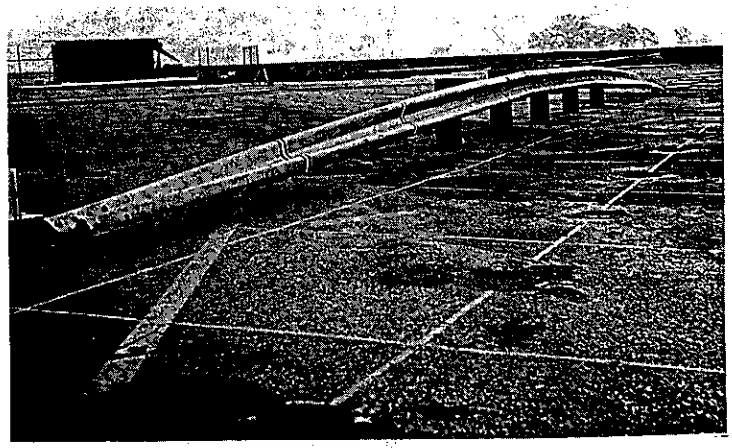
Figure 1

The first guardrail end anchorage design tested was developed by the Texas Highway Department and is referred to as the "Texas Twist". The installation for Test 133 consisted of a 62.5-ft section of corrugated metal guardrail beam. The 25-ft long center portion of California standard guardrail was anchored at each end with 18-ft 9-in. of the beam section twisted 90 deg axially, bent down and bolted to fabricated steel posts cast in 18-in. diameter by 5-ft deep concrete cylindrical footings. The sloped end anchorage beam had no intermediate supports (Figure 1).

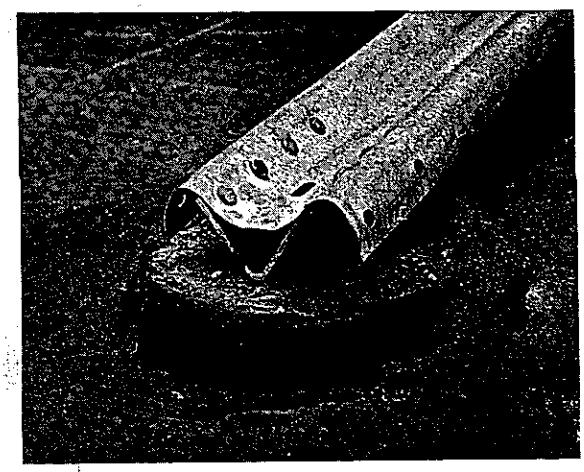
Figure 3

All beam sections were damaged. A 3/8-in. wide crack was opened in the downstream concrete footing and the upstream footing was displaced approximately 2-1/2-in. toward impact (Figure 3).

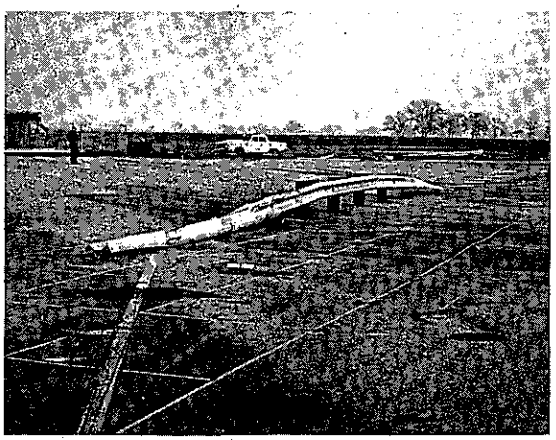
Figure 4

The end section of beam was flattened and one post and block-out block shattered (Figure 4).

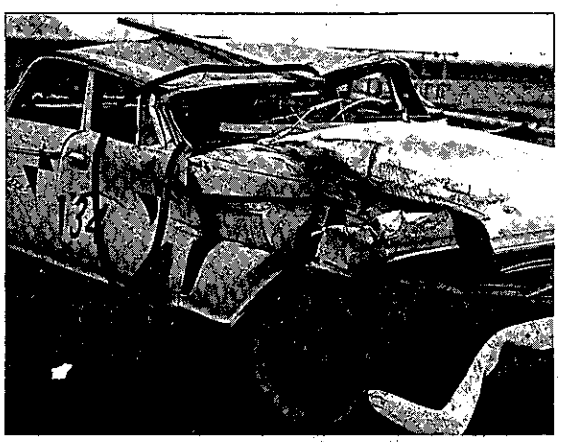
Figure 5

The vehicle sustained major front, side, and top damage and was considered a total loss (Figure 5).

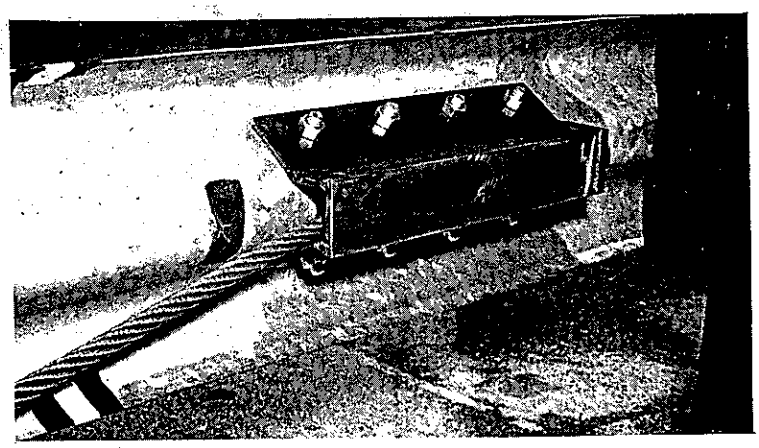
Figure 6

The test installation consisted of a 50-ft length of corrugated metal beam guardrail constructed as a parabolic flare. In order to reduce the lever arm effect of the axial force acting about the posts, block-out blocks were not installed on the end posts and 4-in. thick blocks were used on the posts next to the end. Each end of the beam was secured with a 3/4-in. steel cable (breaking strength 21.4 tons) attached to the beam with a special fitting between the first and second posts (Figure 6 and Exhibit 1).

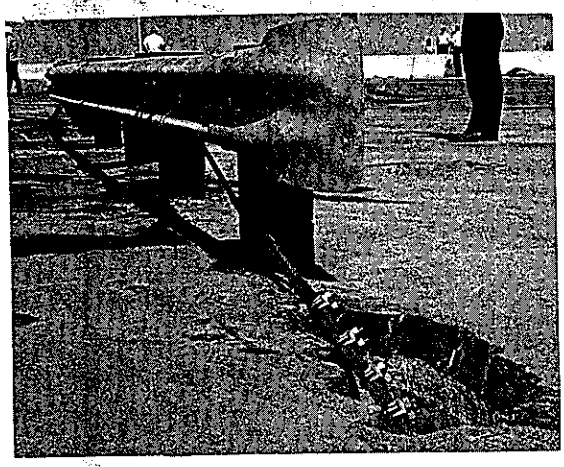
Figure 7

The other end of each cable was clamped to a 1-1/4-in. eye bolt cast in an 18-in. dia by 5-ft deep cylindrical concrete footing (Figures 7 and 8).

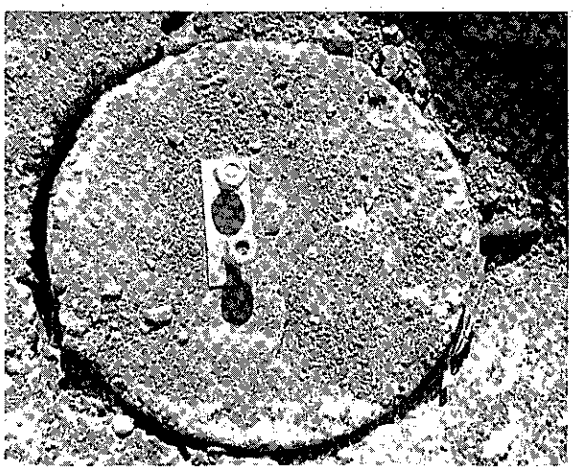
Figure 9

All beam sections were damaged and both anchors were displaced approximately 5/8 in. toward impact (Figure 9). The test vehicle sustained moderate front end damage (Figure 10).

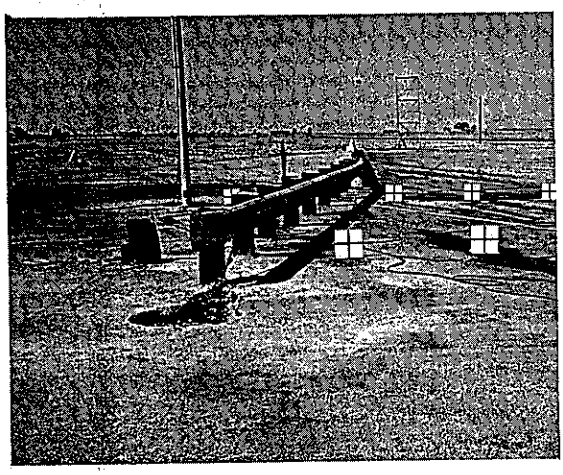
Figure 11

the first 12 ft from the bridge rail end so the remainder of the barrier could be placed on a straight line with a 4- ft end offset from a projection of the bridge rail line (Figure 11). The downstream end of the guardrail beam was secured to a nonreinforced concrete simulated bridge rail with two 1-in. dia high strength bolts through 1-1/8-in. dia holes bored through the concrete. An 8- by 12- by 18-in. wood block was placed between the beam and the concrete (Figure 12).

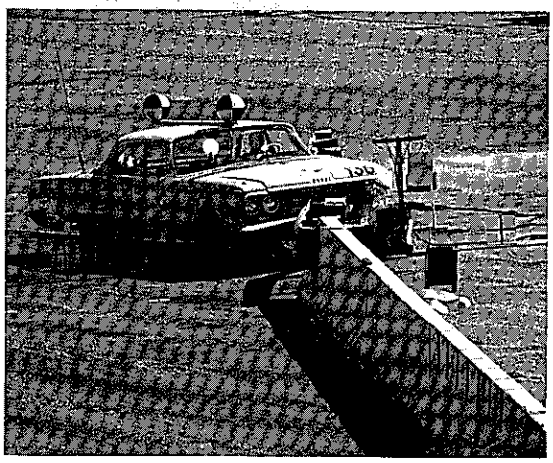
The test vehicle impacted the guardrail at 60 mph/33 deg 18 ft upstream of the end of the simulated bridge rail, pocketing the beam severely (see Figure 13 and Plate D). As the vehicle was being redirected, the nonreinforced concrete bridge rail failed through the connection holes, allowing the beam to pull free and permitting the vehicle to penetrate the barrier. As the vehicle progressed through impact, the right front wheel struck the end of the concrete rail throwing the vehicle into a violent roll-over. The vehicle came to rest 45 ft beyond initial impact in an upright position. Two sections of beam were damaged, three timber posts broken off, and four block-out blocks shattered. The vehicle sustained major front, side, and top damage and was considered a total loss (Figure 14).

Analysis of the data film indicated that even if the concrete bridge rail connection had not failed, beam deflection and pocketing had already occurred to such an

extent that the vehicle would not have been redirected sufficiently to avoid an end-on collision into the concrete rail.

To correct the deficiencies noted in the previous Test 136, several modifications were made for the Test 137 installation. To more accurately depict a typical installation, a simulated California Standard Type 1 bridge rail end post was constructed of reinforced concrete in accordance with design details typical of current operational installations. A 50-ft section of metal beam guardrail was constructed on a straight line so that the upstream end was offset 4-ft from the projected bridge rail line (Figure 15).

The block between the guardrail beam and the concrete end post was constructed of 1/4-in. steel plate rather than wood (see Figure 16 and Exhibit 2) to add rigidity to the system and prevent crushing of the block as occurred in the previous test.

To minimize the pocketing noted in Test 136 and to provide a smooth transition from the semi-flexible guardrail to the rigid bridge rail, the guardrail post spacing near the bridge rail was decreased from 6-ft 3-in. to 3-ft 1-1/2-in. and the size of the three wood posts immediately adjacent to the bridge rail was increased from 8- by 8-in. to 10- by 10-in. posts. The upstream end of the guardrail was anchored with the same cable anchorage installation used in Test 136 (see Exhibits 1 and 2).

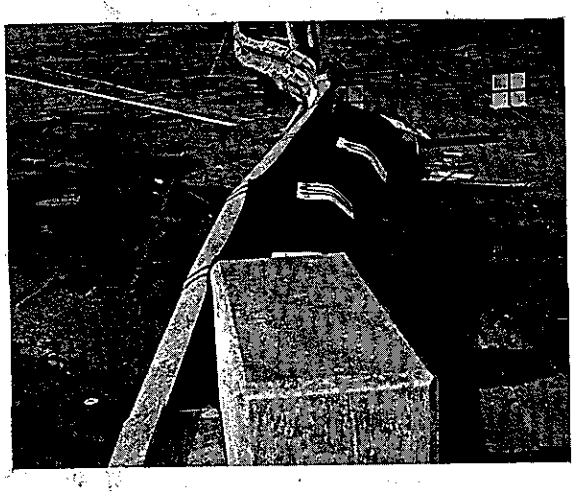
Figure 17

The guardrail beam sustained a permanent deflection of 2.1 ft (Figure 17).

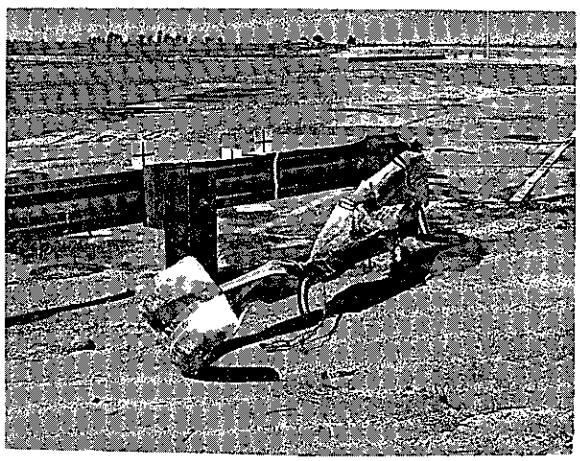
Figure 19

spearing" into the end of a flared guardrail section are not great, the upstream cable anchorage system does present a potential hazard. In Test 138 (installation identical to Test 137) the vehicle impacted the guardrail at 61 mph/25 deg into the end terminal section, upstream of the cable-to-beam connection. The beam bent, the left front wheel rode up and over the cable anchor eye-bolt and the vehicle, straddling the cable, impacted post No. 1. The cable failed in tension as the vehicle, pushing the beam ahead of it, penetrated the barrier (see Plate F and Figure 19).

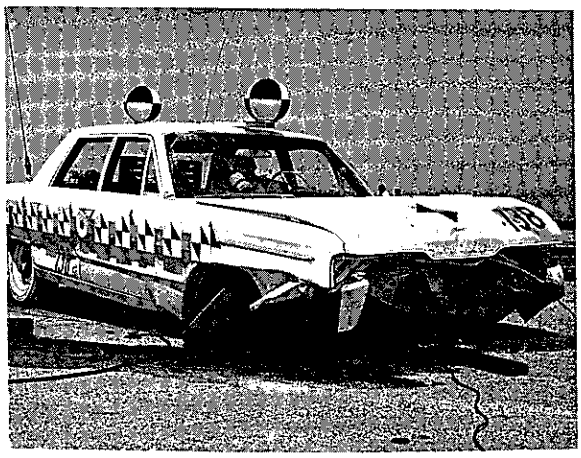
Figure 20

The vehicle sustained major front end damage with both front wheels smashed back under the engine compartment and was considered a total loss (Figure 20).

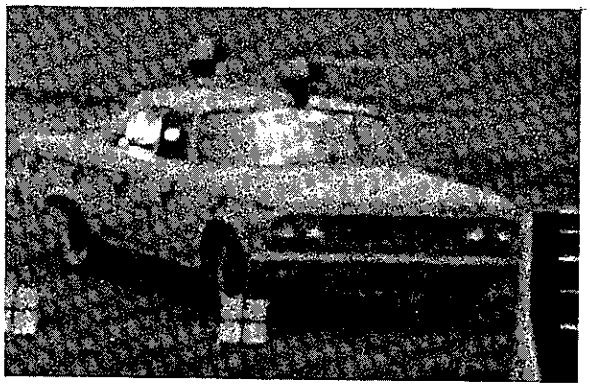
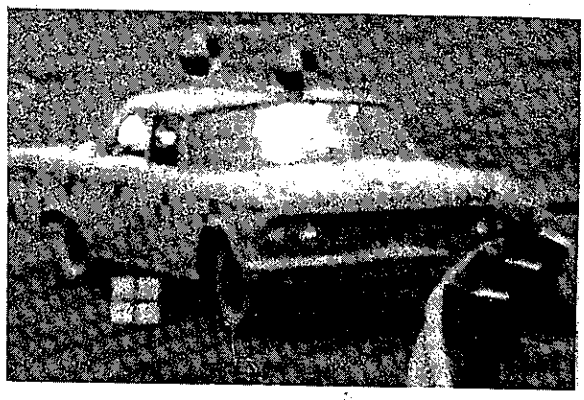
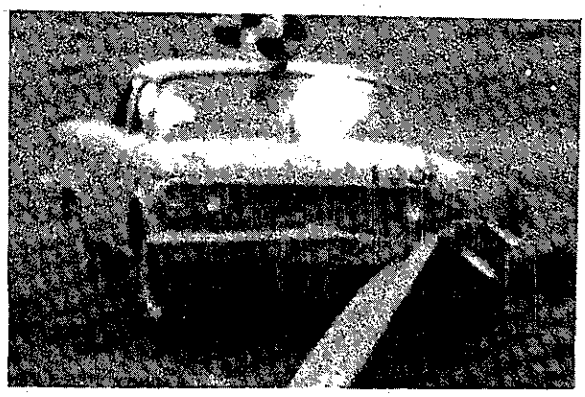
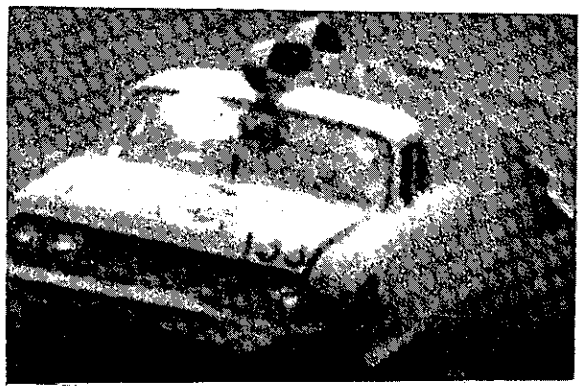
PLATE A TEST 133

being effectively redirected at an exit angle of 7 deg (see Plate A). Vehicle dynamics through impact were

considered good with the vehicle sustaining moderate front end damage (Figure 2). The permanent deflection of the guardrail beam was 2.8-ft horizontal (back) and 6-in. vertical (up).

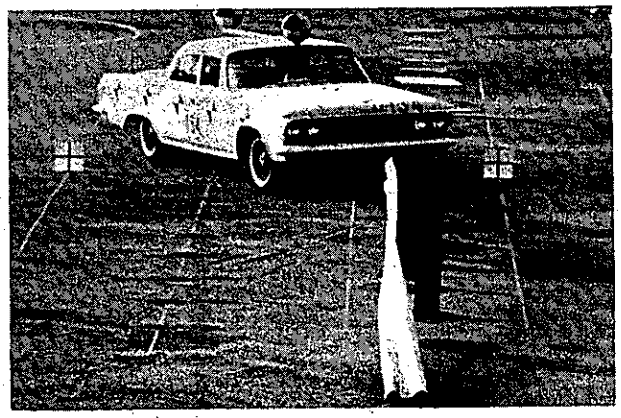
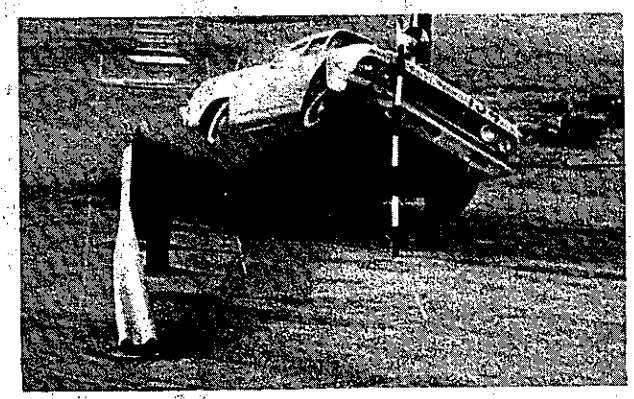
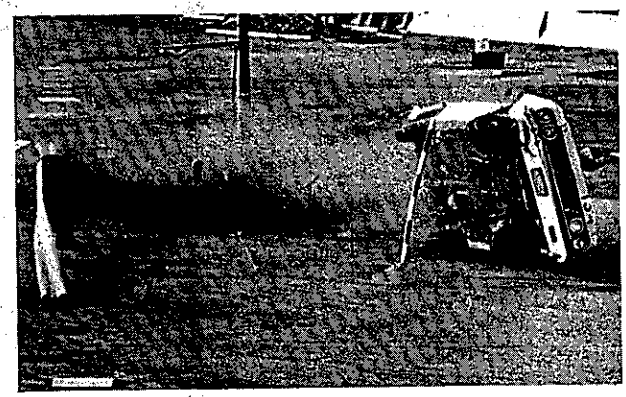
PLATE B TEST 134

2. Although Test 133 demonstrated the structural adequacy of the "Texas Twist" design in providing effective anchorage for short sections of guardrail, Test 134 showed that a hazardous condition exists when vehicle impact occurs at the upstream sloping beam end anchorage.

Although Test 133 demonstrated that the "Texas Twist" anchorage system was structurally adequate, it was felt that the geometric characteristic of the sloping beam end anchorages presented a potentially hazardous condition. The sloping beam could form a ramp upon which an impacting vehicle might climb and vault the barrier. Therefore, in Test 134 (installation identical to Test 133), the point of impact was shifted upstream with the vehicle impacting the barrier within the sloping beam portion, 4.9-ft from the concrete end anchor, at 63 mph/24 deg. The beam at this point was too low to effectively resist the vertical downward force of the impacting left front wheel which deflected the beam down, permitting the front wheel to ride up and over the beam. This reaction of the beam imparted a rolling moment to the vehicle which completely overturned as it vaulted the barrier. The vehicle came to rest 180 ft beyond impact in a regained upright position (see Plate B).

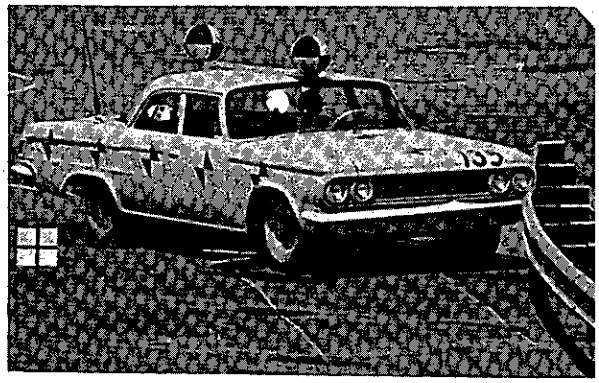
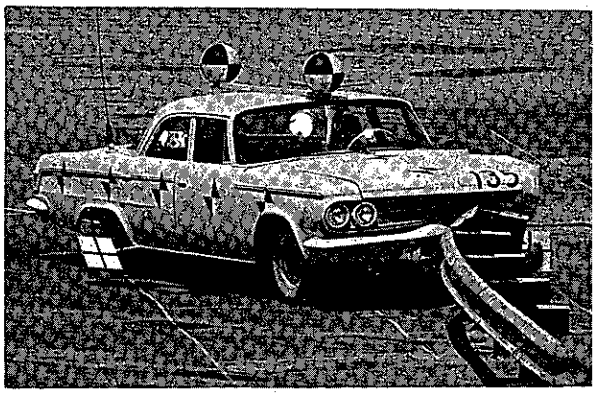
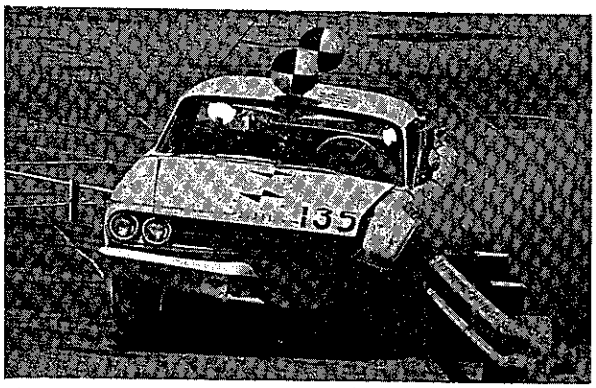
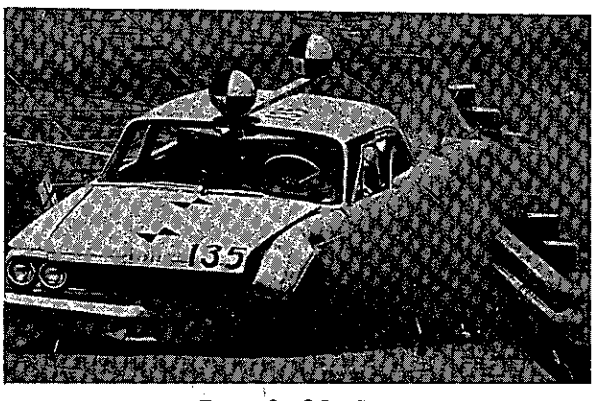
PLATE C TEST 135

4. Test 135 indicated that a parabolic layout line for an anchored guardrail section will increase the likelihood of pocketing over that of a straight section between the same two end anchor points under similar conditions of impact.

The vehicle in Test 135 impacted the barrier between posts No. 2 and 3 at 59 mph/28 deg. The vehicle remained in contact with the barrier for approximately 22 ft before being effectively redirected at an exit angle of 24 deg (see Plate C).

Although vehicle dynamics and barrier reaction were considered satisfactory through impact, deceleration forces were fairly severe as there was a tendency for the vehicle to pocket the beam. Analysis of high speed data film revealed that this pocketing was due, at least partially, to the parabolic configuration of the barrier, since the curved beam had to deform through a straight line before the restraining force of the anchor was effectively developed. As a result, it has been recommended that all short sections of guardrail be flared and placed on a straight line between anchor points even though there is a possibility of increasing the collision impact angle by doing so.

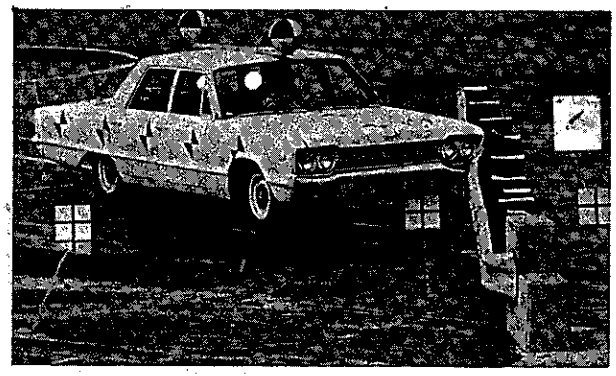
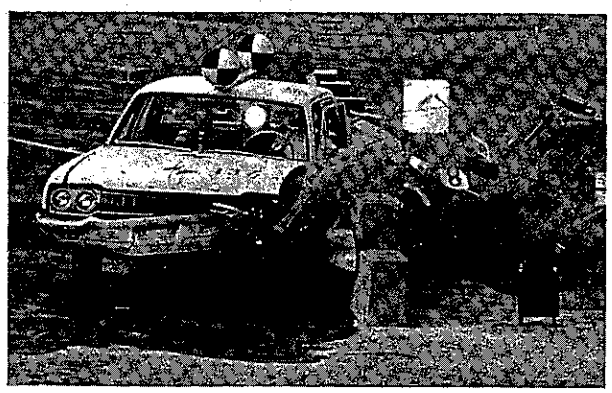
PLATE E TEST 137

The vehicle impacted near the center of the guardrail section at 61 mph/27 deg and remained in contact with the

barrier for approximately 22 ft before being effectively redirected at an exit angle of 16 deg (see Plate E).

Although vehicle dynamics in this high speed oblique angle collision were considered good through impact, the left front wheel was torn off and the vehicle sustained major front end and undercarriage damage. The vehicle was considered a total loss (Figure 18).

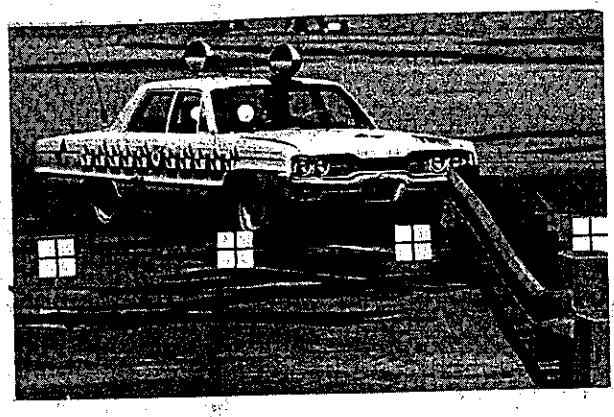
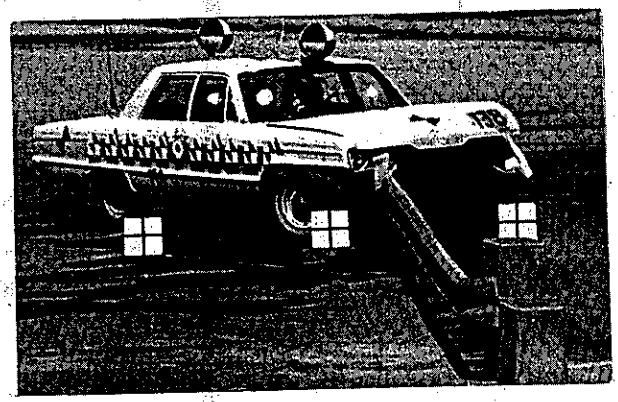
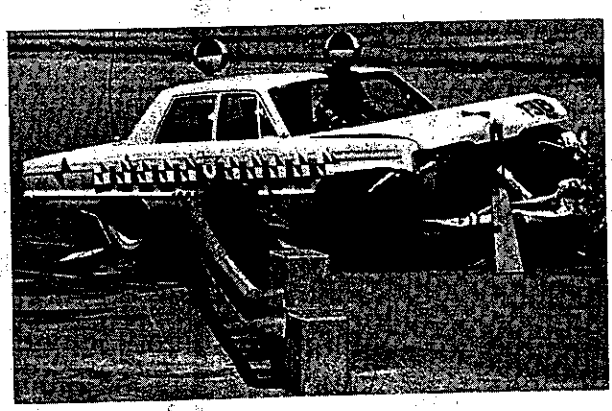
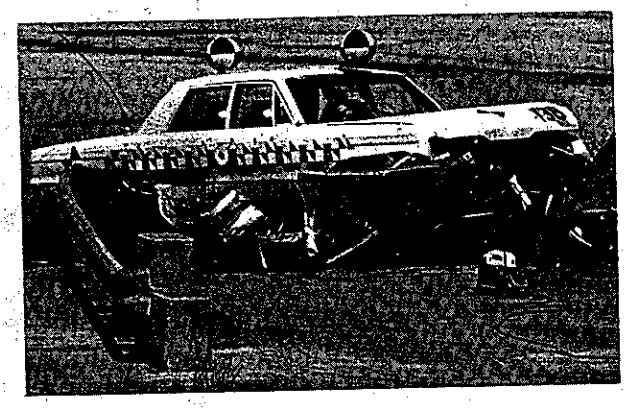
PLATE F TEST 138

5. Test 138 indicated that the effect of a high speed oblique angle impact into the upstream end of a cable anchored guardrail, although sever, is less hazardous than similar impact into sloping beam guardrail end anchorage systems. This would be particularly true for sections of guardrail which are flared away from the traveled way, thereby minimizing the chances of head-on end impact.
