HIGHWAY RESEARCH REPORT

MOVEMENT WITHIN LARGE FILLS
RIDGE ROUTE PROJECT

INTERIM REPORT

NO. M & R 632509-3

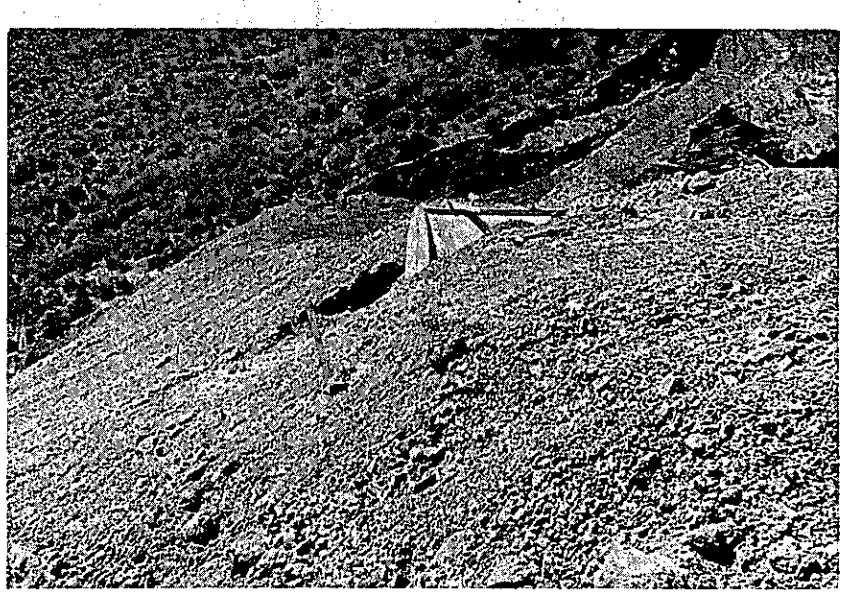
The use of instrument shelters has proved to be entirely effective in preventing extensive damage to instrumentation similar to that which occurred on the San Luis Reservoir Relocation project. Although several of the shelters suffered moderate to heavy damage during construction, all instrumentation remained operable.

Figure 2. Instrument shelter in place at Osito Canyon Fill.
