FINAL REPORT ON THE ZACA-WIGMORE TEST ROAD

By
Ernest Zube and John B. Skog

RESEARCH REPORT

NO. M & R 643308

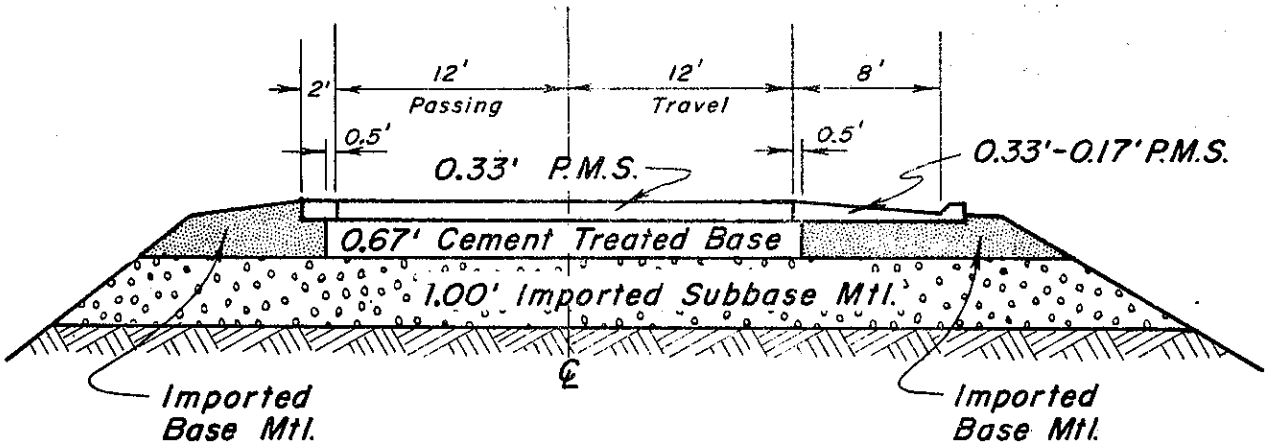
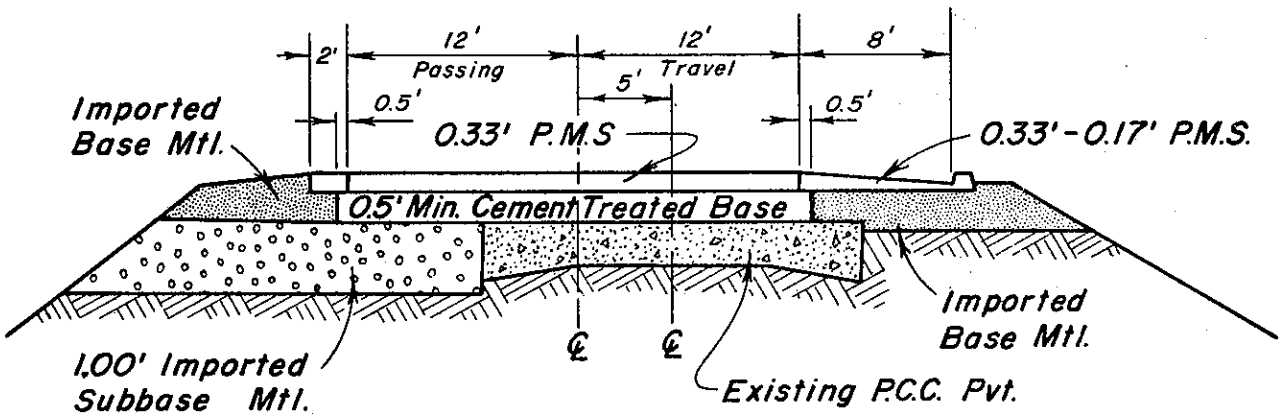
Figure 1

The contract consisted of converting six miles of an existing two lane highway into a four lane divided expressway by constructing two new lanes, and widening the existing pavement. Based on soil surveys and an anticipated Traffic Index of 9.0, the typical structural section for the new alignment consisted of 1.0 ft. imported subbase material, 0.67 ft. of Class B, cement-treated base, and 0.33 ft. asphalt concrete Type B. The existing facility consisted primarily of an old portland cement concrete pavement constructed in the early 30's which was in fair to poor condition. The reconstruction design provided a minimum of 0.5 ft. Class B, cement-treated base to be placed over the existing pavement and to be surfaced with 0.33 ft. of asphalt concrete, Type B. The existing concrete pavement was also subsealed with asphalt prior to placing the new cement-treated base. The roadway was widened to provide a geometric section similar to the new construction. The typical sections for both new and existing pavements are shown in Figure 1.

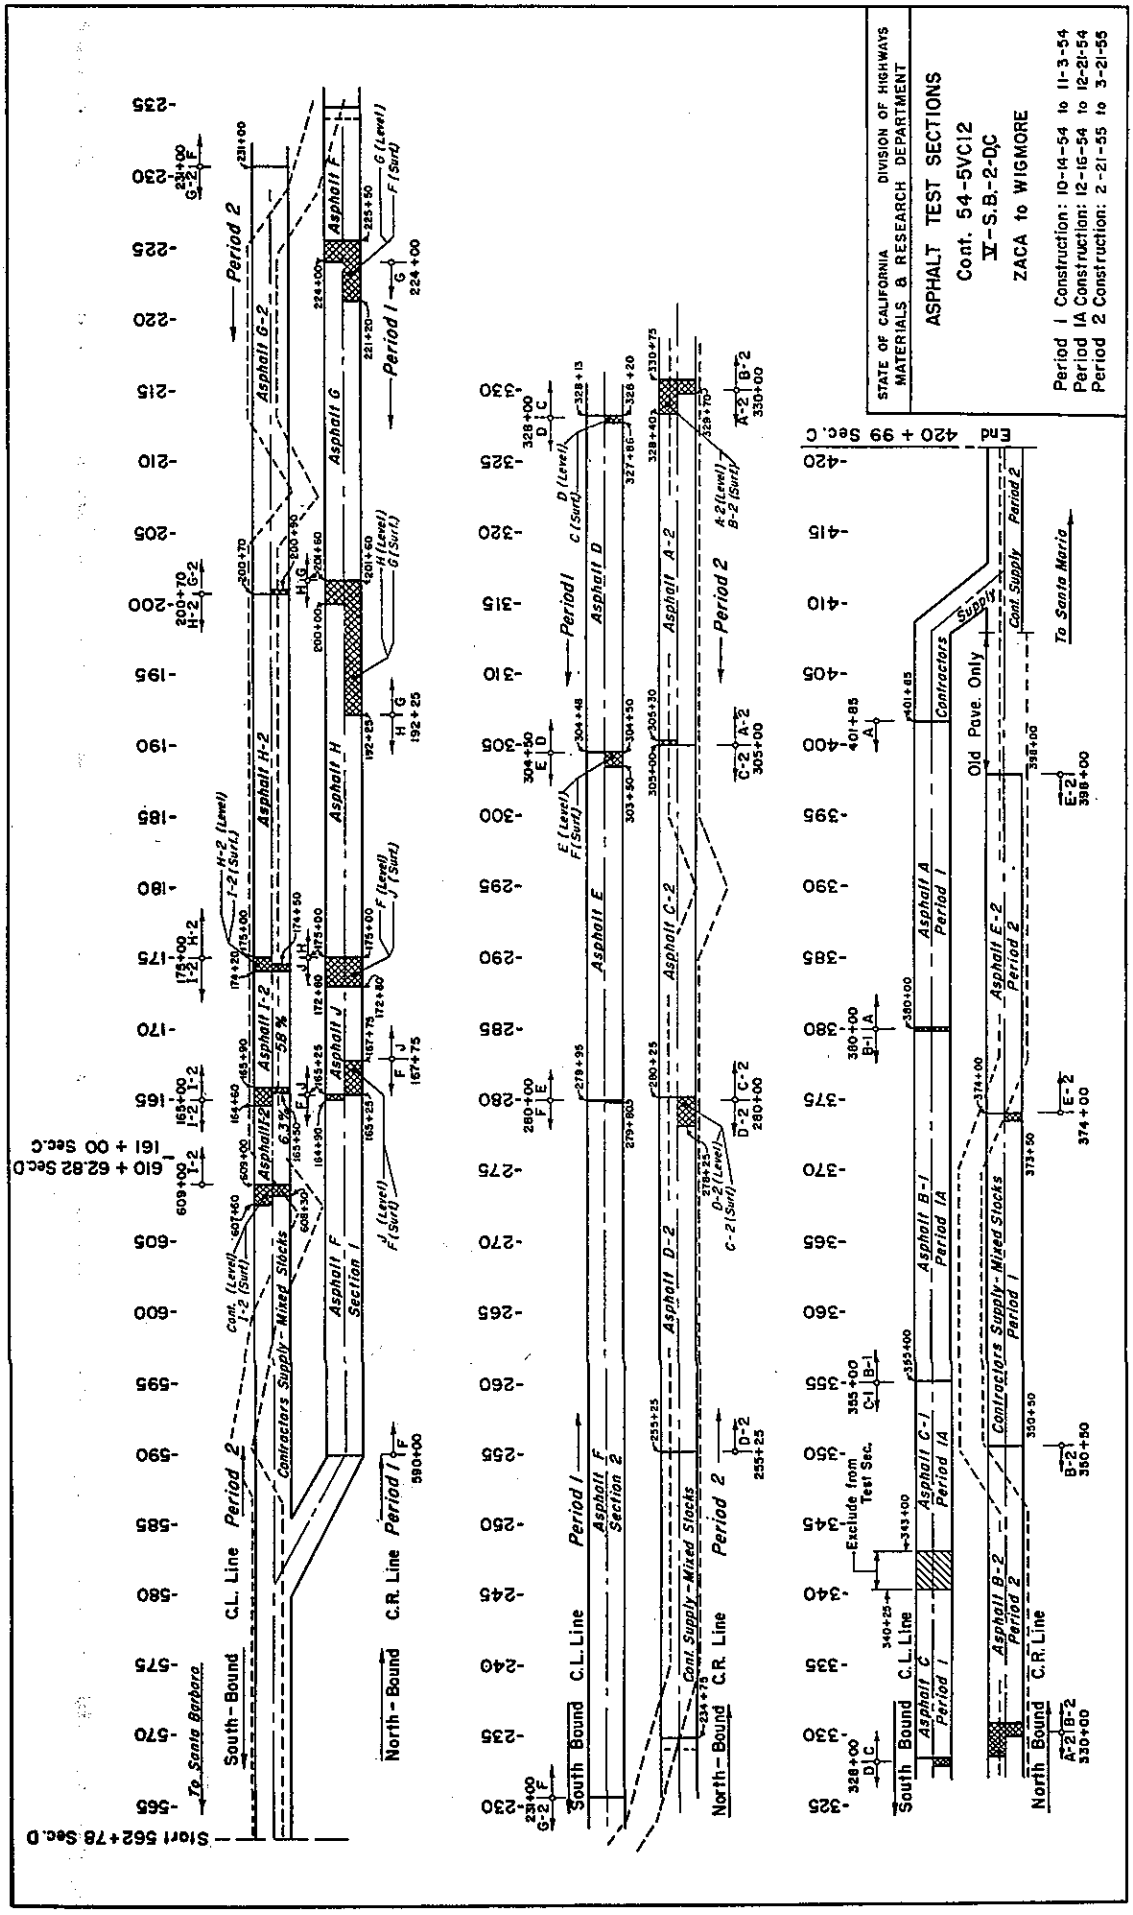
Figure 2

The reasons for selection of the various asphalts are discussed in detail in reference (1). The project as finally constructed is shown in Figure 2. It contained six asphalts complying with the new tentative 1954 specification, two asphalts complying with the requirements of section 54 of the 1954 Standard Specifications and two asphalts not commercially available in California at the time, but placed in order to aid in the evaluation of new test procedures. The following table lists the asphalts by code letters and the specification designations. Paving on new alignment was performed during period 1 and 1A, while paving over the existing pavement was done during period 2.

The asphalts used in the paving mixture during each of these paving periods are shown in Figure 2.

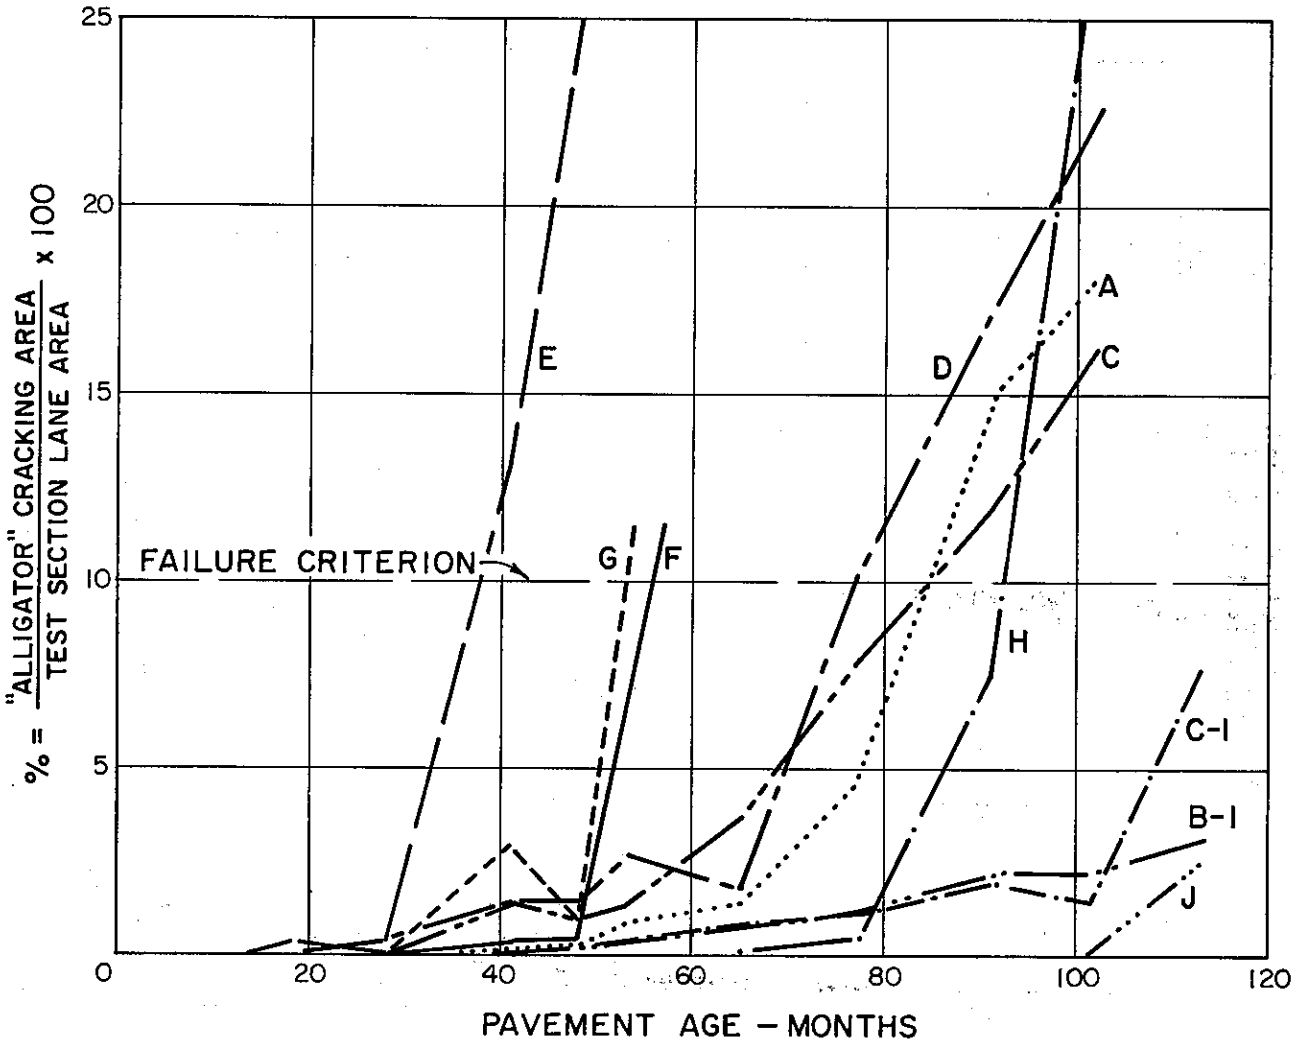
Figure 3

An interesting finding in connection with the "alligator" type cracking in the various sections is the almost explosive increase in area after a certain period of service life, Figures 3 and 4.

The results from this test road clearly indicate that a very rapid increase in "alligator" type cracking may be expected after 10% of the lane area is reached. In other words it may be possible to predict the extent of future maintenance, and the time for required overlay construction by determining when the first rapid increase in "alligator" cracking occurs.

"ALLIGATOR" TYPE CRACKING IN THE TRAVEL LANE DURING SERVICE LIFE

NEW ALIGNMENT

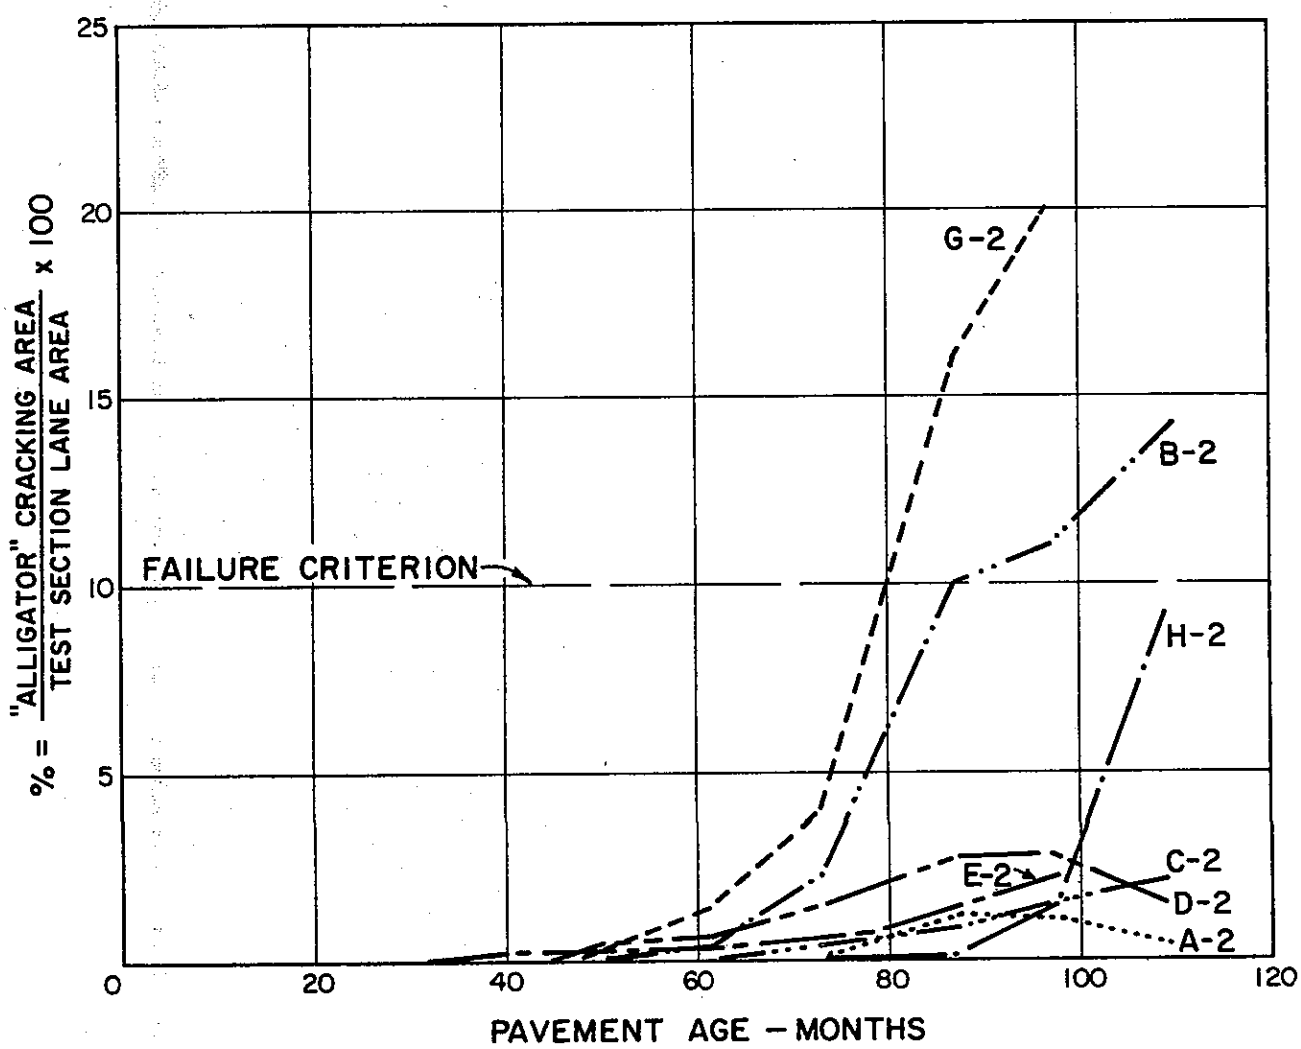
Figure 4

"ALLIGATOR" TYPE CRACKING IN THE TRAVEL LANE DURING SERVICE LIFE

EXISTING ALIGNMENT

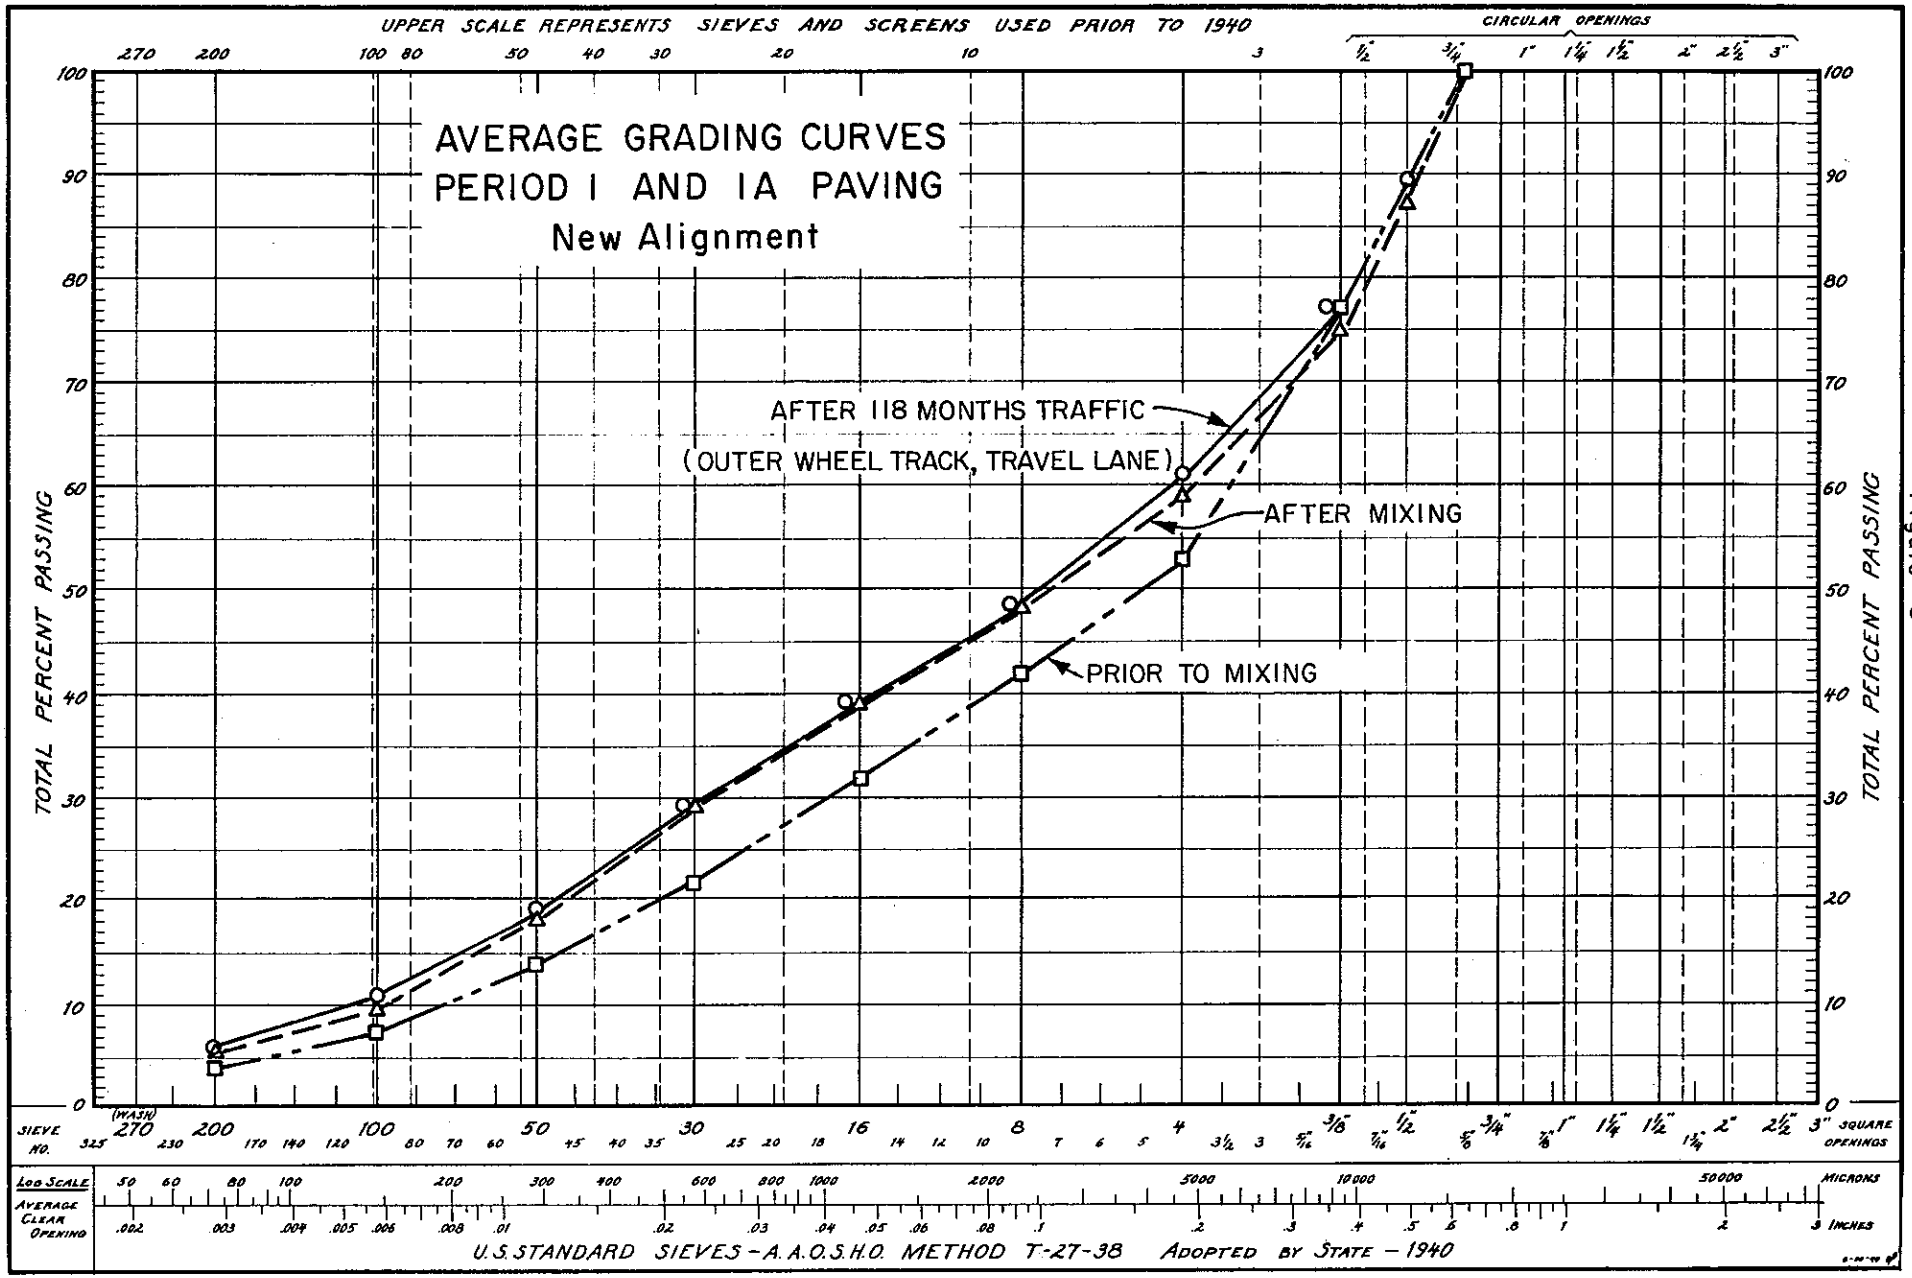
Figure 5

The average grading results from the various core series are shown in Figure 5. There has been virtually no degradation during service life although a definite change was found during the mixing operation.

SEMI-LOG CHART FOR GRADING CURVES

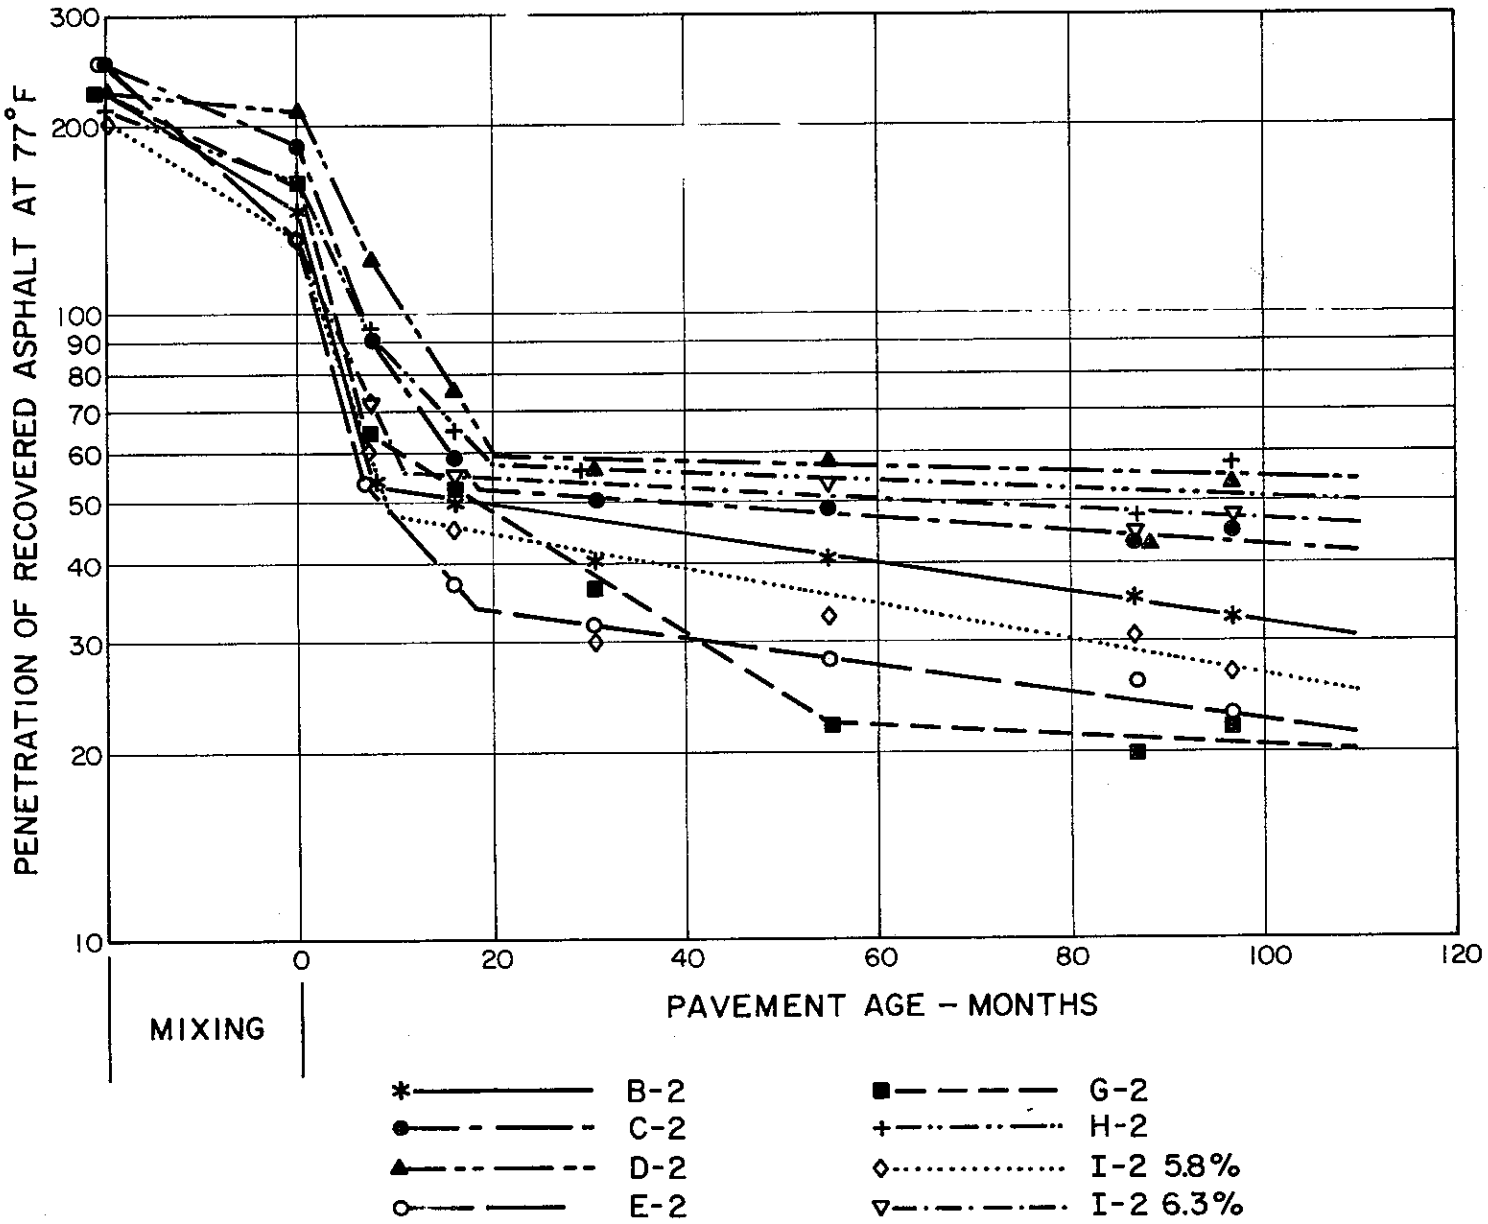
Figure 7

ZACA-WIGMORE PROJECT
PERIOD 2 PAVING

ALL CORES FROM OUTER WHEEL TRACK OF TRAVEL LANE

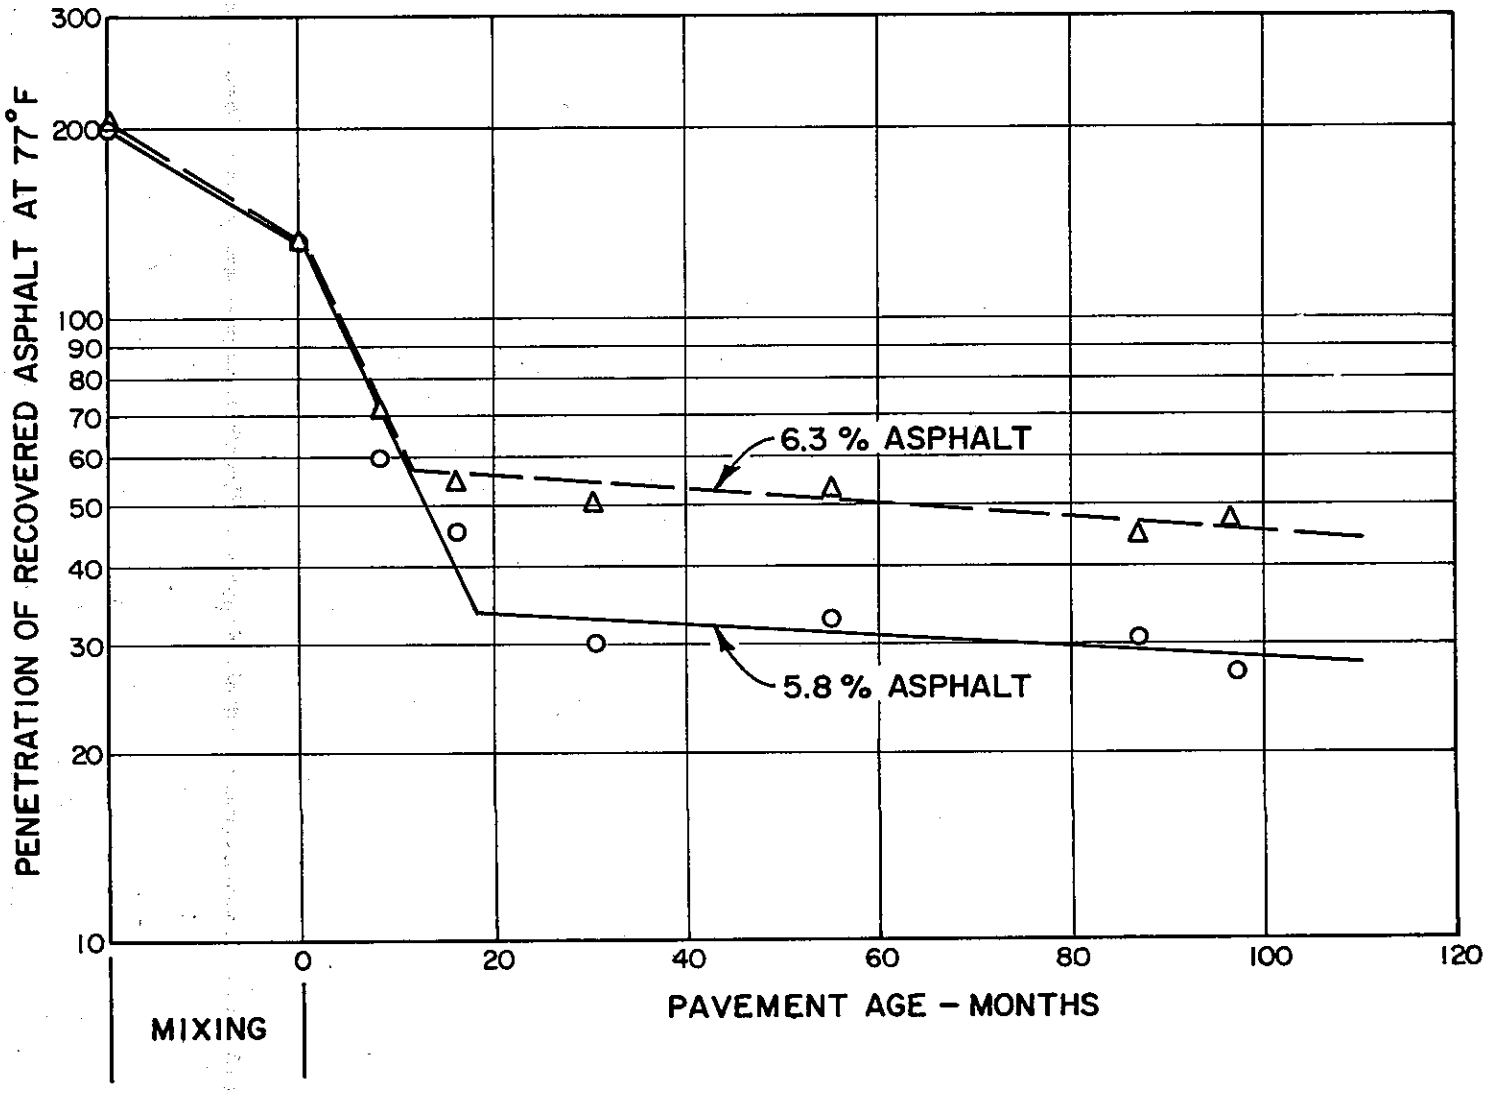
Figure 8

In the case of asphalt I-2, two asphalt contents, 5.8 and 6.3 percent, were used for the adjacent test sections. The change in penetration during mixing and service life is shown in Figure 8. The difference in asphalt content did not appear to be reflected in the penetration drop during mixing and the difference in asphalt content (film thickness) and percent voids, Figure 9, did not influence the rate of hardening

CHANGE IN PENETRATION DURING MIXING AND SERVICE LIFE
ASPHALT I-2, PERIOD 2 PAVING

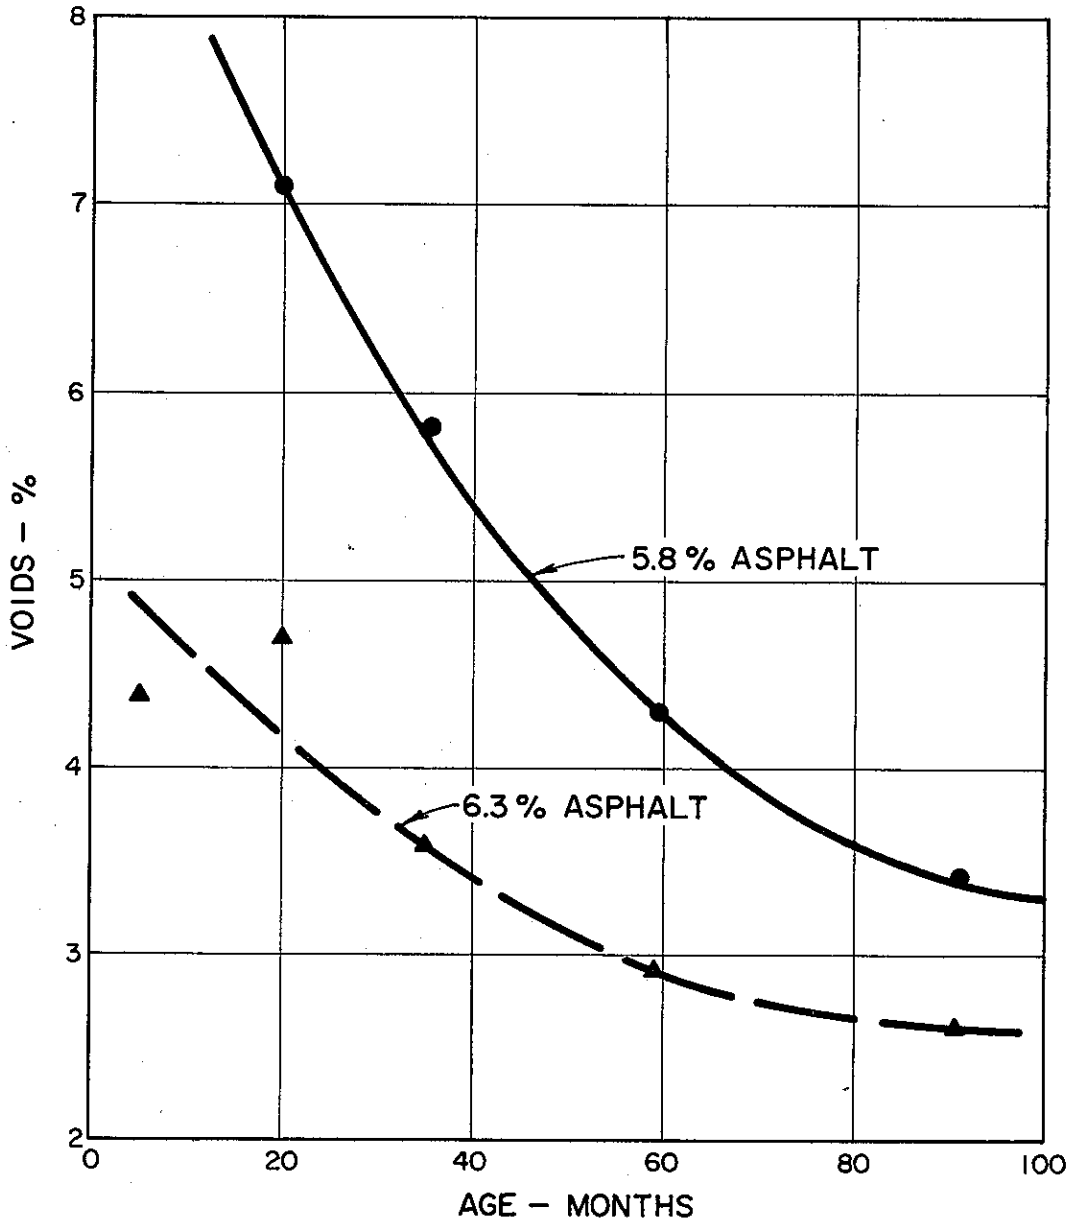
Figure 9

CHANGE IN VOID CONTENT DURING SERVICE LIFE FOR TEST SECTIONS CONTAINING 5.8 % AND 6.3 % OF I-2 ASPHALT

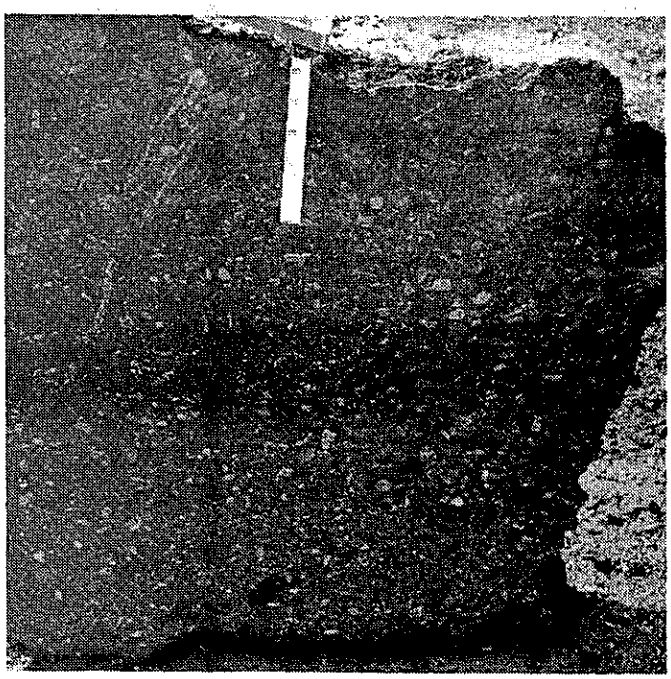
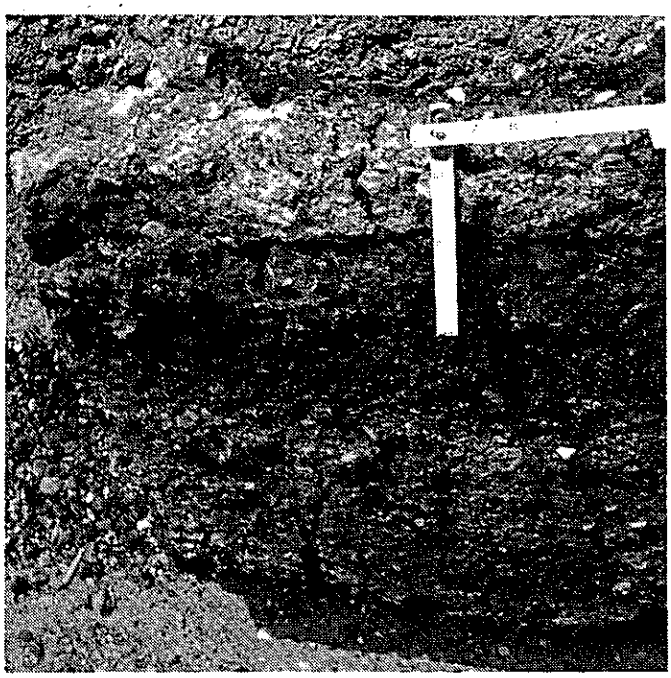
Figure 12

Prior to resurfacing the Zaca-Wigmore Project in 1964, a number of badly "alligator" cracked pavement areas were removed, and replaced with new mixture. During the removal of these areas photographs and observation were made as the large blocks of pavement were lifted from the cement treated base. At a number of locations cracks were found in the bottom of the level course with only a few of these cracks appearing at the surface, Figure 12. There was also evidence of pumping of base fines into the intimate part of the mix as determined by breaking blocks of the pavement and noting the presence of fines. Within the wheel track areas where pumping was evident, the top 1/2 inch of the CTB was quite friable or loose, while below this layer the base was in good condition. In locations where pumping was not evident the pavement had a good bond to the base even though "alligator" cracked. The surface of the CTB was somewhat variable in hardness when tested with a pick, but no cracking of the base was evident even in the wheel tracks, at any of the 21 dig-out locations covering a total of 6268' of 12' lane although all of these locations displayed very severe "alligator" cracking.

Previous examinations of the cracked faces of numerous blocks consistently indicated that the cracking occurred in the matrix of the mix. In only a very few cases were rocks broken along the fracture face although many of the larger aggregate particles were soft and could be easily broken. These observations lead to the conclusion that fatigue cracking on this project started with cracking at the bottom of the pavement. These cracks progressed through the pavement within the binder matrix. Crack propagation probably was initiated during the warm part of the season when the stiffness of the pavement was at a minimum. These findings confirm the studies of Monismith (8) which indicates that the most critical temperature for fatigue in asphalt concrete is in the range of 60-80°F.

4. The fatigue cracking appears to be of the strain type and started in the bottom of the level course. The cracking progressed through the matrix of the mix. In some areas of the project there was evidence of base fines pumped into the intimate part of the pavement as well as along the existing crack faces. Evidence does not indicate that this pumping was a cause of fatigue cracking on the project since many areas were cracked within any specific section with no signs of pumping. Periodical surveys indicate that the fatigue cracking started at isolated places in the wheel tracks of the travel lane and progressed from these spots in opposite directions. The length of these areas might ultimately exceed two hundred feet. It is difficult to assign a reason for this cracking movement from an isolated starting point.

Top of Pavement

Bottom of Pavement

Cracking Pattern of Top and Bottom
of Pavement After 9 Years
of Service Life

The entire project was resurfaced in 1964 with 3" of asphalt concrete. The present condition of this blanket is excellent.

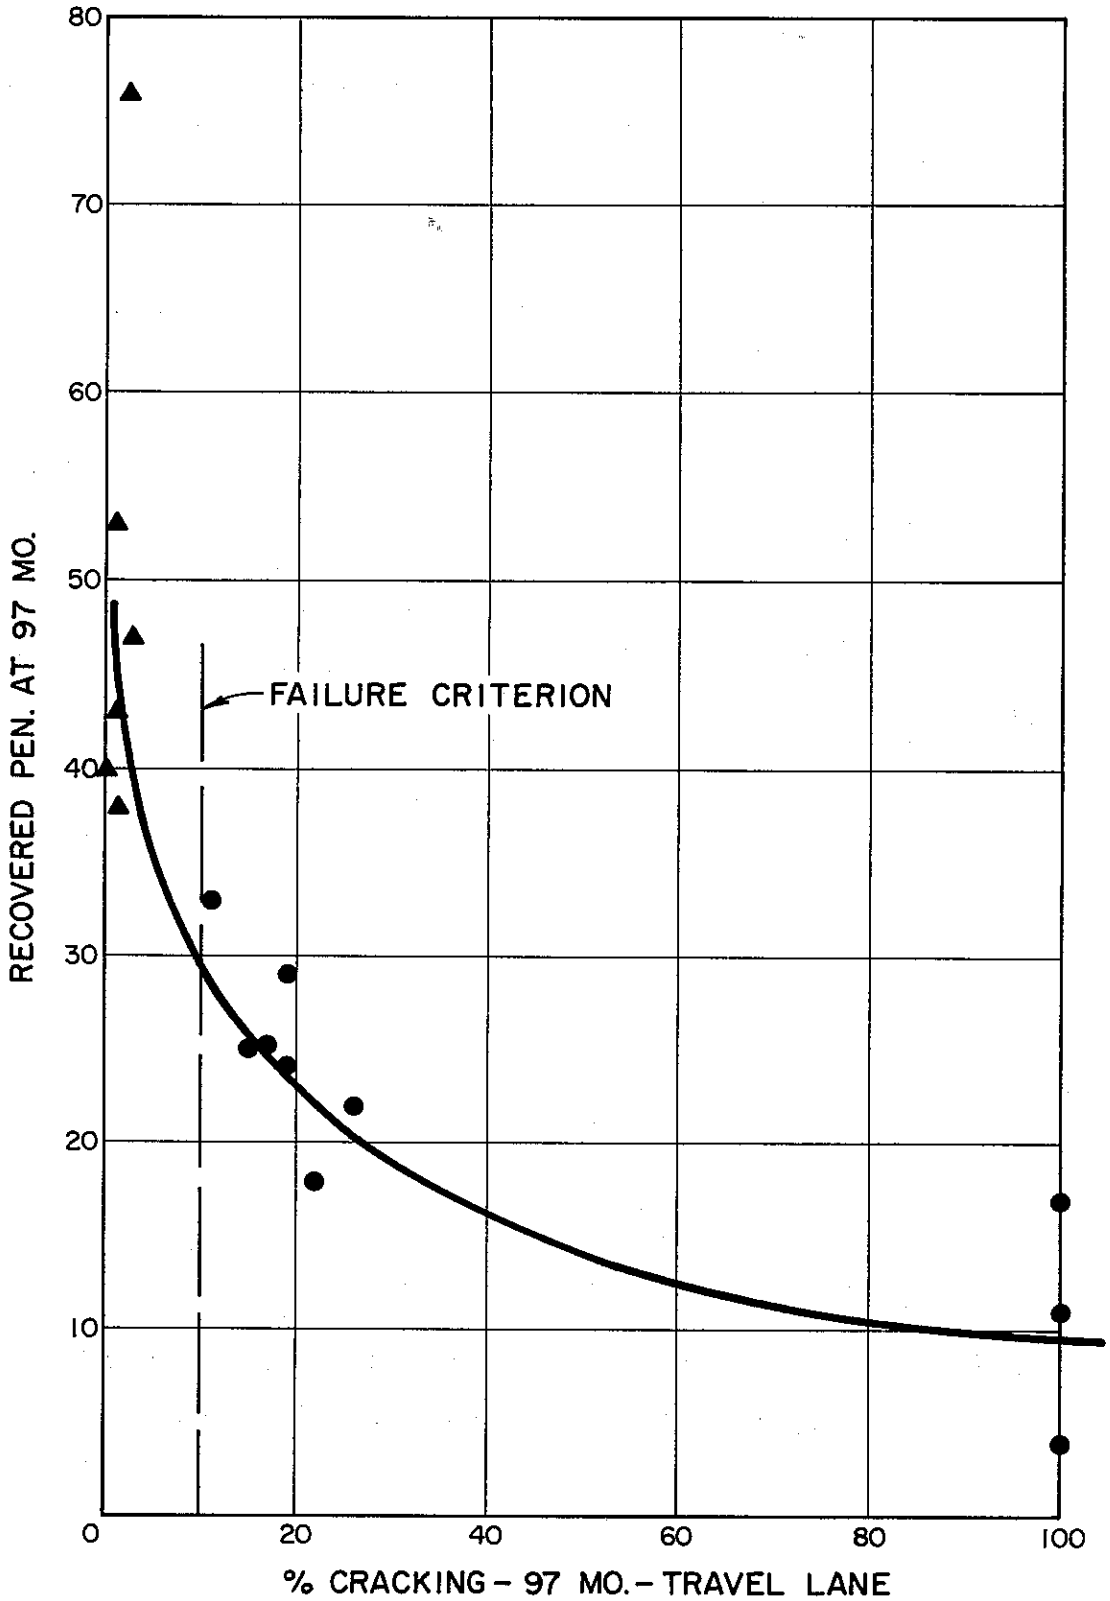
Figure 13

R. J. Schmidt (9) has found that the increase in "alligator" type cracking during service life as shown in Figures 3 and 4 produces a straight line when plotted on semi-log paper. This allows extrapolation of the curves to any service age. Using such a method the percentage of cracking at the end of 97 months of service life was determined and the consistency of the recovered asphalt determined from penetration and viscosity charts. The results, Table N and Figure 13, clearly indicate that the penetration of the recovered asphalt is related to the percentage of fatigue type cracking. On this specific project the results indicate that approximately thirty penetration is the critical consistency for the failure criterion adopted for the project for fatigue type cracking. The viscosity at 77°F and 0.05 Sec^{-1} Shear Rate also provides a good correlation for the percentage of fatigue cracking.

COMPARISON OF CONSISTENCY OF RECOVERED ASPHALTS AND PERCENTAGE OF "ALLIGATOR" TYPE CRACKING AFTER 97 MONTHS OF SERVICE LIFE

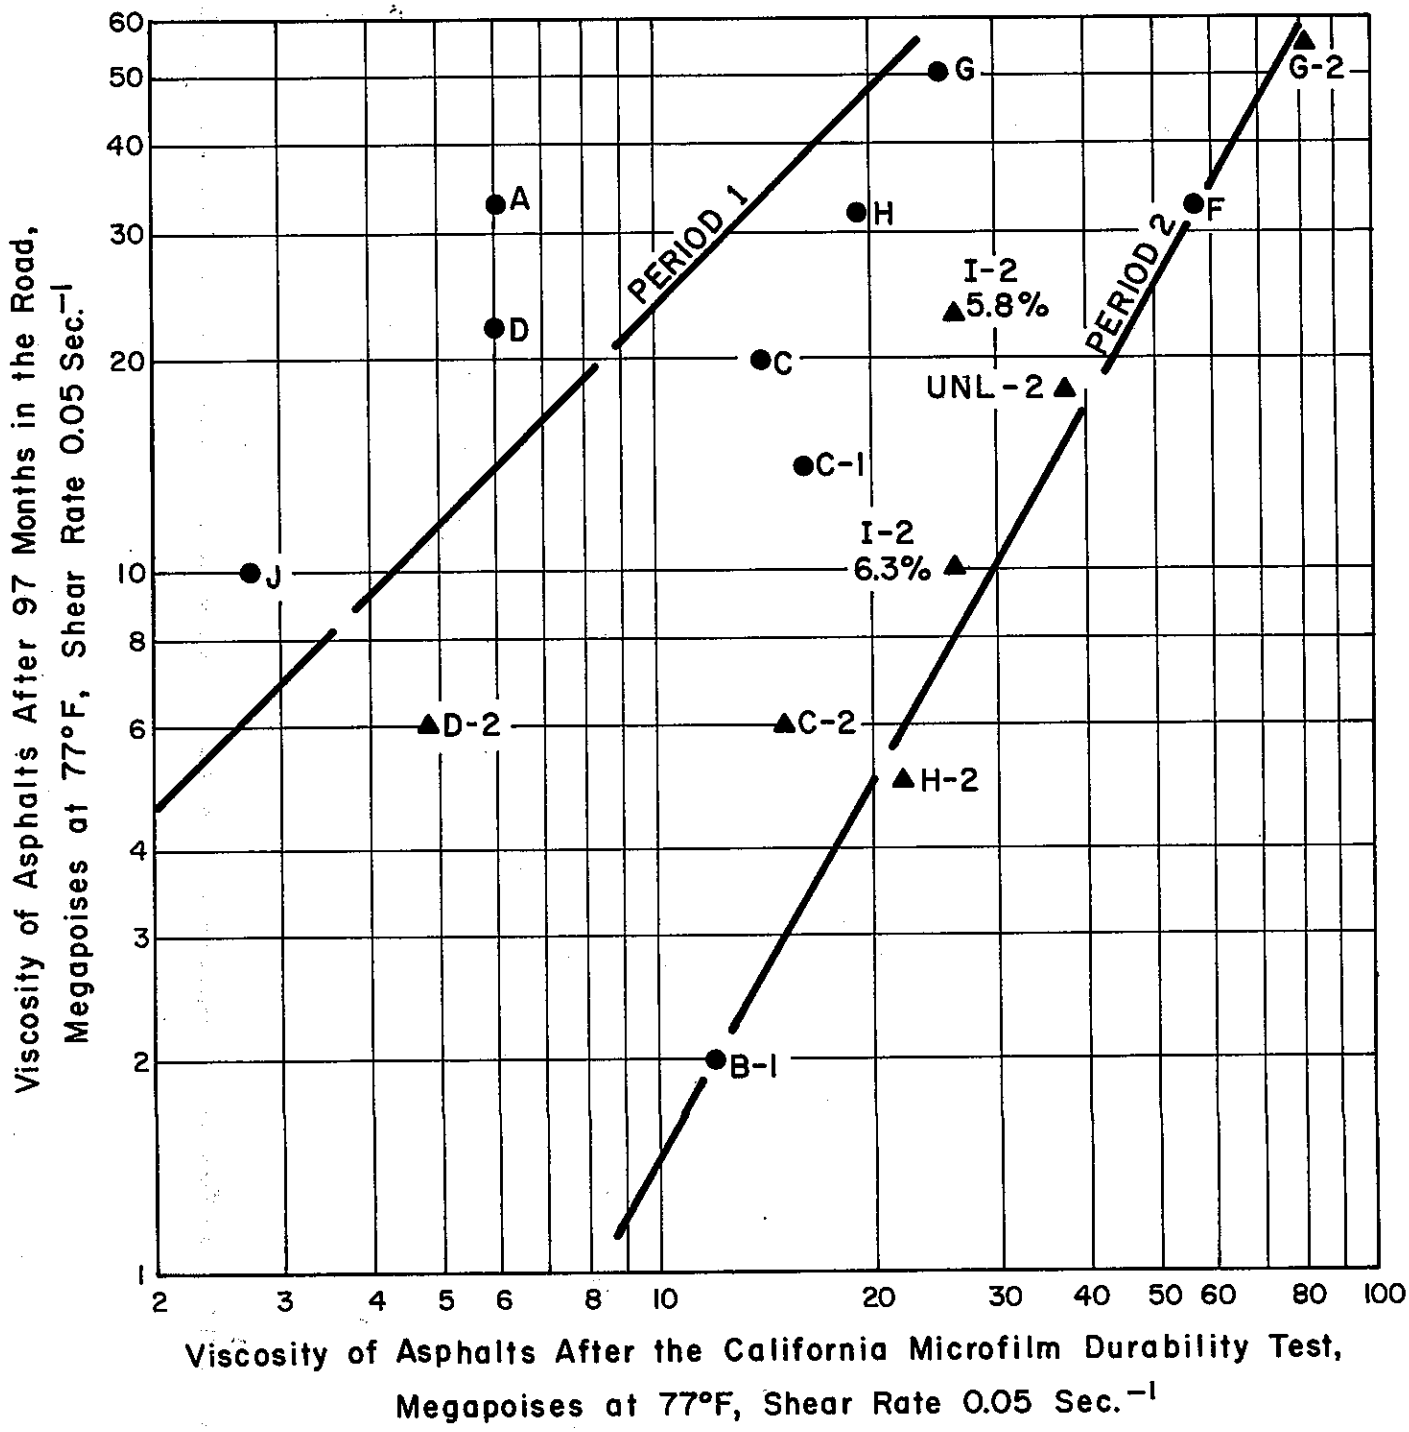
Figure 14

The best test for predicting durability of the asphalt used on this project appears to be the Modified Shell Durability test (10). W. C. Simpson, et al, (11) found a definite correlation between the viscosity after 16 and 30 months of service life and the viscosity after the microfilm durability test. These studies are further confirmed when the comparison is made after 97 months of service life, Figure 14. The data are more scattered, but most of the asphalts used in period 1 paving have weathered faster in the road than those used in period 2.

COMPARISON OF VISCOSITY AFTER 97 MONTHS OF SERVICE LIFE WITH VISCOSITY AFTER THE MICROFILM DURABILITY TEST
