Interim Report
M&R 643450
June, 1970

DEFLECTION STUDIES PERFORMED ON

EL CENTRO ROAD (03-SAC-99)

TEN YEAR REPORT

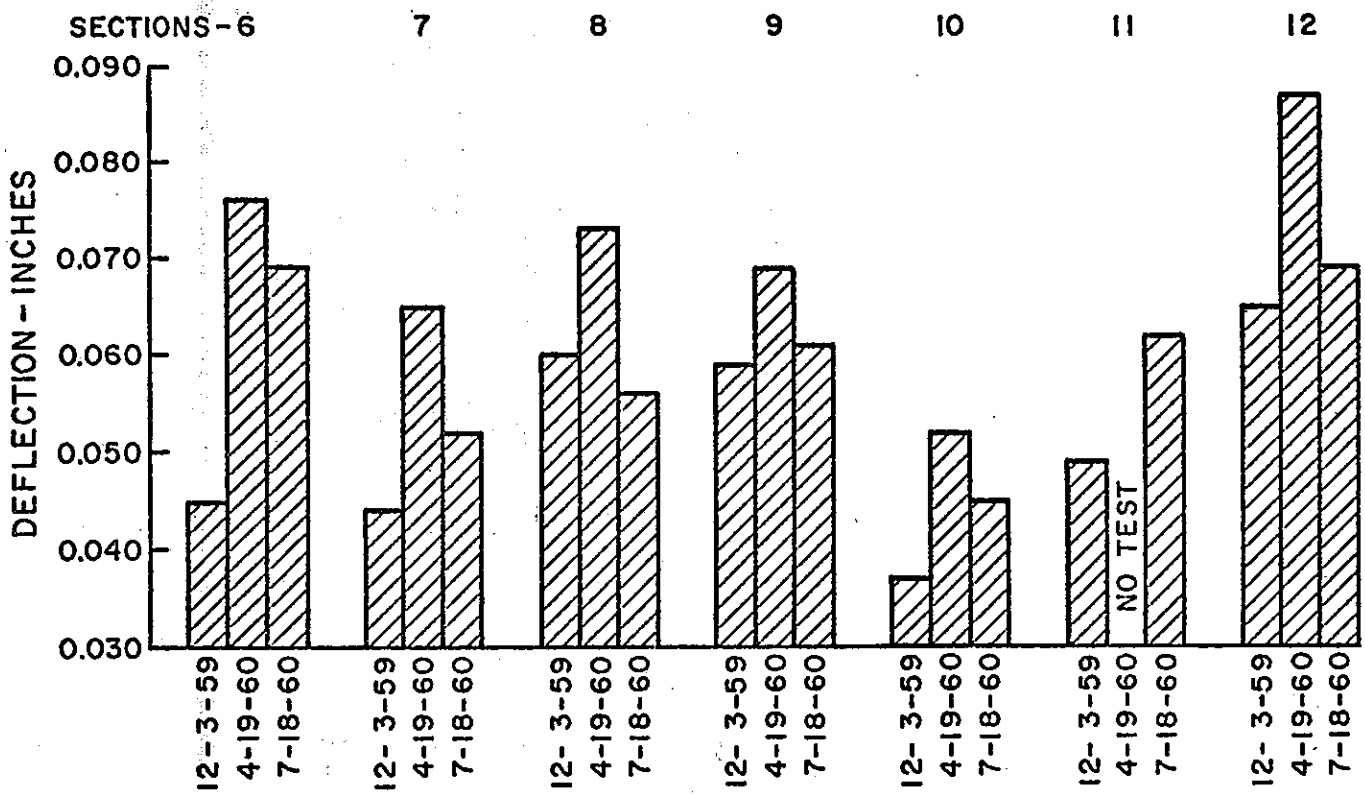
Figure 3

2. The average deflections of individual test sections on the original road varied from 0.037" to 0.087". There was also a seasonal variation in the deflections. The largest deflections occurred during the spring and apparently resulted from high moisture contents in the base and underlying soil.

AVERAGE DEFLECTION READING ON EXISTING ROAD
AT VARIOUS SEASONS OF THE YEAR

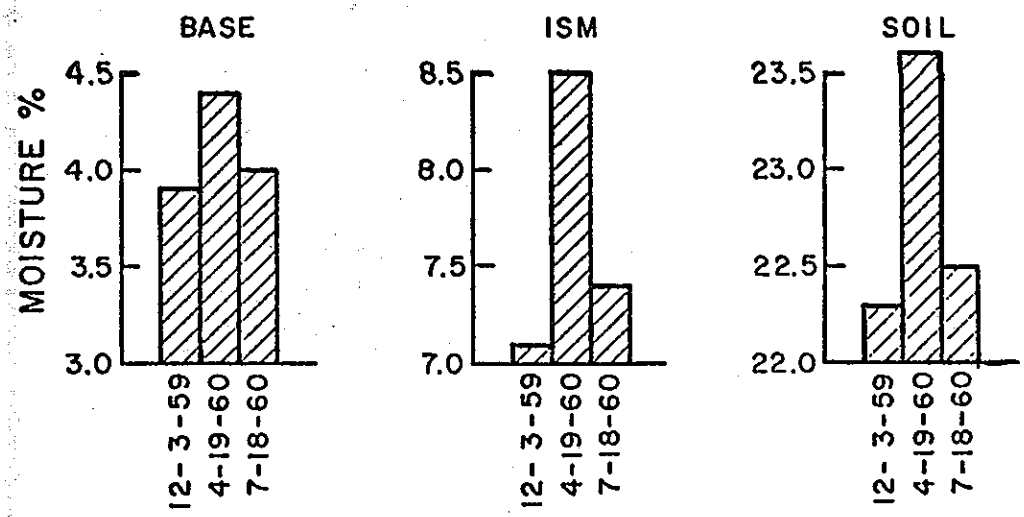
Figure 4

Moisture samples were taken from each layer of material within the test sections in an effort to correlate the variations in deflection with differences in the percent of moisture. A direct correlation was not possible for two reasons. First, no deflection readings were taken at the exact location of the moisture samples and secondly, the moisture content was found to vary not only from location to location but within the layer of material at any one location. It was possible, however, to establish a trend. By averaging all of the moisture values within each layer, it was established that the moisture content of each layer was highest during the spring when the deflection readings were highest. The average moisture contents of each material are shown in Figure 4.

AVERAGE MOISTURE CONTENT OF EXISTING ROAD
AT VARIOUS SEASONS OF THE YEAR

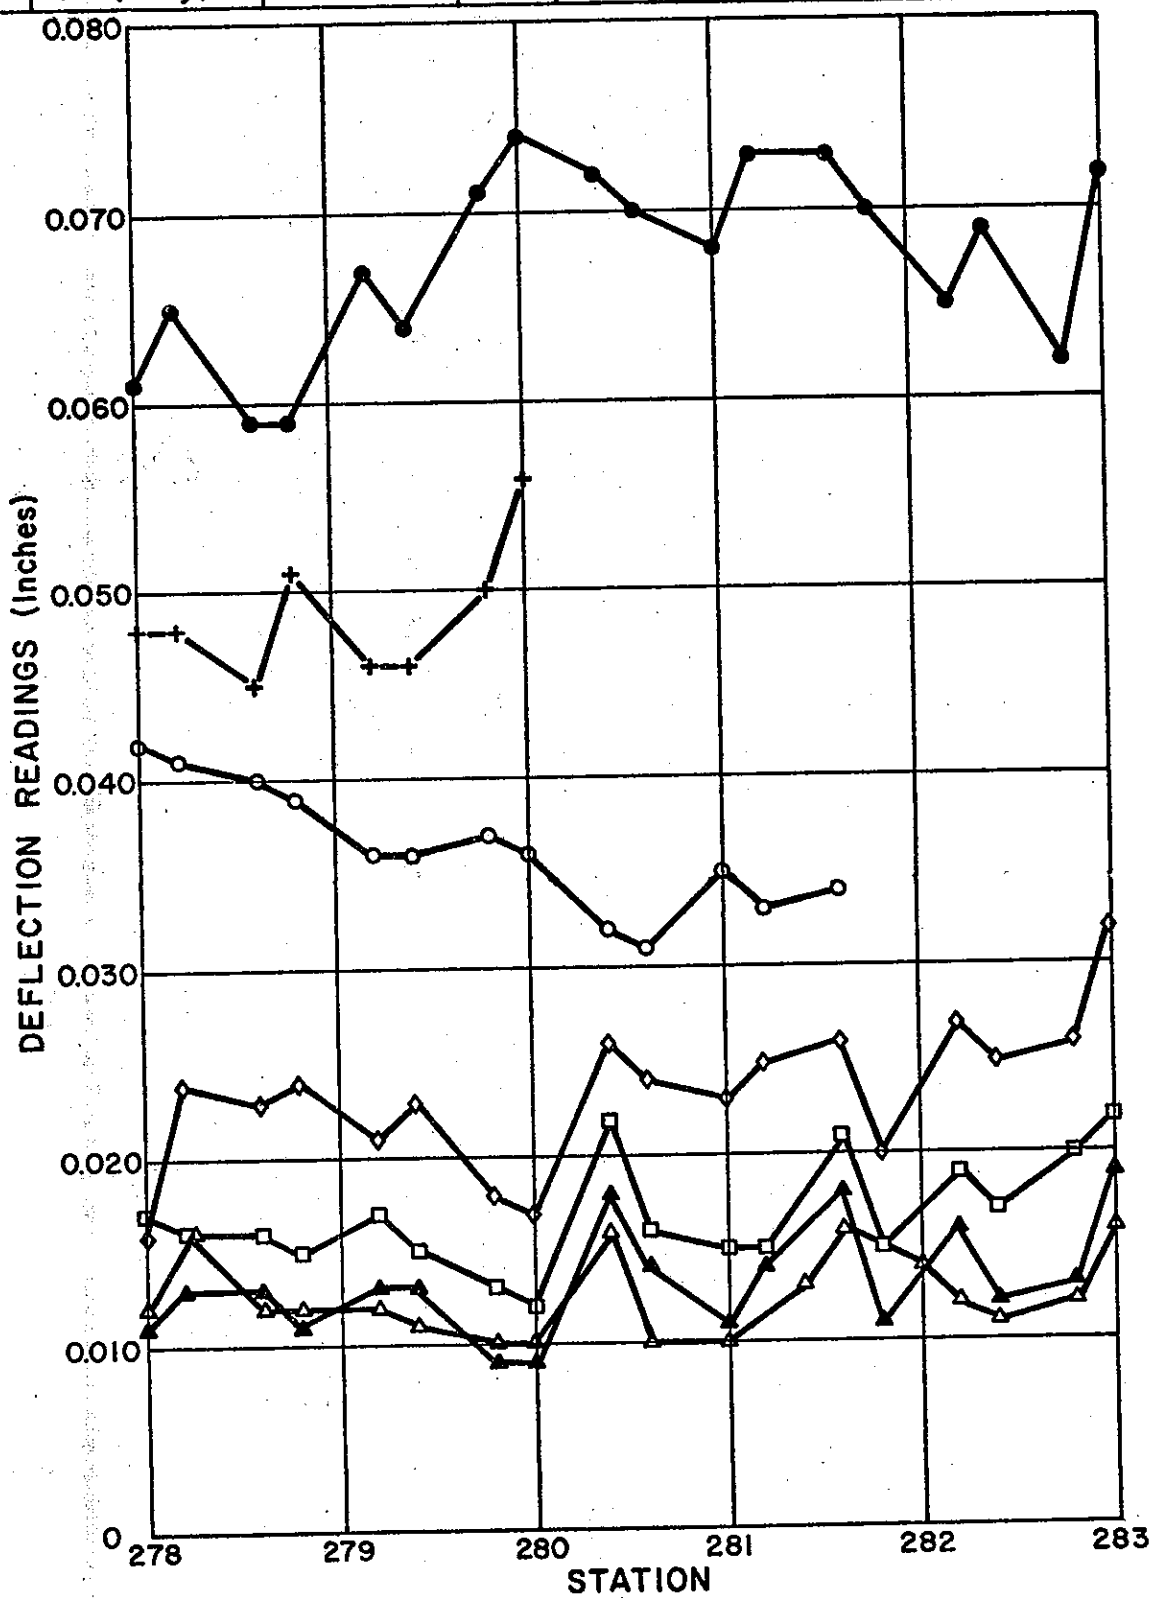
Figure 6

The average deflection readings for Test Section 4 (Figure 6) are substantially reduced by the completed structural section. It should be noted, however, that the average deflection of the completed roadway just meets the design maximum pavement deflection[7] for cement treated base surfaced with AC. Two of the five CTB sections exceeded this .012 maximum deflection criteria.

DEFLECTION READINGS DURING STAGES OF CONSTRUCTION
SECTION 4 CTB
STATION 278+00 TO STATION 283+00
Northbound Lane

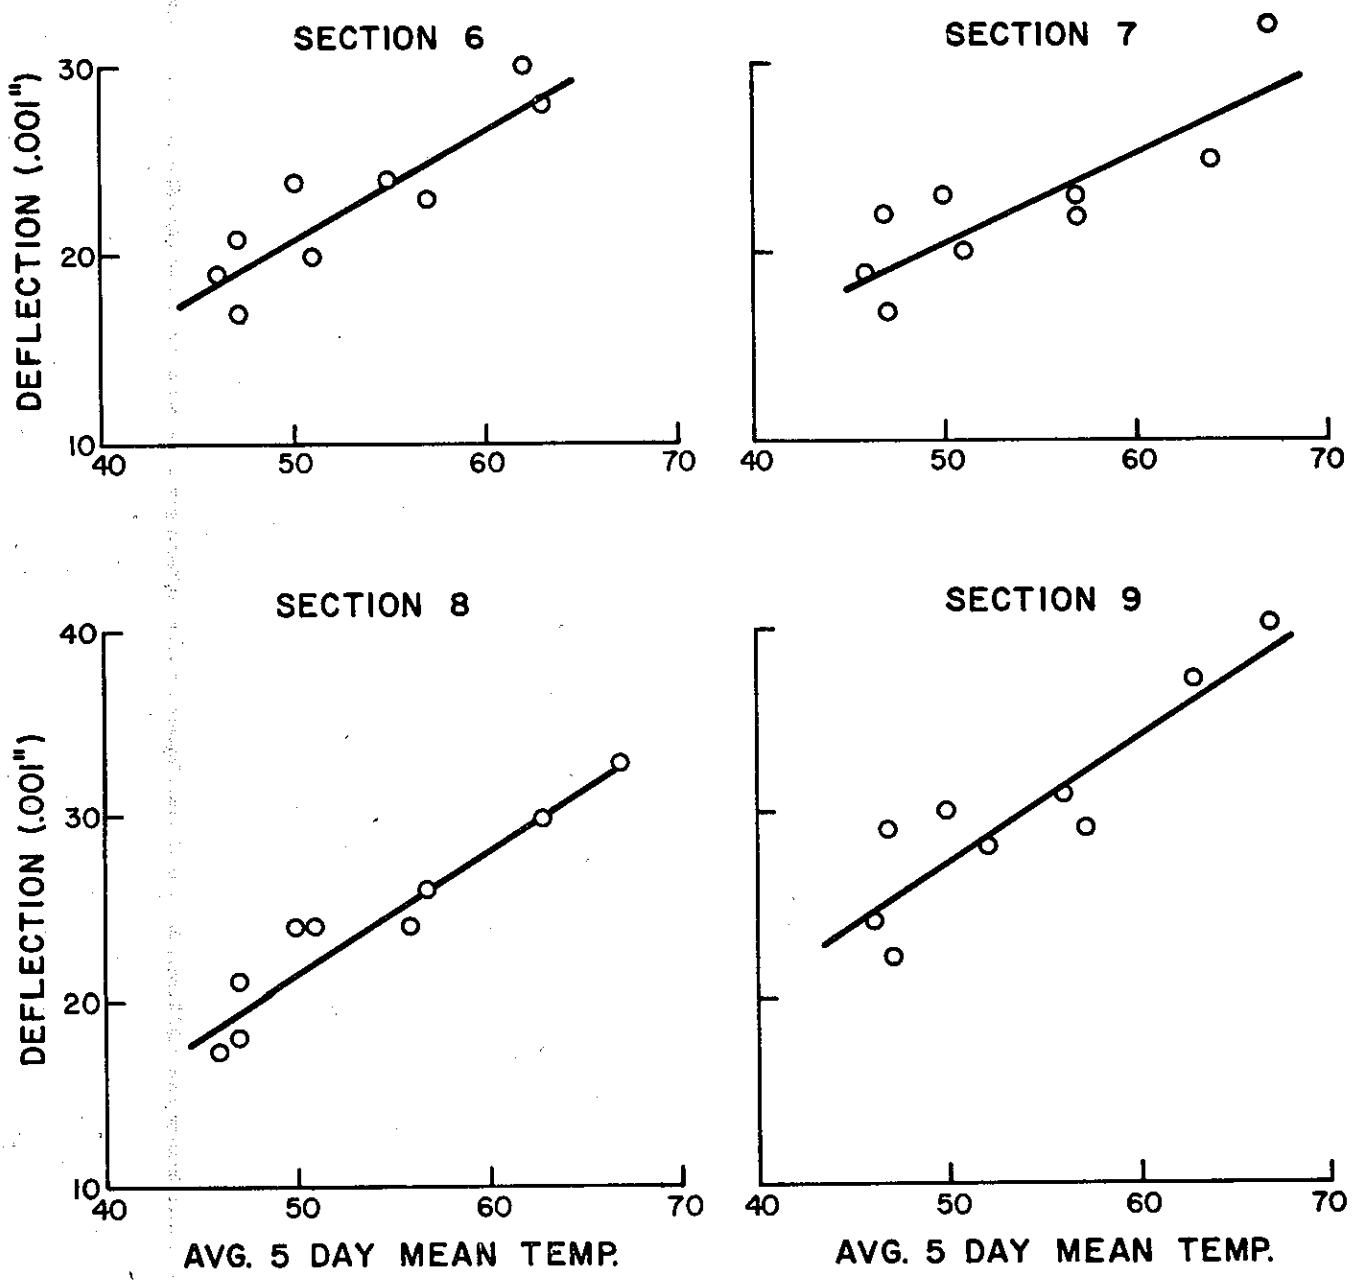
Figure 28

5. Temperature directly affected deflection readings. The deflections on the ACB sections changed about 0.0005" for each 1°F of change in 5 day average mean temperature. The temperature had less influence on the deflections of the cement treated base and aggregate base sections than it did on the deflections of the asphalt concrete base sections.

EFFECT OF MEAN DAILY TEMPERATURES ON DEFLECTION READINGS
