HIGHWAY RESEARCH REPORT

NO. M & R 636405—2

DYNAMIC TESTS OF AN

ENERGY ABSORBING BARRIER EMPLOYING

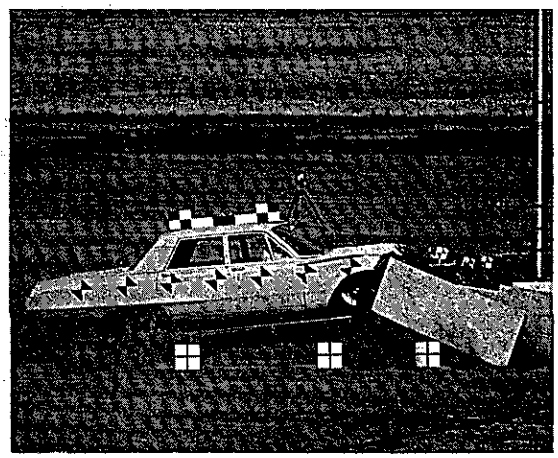
FIGURE 5

There was a noticeable vertical force imparted to the vehicle as shown by the vehicular rise in Figure 5, below. The rise was caused, at least in part, by the right front wheel riding up on the cable. There was virtually no vehicular "rebound".

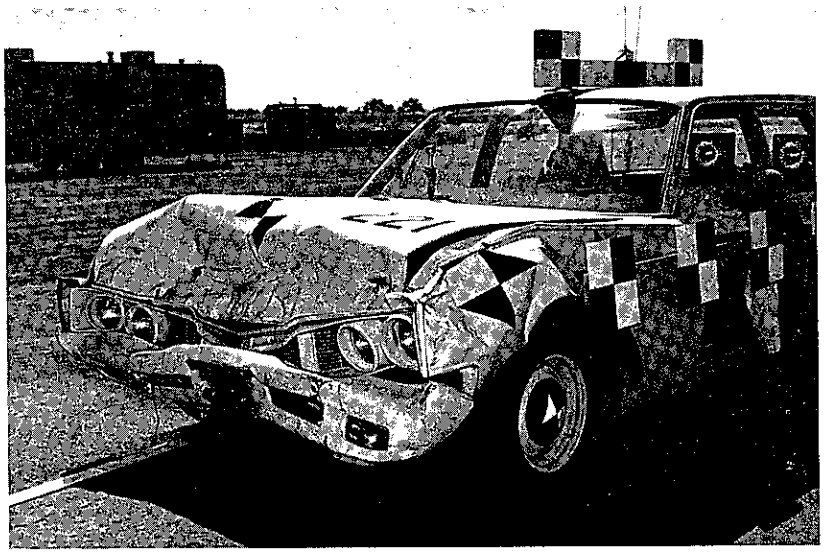
FIGURE 6

Vehicular damage consisted of some bumper deformation, a cracked windshield, a jammed door on the right front side, damage to both front quarter panels, 3.4 inches of steering column collapse

(energy absorbing steering column), and some dashboard deformation (see Figures 6 and 7, below). Maximum vehicular crush was 16.5 inches.

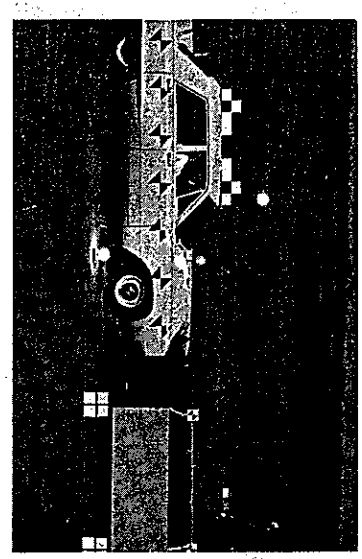
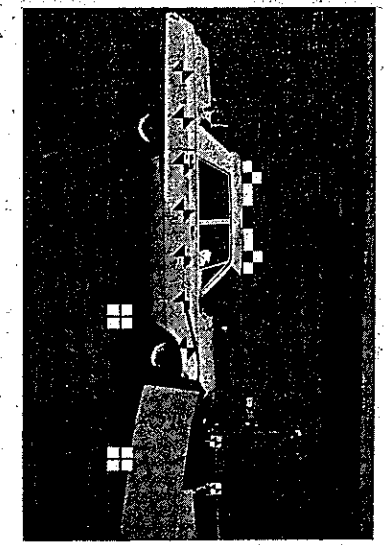
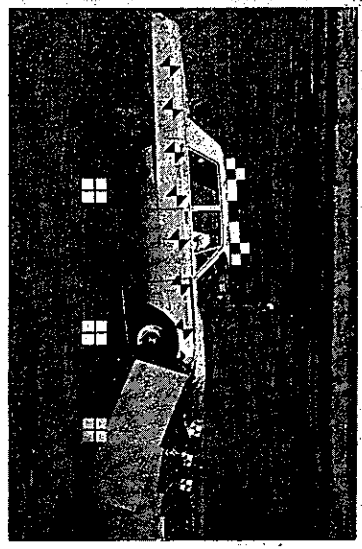
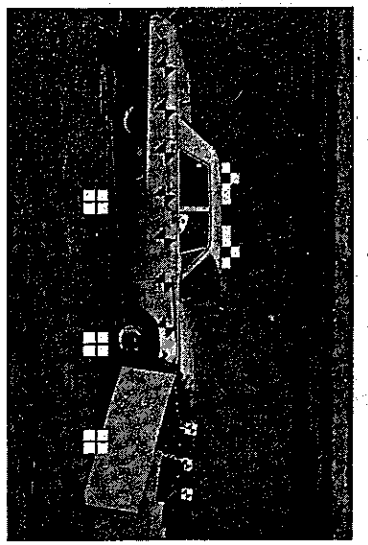
PLATE 3

All the drums in the barrier were deformed (see Figures 8 and 9). The cables were slack but undamaged. The plywood fender panels were badly cracked and splintered but remained attached to the barrier as it was deformed around the nose of the bridge approach guardrail. The drums crushed one row at a time, in successive order, as had been assumed in the design procedure. See Plate 3 (following page) for additional test data.

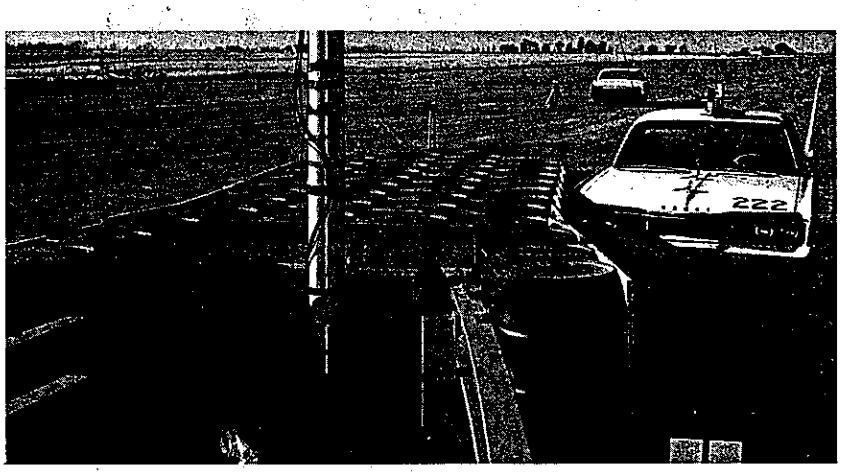
FIGURE 10

The 4760 pound 1968 Dodge sedan impacted the left side of the barrier 10.2 feet in front of the bridge approach guardrail at a speed of 59.8 mph and an angle of 11 degrees with the barrier (see Figure 10, below, for approximate location at impact). The vehicle was redirected but minimal redirectional forces were provided by the drums. The vehicle axis was displaced 12 inches laterally from its location at impact before any redirection began (i.e., crabbing occurred). At this time, solid contact with the bridge approach guardrail had been established.

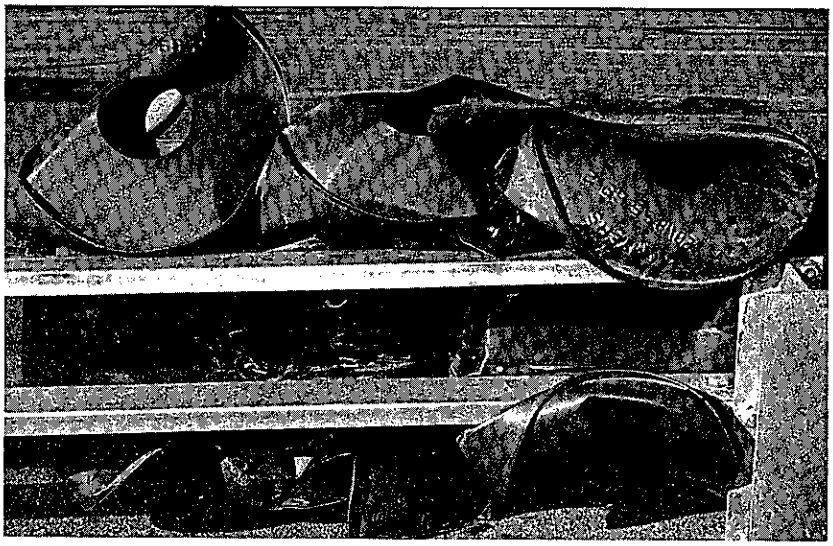
FIGURE 11

The force of the impact caused a clamping action to take place between the rear drums and the bridge approach guardrail, thus preventing drum ejection (see Figure 11).

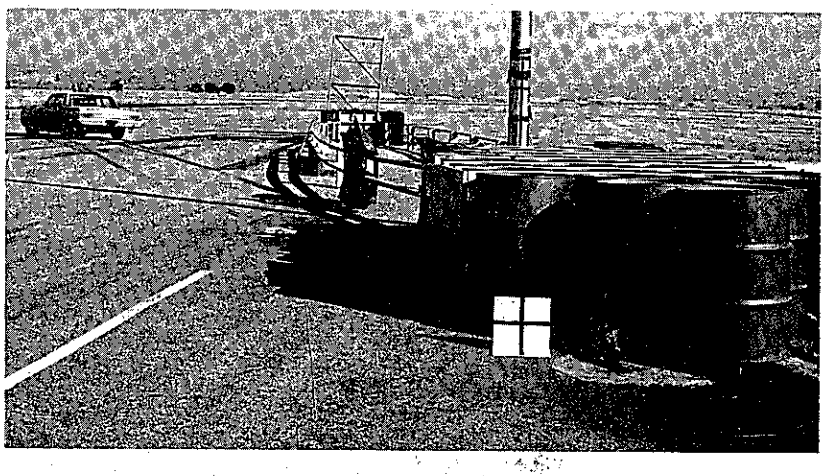
FIGURE 12

Additional barrier damage consisted of crushing of the outside drums in the back half of the barrier on the impacted side. All the fender panels beyond the point of impact were torn off the barrier. There were some failures at hinge pins; the ends of the last few diaphragms were broken off on the impact side. There was an unacceptable amount of debris deposited in what would be the adjacent traveled way. Some of the fender panel fragments were thrown 155± feet from the point of impact (see Figures 12 and 13).

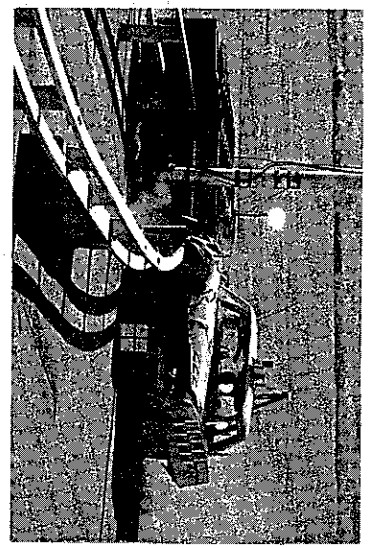
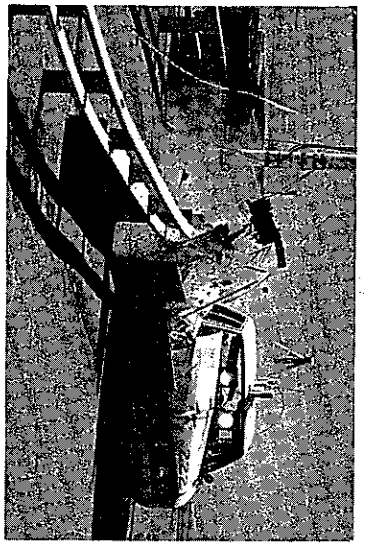
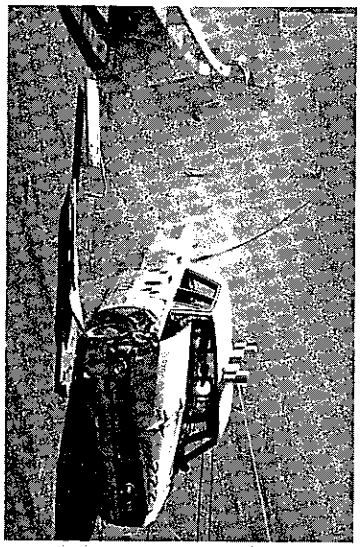
Vehicle damage included severe crushing of the right front quarter panel, jamming of the right front door, scars on the right doors and right rear panel, and displacement of the radiator to the point of touching one fan blade (see Figure 14, below). See Plate 4 (following page) for additional test data.

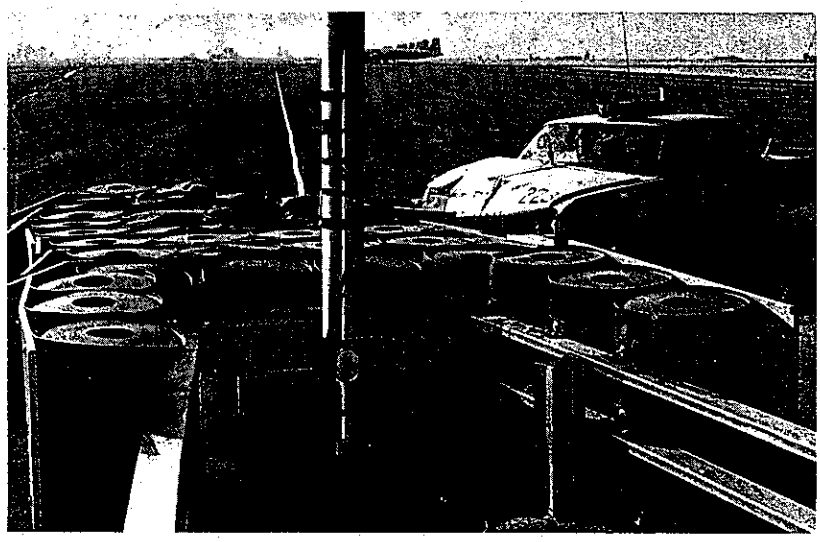
FIGURE 15

Test 223. This test consisted of a 4740 pound 1968 Dodge sedan impacting the same barrier design used for the previous test. The vehicle impacted the left corner of the barrier nose at a speed of 53.6 mph and an angle of 9 degrees. At impact, the center of the front of the vehicle was offset 3.5 feet from the barrier axis. Significant elastic lateral deflection of the barrier took place as the vehicle penetrated 13.2 feet, rotated clockwise, and then rebounded 2.5 feet. The maximum 50 ms average vehicular passenger compartment deceleration, based on accelerometer data, was 10.9 G's (in the longitudinal direction). The average passenger compartment longitudinal deceleration was 7.2 G's. (The vehicular rotation was neglected because the longitudinal velocity was approximately zero before rotation began.) Deceleration of this magnitude would probably result in moderate to severe injury for an unrestrained occupant, minor to moderate injury for an occupant restrained by a lap belt, and little or no injury for an occupant using both a lap belt and a diagonal shoulder harness. The position of the vehicle after the collision was such that it would have been a hazard to adjacent traffic (see Figure 15, below).

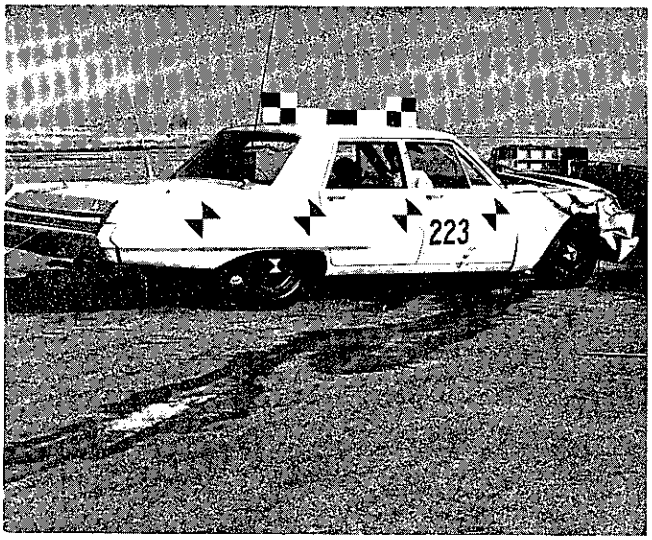
FIGURE 16

Vehicle damage consisted of a crimp in the roof on the passenger side, extensive hood deformation, slight displacement of the left front quarter panel, and 3.6 inches of (energy absorbing) steering column collapse (see Figures 16 and 17). There was a slash high on the cheek of the dummy driver and the windshield was broken in front of the dummy passenger. The dummy passenger was badly cut on the tip of the bridge of his nose, over his right eye and on his forehead, and on the right side of his face and cheek. This dummy's lower legs were removed before the crash; this may have contributed to some excessive movement of his upper body during the collision.

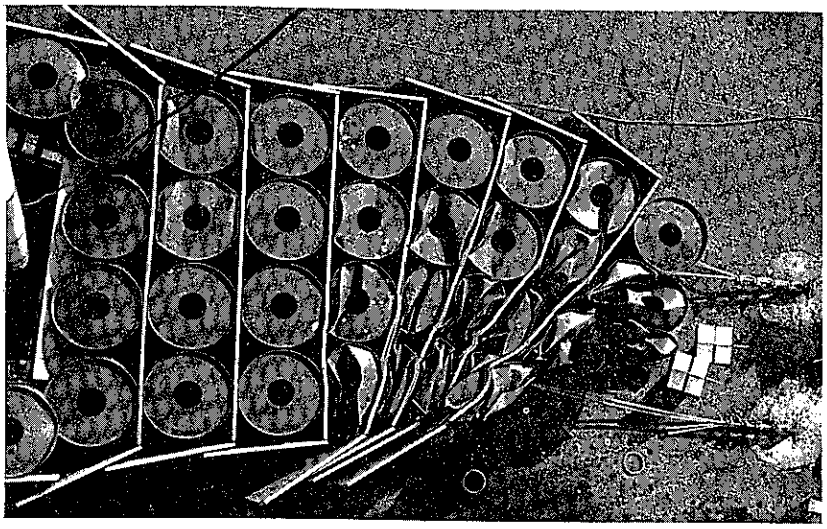
FIGURE 18

All but two drums were damaged. The left front and the right rear plywood fender panels were the only ones damaged. It appeared that the impact force was transmitted somewhat diagonally from the left front to the right rear of the barrier (see Figure 18, below). The left front portion of the barrier was crushed much more than the right front side. The film record shows the drums crushing one row at a time in successive order with the exception of the back row, which was deformed soon after impact. This was very similar to the dynamic barrier compression sequence observed during Test 221 and again verified the design assumptions. From a maintenance standpoint, all the drums would have required replacement.

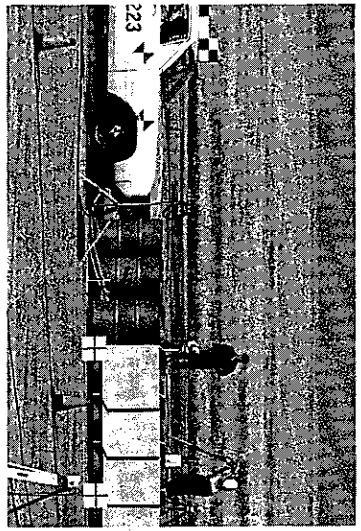
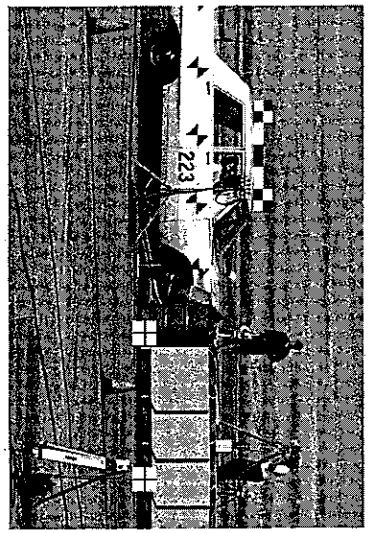
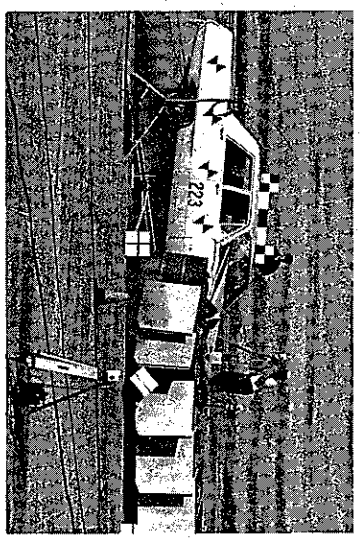
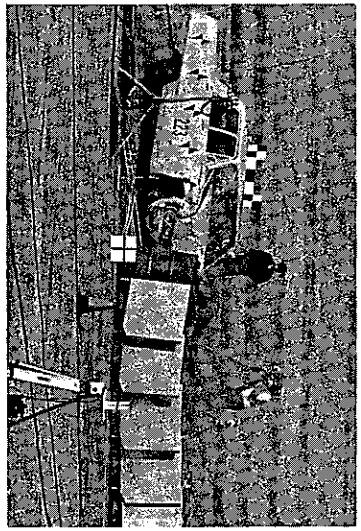
PLATE 5

The movies showed the car being ejected outward from the barrier due to the elastic energy stored within the barrier. The clockwise rotation of the car was probably caused by a moment couple consisting of the vehicular momentum, acting through the vehicle CG, and this "elastic" energy, acting through the centroid of the vehicle-barrier contact interface. See Plate 5 (following page) for additional test data.
