California Department Of Transportation

Transportation Materials And Research

FIELD TESTS AND EVALUATION OF ROCKFALL RESTRAINING NETS

Report No. CA/TL - 90/05

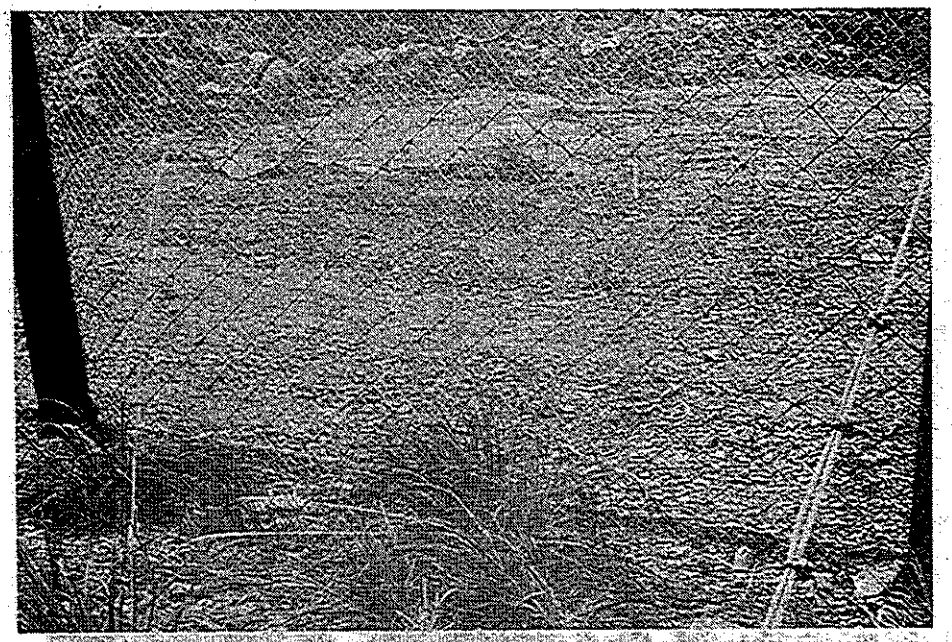
- Wire twists work more effectively than hog rings for attachment of the chain link fencing to the net panels.
- Brugg's 2 mm mild steel net fasteners frequently failed below 70 ft-tons of energy with and without the fencing. Broken fasteners were replaced with wire rope clips.

Photo 5. CHAIN LINK FENCING MATERIAL COVERING A BRUGG NET PANEL ON THE UPSLOPE SIDE. FENCING IS ATTACHED WITH HOG RINGS AND WIRE TWISTS

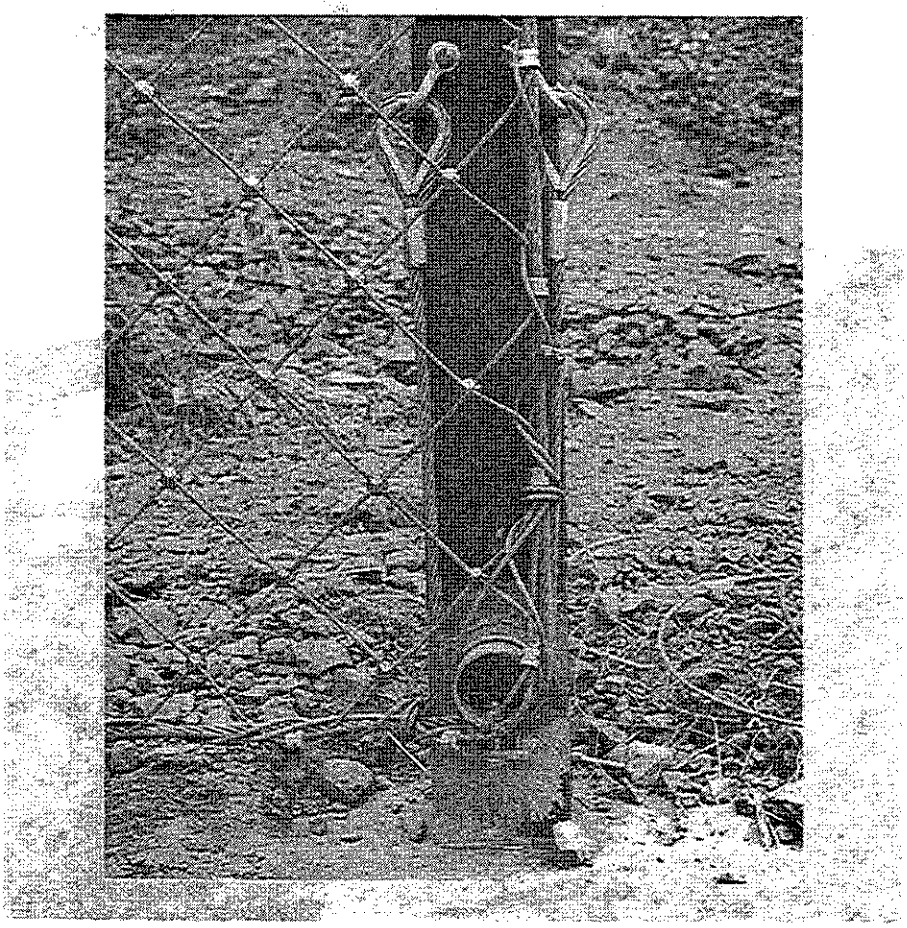
- Partial connection of Brugg's net panel to the posts directed energy to the net panel corners.
- Brugg's 5/16-inch wire rope lacing occasionally failed at design load in the fixed corners where the lacing was triple twisted.

Photo 8. DETAIL OF BRUGG FULLY EMBEDDED POST. NOTE TRIPLE-TWISTED LACING CABLE ATTACHMENT AND SINGLE CABLE CLIP CONNECTION

- When lacing is used to attach Brugg net panels, 5/16-inch wire rope lacing should be used to mitigate net panel failure.

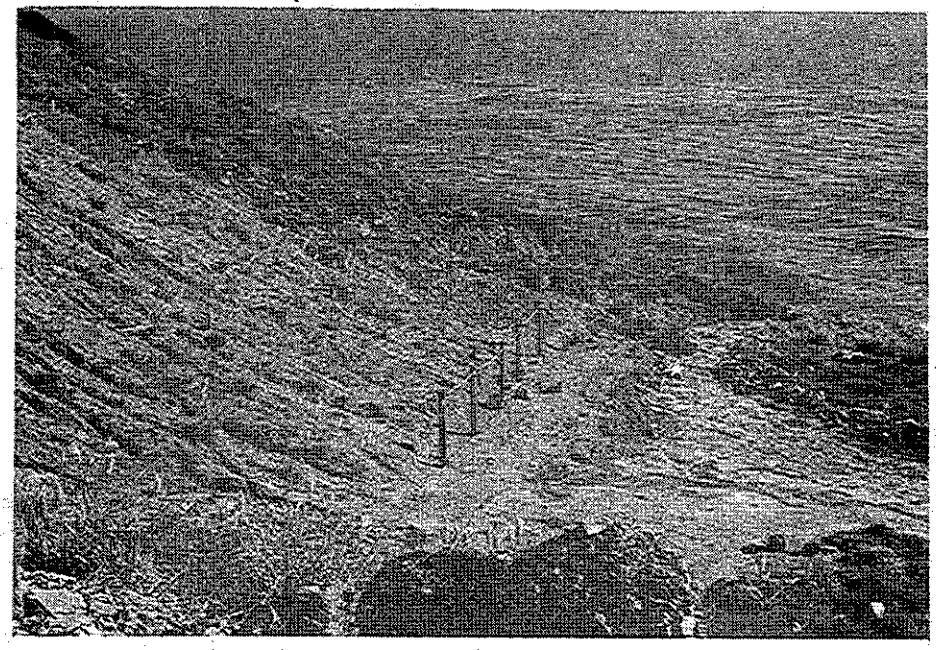
Photo 37. PENETRATION OF THE BRUGG NET BY ROCKS #6 AND #8 AFTER LOOSENING OF THE NET FASTENERS BY PREVIOUS ROCK IMPACTS

Maintenance of the net required replacing missing fasteners with wire rope clips and refitting the wire rope clips on the wire rope lacing.

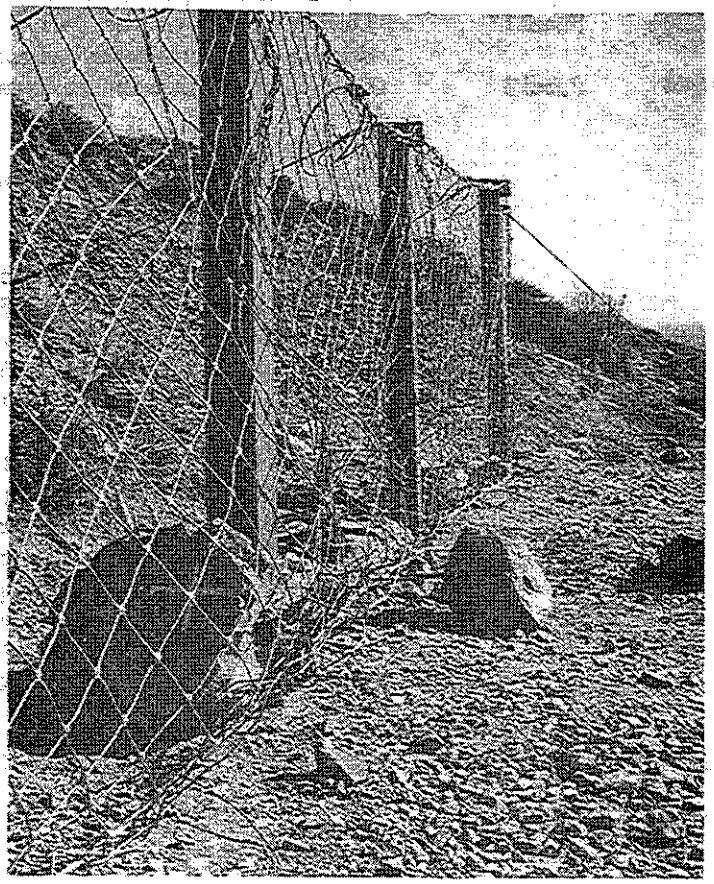
Photo 38. CLOSE-UP VIEW OF BRUGG NET AND ROCKS AFTER ROCK ROLLS 1-10. NOTE ROCK #6 IN CENTER OF PHOTO

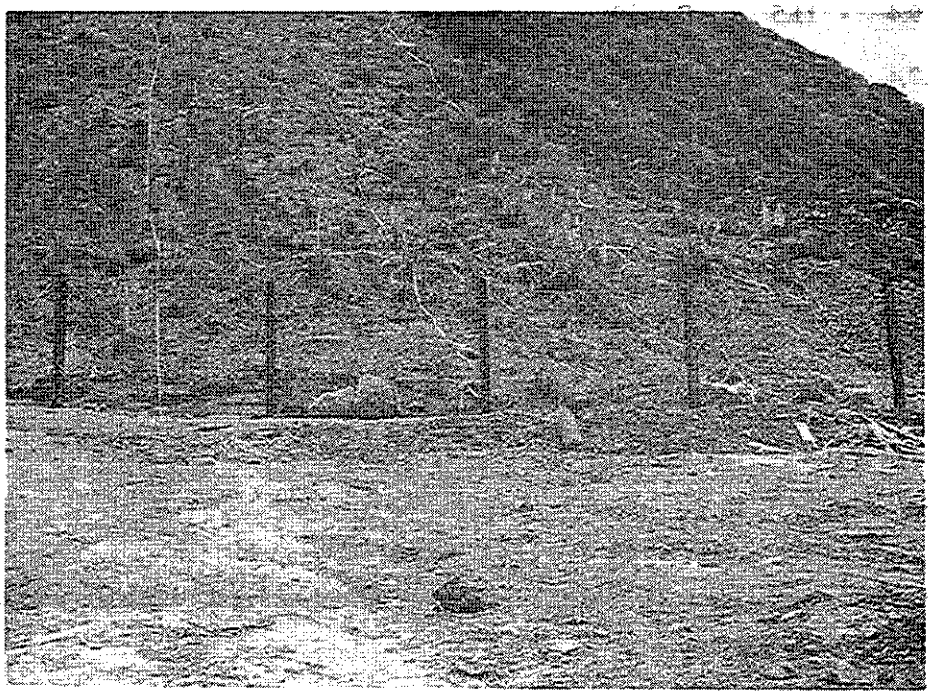
Photo 40. ROAD LEVEL VIEW OF BRUGG ROCK NET AFTER ROCK ROLLS 12-19. NOTE SLIGHT SAG IN NET PANEL 3

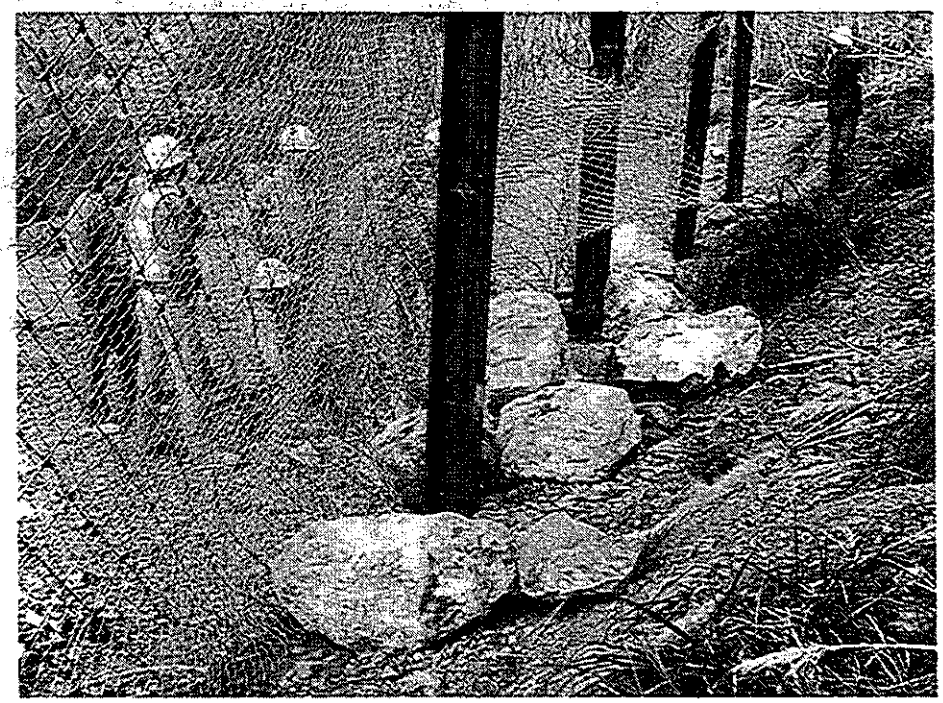
Photo 42. BRUGG ROCK NET AFTER ROCK ROLLS 9-18. NOTE CHAIN LINK MESH SEPARATING FROM THE ROCK NET. NET PANEL 1 IS IN THE FOREGROUND.

Maintenance of the nets required replacing missing fasteners with wire rope clips, replacing some of the lacing cable, and repairing the wire rope net strands at the corners.

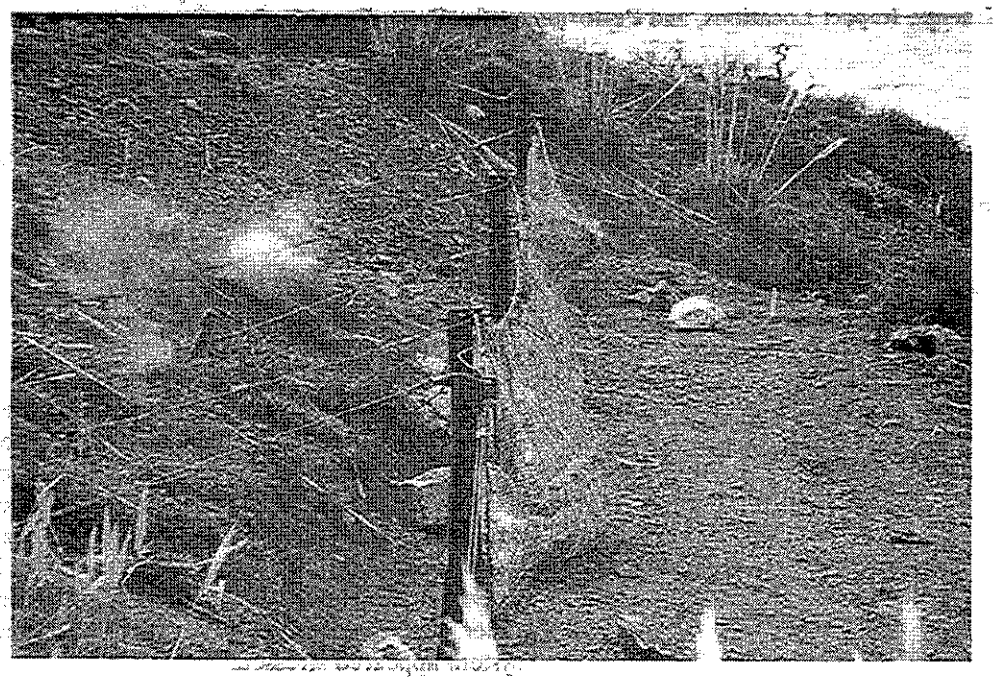
Photo 44. ONE AND ONE-HALF-TON ROCK #35 IMPACTING NET PANEL 1. (Photo Courtesy of John Walkinshaw)

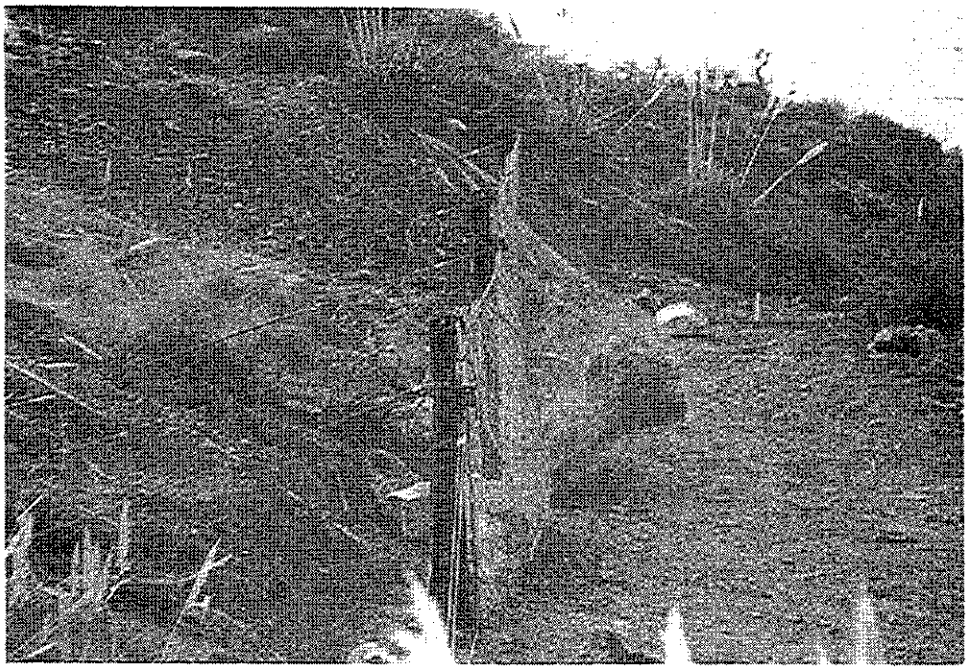
Photo 45. THREE-TON ROCK #36 IMPACTING NET PANEL 2 (Photo Courtesy of John Walkinshaw)

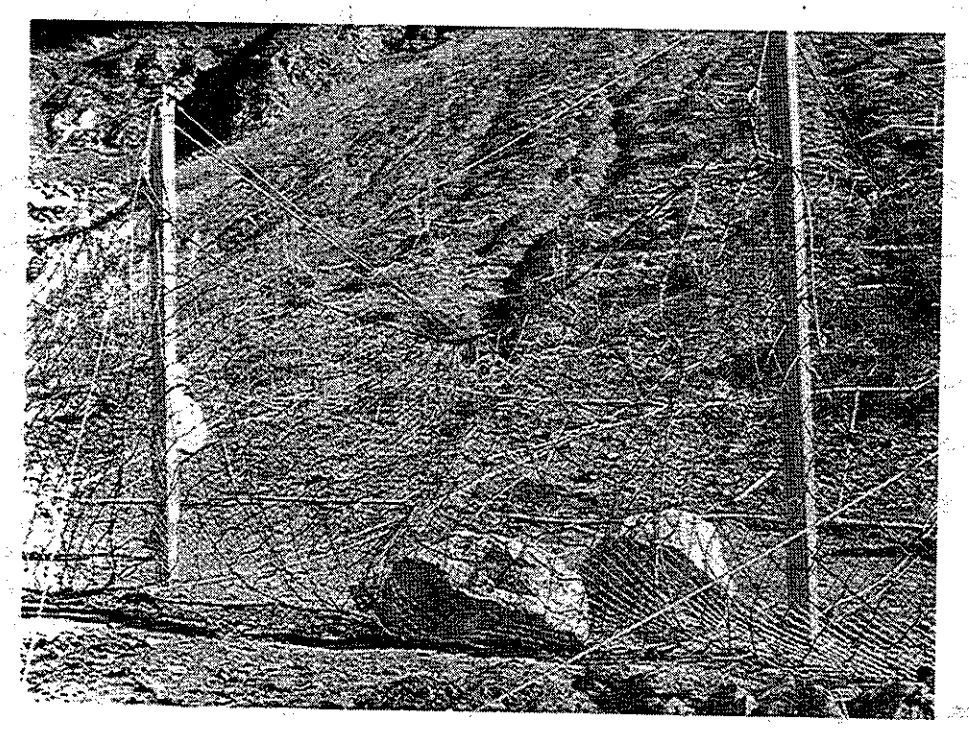
Photo 46. INDUSTRIAL ENTERPRISE ROCK NET PANEL 2 AS VIEWED FROM ROAD LEVEL AFTER ROCK ROLL 1 (1590 POUNDS) AND ROCK ROLL 2 (1860 POUNDS). NOTE CONSIDERABLE SAG IN THE ROCK NET

The sagging net was raised, the net fastening bands replaced, the perimeter wire rope clips repositioned, and rock rolling continued.

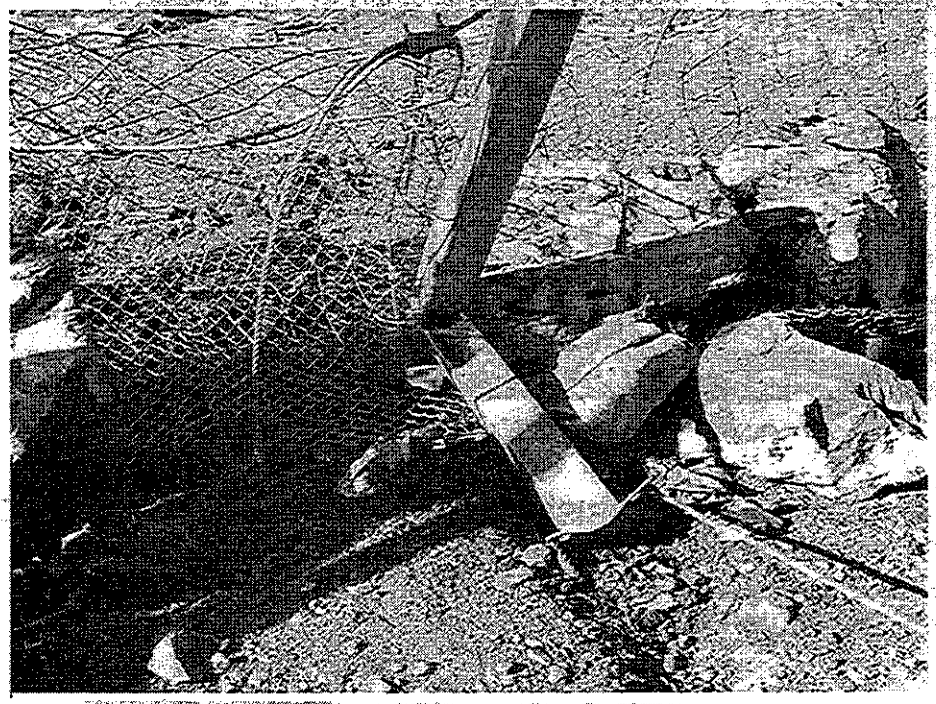
Photo 47. COLLAPSED INDUSTRIAL ENTERPRISE STEEL BOX POST #2 AFTER IMPACT BY A 1 1/4-TON ROCK. NOTE LOW ROCK NET HEIGHT AT TOP OF PHOTO

Post 2 was replaced, all three nets were raised, and rock rolling continued.

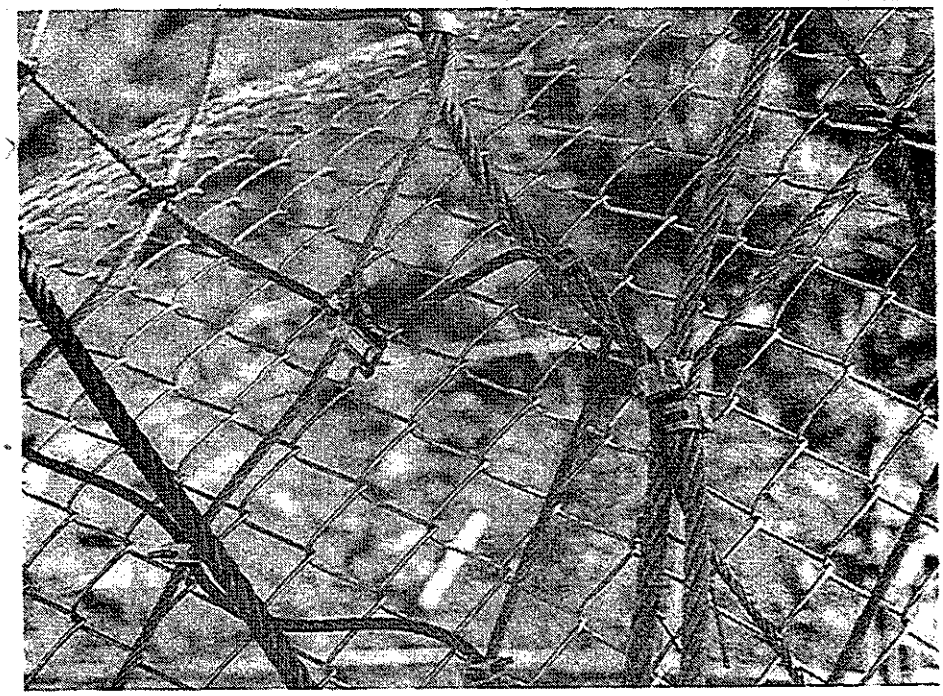
Photo 49. CLOSE-UP OF BROKEN INDUSTRIAL ENTERPRISE NET PANEL FASTENING BANDS. NOTE CHAIN LINK MESH SEPARATED FROM THE NET

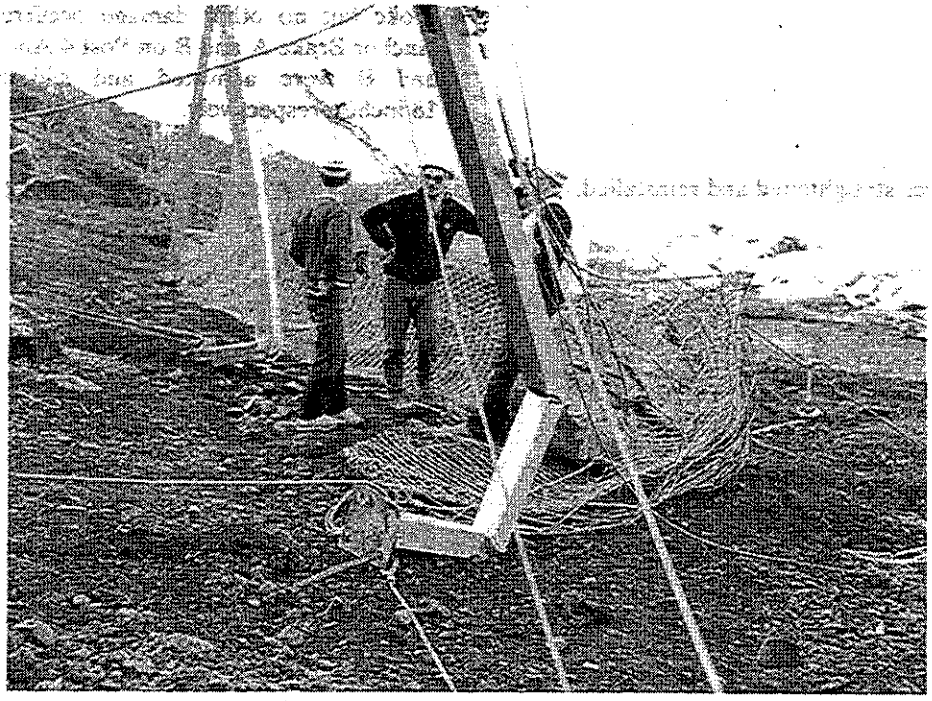
Photo 50. COLLAPSED INDUSTRIAL ENTERPRISE 51/2-x 51/2-INCH STEEL BOX POST #3 AFTER IMPACT BY 5-TON ROCK #10. NOTE ROCK #10 IN NET PANEL #3

Post 3 was straightened and reinstalled. The sagging nets were raised and rock rolling continued.

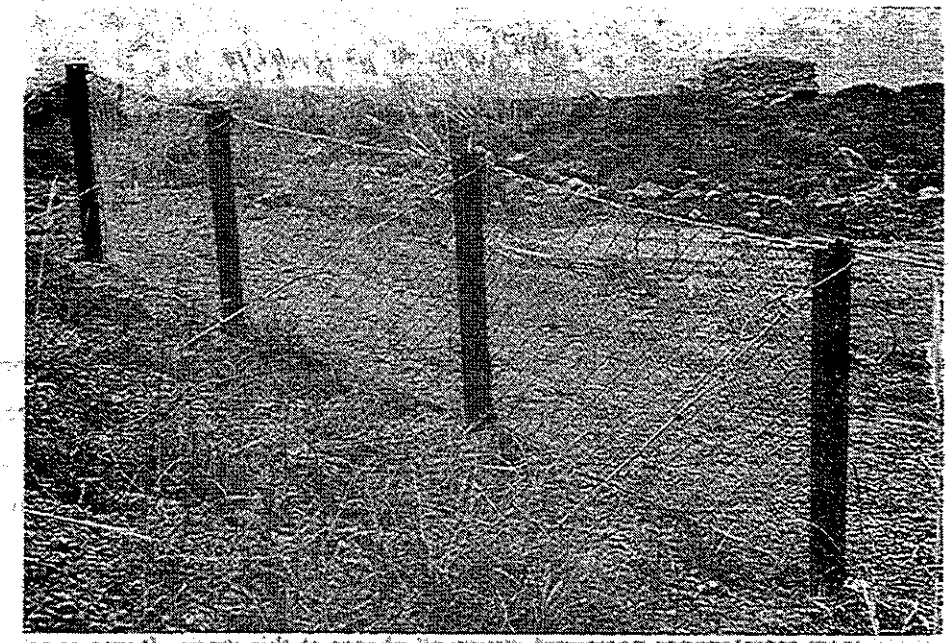
Access for cleaning boulders and rockfall debris (Photos 51 and 52) from the Brugg rock net was provided by raising individual panels from the bottom or by lowering them from the top (Photos 53 and 54). This required removing the lacing wire rope at the top or bottom along with a portion or all of the lateral or side lacing wire ropes. Both methods worked well.

Photo 51. BRUGG ROCK NET LOOKING DOWNSLOPE PRIOR TO ROCK ROLLING

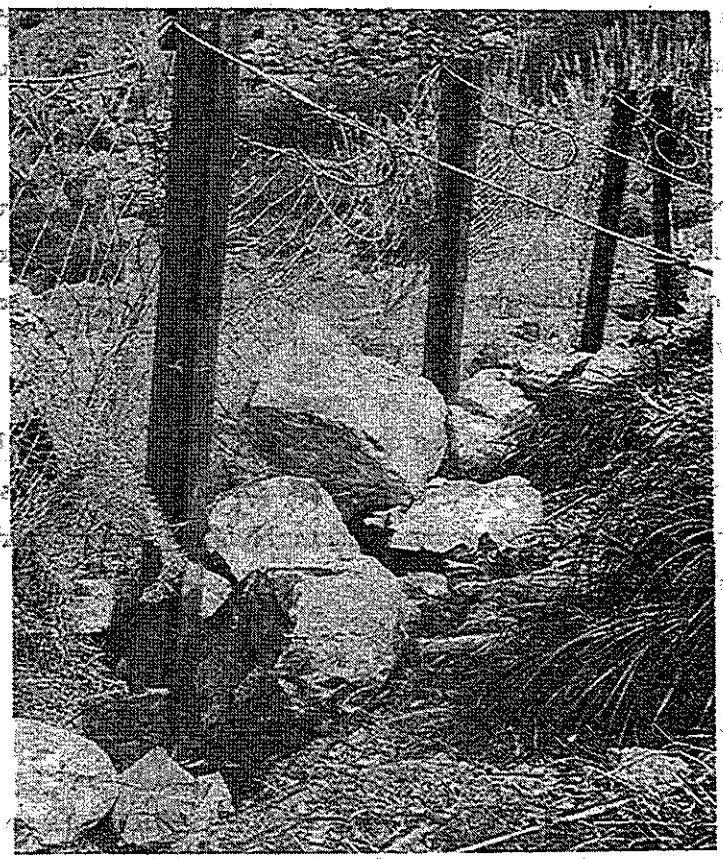
Photo 52. BRUGG ROCK NET LOOKING DOWN SLOPE AFTER 20 ROCK ROLLS

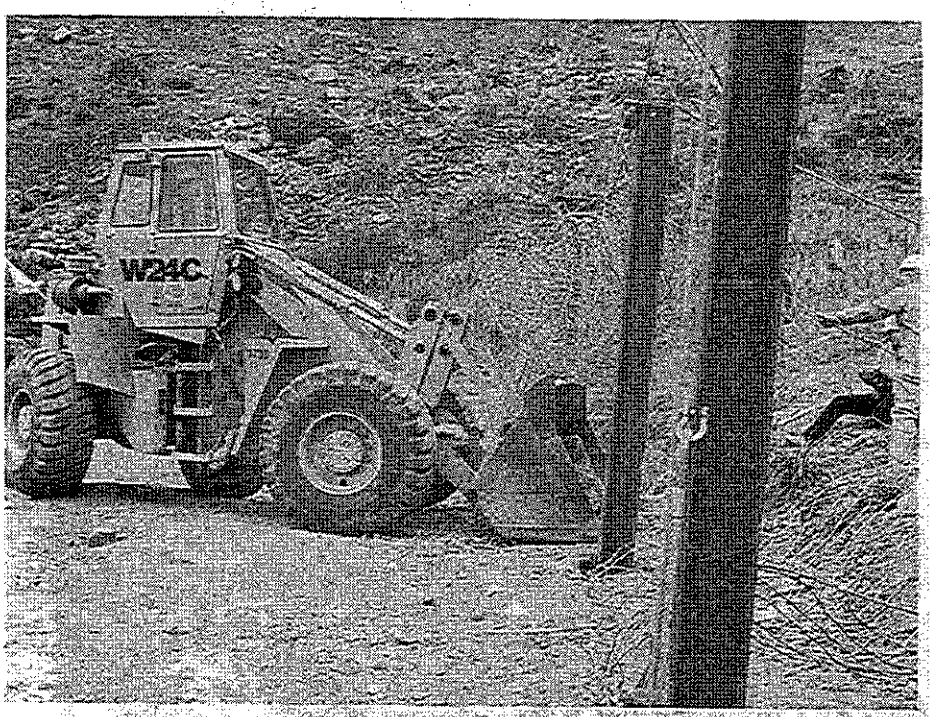
Photo 53. CLEANING BRUGG ROCK NET BY RAISING THE NET PANEL FROM THE BOTTOM

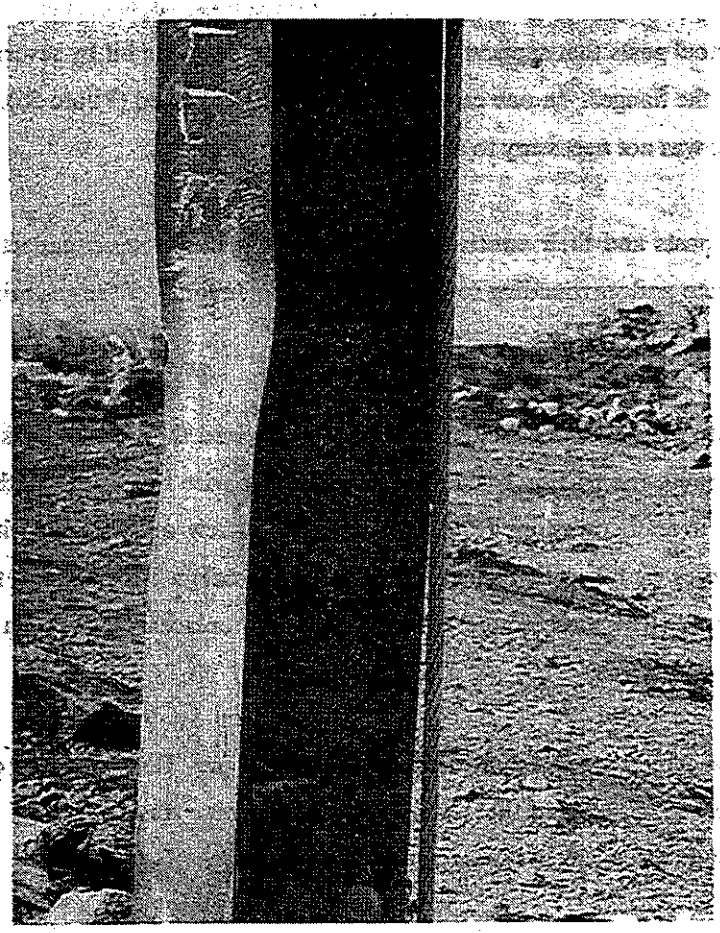
Photo 56. SLIGHTLY BOWED BRUGG 8-x8-INCH-WIDE FLANGE 48 POUND / FOOT STEEL POST AFTER A DIRECT HIT BY A 11/2-TON ROCK

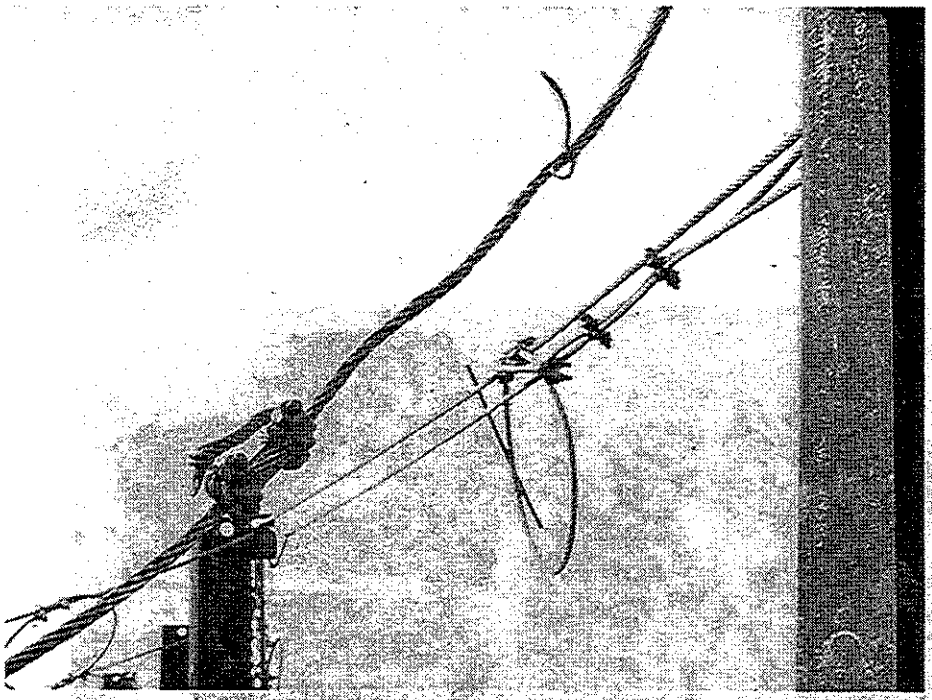
Photo 57. ACTIVATED BRUGG FRICTION BRAKE AND DAMAGED ANCHOR WIRE ROPE CAUSED BY IMPACTING ROCK #32. SEE PHOTO BELOW

Post 5 was reused, the anchor brake was replaced, and rock rolling continued.

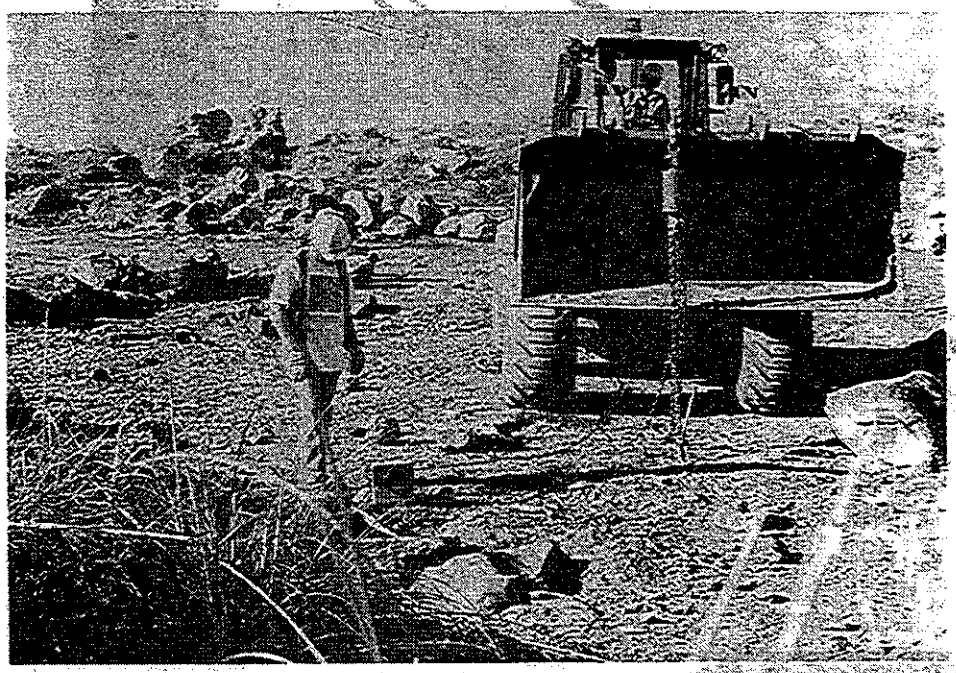
All upslope and lateral anchors performed well up to and beyond the design load. In one case, a boulder delivered at least three times the design load causing about two inches of displacement in the easterly lateral anchor. This anchor was later tested and resisted a 20,000 lb pull (Photo 59). No maintenance of the upslope or lateral anchors was required.

Photo 59. PULLOUT TEST OF ANCHOR USING A LOAD CELL ATTACHED TO FRONT END LOADER. ANCHOR RESISTED 20,000 POUND PULL

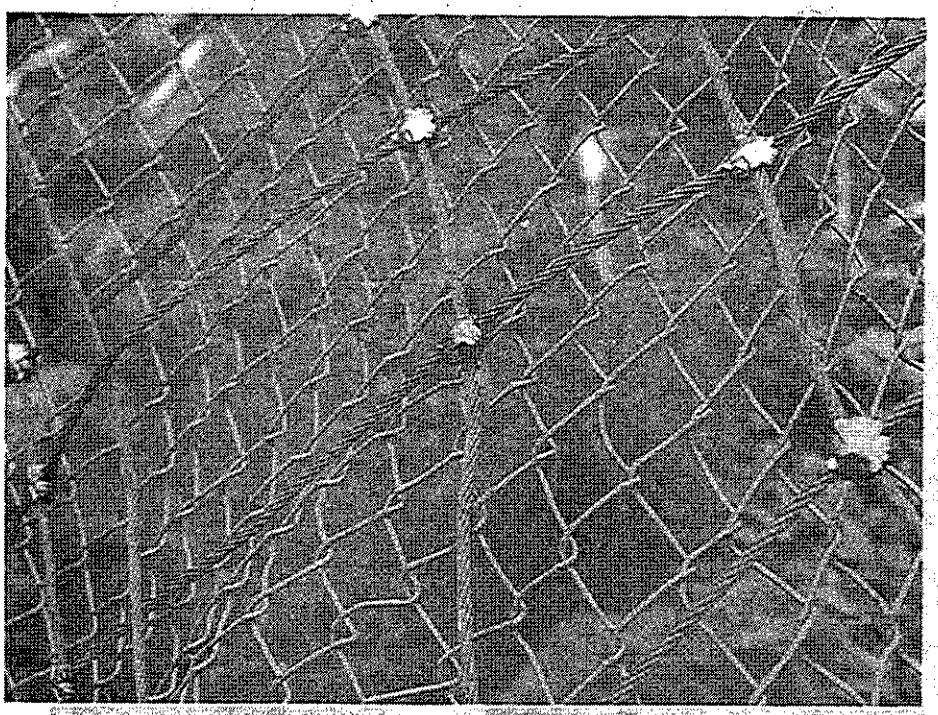
Photo 60. MISSING AND LOOSE BRUGG FASTENERS ON THE NET PANEL

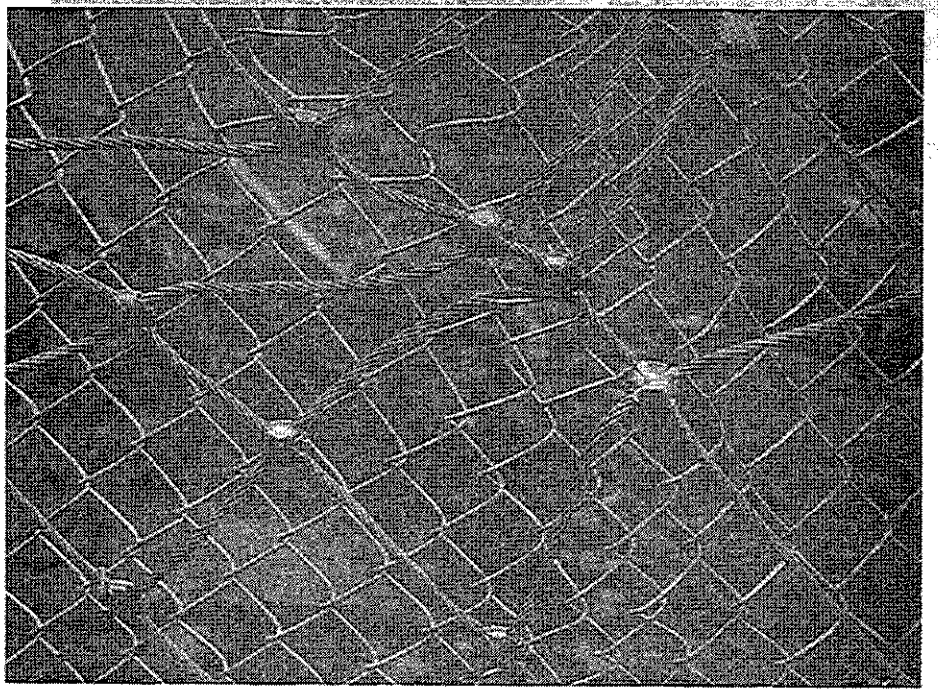
Photo 61. SHIFTING OF LOOSE BRUGG FASTENERS ON THE NET PANEL

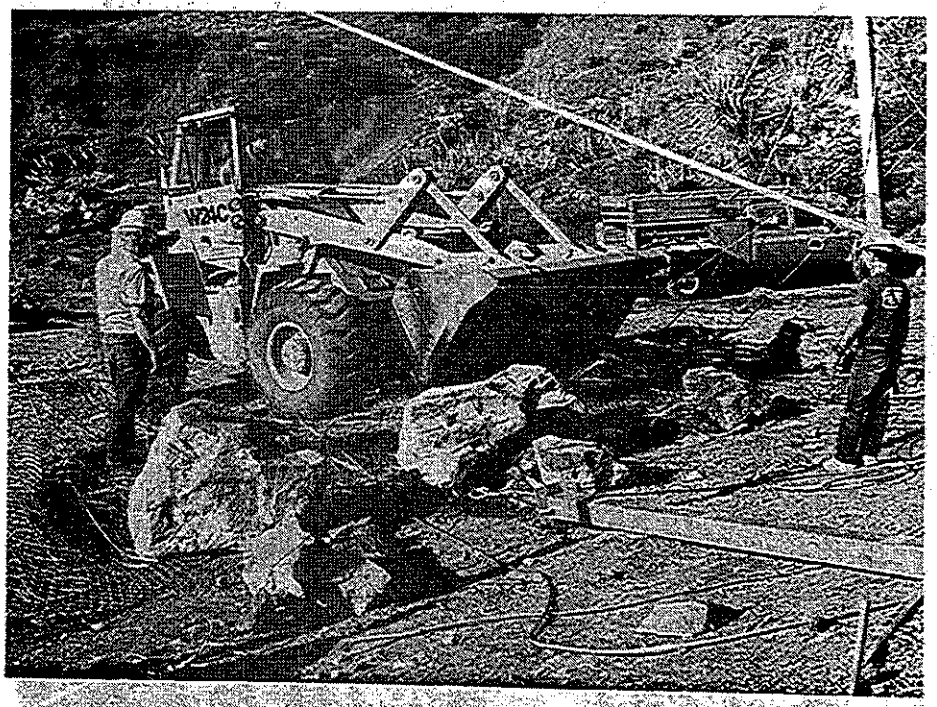
Photo 65. CLEANING INDUSTRIAL ENTERPRISE ROCK NET BY LAYING DOWN THE NET PANEL. NOTE THAT TWO PANELS AND ONE POST ARE LAID DOWN FOR CLEANING. ALSO NOTE THE LOADER WORKING ON TOP OF THE NET.

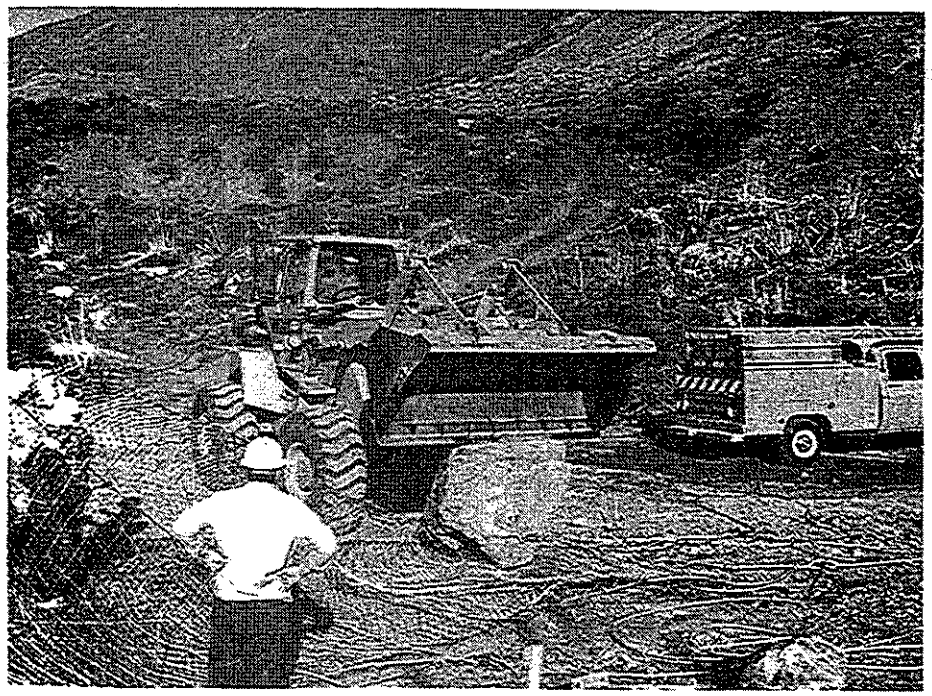
Photo 66. FRONT END LOADER ROLLING ROCK OFF INDUSTRIAL ENTERPRISE NET PANEL

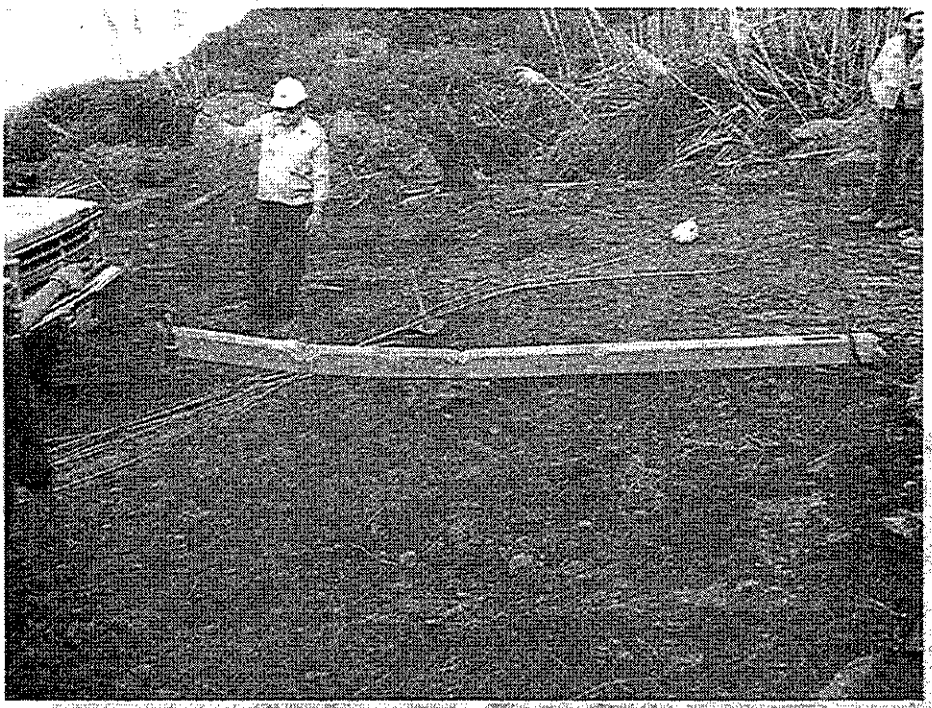
Photo 68. STRAIGHTENING A POST BY SECURING ONE END TO A FIXED POINT AND PULLING THE OTHER END WITH A VEHICLE

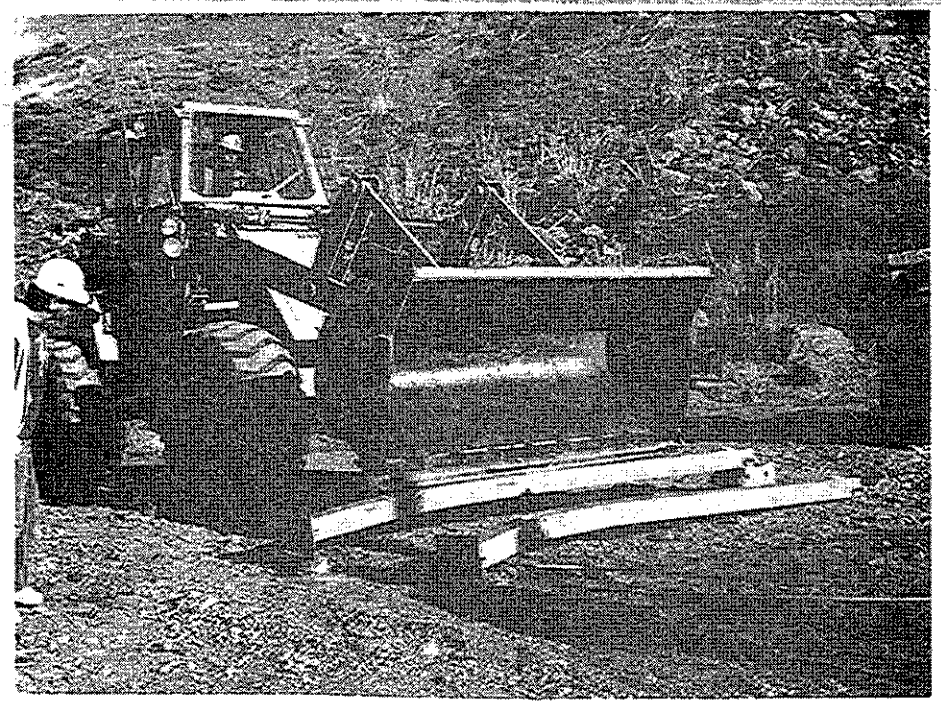
Photo 69. FINAL BOX POST STRAIGHTENING BEING DONE BY BENDING THE POST WITH A FRONT END LOADER

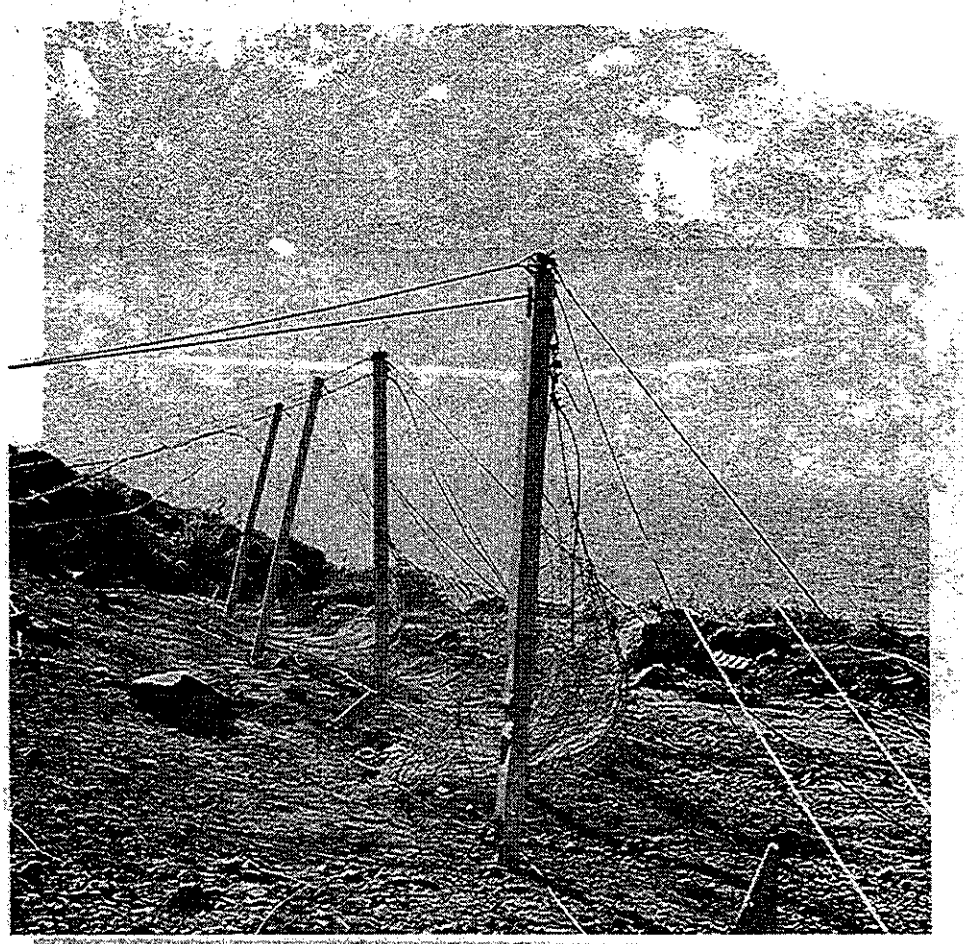
Photo 70. INDUSTRIAL ENTERPRISE ROCK NET AFTER 1300-POUND ROCK #12 IMPACTED THE NET WITH 180 FOOT-TONS OF KINETIC ENERGY. ROCK #12 ROLLED OVER THE NET PANEL.

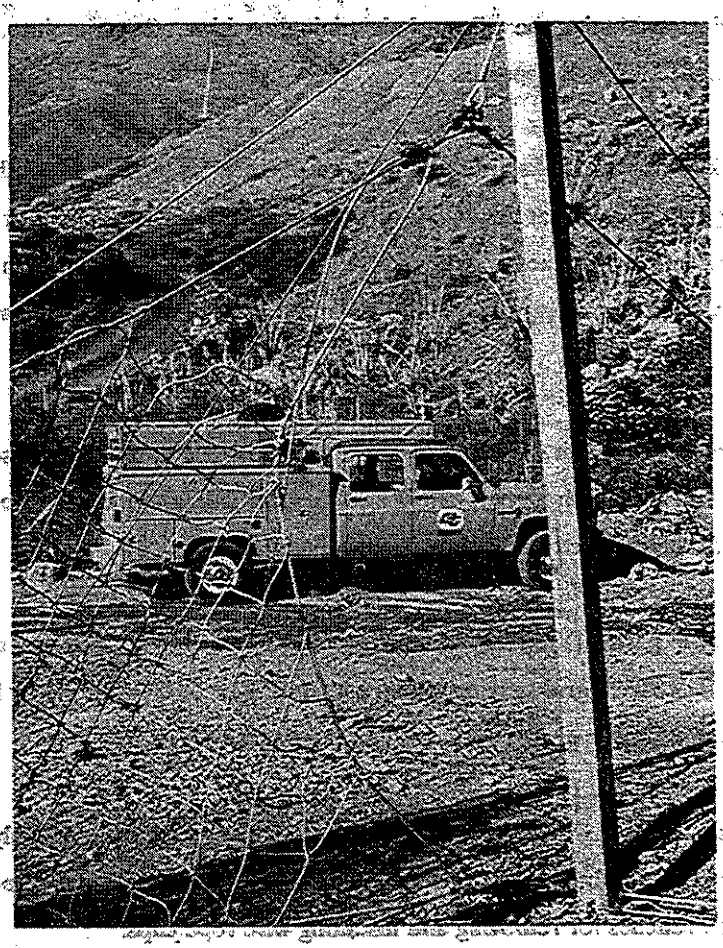
Photo 71 – DOWNSLOPE VIEW OF THE RIGHT SIDE OF INDUSTRIAL ENTERPRISE NET PANEL 3. NOTE THE SHIFTING BORDER WIRE ROPE CLIPS AND SAGGING NET

Loose or sagging chain link mesh on the rock nets can be corrected by repositioning the mesh and attaching it to the wire rope panels with wire twists.

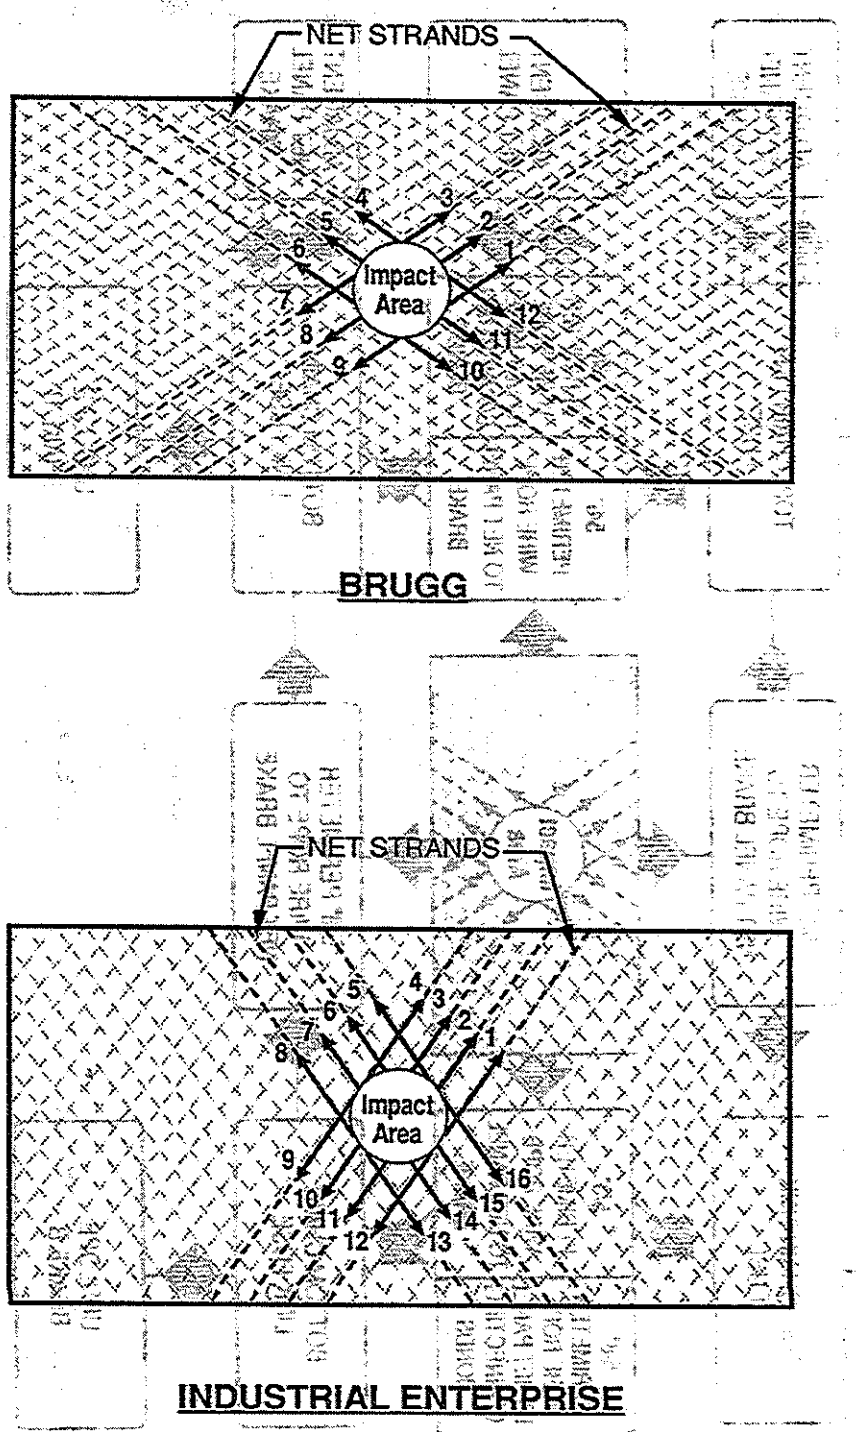
Figure 16. IMPACTED NET STRANDS FROM A 25 INCH DIAMETER BODY

The Brugg net was connected to a 3/8-inch perimeter wire rope at 18 points equally spaced along the top and bottom of the net and at 11 points equally spaced along the sides. The resulting grid squares were diamond-shaped. Flexibility was equal horizontally and vertically. This design transferred equal loads in all directions (Figure 16)

The Industrial Enterprise net was connected to a 5/8-inch perimeter wire rope at 26 points equally spaced along the top and bottom of the net and at 9 points equally spaced along the sides. The resulting grid squares were parallelogram-shaped and more flexible horizontally than vertically. This design transferred more load to the top and bottom of the net than to the sides (Figure 16).

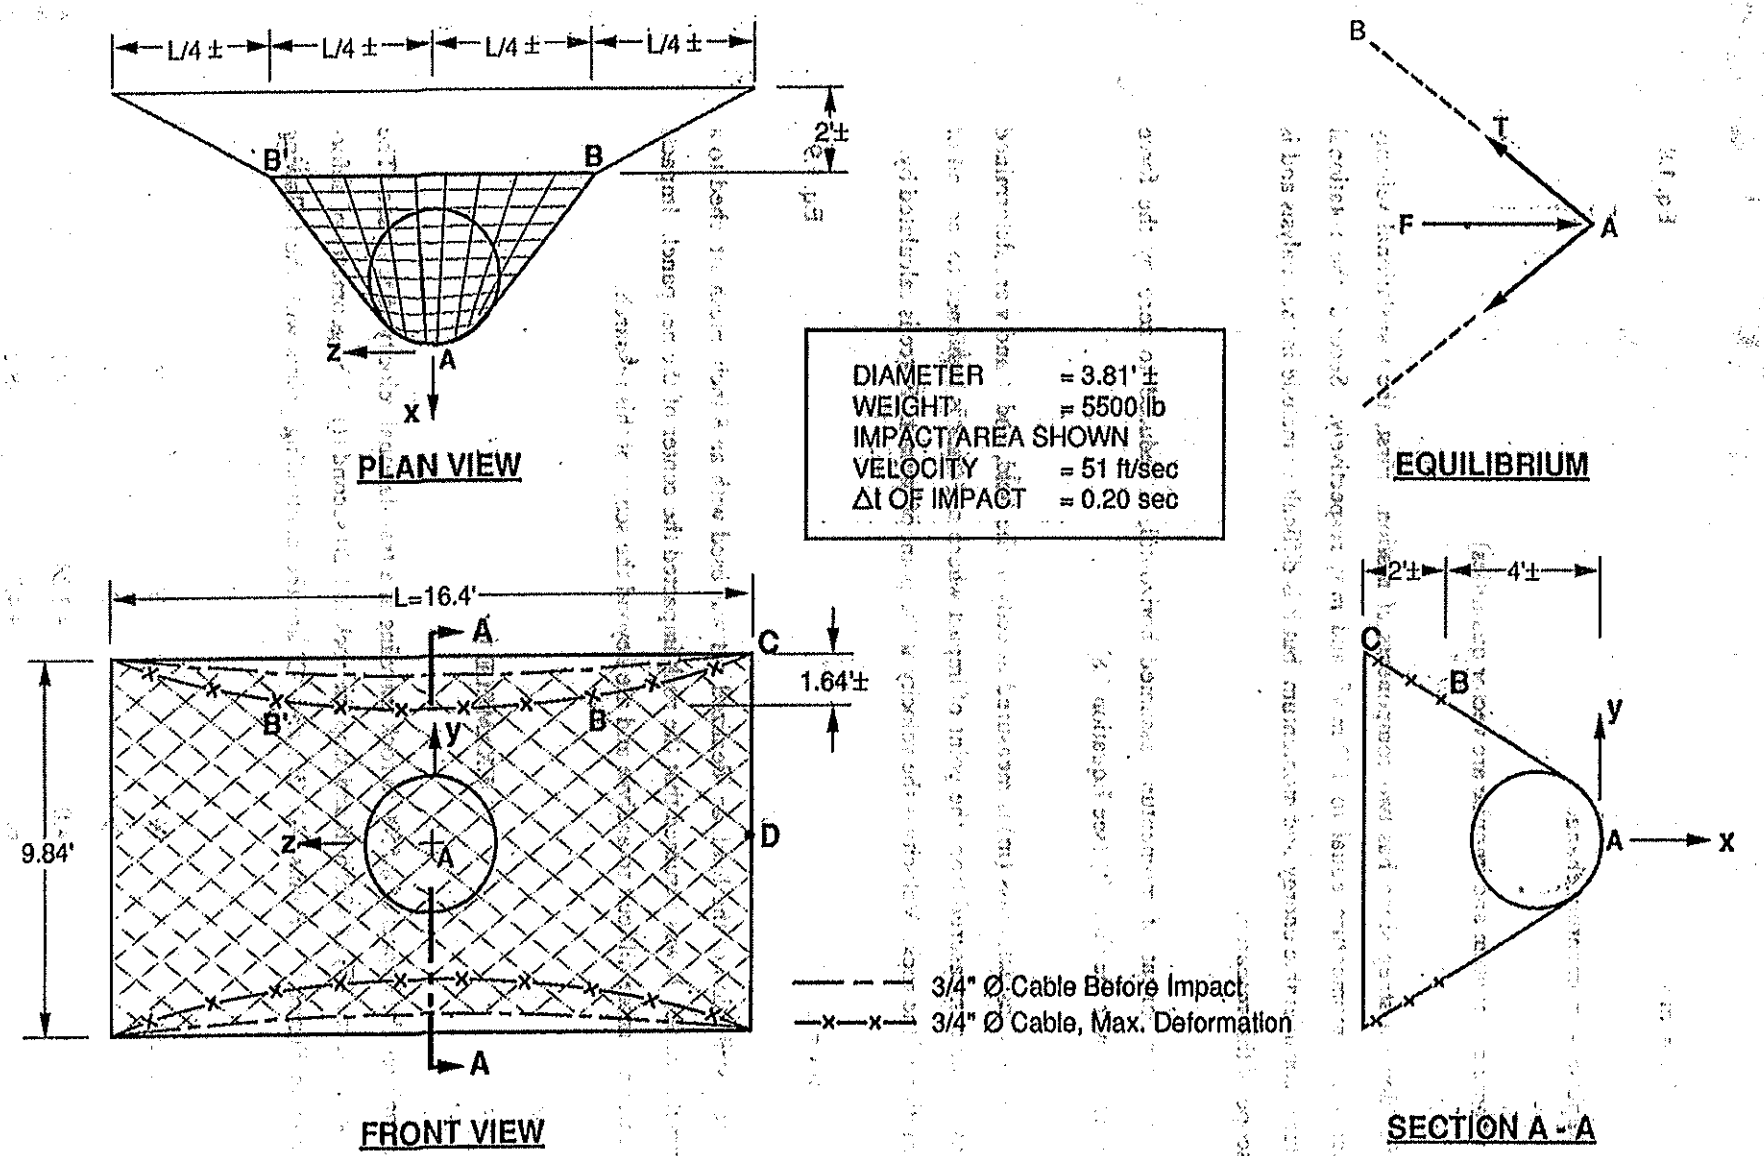
Figure 17. GEOMETRY OF DEFORMATION AND EQUILIBRIUM AT THE POINT OF CONTACT OF THE ROCK BODY

The test case analyzes the impact of a 5500 lb rock traveling at a translational velocity of 51 ft/sec. The net will react with a force (F) of 43556 lb and stop the rock in 0.20 second (t). The geometry of deformation is shown in Figure 17. Points "A", "B", and "C" are the controlling points with the following coordinates:

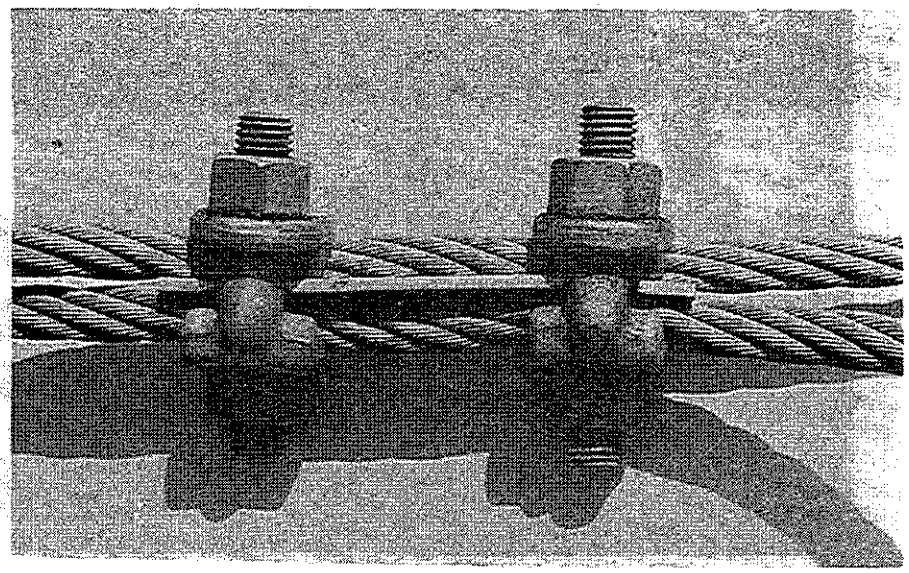
- Heavily torqued friction brakes and minimal friction surface of the Brugg friction brakes caused permanent distortion of the wire rope upon brake activation, requiring replacement.

Photo 72. BRUGG FRICTION BRAKE. NOTE DISTORTION OF THE WIRE ROPE IN THE CLAMP

- Brugg 3/4-inch friction brake tensile strength should be reduced by approximately 50% to reduce repairs.
