California Department Of Transportation

Transportation Materials And Research

FIELD TESTS AND EVALUATION OF ROCKFALL RESTRAINING NETS

Report No. CA/TL - 90/05

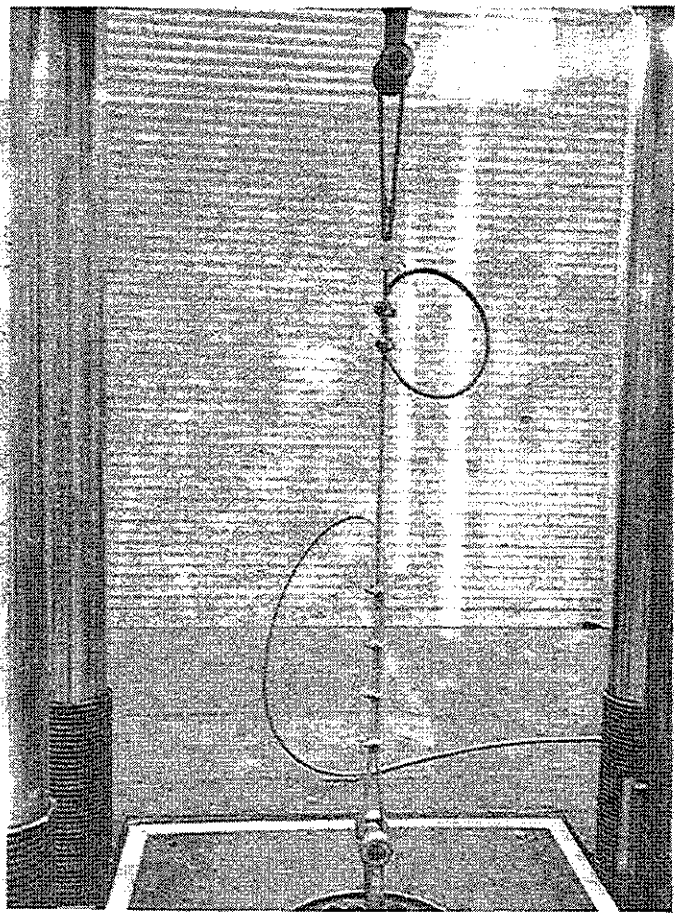
Seven tests on friction brakes were performed to evaluate friction brake capabilities. The testing device was an MTS electro hydraulic machine with a one million pound capacity (Photos 73 and 75). Testing rate was two inches per minute. The purpose of the testing was to confirm manufacturers specifications and evaluate brake performance.

Photo 73. BRUGG FRICTION BRAKE UNDER TENSION IN THE **MTS** ELECTRO HYDRAULIC MACHINE

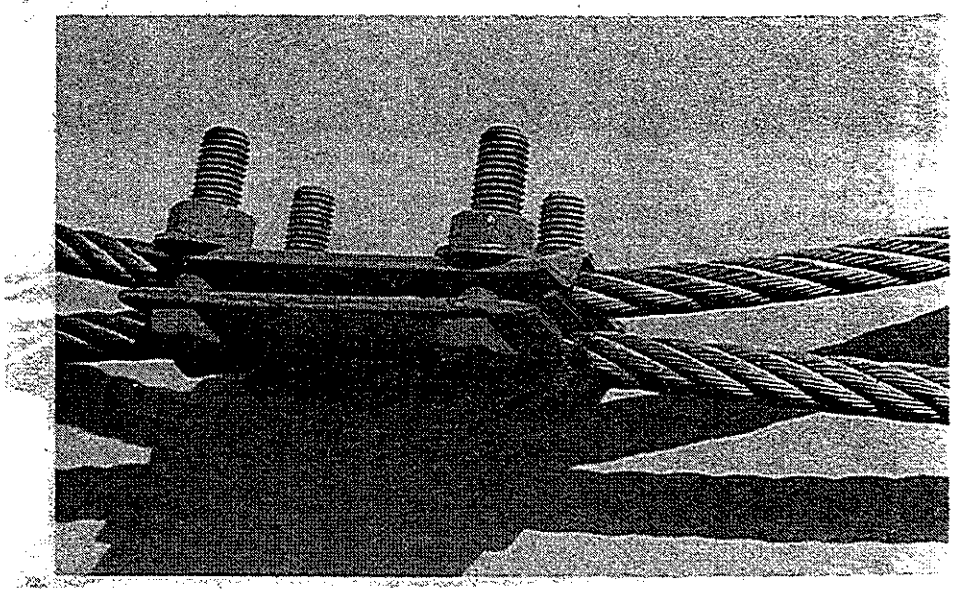
EI brakes caused little damage to the cable as it passed through the brake resulting in a reusable cable (Photo 74). This was largely due to the large brake friction surface area and moderate bolt torques which did not squeeze the cable excessively. This action can be seen in the graphs as a smooth curve indicating the cable slides through without a change in its shape (Figures 22 through 24). Tensile brake

Photo 74. INDUSTRIAL ENTERPRISE FRICTION BRAKE. NOTE FLARED ENDS OF BRAKE PLATES

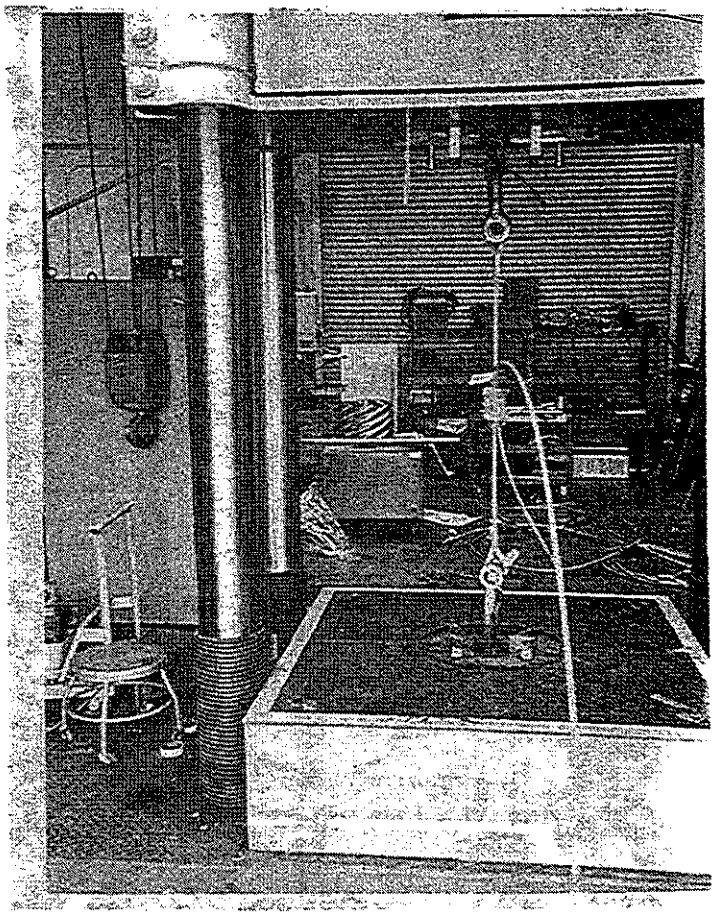
Photo 75. INDUSTRIAL ENTERPRISE FRICTION BRAKE UNDER TENSION IN THE MTS ELECTRO HYDRAULIC MACHINE

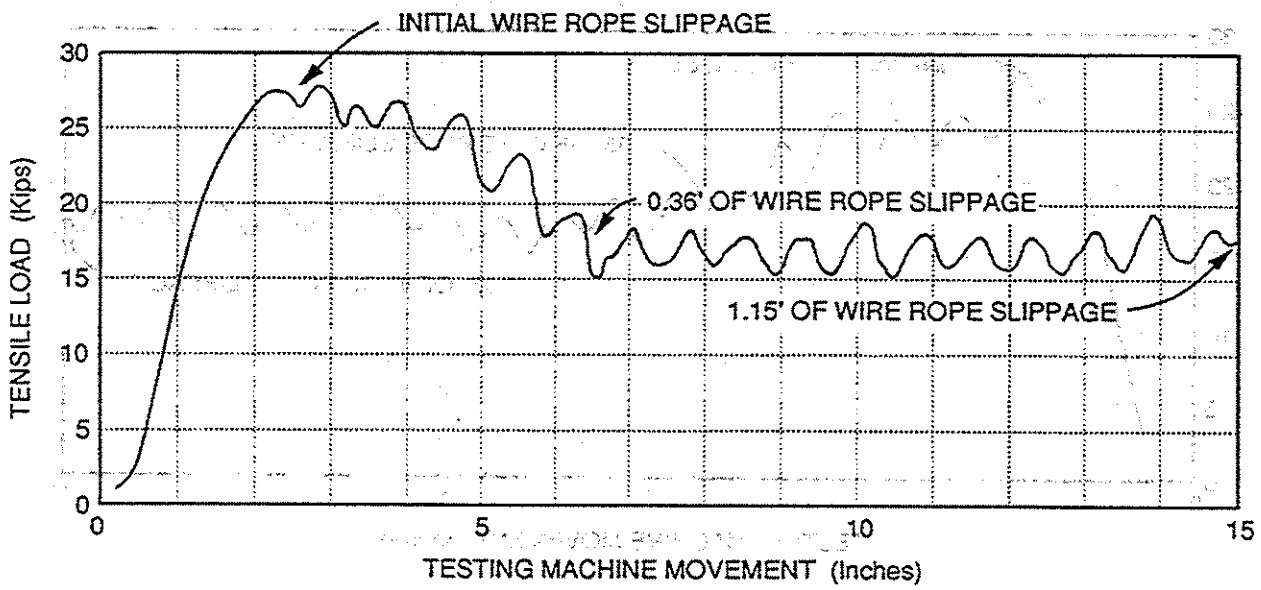
Figure 18. BRUGG FRICTION BRAKE TEST # 1 SHOWING FRICTION BRAKE SLIPPAGE UNDER LOADING

TEST 1	BRUGG 5/8" DIAMETER FRICTION BRAKE
Testing rate	2 inches / minute
Tensile strength of wire rope	38304 lbs (Factory specifications)
Tensile strength of brake	26880 lbs (Factory specifications)
Test tensile strength of brake	27800 lbs
Bolt torque in ft-lbs prior to test:	67 30 70 30

REMARKS:
The brake linings were rough and grooved prior to testing.
After the test the metal was scoured, out of round and frayed.

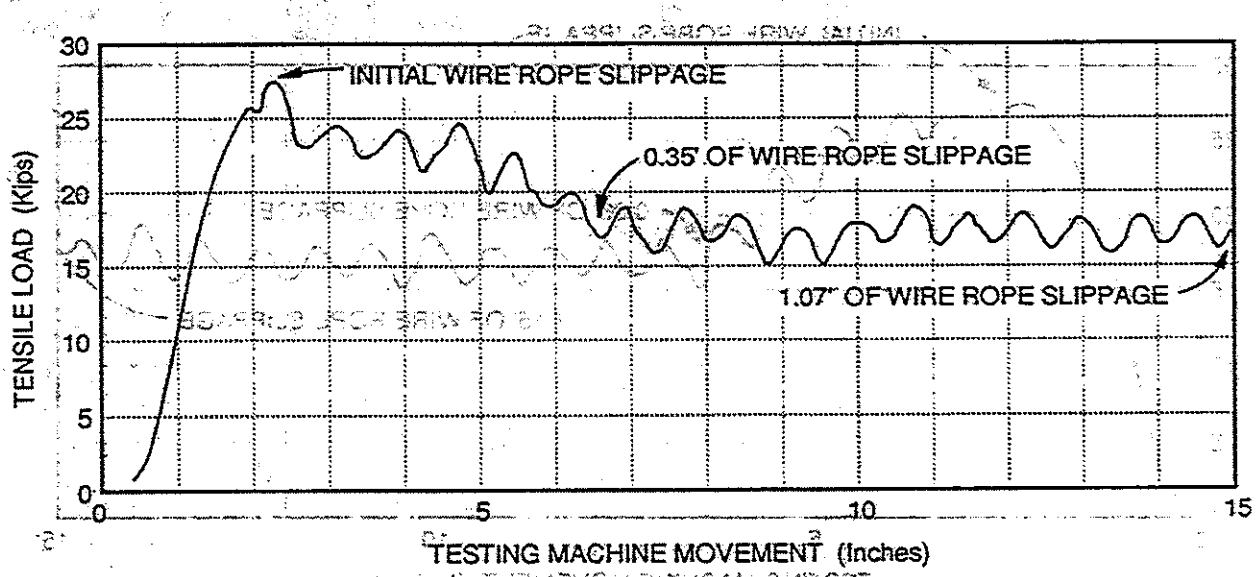
Figure 19. BRUGG FRICTION BRAKE TEST #2 SHOWING FRICTION BRAKE SLIPPAGE UNDER LOADING

TEST 2	BRUGG 5/8" DIAMETER FRICTION BRAKE
Testing rate	2 inches / minute
Tensile strength of wire rope	38304 lbs (Factory specifications)
Tensile strength of brake	26880 lbs (Factory specifications)
Test tensile strength of brake	27800 lbs
Bolt torque in ft-lbs prior to test:	60 55 / 80 60
Bolt torque in ft-lbs after test:	55 50 / 50 50

REMARKS: Initially the bolts may have been torqued to 90 ft-lbs but over time the wire ropes seated themselves and slipped reducing apparent bolt torque. Wire rope was out of round and frayed.

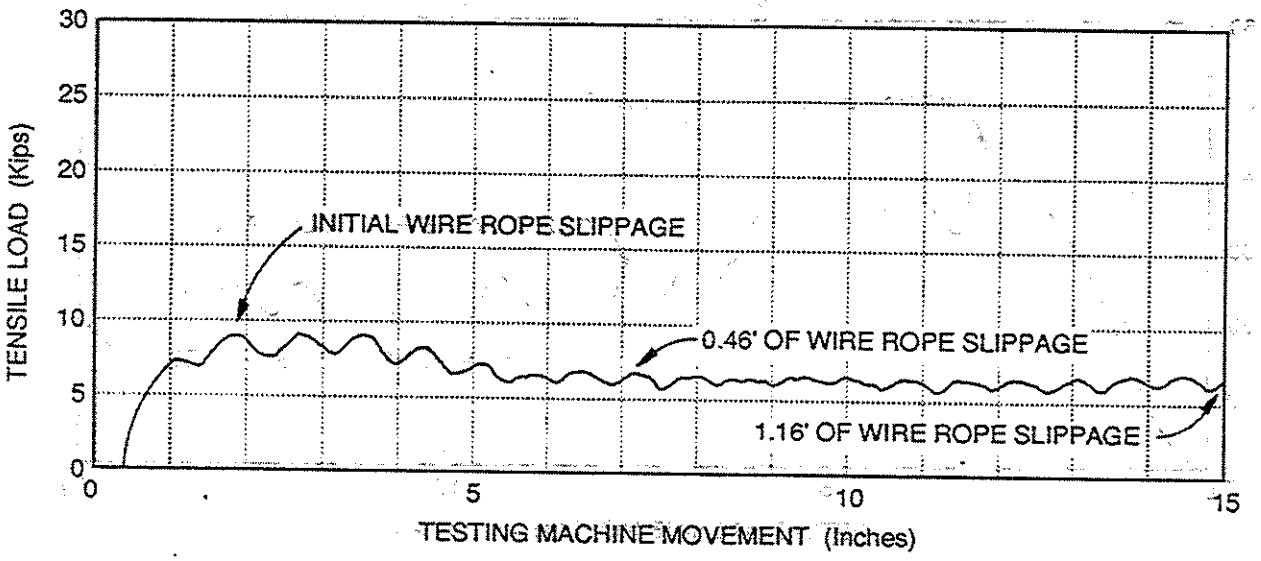
Figure 20. BRUGG FRICTION BRAKE TEST # 3 SHOWING FRICTION BRAKE SLIPPAGE UNDER LOADING

TEST 3	BRUGG RE-SET 5/8" DIAMETER FRICTION BRAKE
Testing rate	2 inches / minute
Tensile strength of wire rope	38304 lbs (Factory specifications)
Tensile strength of brake	26880 lbs (Factory specifications)
Test tensile strength of brake	8000 lbs
Bolt torque in ft-lbs prior to test:	50 50 / 50 50
Bolt torque in ft-lbs after test:	25 30 / 40 30
REMARKS: Wire rope damage minimal

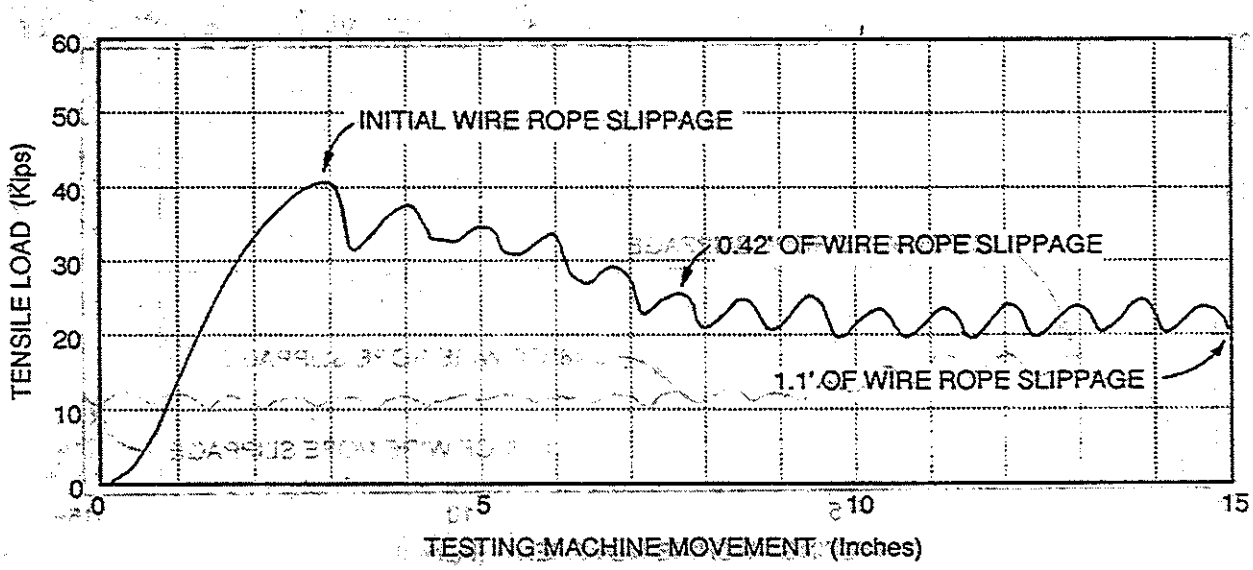
Figure 21. BRUGG FRICTION BRAKE TEST # 4 SHOWING FRICTION BRAKE SLIPPAGE UNDER LOADING

TEST 4	BRUGG 3/4" DIAMETER FRICTION BRAKE
Testing rate	2 inches / minute
Tensile strength of wire rope	48160 lbs (Factory specifications)
Tensile strength of brake	44800 lbs (Factory specifications)
Test tensile strength of brake	41000 lbs
Bolt torque in ft-lbs prior to test:	160 170 140 150
Bolt torque in ft-lbs after test:	140 120 110 120
REMARKS:	Wire rope was out of round and frayed.

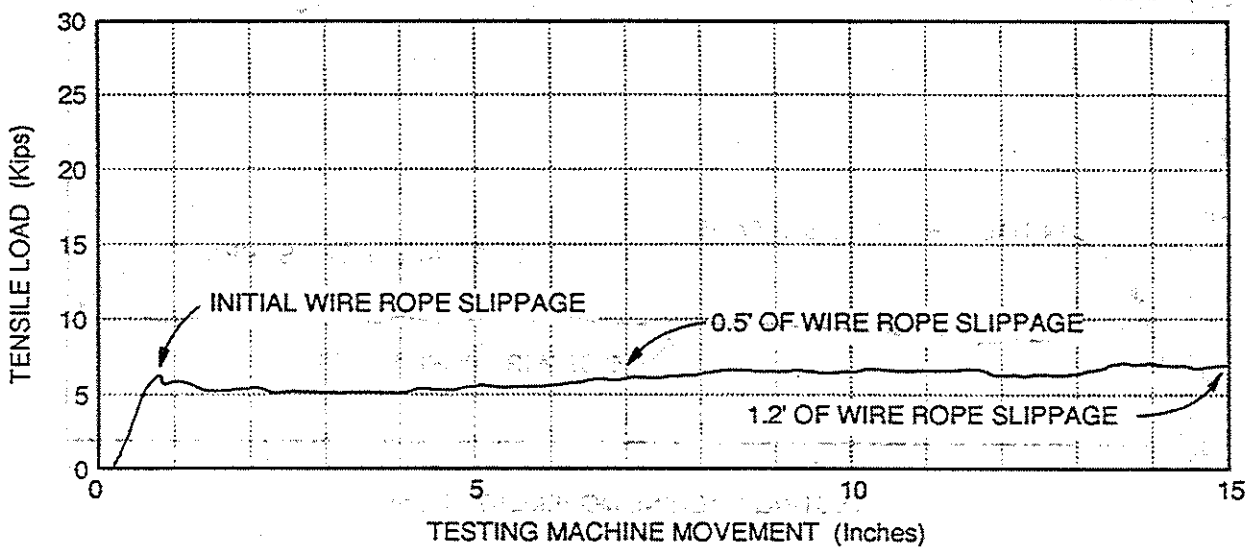
Figure 22. INDUSTRIAL ENTERPRISE FRICTION BRAKE TEST # 5 SHOWING FRICTION BRAKE SLIPPAGE UNDER LOADING

TEST 5	INDUSTRIAL ENTERPRISE 5/8" DIAMETER FRICTION BRAKE
Testing rate	2 inches / minute
Tensile strength of wire rope	37477 lbs (Factory specifications)
Tensile strength of brake	5500 lbs (Factory specifications)
Test tensile strength of brake	6500 lbs
Bolt torque in ft-lbs prior to test:	50 50 / 50 50
Bolt torque in ft-lbs after test:	50 38 / 50 45
REMARKS:	Wire rope on the nut side, fastened to the upper grip, moved. Wire rope damage was minimal.

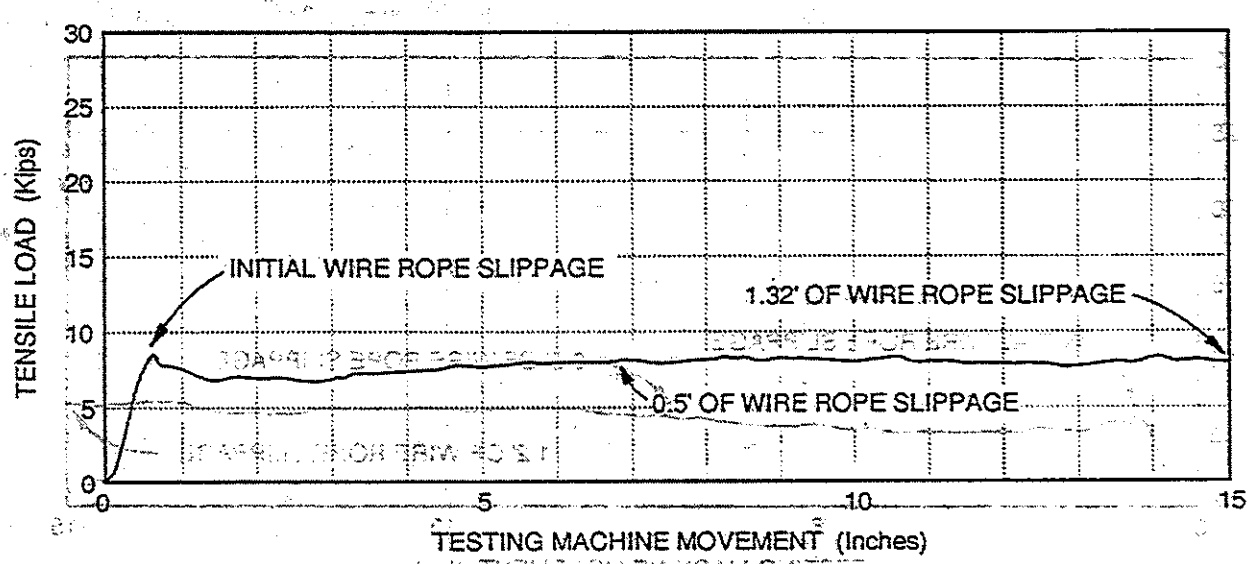
Figure 23. INDUSTRIAL ENTERPRISE FRICTION BRAKE TEST # 6 SHOWING FRICTION BRAKE SLIPPAGE UNDER LOADING

TEST 6	INDUSTRIAL ENTERPRISE 5/8" DIAMETER FRICTION BRAKE
Testing rate	2 inches / minute
Tensile strength of wire rope	37477 lbs (Factory specifications)
Tensile strength of brake	5500 lbs (Factory specifications)
Test tensile strength of brake	8000 lbs
Bolt torque in ft-lbs prior to test:	60 50 / 50 50
Bolt torque in ft-lbs after test:	55 45 / 50 50

REMARKS: Wire rope on the nut side, fastened to the upper grip, moved. Wire rope damage was minimal.

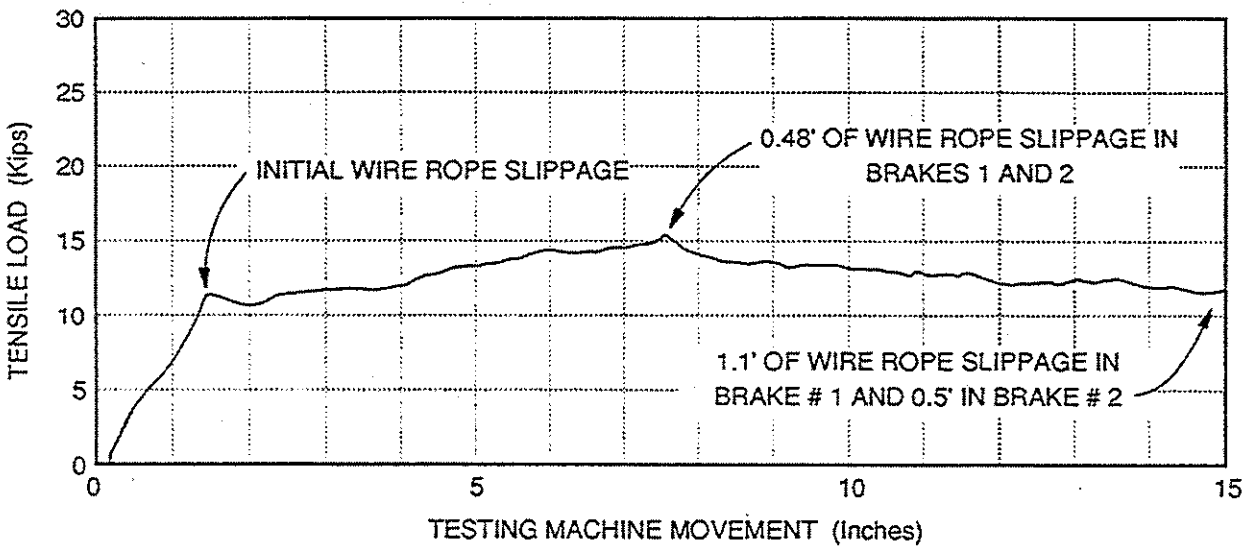
Figure 24. INDUSTRIAL ENTERPRISE FRICTION BRAKE TEST # 7 SHOWING FRICTION BRAKE SLIPPAGE UNDER LOADING

TEST 7	TWO INDUSTRIAL ENTERPRISE 5/8" DIAMETER FRICTION BRAKES

REMARKS: Wire rope on the nut side, fastened to the upper grip, moved. Wire rope damage was minimal.
