Title: Preliminary Investigation of Cathodic Protection of a Bridge Deck

PRELIMINARY INVESTIGATION OF CATHODIC PROTECTION OF A BRIDGE DECK

R. F. Stratfull
Senior Corrosion Engineer

November 1973

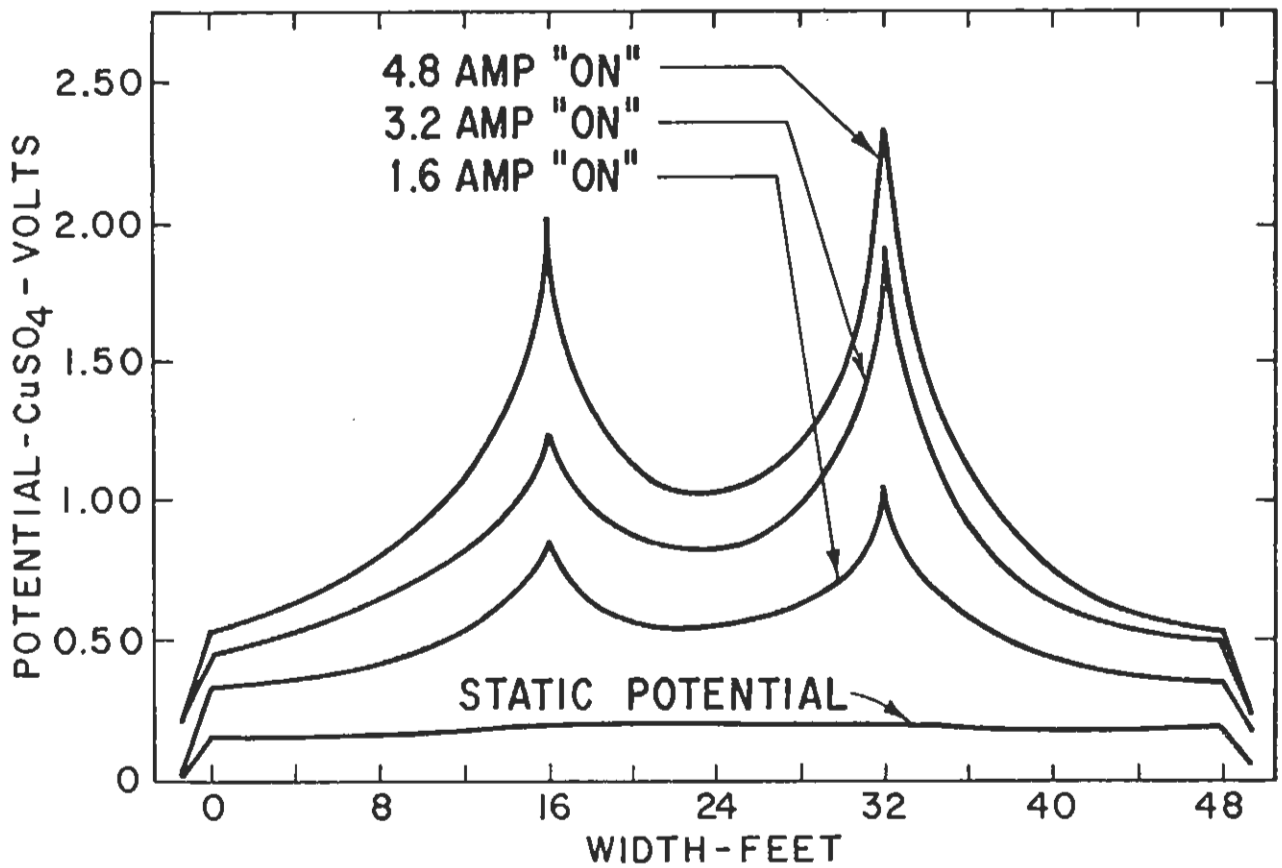
As shown by Figures 1 and 2, the cathodic protection currents can spread for a minimum radius of about 25 feet and adequately polarize the reinforcing steel. This test was considered a particularly severe test of the theory of protection because the loose and dry coke breeze had a specific electrical resistance in the range of 200 ohm cm.

Figure 1. Distribution of potentials with current on, two anodes.

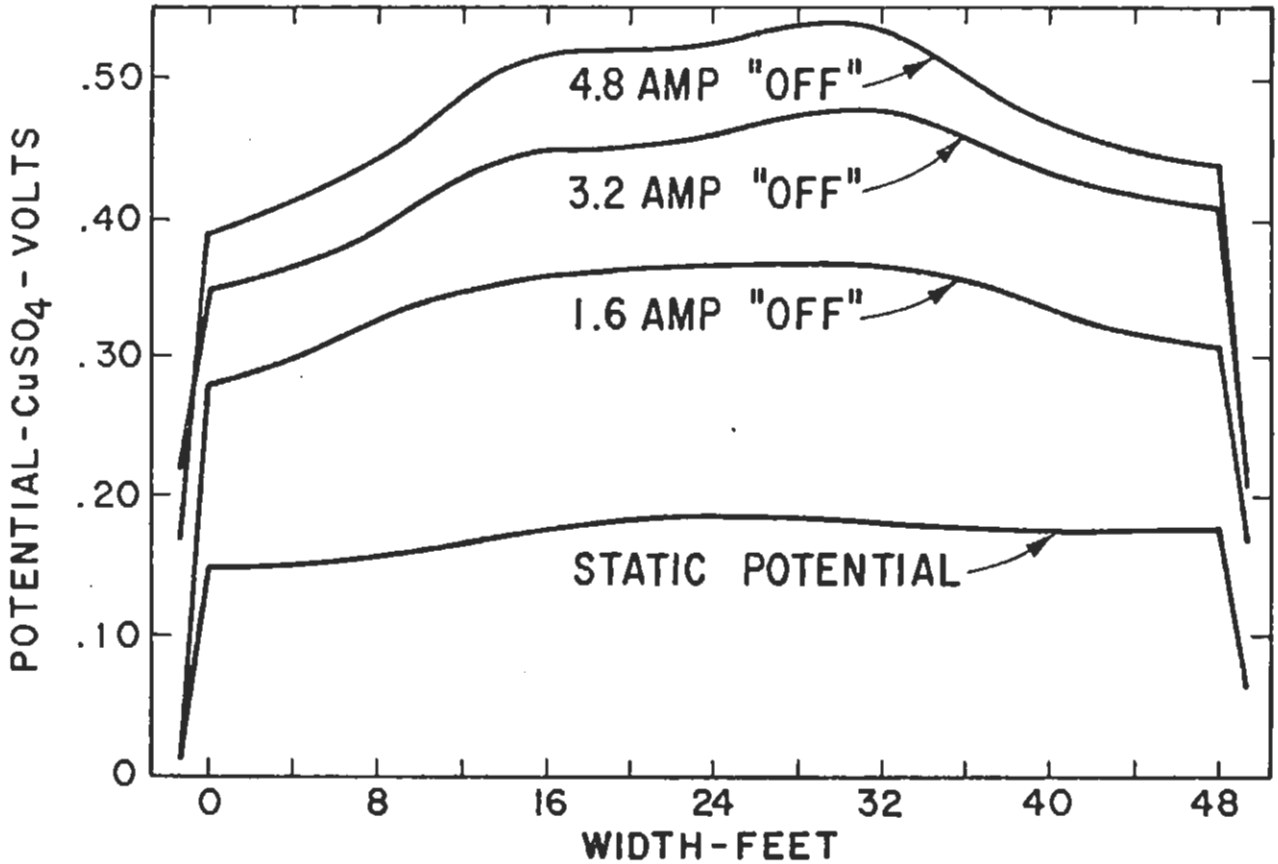
Figure 2. Distribution of polarized potentials - two anodes.
