STATE OF CALIFORNIA
DEPARTMENT OF TRANSPORTATION
DIVISION OF CONSTRUCTION
OFFICE OF TRANSPORTATION LABORATORY

GUIDELINES FOR USING RECYCLED TIRE CARCASSES IN HIGHWAY MAINTENANCE

FINAL REPORT # FHWA/CA/TL-87/07

CALTRANS STUDY # R81TL08

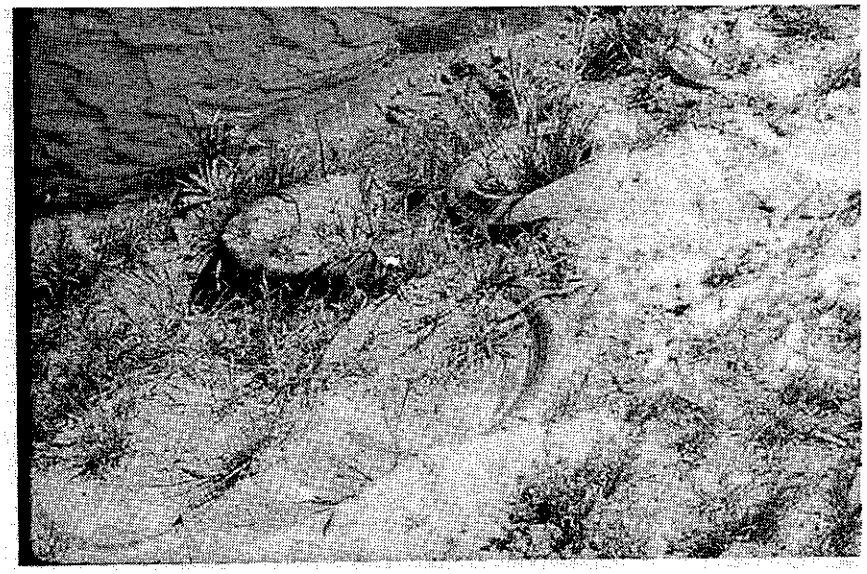
The proper installation procedures for tires is very important. The slope protection projects shown in Photos 5.4 & 5.5 reflect a lack proper engineering practices for installations.

Photo 5.4 - Slope Protection In San Luis Obispo Co.

Photo 5.5 - Fresno County - 06-Fre-46

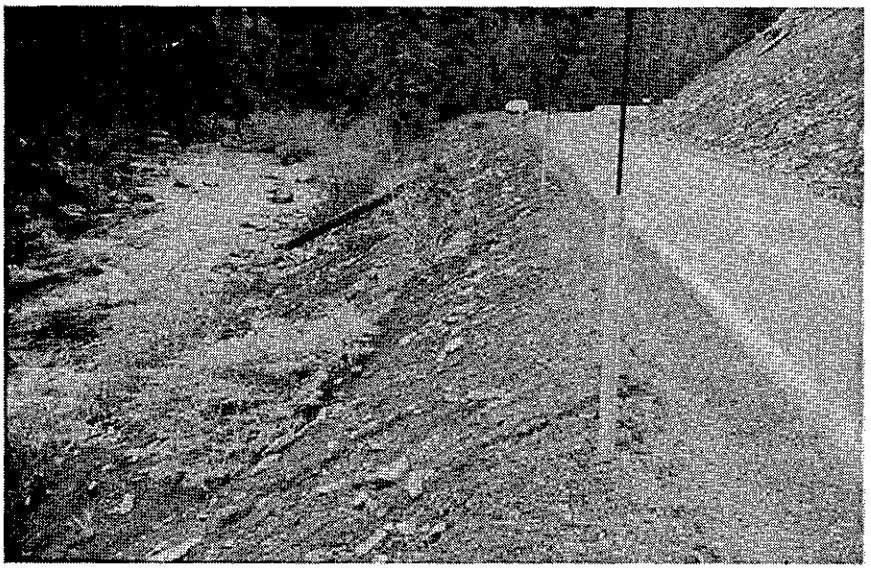
Photo 7.1 - Site Before Installation Of Tires

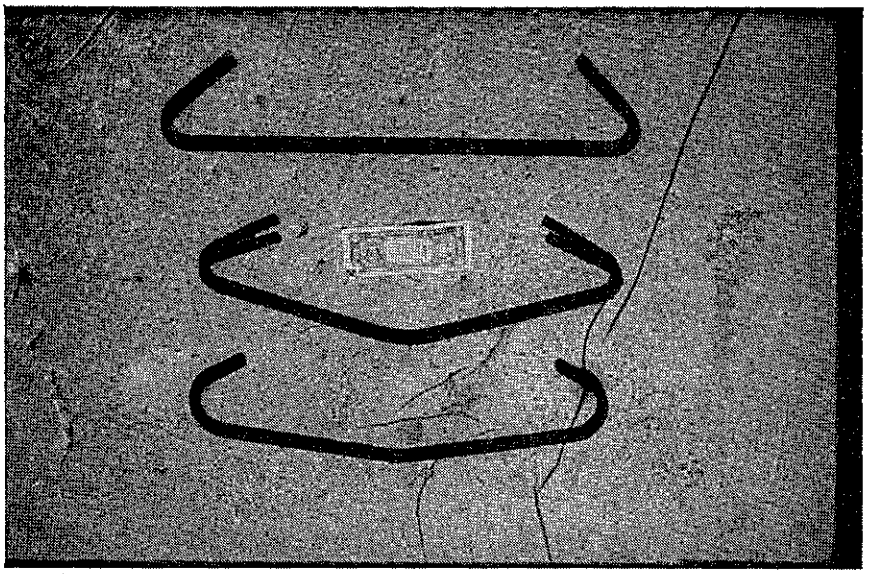
Photo 7.8 - 1/2" Rebar Tire Clips

bent into the form of a clip (Photo 7.8). These clips provide a strong connection and a longer corrosion life.

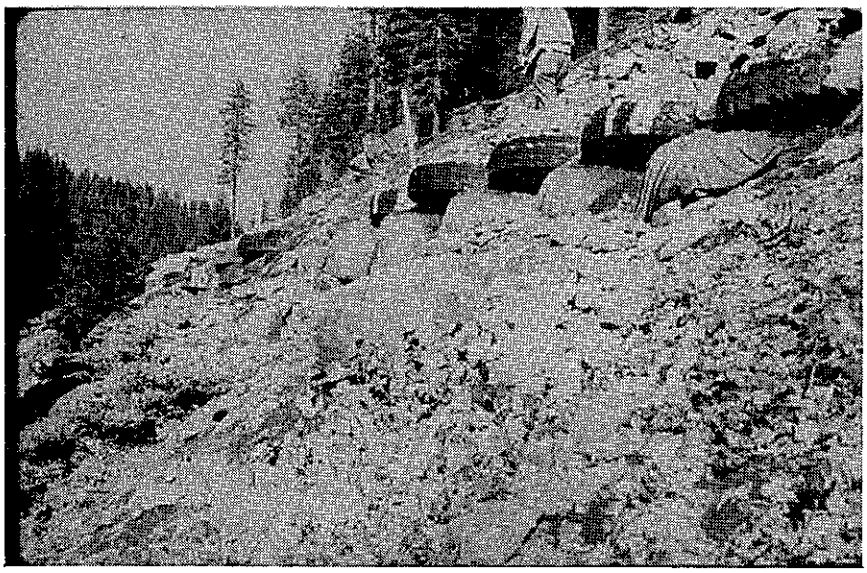
Photo 7.15 - Unit "A" Site (1983)

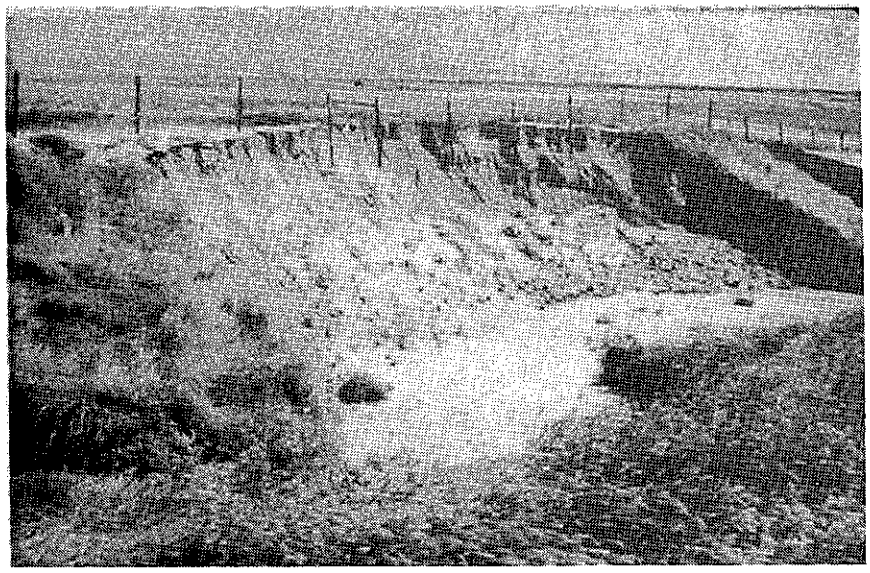
Photo 8.1 - Unit "A" - Eroded Channel Slope (1978)

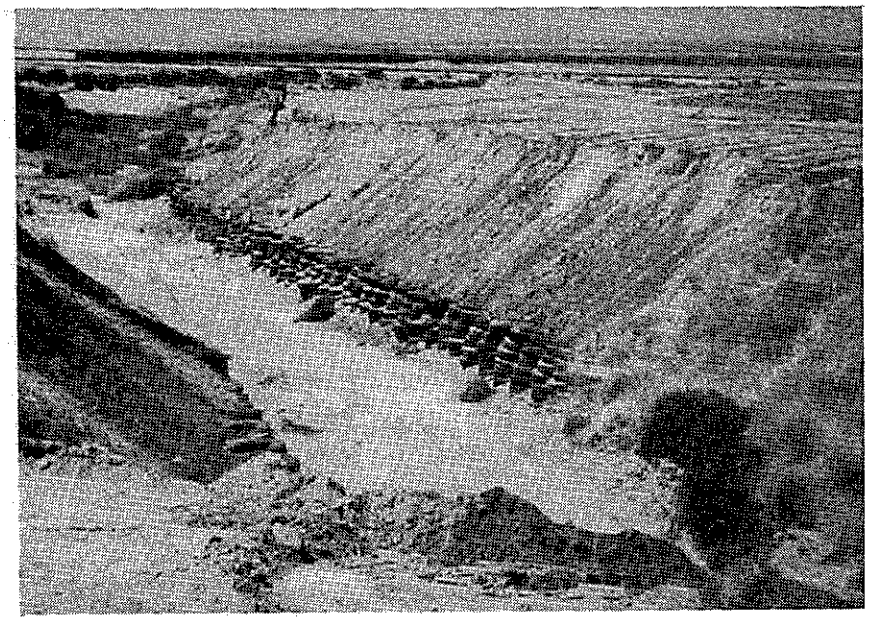
Photo 8.2 - Unit "A" - Channel After Tire Installation (1978)

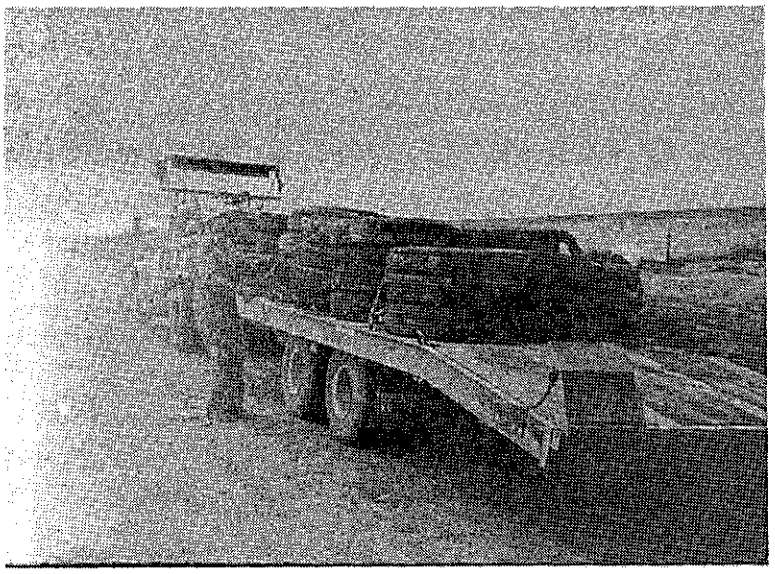
Photo 8.5 - Transport Vehicle

On the research sites problems occurred due to different thickness of tires and weak carcasses. On Unit "D" the problem was the tilting outward of the tires. Another was the loss of the staggered layered pattern, on Unit "C", as the tires progressed toward the end of the section due to the variation in sizes of tires.

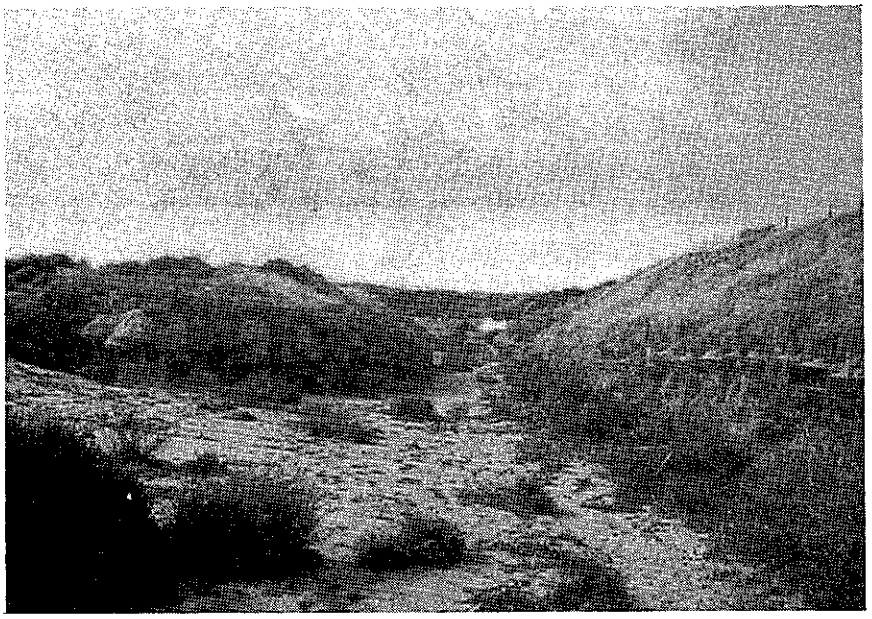
Photo 8.10 Control Section - Channel East Of Unit "C"

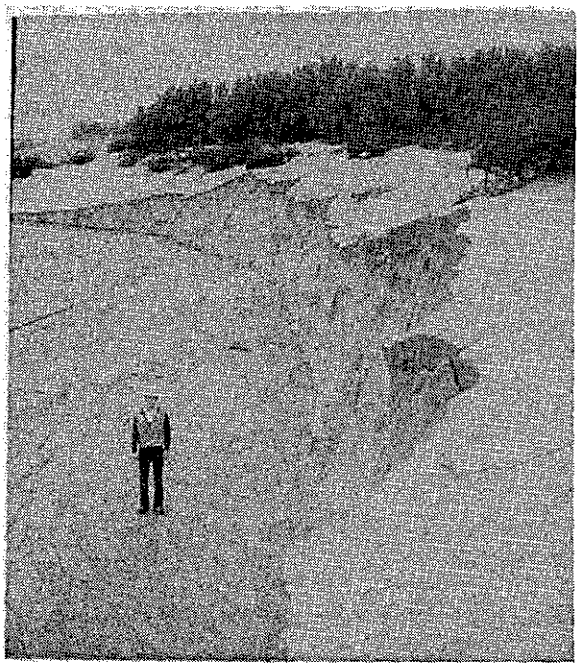
One indirect benefit provided by the contained tire installation was the protection of the highway embankment by tire Unit 5. Photo 9.19 shows the Unit 5 site before the installation and the force of the sheet flow eroding the protective slope. Photo 9.20 shows the area three months after the installation of the tire barrier. The impoundment of sand has replaced the material removed by erosion before installation of Unit 5. The unit now protects the slope from further erosion as well as impounding sand before it reaches the tree row.

Photo 9.19 - Before Unit 5 Was Installed

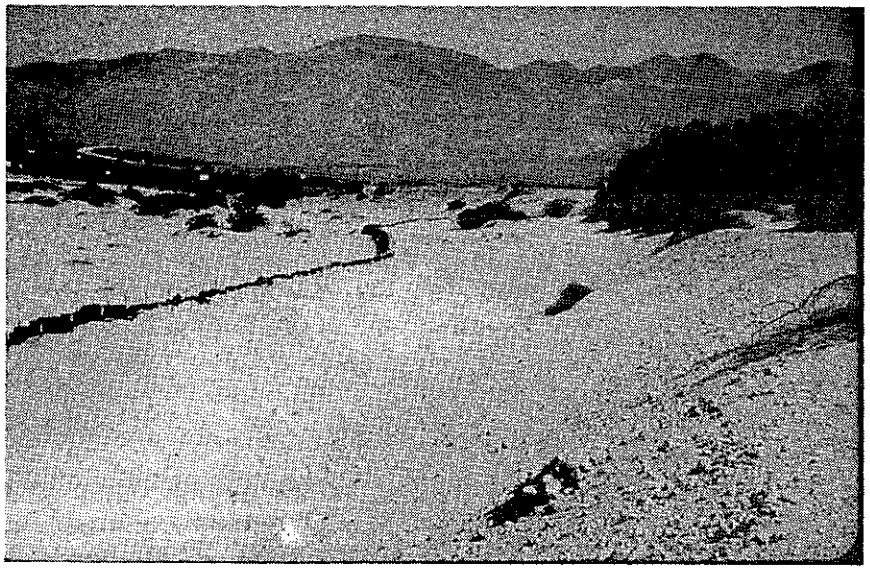
Photo 9.20 - After Unit 5 was installed
