STATE OF CALIFORNIA
DEPARTMENT OF TRANSPORTATION
DIVISION OF ENGINEERING SERVICES
OFFICE OF TRANSPORTATION LABORATORY

INVESTIGATION OF CORROSION AT 14 MECHANICALLY STABILIZED EMBANKMENT SITES

1. REPORT NO.	2. GOVERNMENT ACCESSION NO.	3. RECIPIENT'S CATALOG NO.
CA/TL-87/12

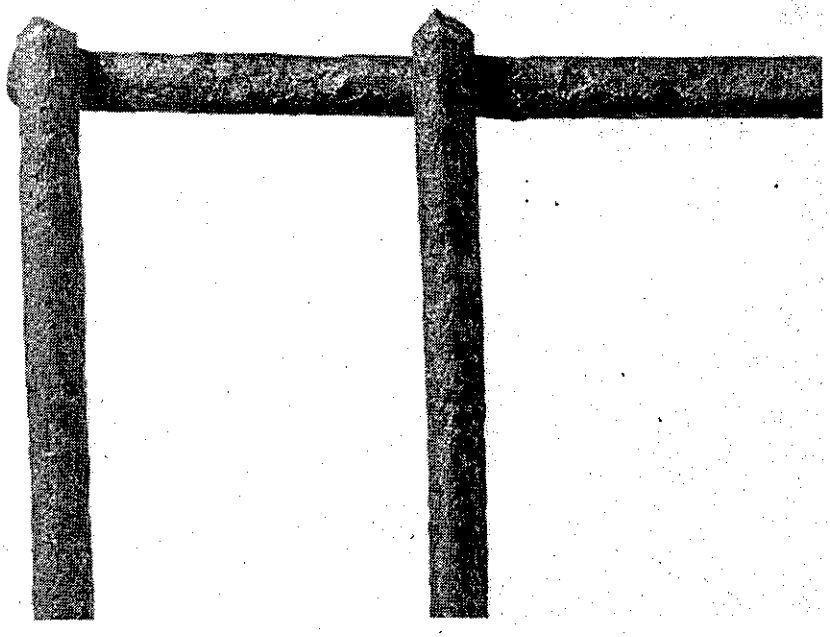
has been in service 6 years. Backfill in the upper one-third of the wall was different than the lower two-thirds of the wall. Backfill in the upper one-third portion of the wall consisted of 34% gravel, 31% sand, and 35% fines and exhibited the following properties: minimum electrical resistivity (R) = 3,500 ohm-cm, plasticity index (PI) = 7, soil acidity (pH) = 6.6. Backfill in the lower two-thirds of the wall consisted of 56% gravel, 25% sand, and 19% fines and exhibited the following properties: R = 3700 ohm-cm, PI = 11, pH = 6.6. Corrosion inspection of the upper one-third of the wall was obtained by exhuming bar mat sections and in the lower two-thirds of the wall by examining inspection rods. Exhumed bar mat sections were taken at a point ten feet behind the face at the one foot and three foot depths. Sampling occurred in the summer and surface soil moistures were low with saturation levels estimated at 30% at the one foot depth and 40 to 50% at the three foot depth. (Data on soil moisture for all sites found on Table IIB is reported as moisture content (%) rather than a saturation level (%) due to sampling techniques.) The exhumed steel bar mats showed corrosion losses equivalent to 25% of the design values.* Pitting was minimal.

Photo 4 - Section of bar-mat removed from top of MSE wall near Mariposa, California

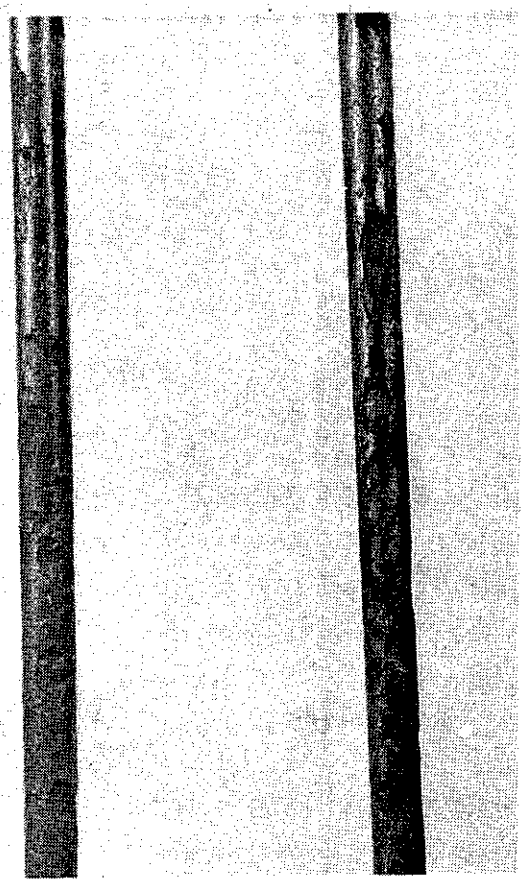
At the time of inspection the MSE wall at Site 2 (Baxter) had been in service for 3 years. The five 10-foot long inspection rods that were retrieved from the lower half of the wall exhibited two distinct areas of corrosion activity; the first three feet, and the remainder of the rod. The front three feet exhibited losses more than three times that of corrosion on the remainder of the rod, and were equivalent to 88% and 25% of the design values, respectively. A hand-excavated bar mat sample removed from the top layer of reinforcement at the one foot depth immediately behind the wall face showed corrosion losses as equivalent to 88% of the design value. Pitting on all samples, by visual inspection, was minimal. Welds were visually inspected and showed little corrosion.

Photo 5 - Photo of two inspection wires removed from the MSE wall near Baxter, California.

Note transition area between corroded lower section and non corroded upper section; age 3 years.

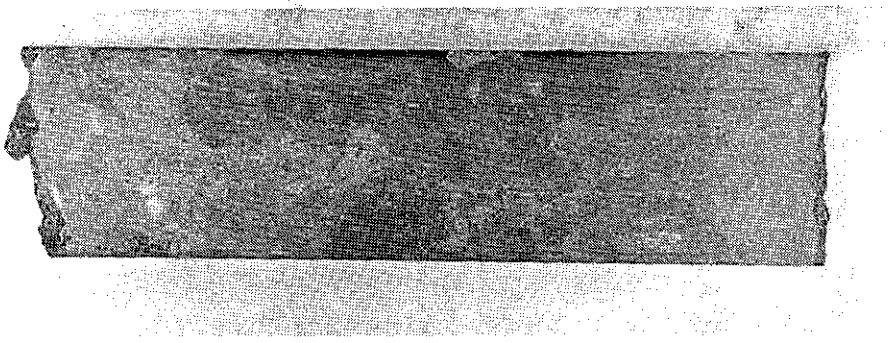
Photo 13 - Reinforcing strap removed near the base of the RE wall in the San Gabriel Mountains on Rt 39 near Los Angeles. Strap is in excellent condition after 13 years.

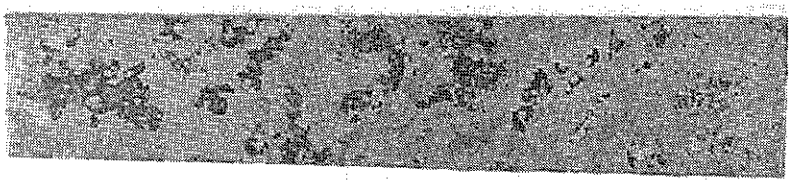
Inspection revealed all but one of the excavated strips were in good condition. The exception was a strip at Dunsmuir, located in a year-round wet area. Visual inspection indicated about a 50% zinc free area on the strip's upper surface. However, rusting was barely visible on the exposed base metal attesting to the protection zinc provides even at a distance. Galvanizing on the bottom of the strap appeared fresh.

Photo 14 - Photo of slightly corroded galvanized strap from the RE wall in Dunsmuir. Age 11 years.
