STATE OF CALIFORNIA
DEPARTMENT OF TRANSPORTATION
DIVISION OF ENGINEERING SERVICES
OFFICE OF TRANSPORTATION LABORATORY

VEHICLE IMPACT TESTS OF A SEE-THROUGH, COLLAPSING RING, STRUCTURAL STEEL TUBE, BRIDGE BARRIER RAILING

83-05

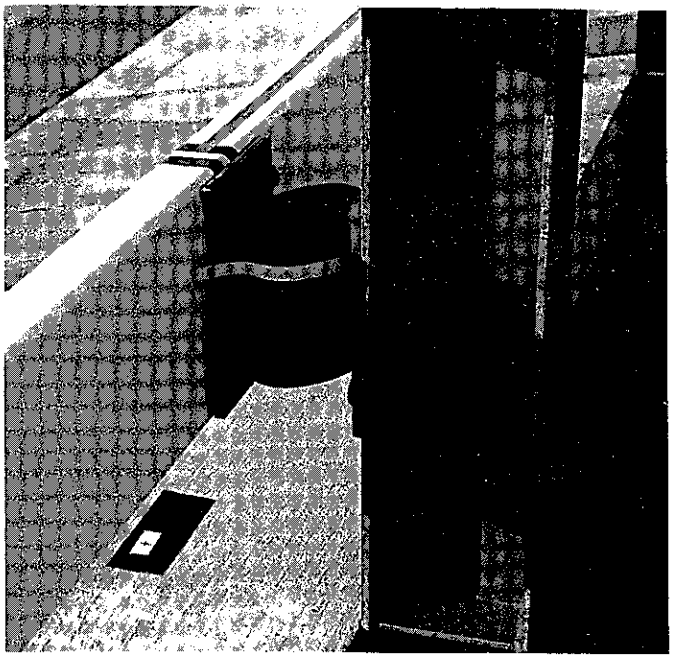
Pipe Ring Crushed 1 7/8" at Post 5

repaired simply by replacing the collapsed steel pipe rings. Slightly more crush in the pipe rings might have been possible if the bolts connecting the 1/2-inch plates to the post and rail had been offset.

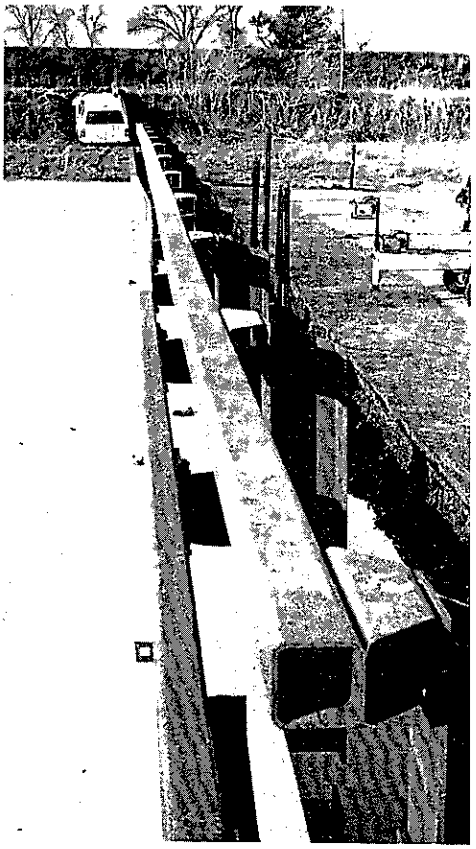
Deflection in 3"x12" Tube Rail - 2 5/8" Max; Final Location of Car on Earth Berm

Measurements taken after the test showed that the permanent lateral deflections of the 3x12 rail (measured at the top of the rail) were 0.25 inch and 1.88 inches at posts 4 and 5 upstream of impact and 2.63 inches and 0.63 inch at posts 6 and 7 downstream of impact. All of this deflection was due to crushing of the steel pipe rings. Only the four partially crushed steel pipe rings and attached plates from the four posts near the point of impact needed replacement. When they were removed, the deflected portion of the 3x12 rail sprung back into a straight alignment. Although it probably was not necessary, 16'-0" of this 3x12 rail was replaced with new rail for the second test in the series. The barrier deflections are shown in Figure 13. Figure 14 shows how the deflections were measured.

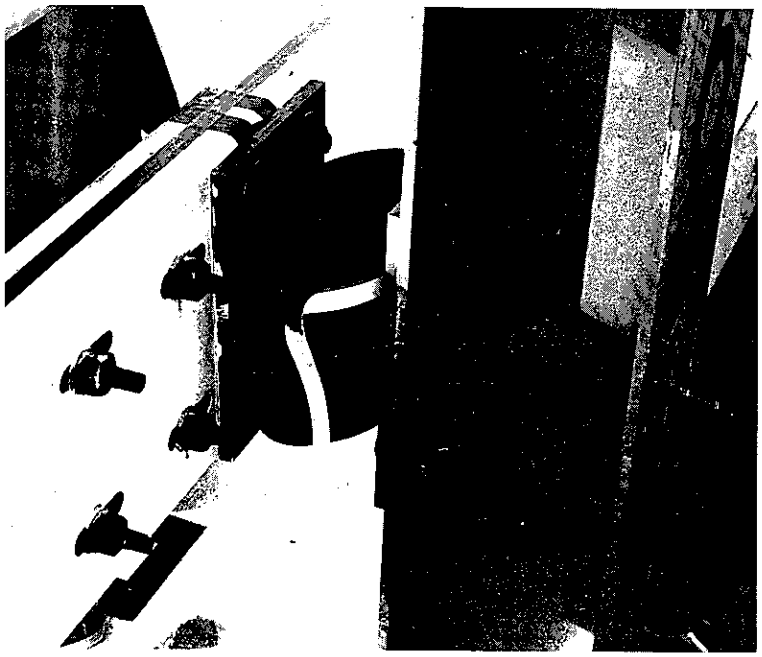
Pipe Ring Crushed 2 5/8" at Post 6

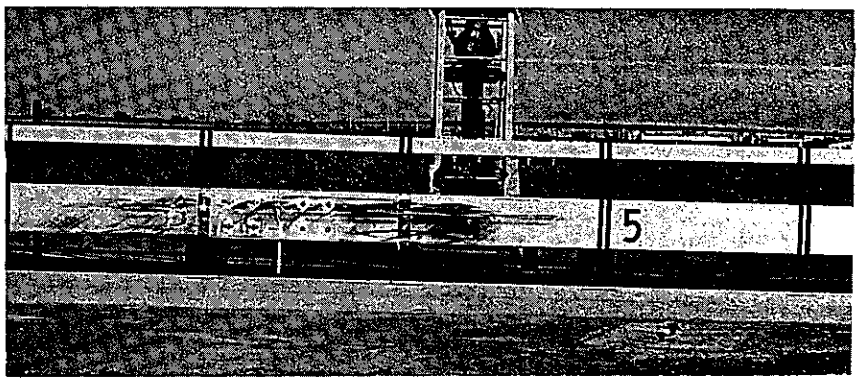
Total Length of Vehicle Contact on
3"x12" Tube - 12.6 Ft.
No Vehicle Contact With 4"x4" Tube

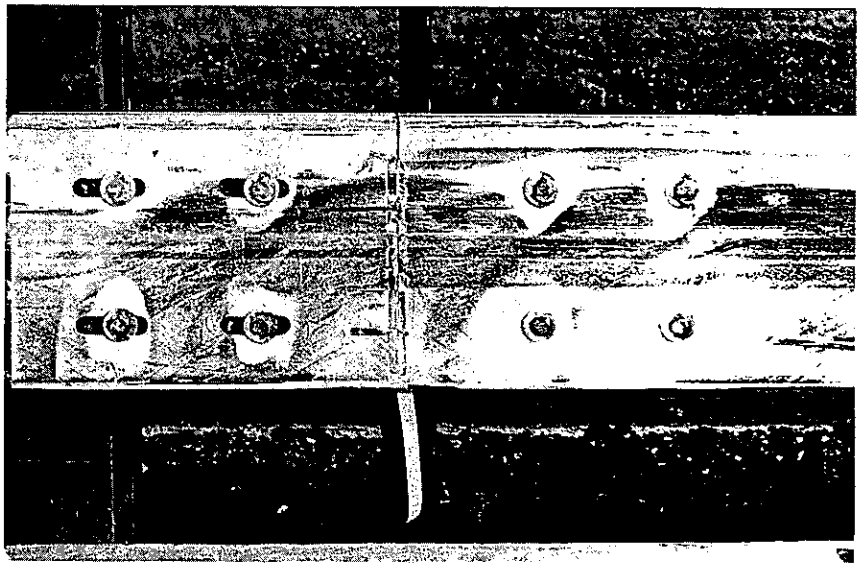
Tire Scuff Marks on 3"x12" Tube at
Expansion Joint Splice - No Movement
of Splice

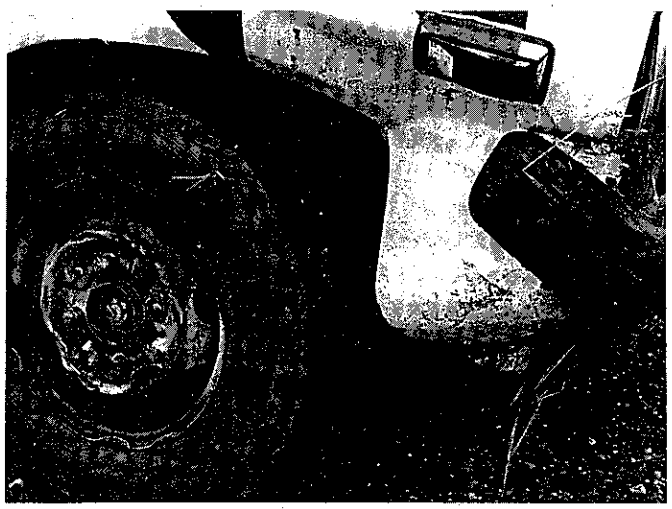
Crinkles on Rim Due to Contact With Button Heads of Bolts at Expansion Joint Splice; One Lug Bolt on Wheel Sheared Off.

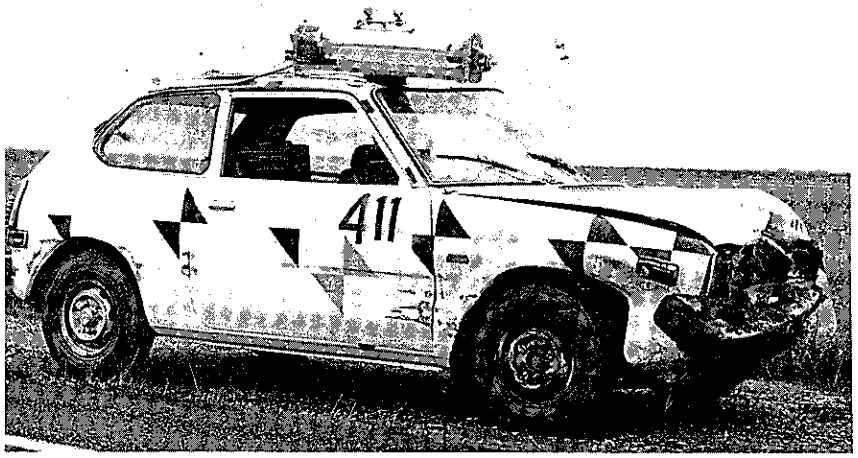
Car After Removal From Earth Berm; Front Crush All Due to Impact With Earth Berm; Light Scuffing and Denting From 3"x12" Tube Entire Length of Car.

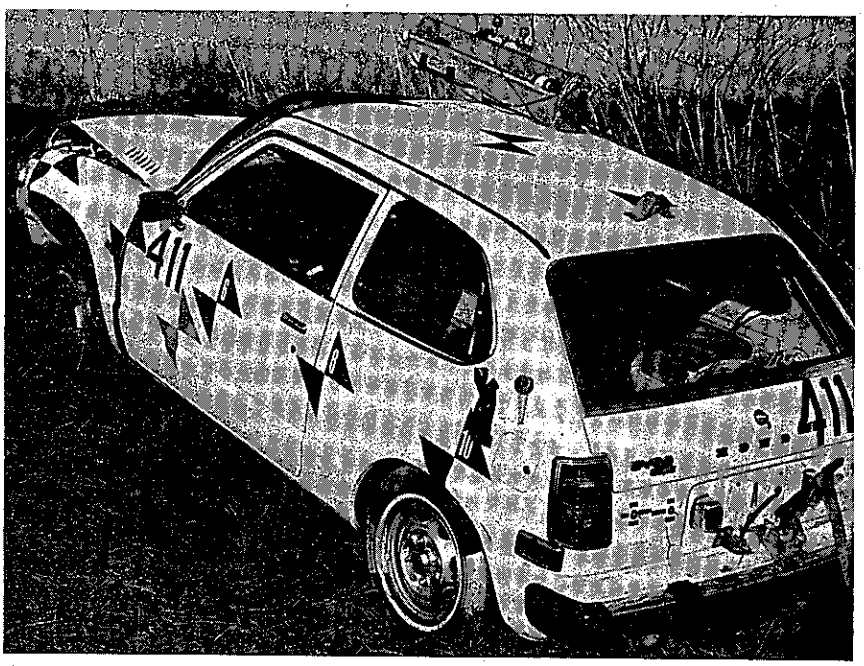
Final Location of Car on Earth Berm.

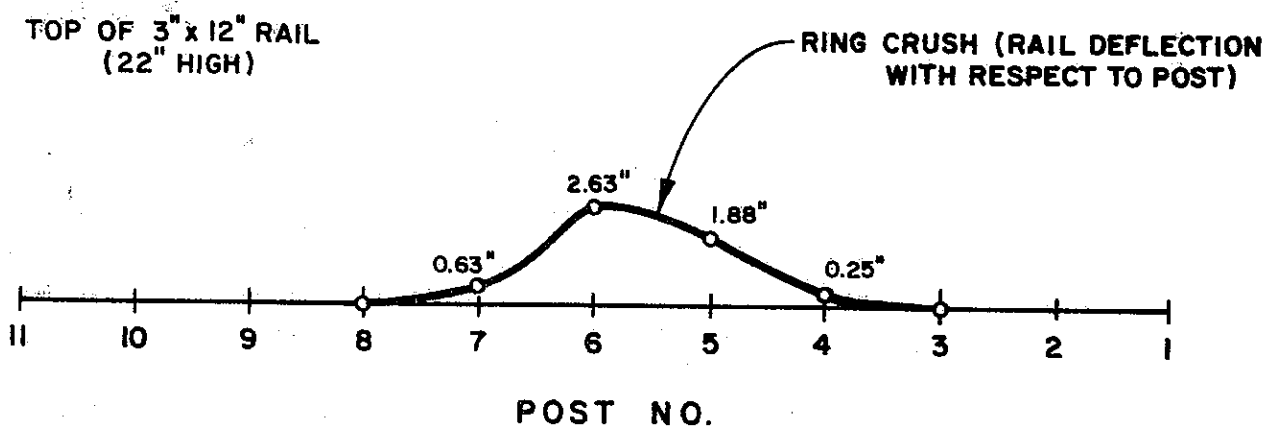
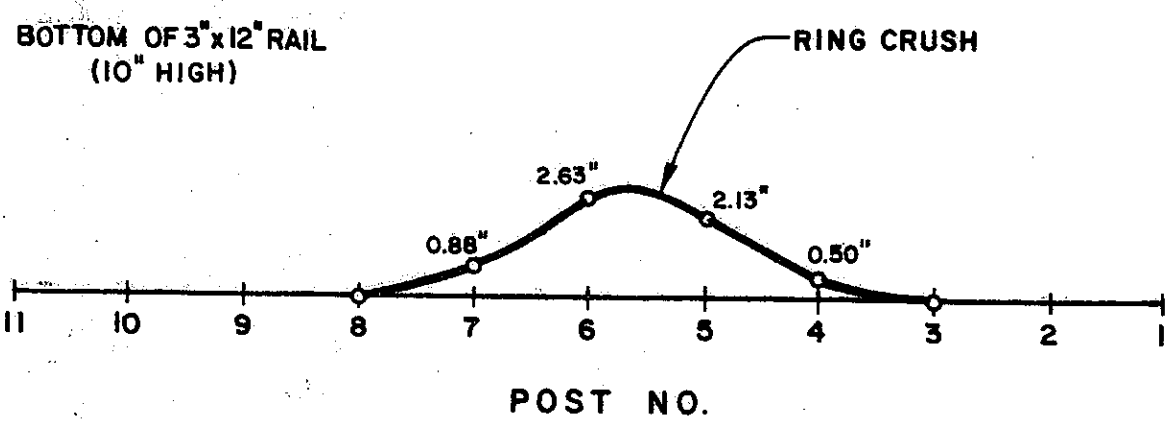
TEST 411

NO DEFLECTION OF 4"x 4" RAIL.

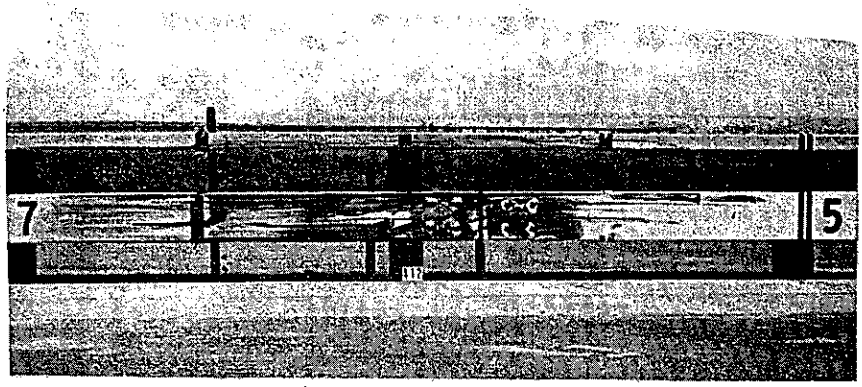
Vehicle Scuff Marks From Impact With Bridge Rail.

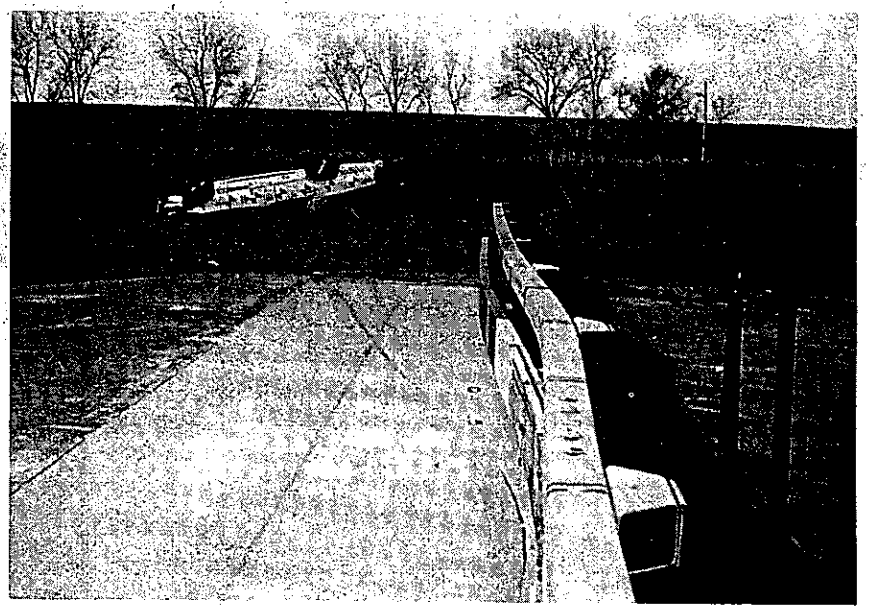
Deflected Bridge Rail and Final Location of Vehicle Which Rolled 180° After Skidding on Soft Earth.

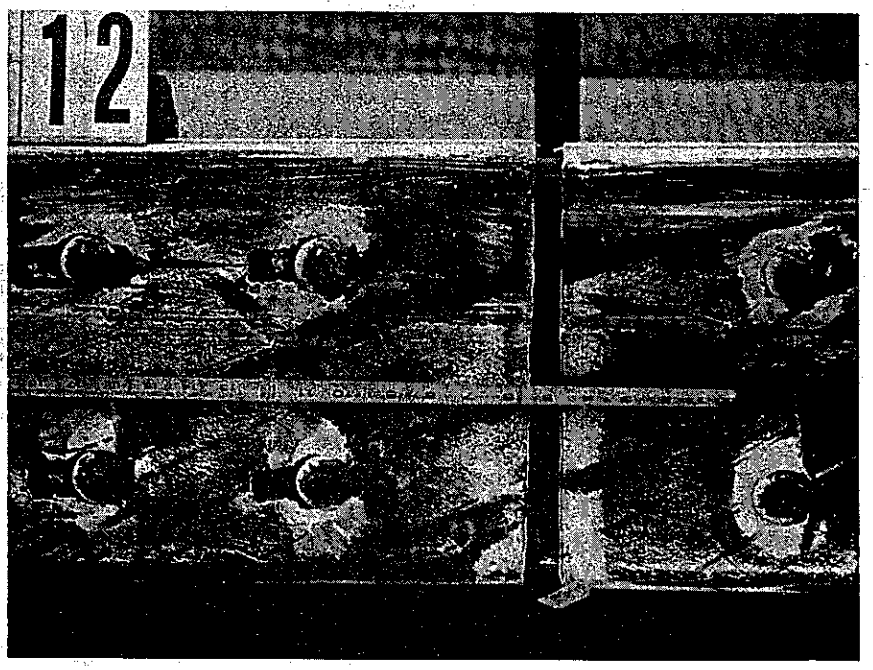
Scuff Marks on 3"x12" Tube Rail at Expansion Joint Splice. Slight Outward Movement of Rail at Splice.

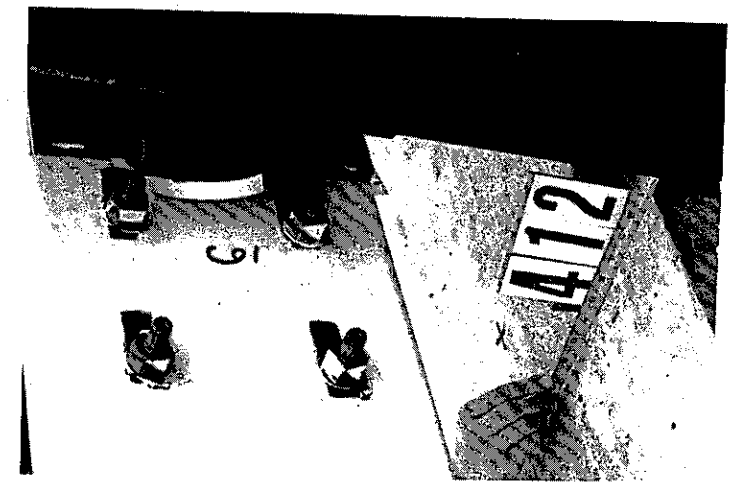
FIGURE 18 TEST 412 CRUSHED PIPE RINGS

Post 6
Crush 5 9/16"
Tape Measure Shows Separation of Post Flange From Edge of Deck. This Post is Adjacent to Expansion Joint Splice.

provide an accurate measurement of the dynamic rail deflection. The 8-inch pipe rings crushed over 1/4 inch at posts 4 through 8 (Figure 18).

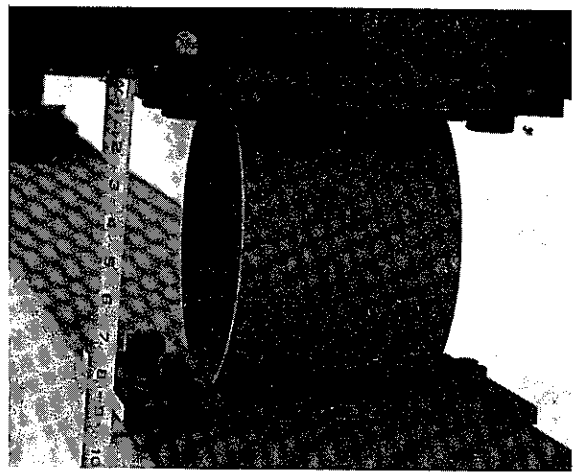
Post 9
Crush 1/4"

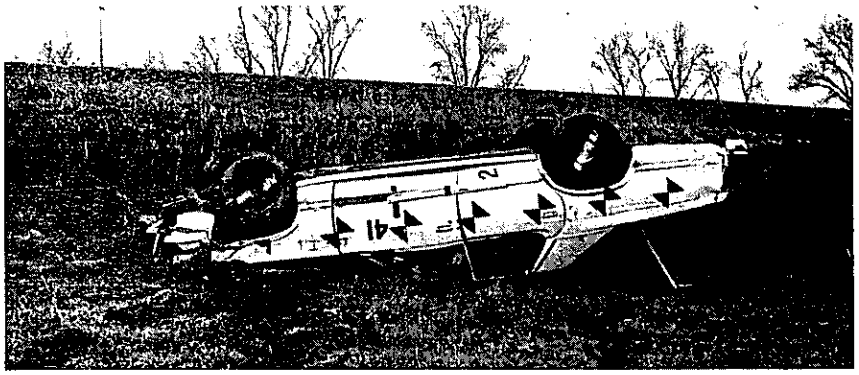
FIGURE 19 TEST 412 VEHICLE DAMAGE

Final Location of Vehicle After Impact.

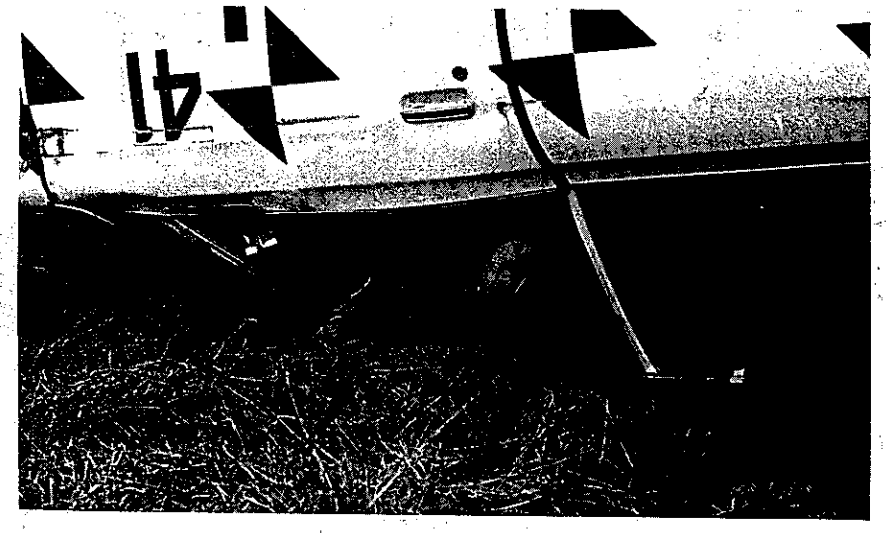
Final Location of Driver Dummy After Impact.

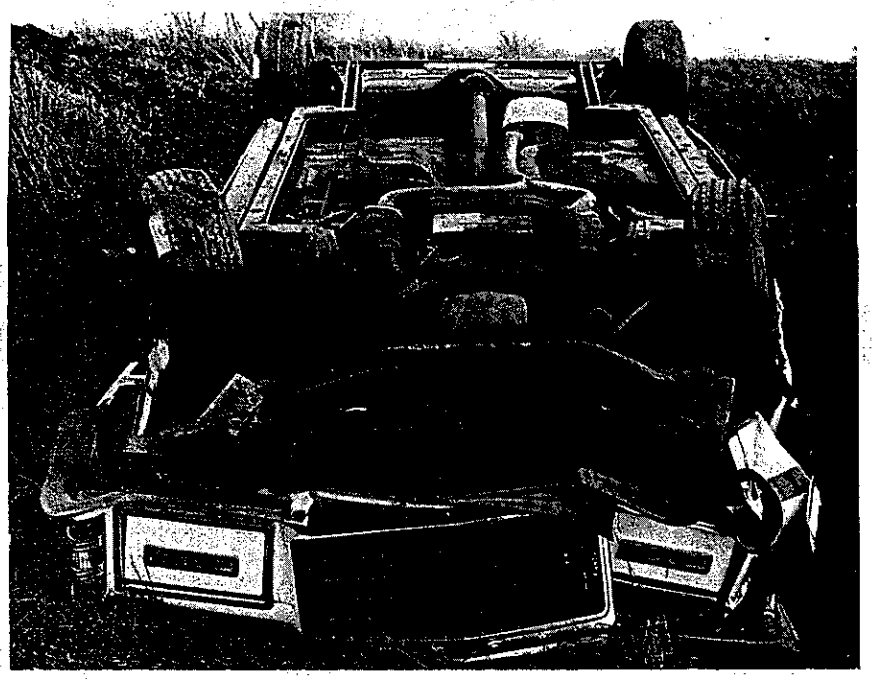
Front End of Vehicle. End of Frame is Bent to the Left Where Bumper was Sheared Off.

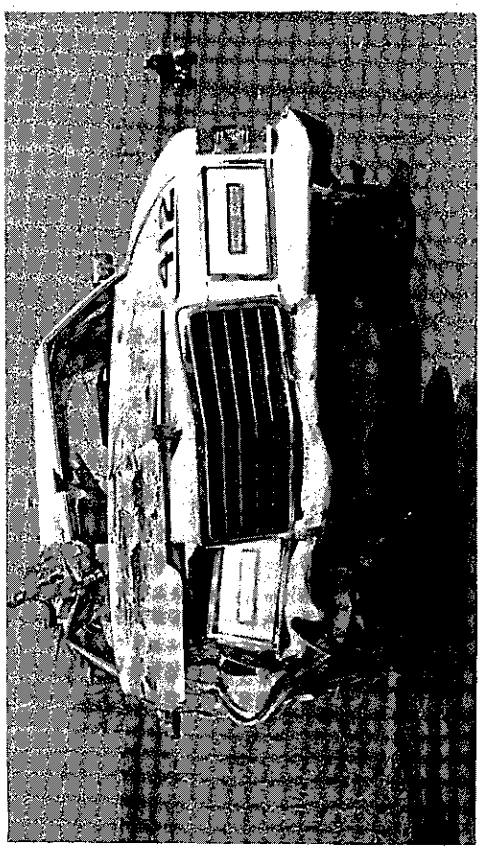
Roof Damage Due to Rollover Was Increased Due to Sliding Weight Device on Roof

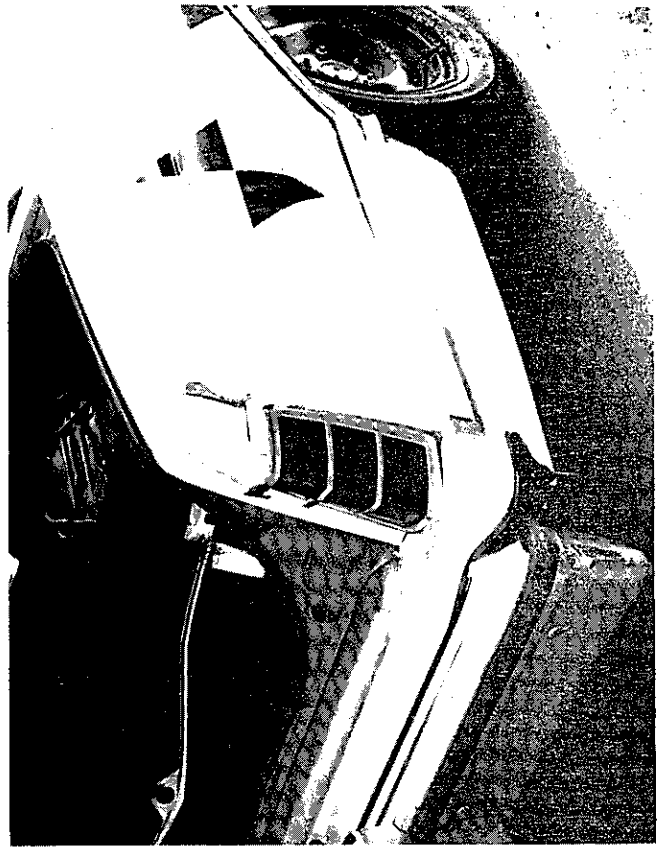
Minor Damage at Right Rear Corner of Vehicle

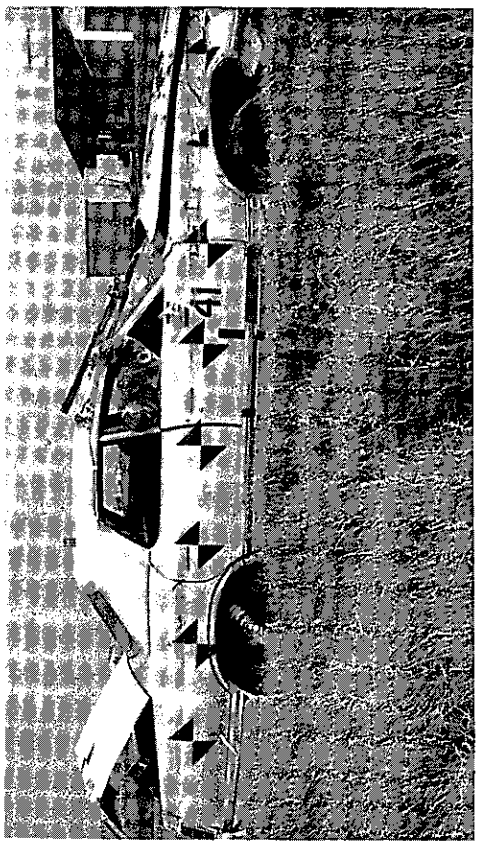
Impact Side of Vehicle

Crush at Top of Fender is From 4"x4" Tube Rail

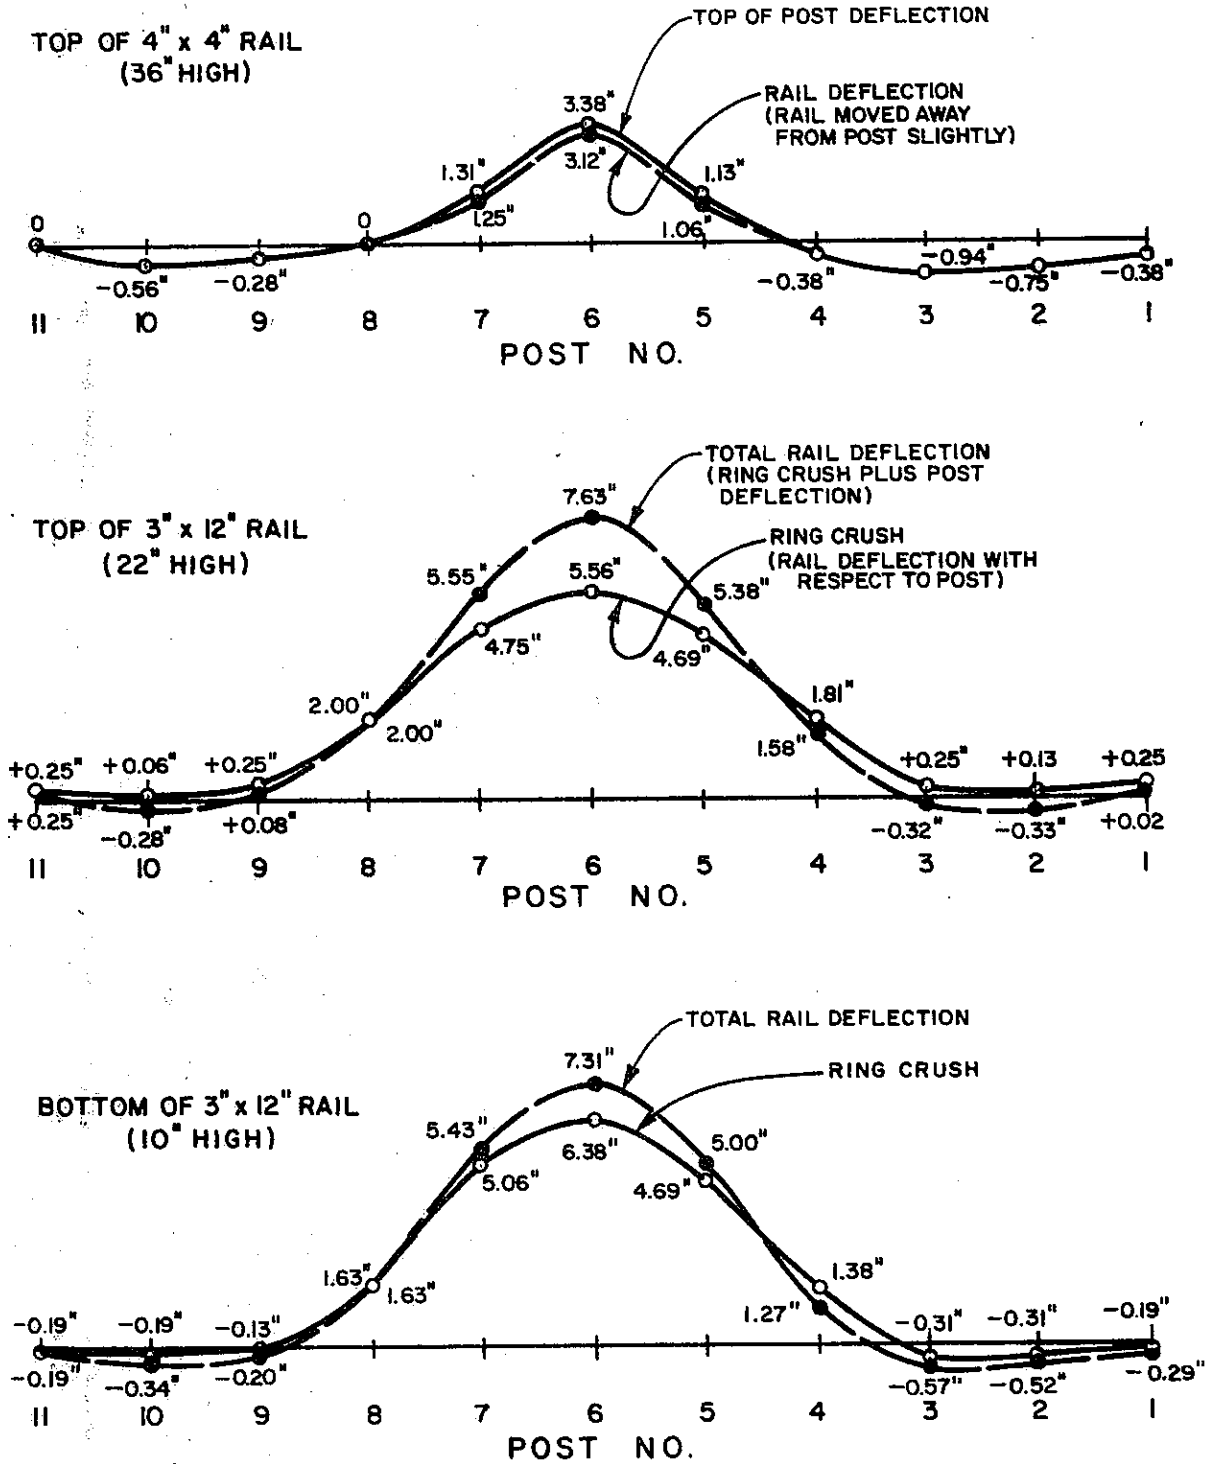
TEST 412

PERMANENT HORIZONTAL DEFLECTIONS OF RAIL AND POSTS

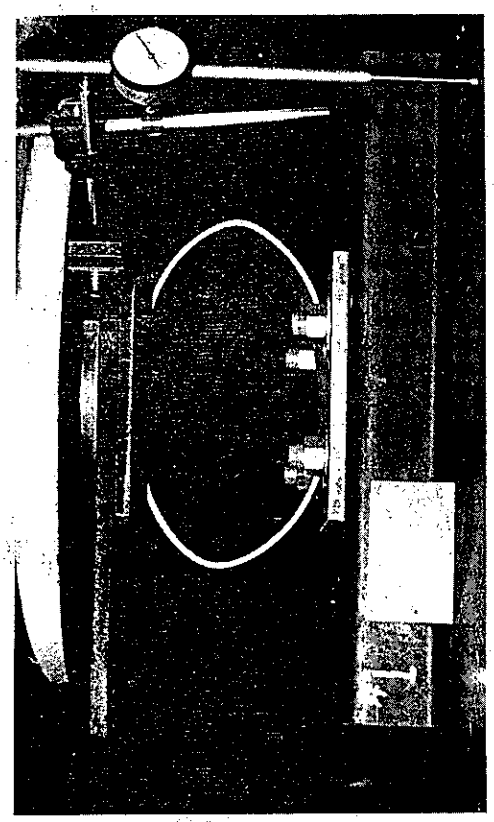
FIGURE D3 TEST SAMPLE NO. 1 DURING STATIC TEST

Load = 4120 lb. Deflection = 2.4 in.

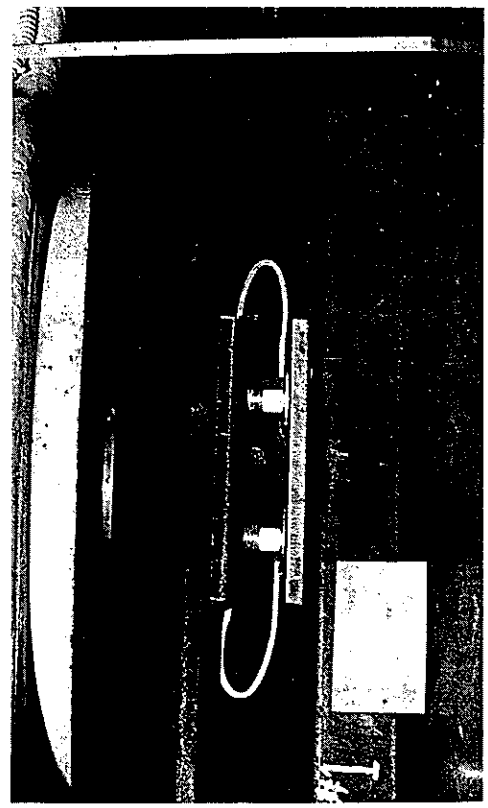
Load = End of Test Deflection = 7.6 in.

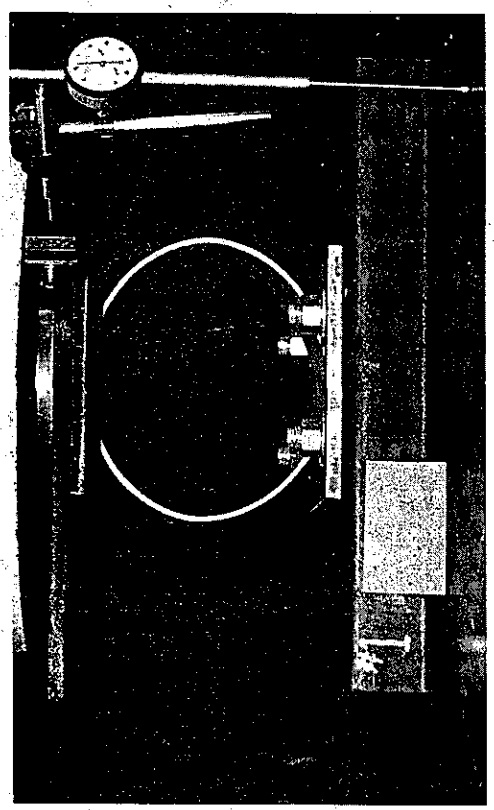
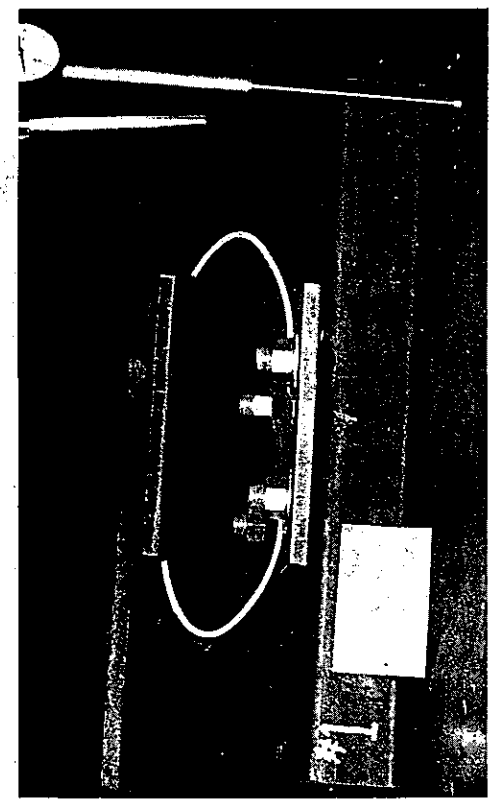
FIGURE D4 SAMPLE NO. 2 DURING STATIC TEST

Load = 4230 lb. Deflection = 0.8 in.

Load = 4820 lb. Deflection = 5.0 in.

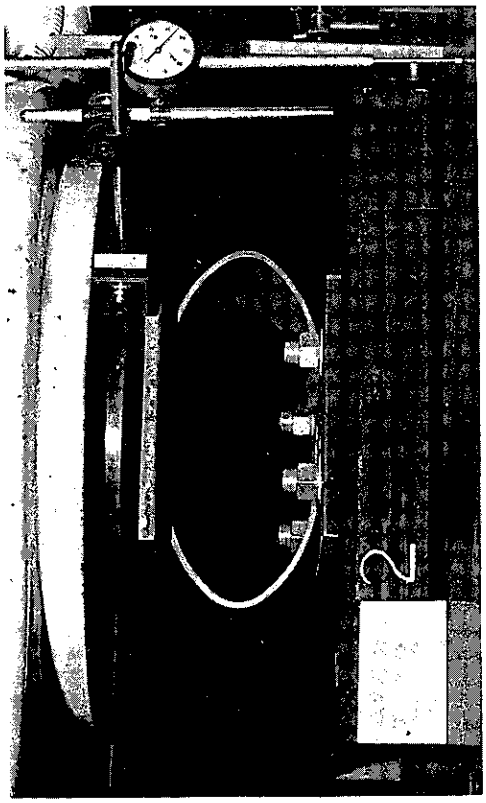
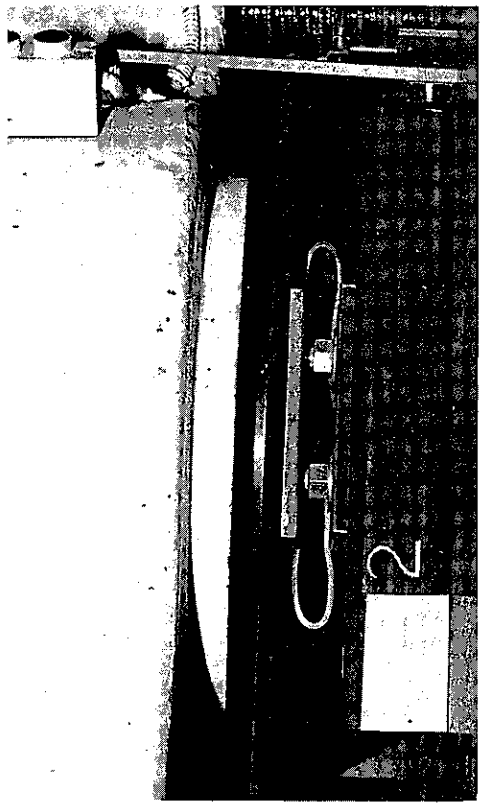
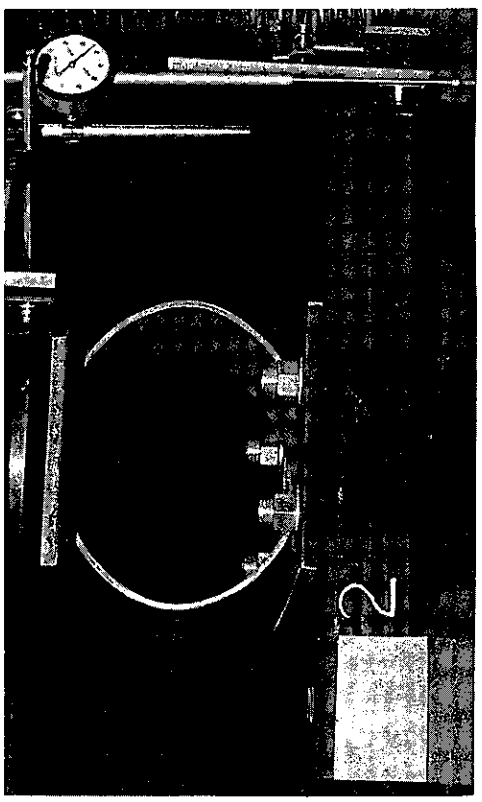
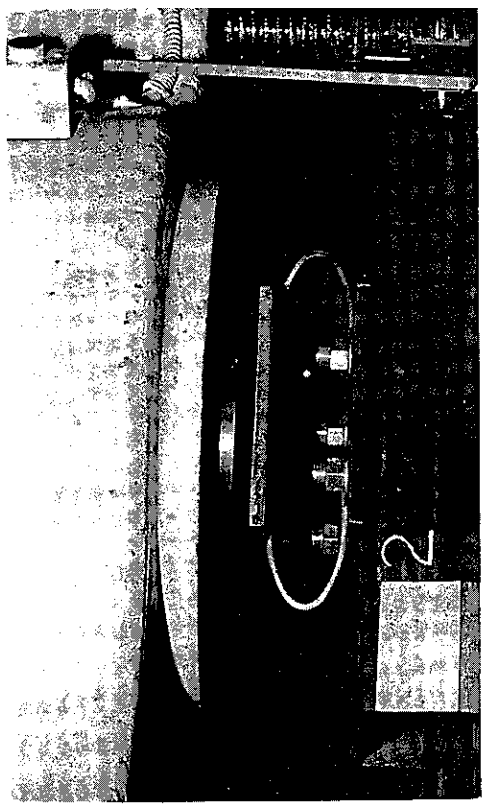
FIGURE D5 SAMPLE NO. 3 DURING STATIC TEST

Load = 4680 lb. Deflection = 2.8 in

Load = Deflection = End of Test

Load = 5380 lb. Deflection = 0.8 in.

Load = 5350 lb. Deflection = 5.1 in.

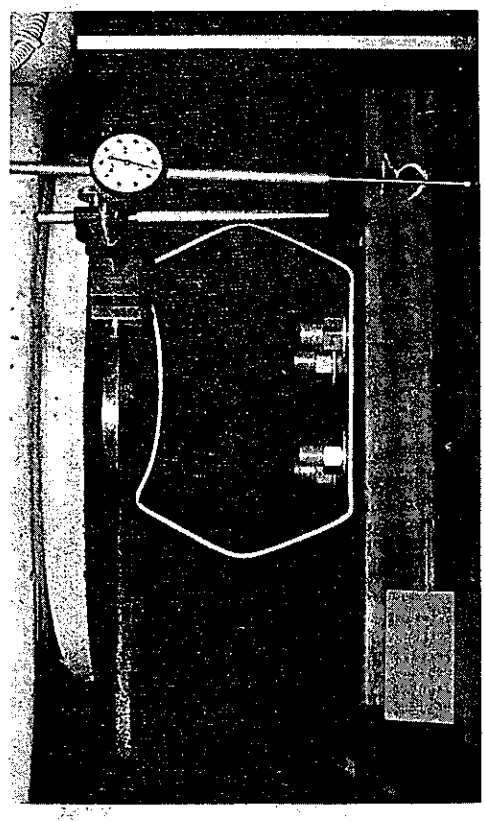
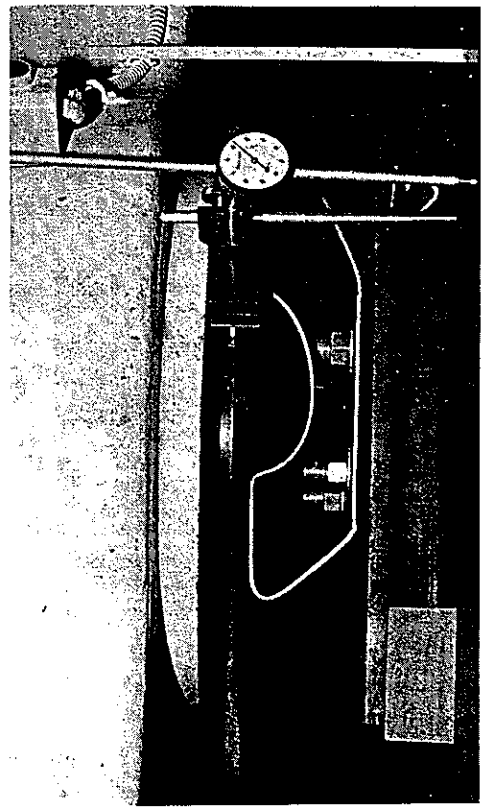
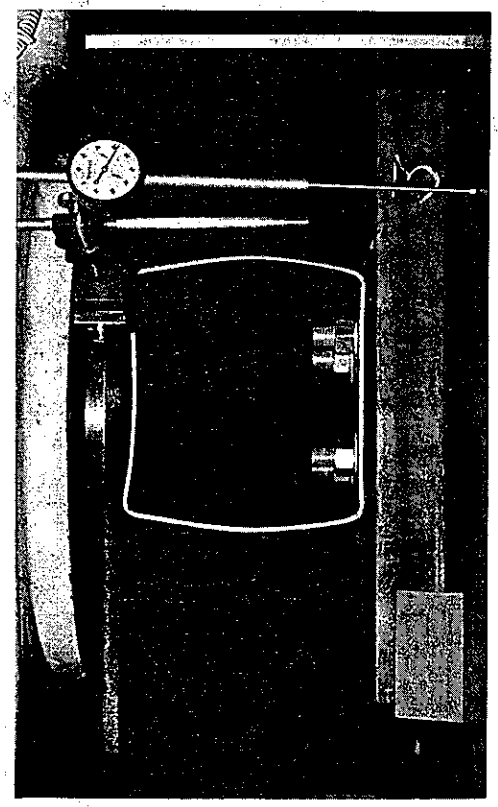
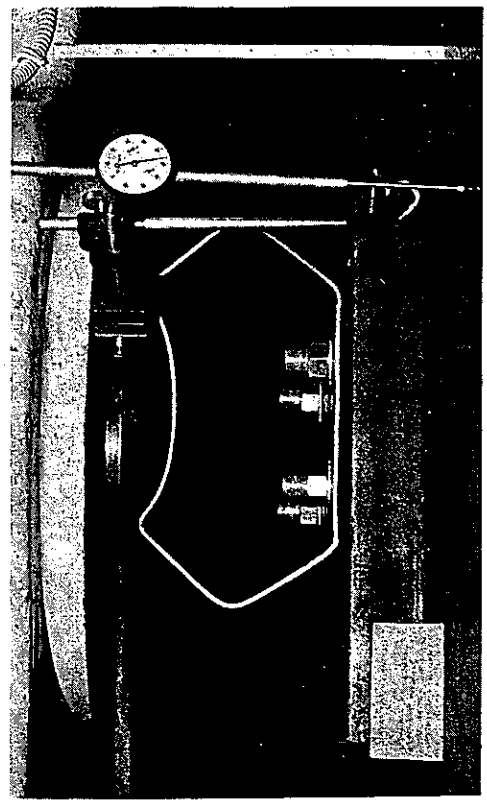
Load = 13,700 lb. Deflection = 1.2 in.

Load = End of Test Deflection = 7.2 in.

Load = 25,500 lb. Deflection = 0.4 in.

Load = 10,900 lb. Deflection = 2.0 in.

ring projecting farther into the holes in the 1/2 inch plates. Sample No. 3 was much stiffer than the other two. The square tube would not be practical for a collapsing ring. There was no bending or damage apparent in the 3x12 tubes, bolts or 1/2 inch plates in Sample Nos. 1-3.
