STATE OF CALIFORNIA
DEPARTMENT OF TRANSPORTATION
DIVISION OF NEW TECHNOLOGY AND RESEARCH
OFFICE OF TRANSPORTATION LABORATORY

VEHICLE IMPACT TESTING OF LIGHTWEIGHT LIGHTING STANDARDS

1. REPORT NO. FHWA/CA/TL-88/07	2. GOVERNMENT ACCESSION NO.	3. RECIPIENT'S CATALOG NO.
4. TITLE AND SUBTITLE VEHICLE IMPACT TESTING OF LIGHTWEIGHT LIGHTING STANDARDS		5. REPORT DATE Oct. 1988
		6. PERFORMING ORGANIZATION CODE
7. AUTHOR(S) A. Abghari, R. L. Stoughton, and J. Dusel		8. PERFORMING ORGANIZATION REPORT NO. 636964
9. PERFORMING ORGANIZATION NAME AND ADDRESS Office of Transportation Laboratory California Department of Transportation Sacramento, California 95819		10. WORK UNIT NO.
		11. CONTRACT OR GRANT NO. F82TL17
12. SPONSORING AGENCY NAME AND ADDRESS California Department of Transportation Sacramento, California 95807		13. TYPE OF REPORT & PERIOD COVERED FINAL
		14. SPONSORING AGENCY CODE

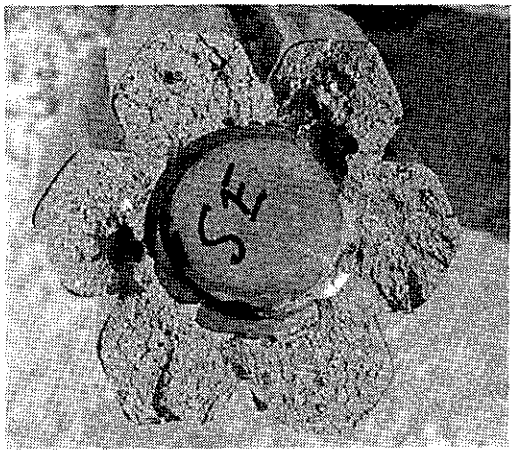
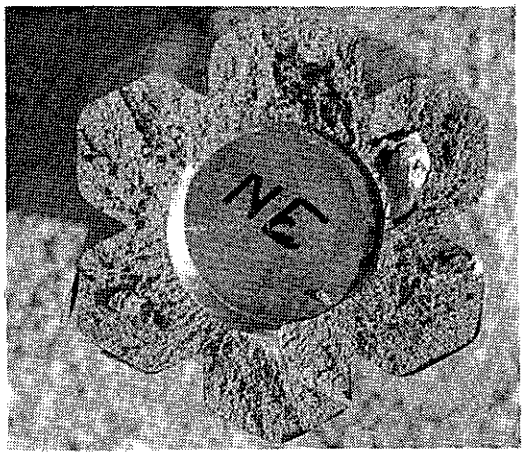
A- Excessive porosity was observed on the fractured surfaces of the couplings and subsequent x rays proved that the couplings were not acceptable based on Caltrans specifications and limits in ASTM E505 reference radiographs.

Figure 8. Fractured Surfaces of Transpo Die-Cast Aluminum Couplings Used in Tests 401 and 402

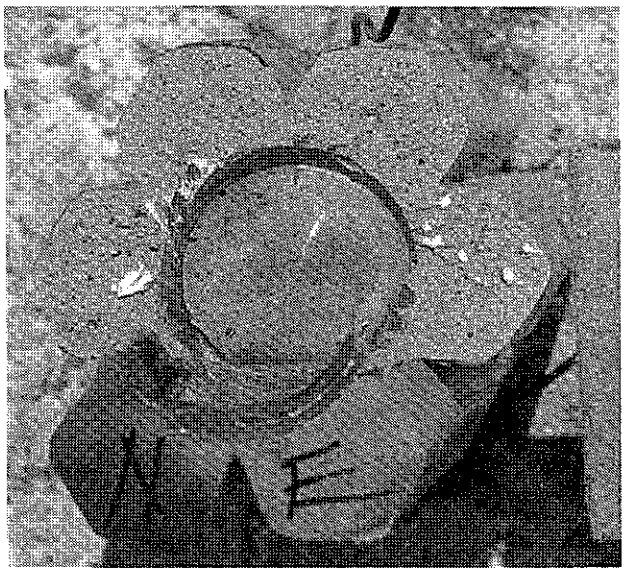
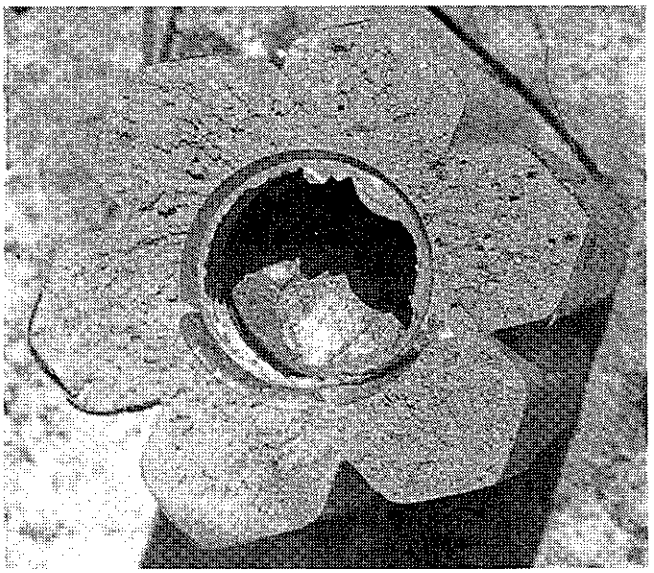
Although results of Tests 401, 402, and 403 met the evaluation criteria of test designations 62 and 63 of NCHRP Report 230, an excessive amount of porosity was observed in the fractured die-cast aluminum couplings after impact. Because of this, a considerable amount of testing was done on both the die-cast aluminum couplings manufactured by Transpo Industries, Inc. and the extruded aluminum couplings manufactured by Aluminum Company of America (ALCOA). As a result of these laboratory tests and x rays, a comprehensive specification controlling aluminum couplings was written (Appendix E). Since neither the die-cast nor the extruded aluminum couplings complied with the newly formulated specifications for aluminum couplings, the use of aluminum couplings was discontinued and it was decided to use the standard Caltrans type 31 triangular slip base for the rest of the project.

Figure 26. Fractured Surfaces of Die-Cast Aluminum Couplings - Test 401

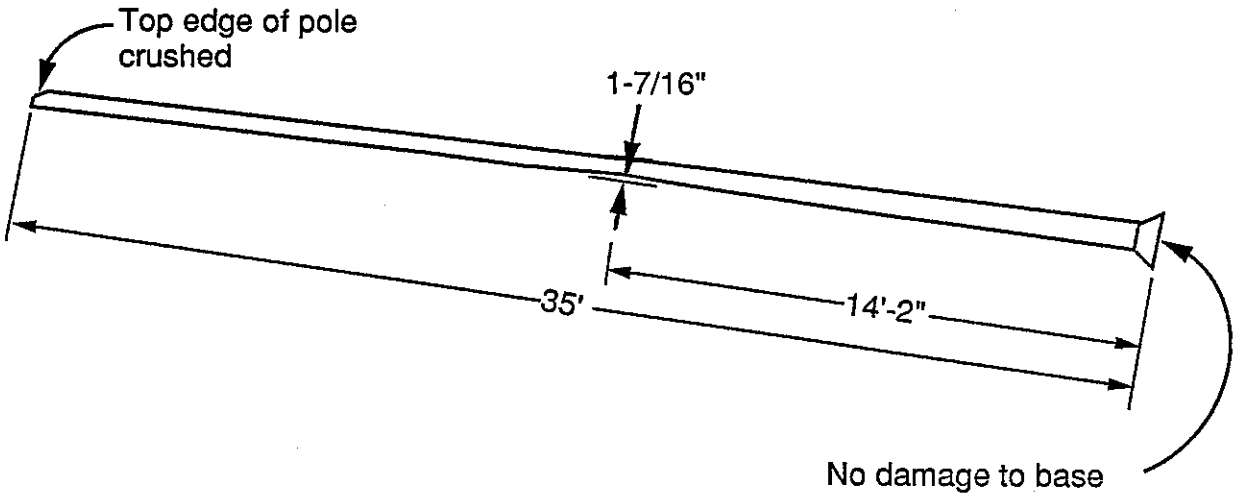
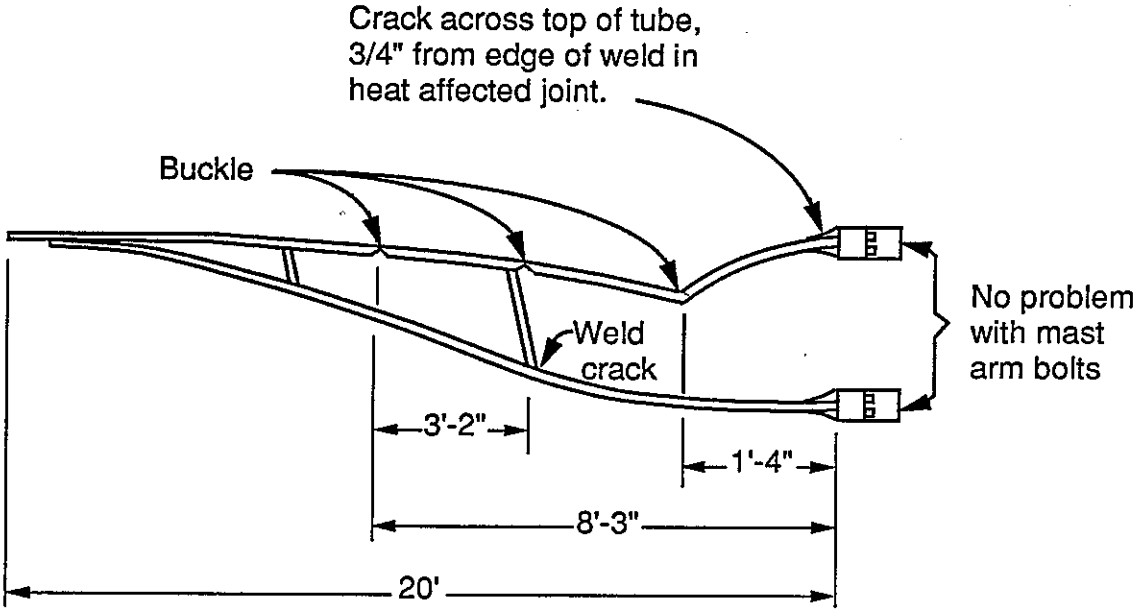
Figure 27. Damage To The Pole And The Mast Arm - Test 401

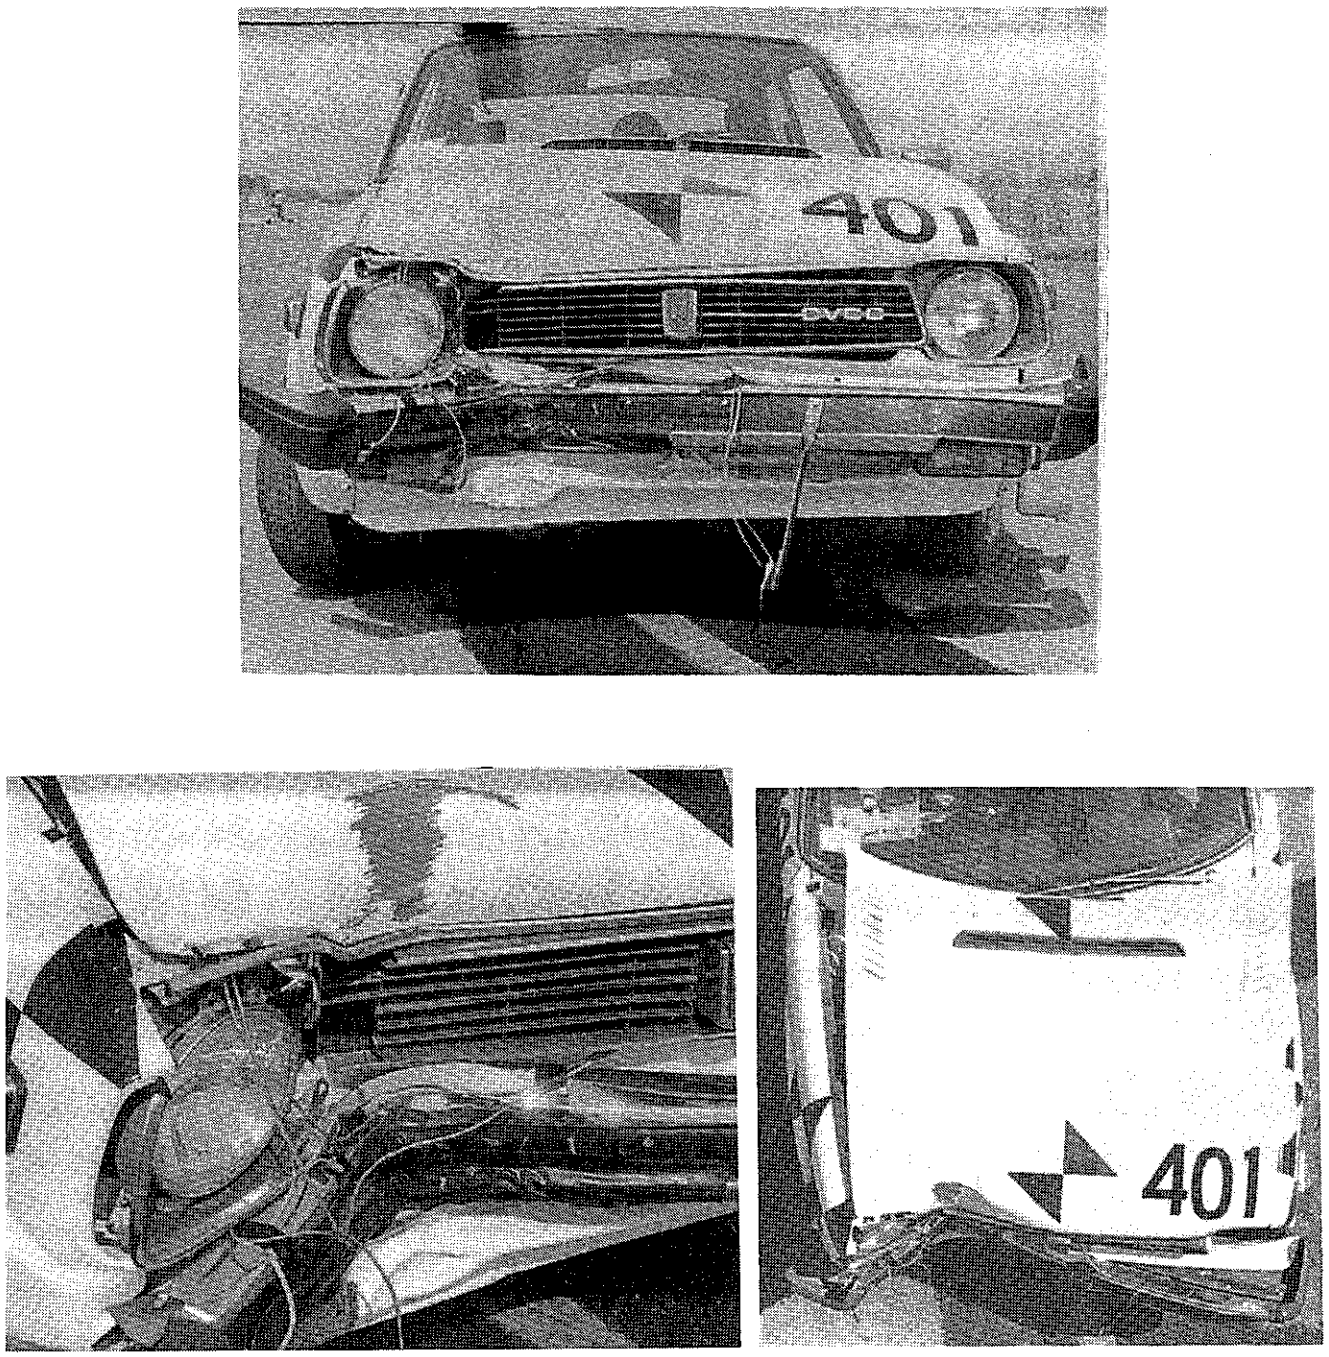
Figure 28. Test Vehicle After Impact - Test 401

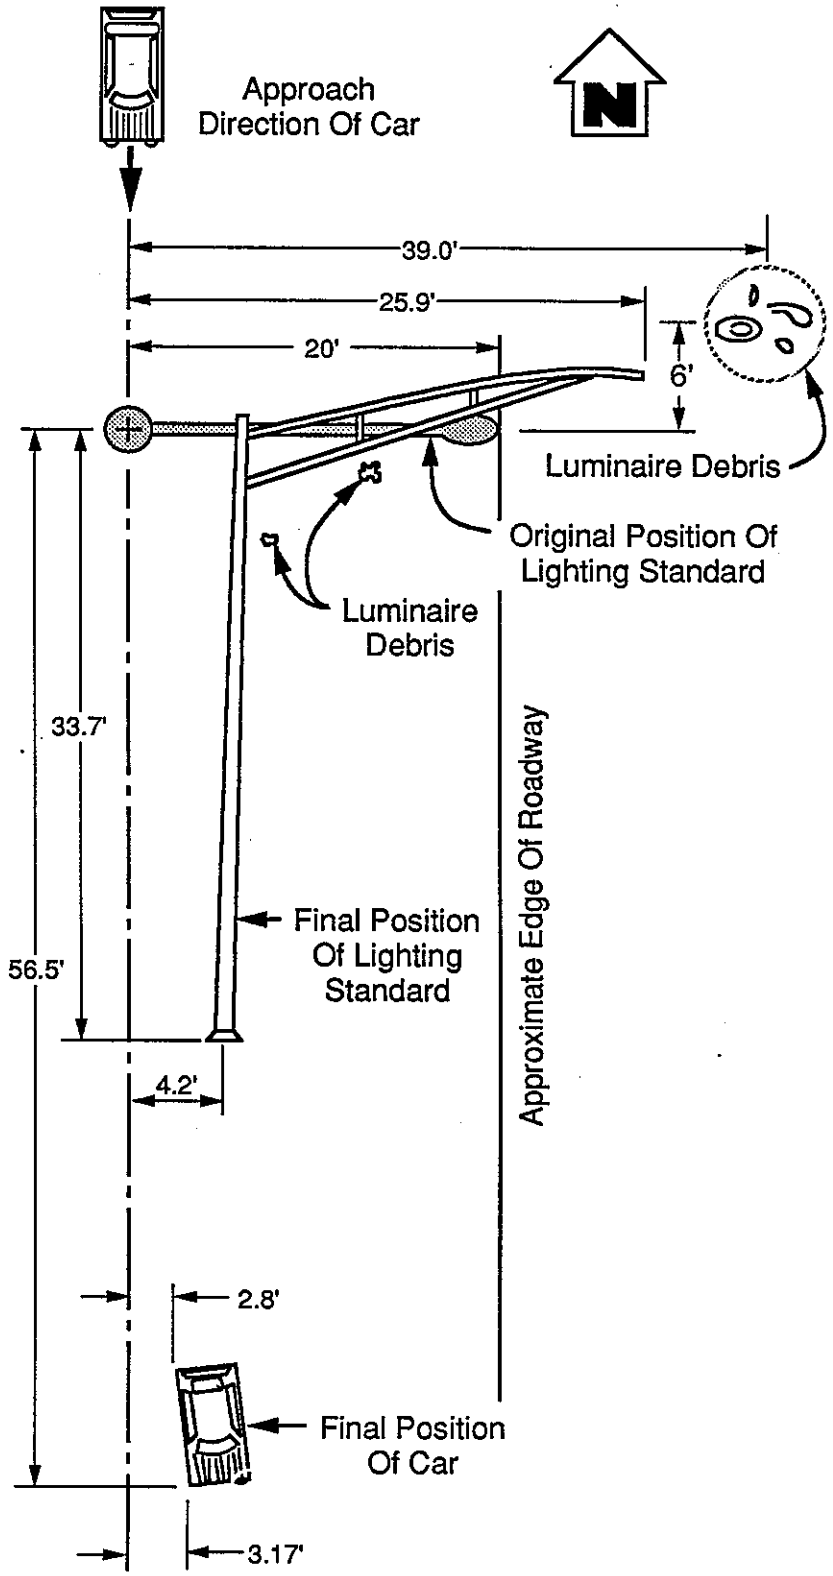
Figure 31. Final Location of the Lighting Standard and the Car After Collision - Test 402

standard. The base of the lighting standard pole came to rest 33.7 ft downstream and 4.2 ft toward the outside lane of traffic from the original location of the foundation, with the pole laying parallel to the approach angle of the vehicle. The direction which the mast arm pointed was 180 degrees from that which occurred in Test 401. The mast arm, still attached to the pole, came to rest even with the foundation and was pointed eastward. Its tip was 25.9 ft from the foundation, projecting 5.9 ft into an imaginary outside lane of traffic.

The luminaire broke into many pieces that were scattered over a large area (well into the imaginary traffic lanes). The largest pieces were lying about 39 ft east of the concrete foundation (Figure 31).

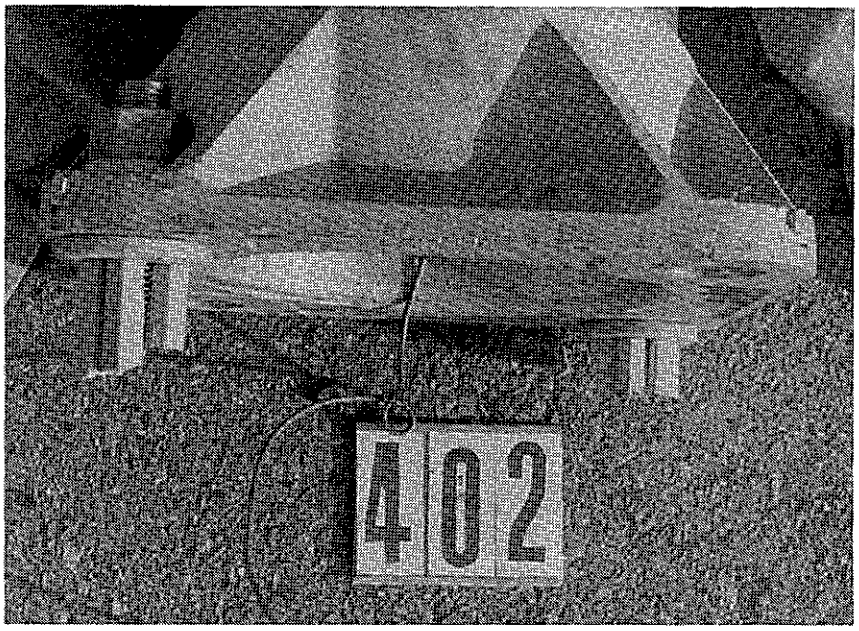
Figure 32. Aluminum Lighting Standard Shoe Base After Impact - Test 402

The couplings fractured as expected. The bottom portion of the two top stainless studs which remained in the upstream side of the

lighting standard shoe base, Figure 32, impacted the broken aluminum coupling stubs (still intact on the anchor bar stubs) and bent the two downstream anchor bars as occurred in Test 401. Figure 33 shows the couplings and the anchor bars after the impact. The schematic of the vehicle approach direction and the anchor bar stubs after the impact are shown in Figure 34. As mentioned before, this vehicle approach direction offers the highest shear resistance as required by NCHRP Report 230; however, the approach of an errant car is typically skewed. No relative movement between the concrete foundation and the surrounding asphalt concrete occurred due to the impact.

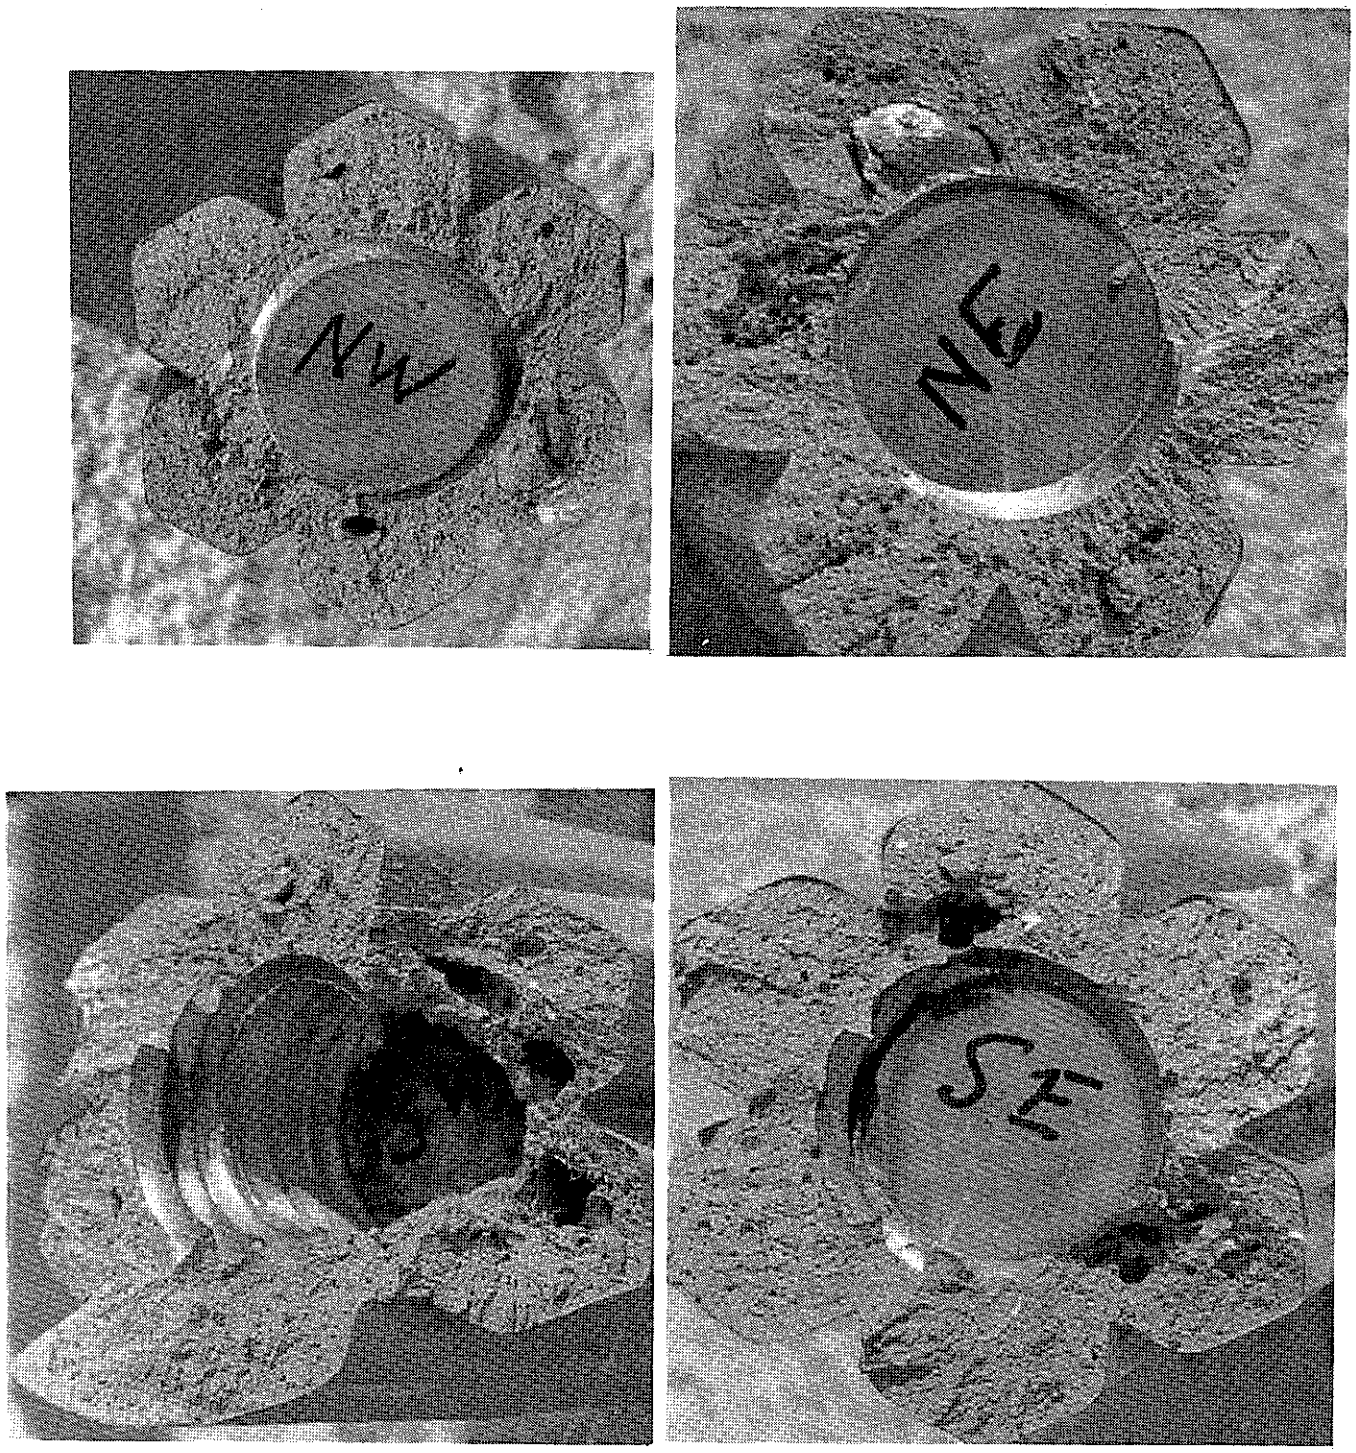
Figure 35. Fractured Surfaces of Die-Cast Aluminum Couplings - Test 402

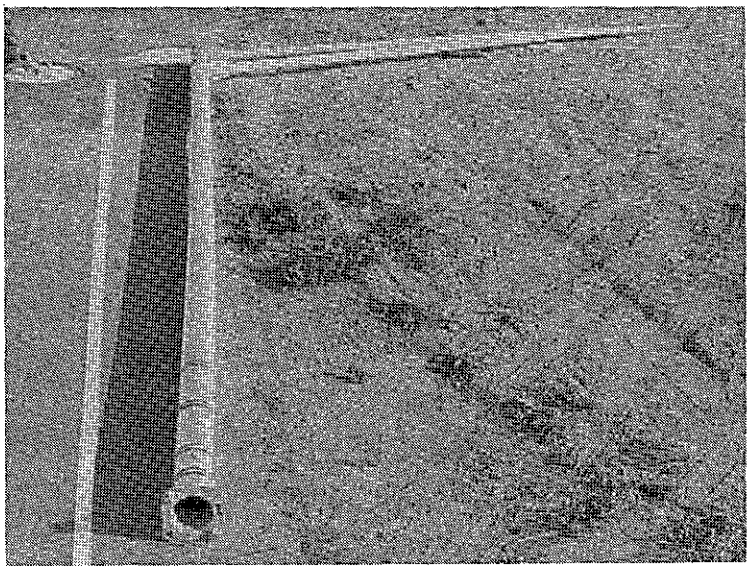
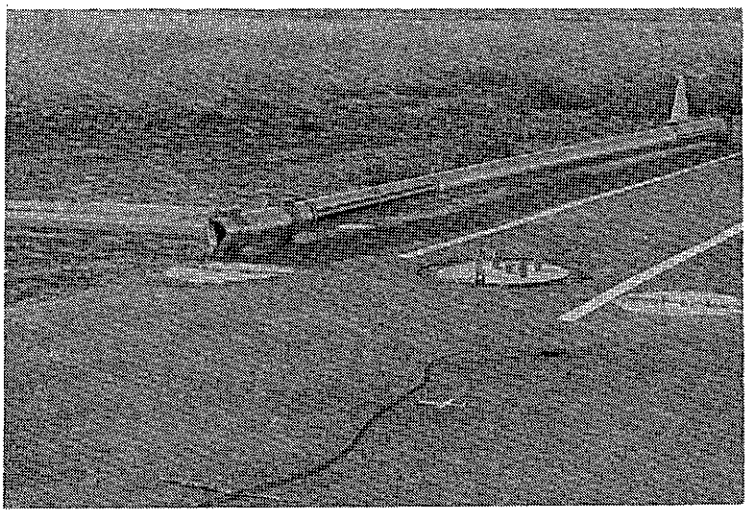
Figure 36. Lighting Standard Damage - Test 402

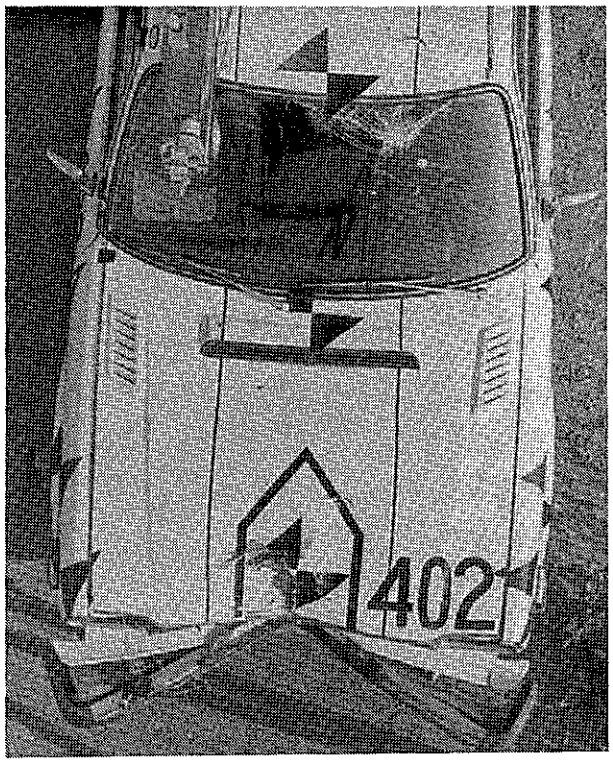
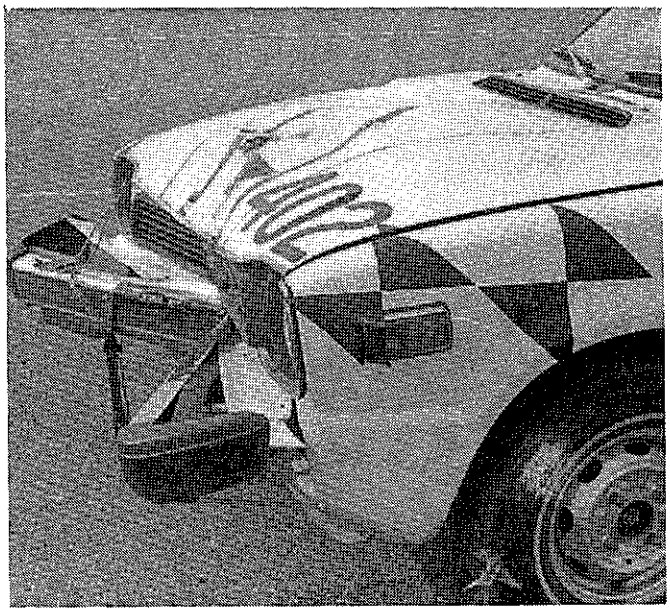
Figure 37. Test Vehicle After Impact - Test 402

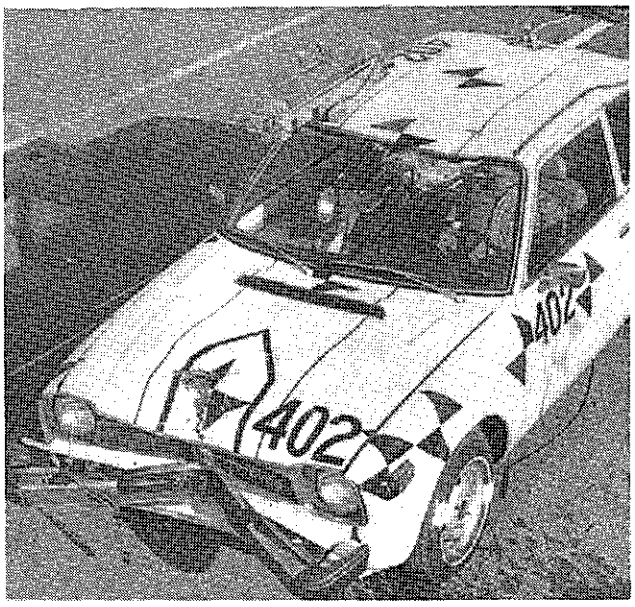
Figure 37 shows the test vehicle after the impact. The front crush profiles of the vehicle measured horizontally at different heights are shown in Figure 38. A maximum crush of 11.25 in. was measured at the center of the bumper. The top front edge of the car's roof was dented 1.25 in. and the windshield was cracked as the pole contacted the roof of ~~the~~ auto about 8 ft up from the base plate after the impact. The rear quarter panel on the driver's side of the vehicle also had a small dent caused by the base plate barely clipping the rear quarter panel of the vehicle.

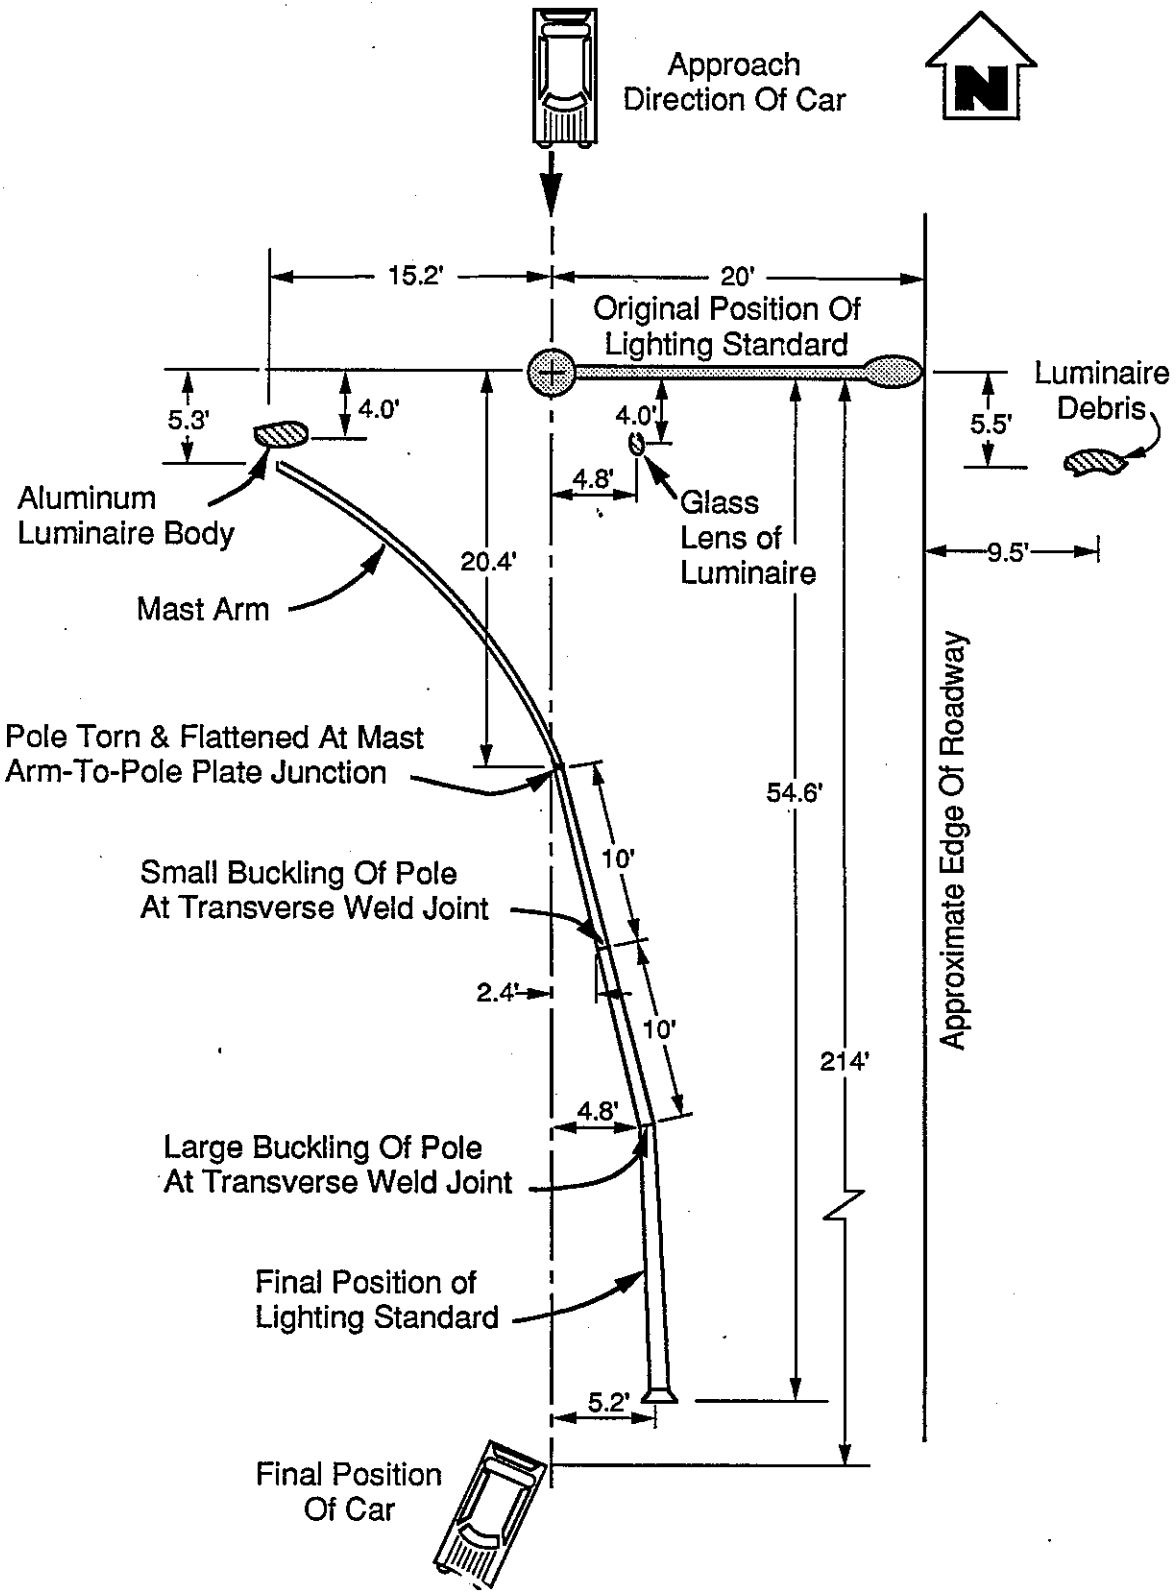
Figure 40. Final Location of the Lighting Standard and the Car After Collision - Test 403

As shown in Figures 40 and 42, the 11 gage (0.1196 in. thick) steel pole was severely damaged. Upon impact, the pole buckled at the transverse weld joint 20 ft down from the top of the pole. No buckling occurred at the bottom transverse weld joint. In addition, as the mast arm and top of the pole impacted the ground, the pole buckled 10 ft down from the top of the pole. It appears as though the heat-affected zones of the transverse welds reduced the yield strength of the steel. In addition, the slight reduction of wall thickness of the pole in these areas, where the transverse welds

The lighting standard came to rest downstream from the pole foundation (Figure 40), with the pole base plate 54.6 ft downstream (south) and 5.2 ft east of the foundation. The tip of the pole was 20.4 ft south of the foundation. The mast arm, still undamaged and attached to the pole, rotated 180 degree from its original direction with its tip 15.2 ft west and 5.3 ft south of the pole foundation.

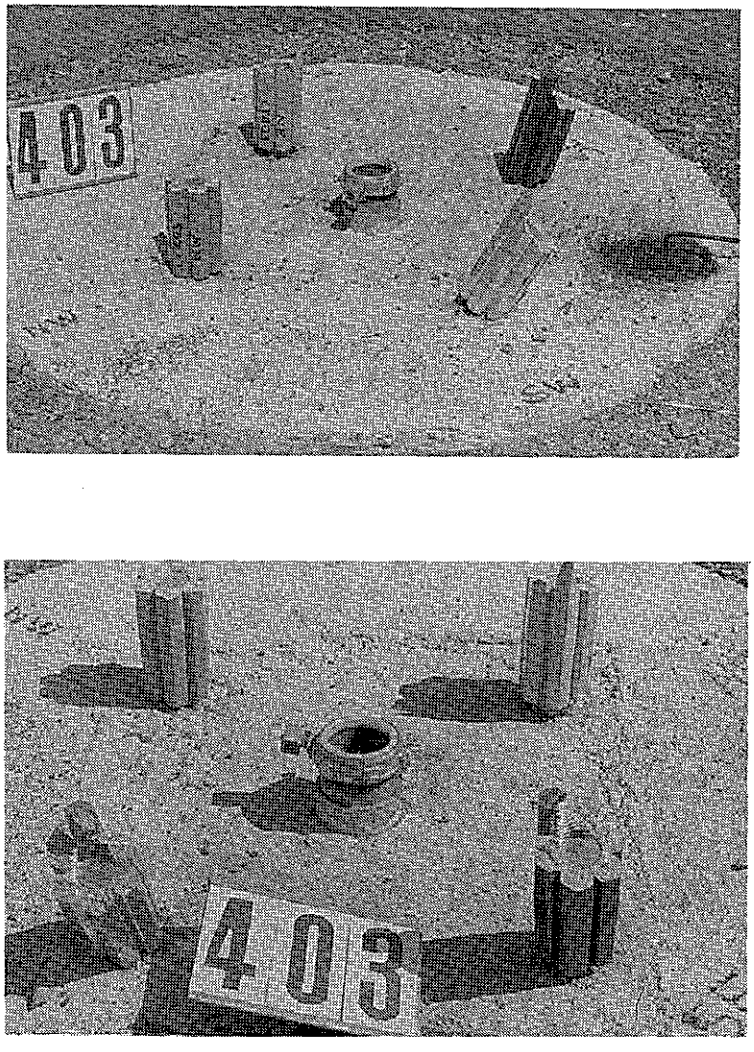
Figure 41. Die-cast Aluminum Couplings After Impact-Test 403

Upon impact, all four couplings sheared relatively cleanly just at the bases of the top stainless steel studs as shown in Figure 41. The remaining bottom portions of the two upstream couplings (marked NW and NE on Figure 41), still screwed onto the anchor bars, were approximately equal in height and projected 3-3/4 in. above the foundation surface. The stub marked NE had a sharp jagged spike on the upstream side. The two downstream stubs each had one flute intact on the upstream side which projected above the stud shear plane with the reminder of the top portion of the coupling sheared at the base of the stainless steel stud pocket. A couple of small porosity voids were noted; however, the cast aluminum material in these handpicked couplings was, on the whole, sound and nearly solid, and of much better quality than that of those used in

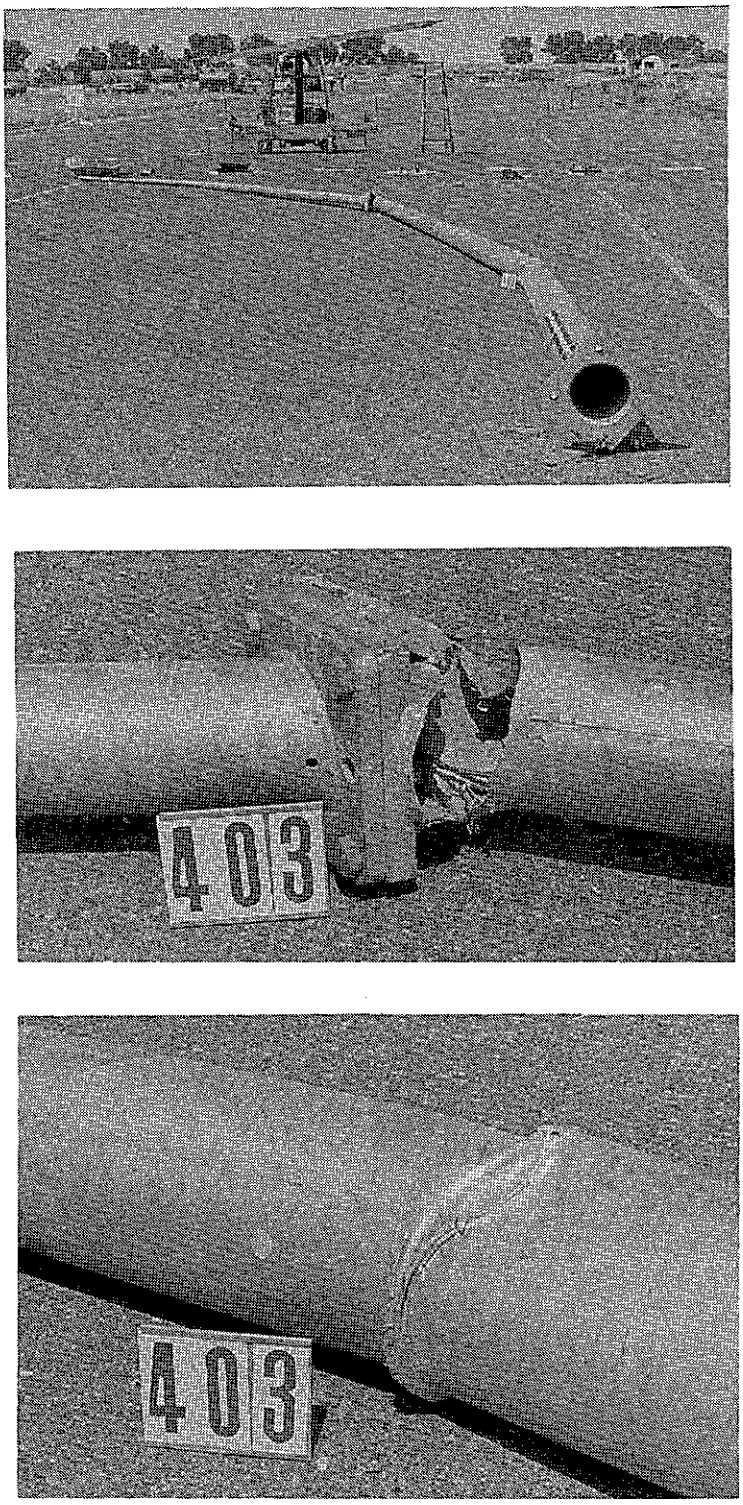
Figure 42. Lighting Standard Damage - Test 403

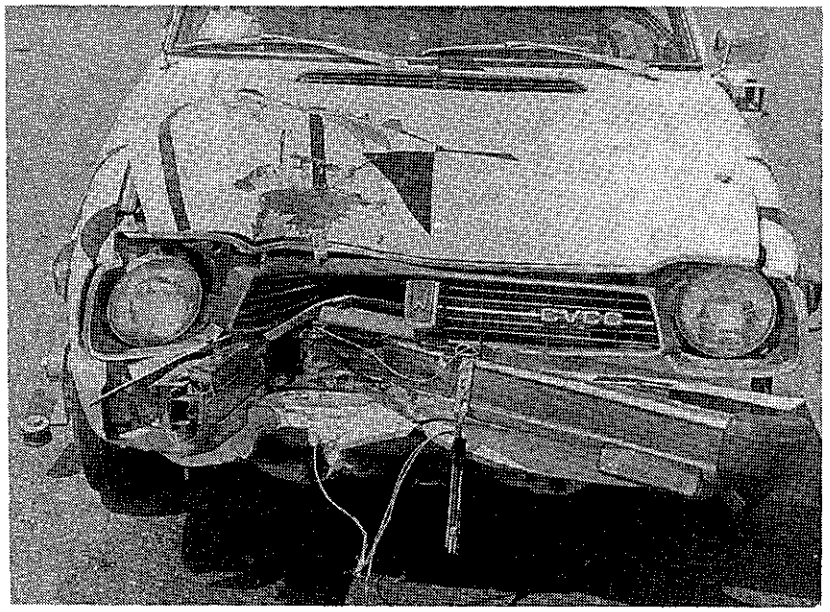
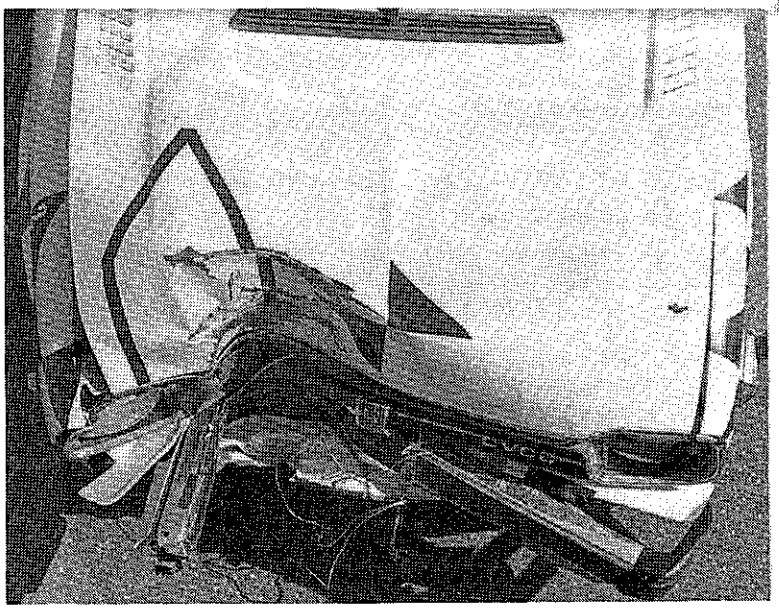
Figure 43. Test Vehicle After Impact - Test 403

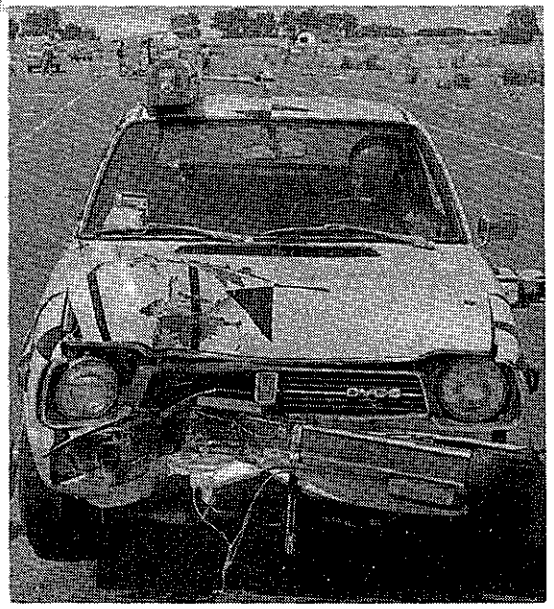
Figure 43 shows the test vehicle after the impact. The crush profiles of the vehicle (measured in horizontal planes at different

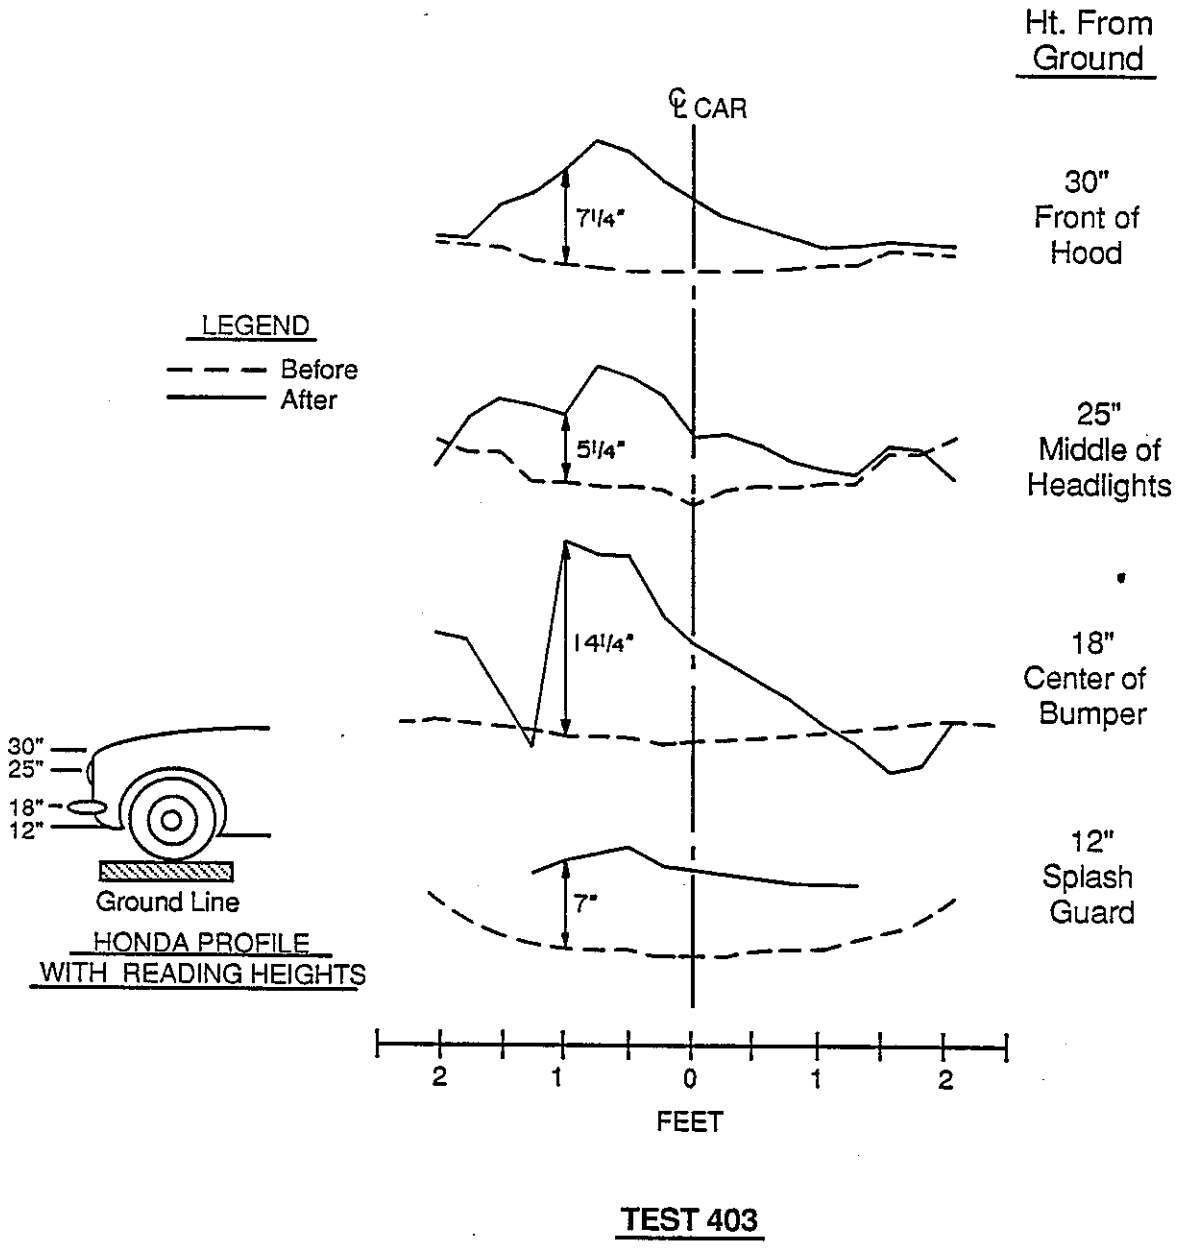
Figure 44. Crush Profiles of the Front End of Test Vehicle - Test 403

heights) are shown in Figure 44. The maximum crush of the bumper was 14.25 in.

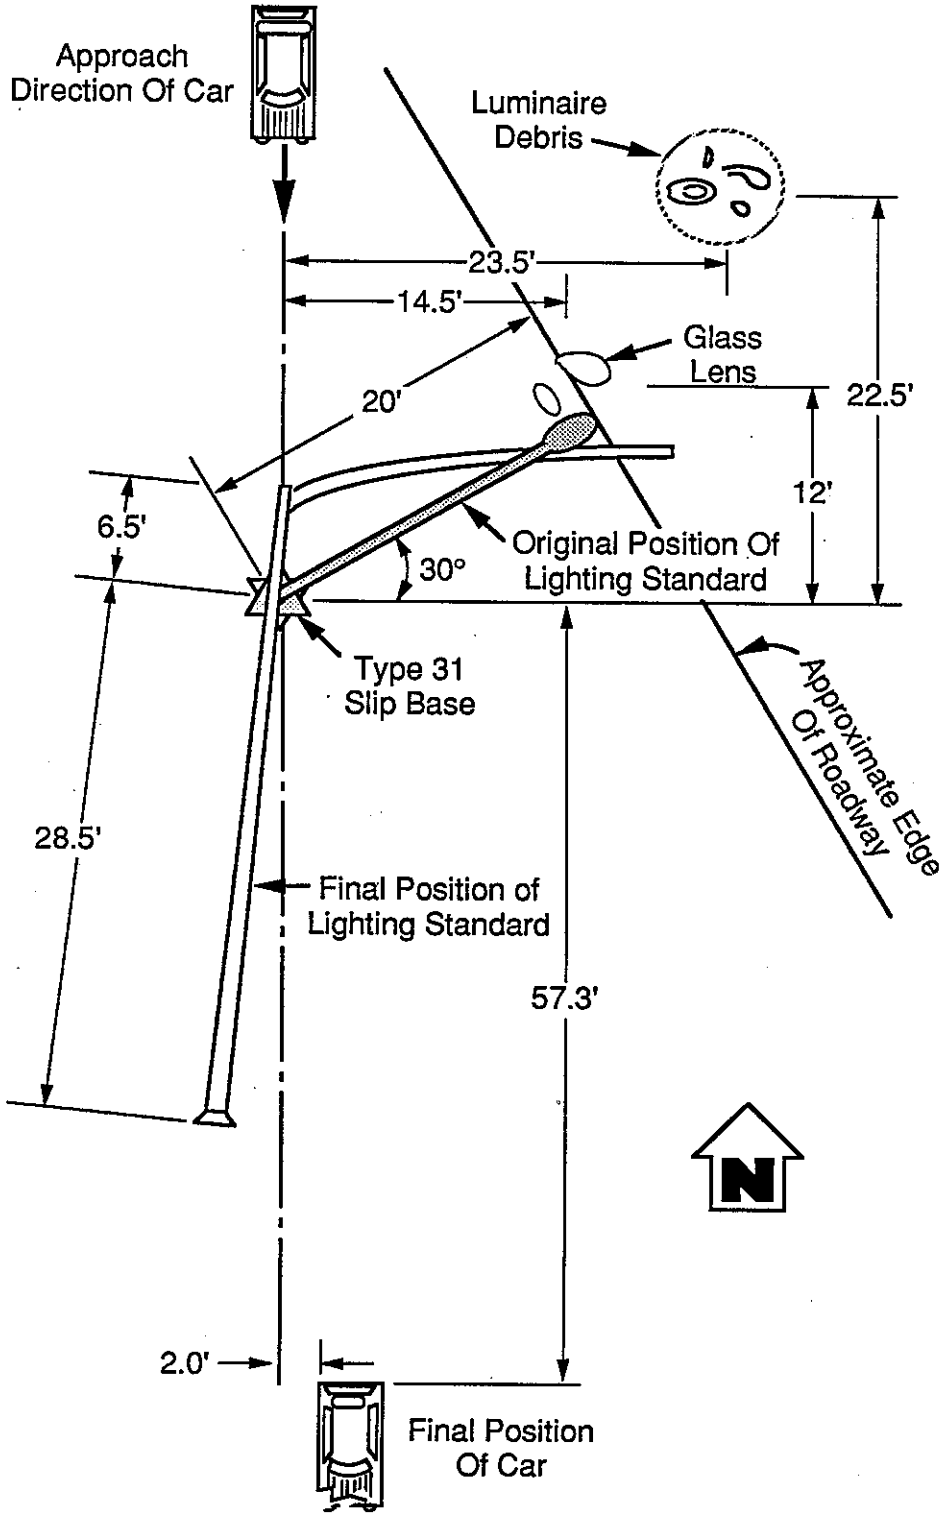
Figure 46. Final Location of the Lighting Standard and the Car After Collision - Test 404

After impact, the pole did not rotate and came to rest on top of the bottom slip base plate with its top 6.5 ft north of the concrete foundation (Figure 46). The tip of the mast arm projected about 1 ft into the outside traffic lane. Upon impact, the keeper plate which was installed at the slip plane, ripped open at two corners, and was carried downstream approximately 14 ft, still retaining one of the clamping bolts. The other two clamping bolts were nearby. No relative movement between the concrete foundation and the surrounding soil backfill was evident.

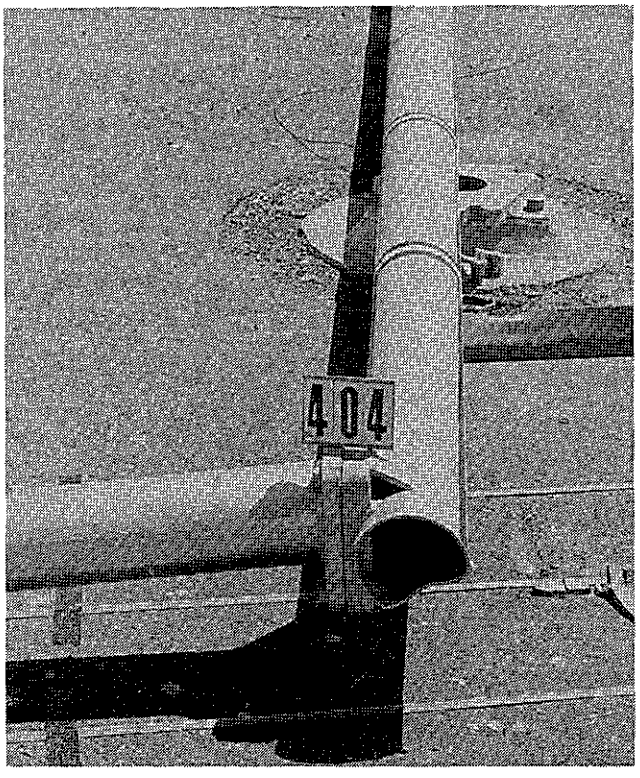
Figure 47. Lighting Standard Damage - Test 404

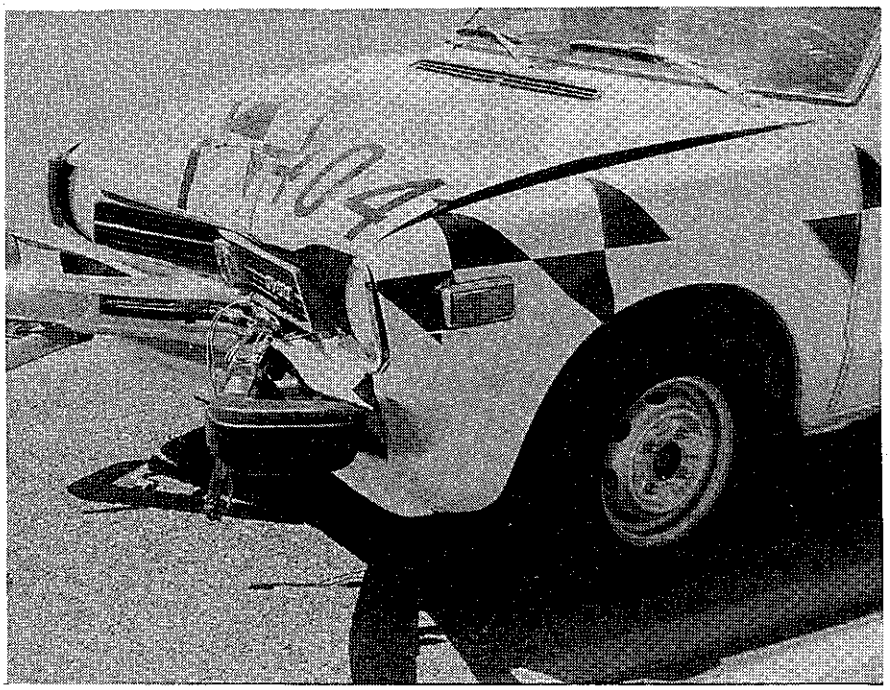
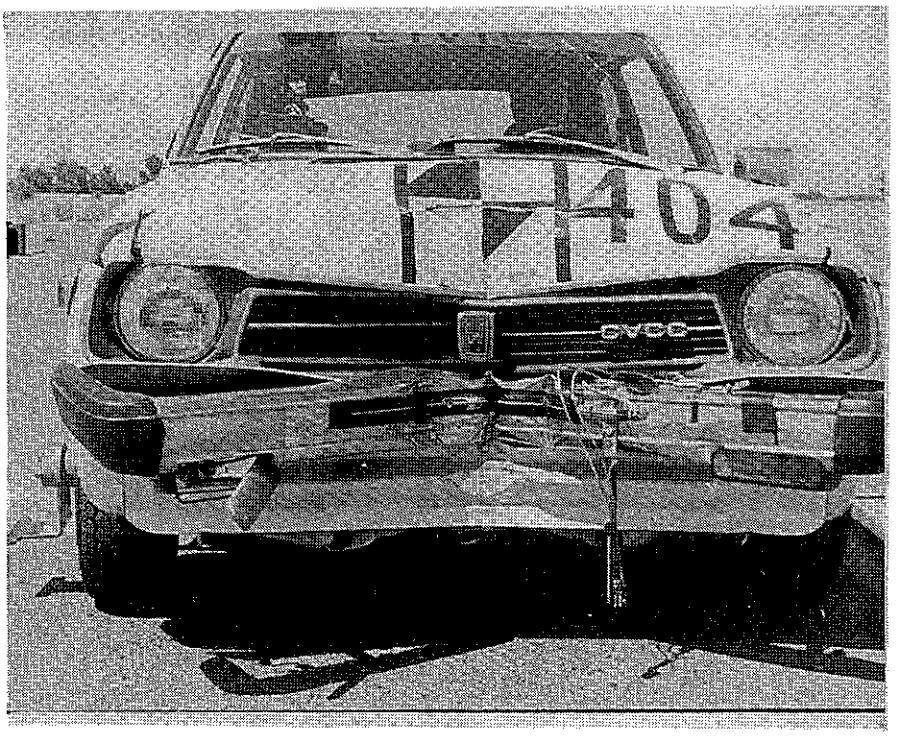
Figure 48. Test Vehicle After Impact - Test 404
