STATE OF CALIFORNIA
DEPARTMENT OF TRANSPORTATION
DIVISION OF NEW TECHNOLOGY AND RESEARCH
OFFICE OF TRANSPORTATION LABORATORY

VEHICLE IMPACT TESTING OF LIGHTWEIGHT LIGHTING STANDARDS

1. REPORT NO. FHWA/CA/TL-88/07	2. GOVERNMENT ACCESSION NO.	3. RECIPIENT'S CATALOG NO.
4. TITLE AND SUBTITLE VEHICLE IMPACT TESTING OF LIGHTWEIGHT LIGHTING STANDARDS		5. REPORT DATE Oct. 1988
		6. PERFORMING ORGANIZATION CODE
7. AUTHOR(S) A. Abghari, R. L. Stoughton, and J. Dusel		8. PERFORMING ORGANIZATION REPORT NO. 636964
9. PERFORMING ORGANIZATION NAME AND ADDRESS Office of Transportation Laboratory California Department of Transportation Sacramento, California 95819		10. WORK UNIT NO.
		11. CONTRACT OR GRANT NO. F82TL17
12. SPONSORING AGENCY NAME AND ADDRESS California Department of Transportation Sacramento, California 95807		13. TYPE OF REPORT & PERIOD COVERED FINAL
		14. SPONSORING AGENCY CODE

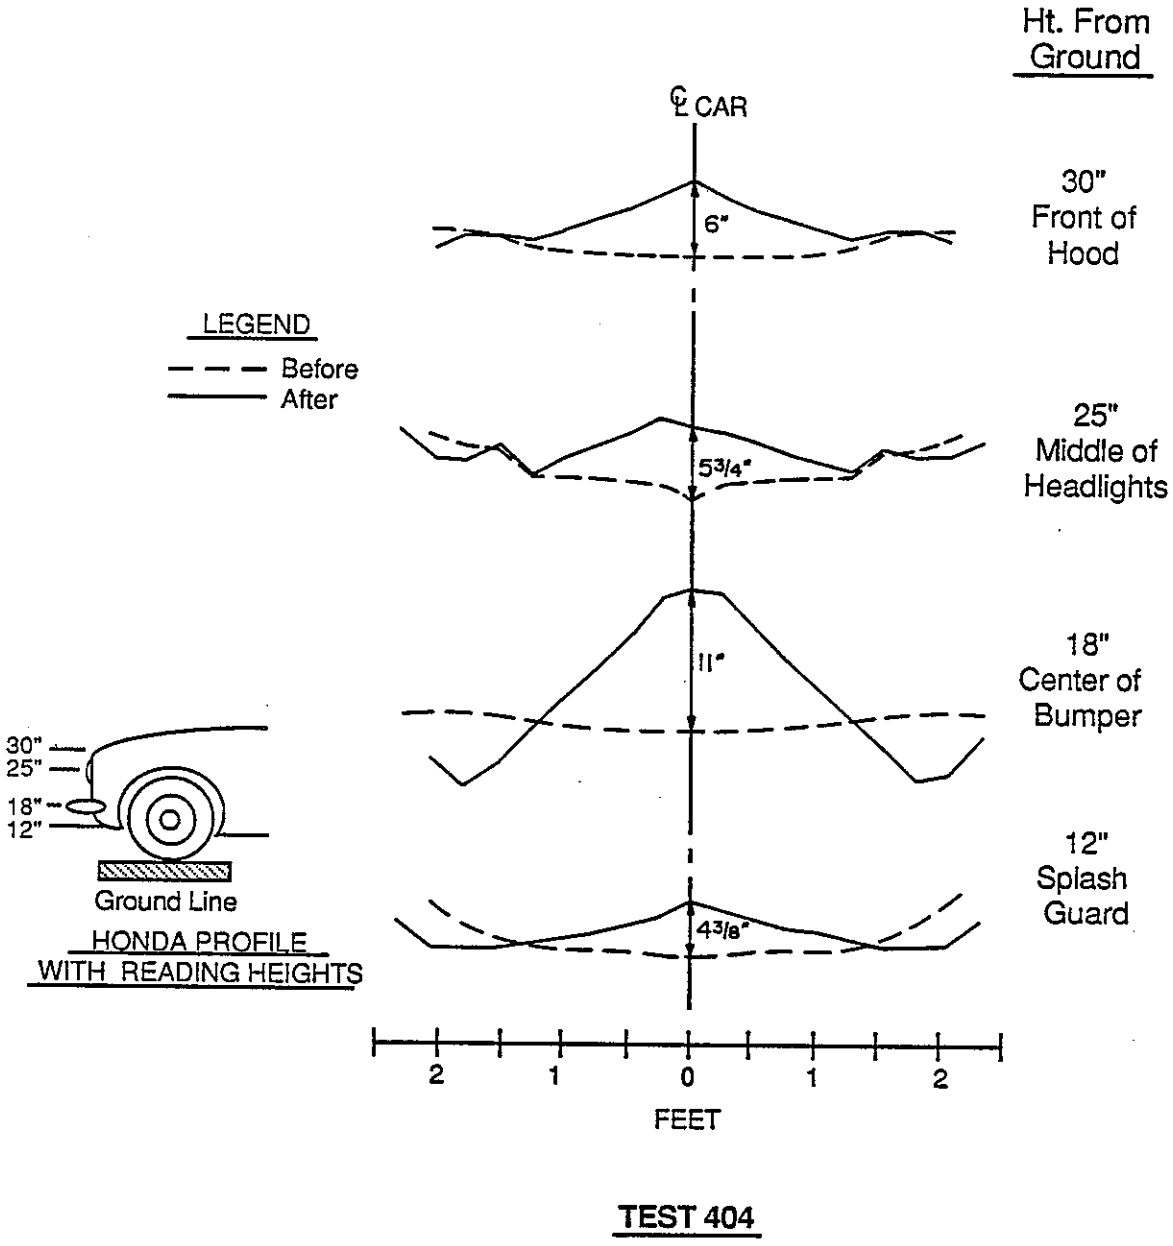
Figure 49. Crush Profiles of the Front End of Test Vehicle - Test 404

Figure 48 shows the test vehicle after the impact. The crush profiles of the vehicle (measured in horizontal planes at different heights) are shown in Figure 49. The maximum crush of the front bumper was 11 in.

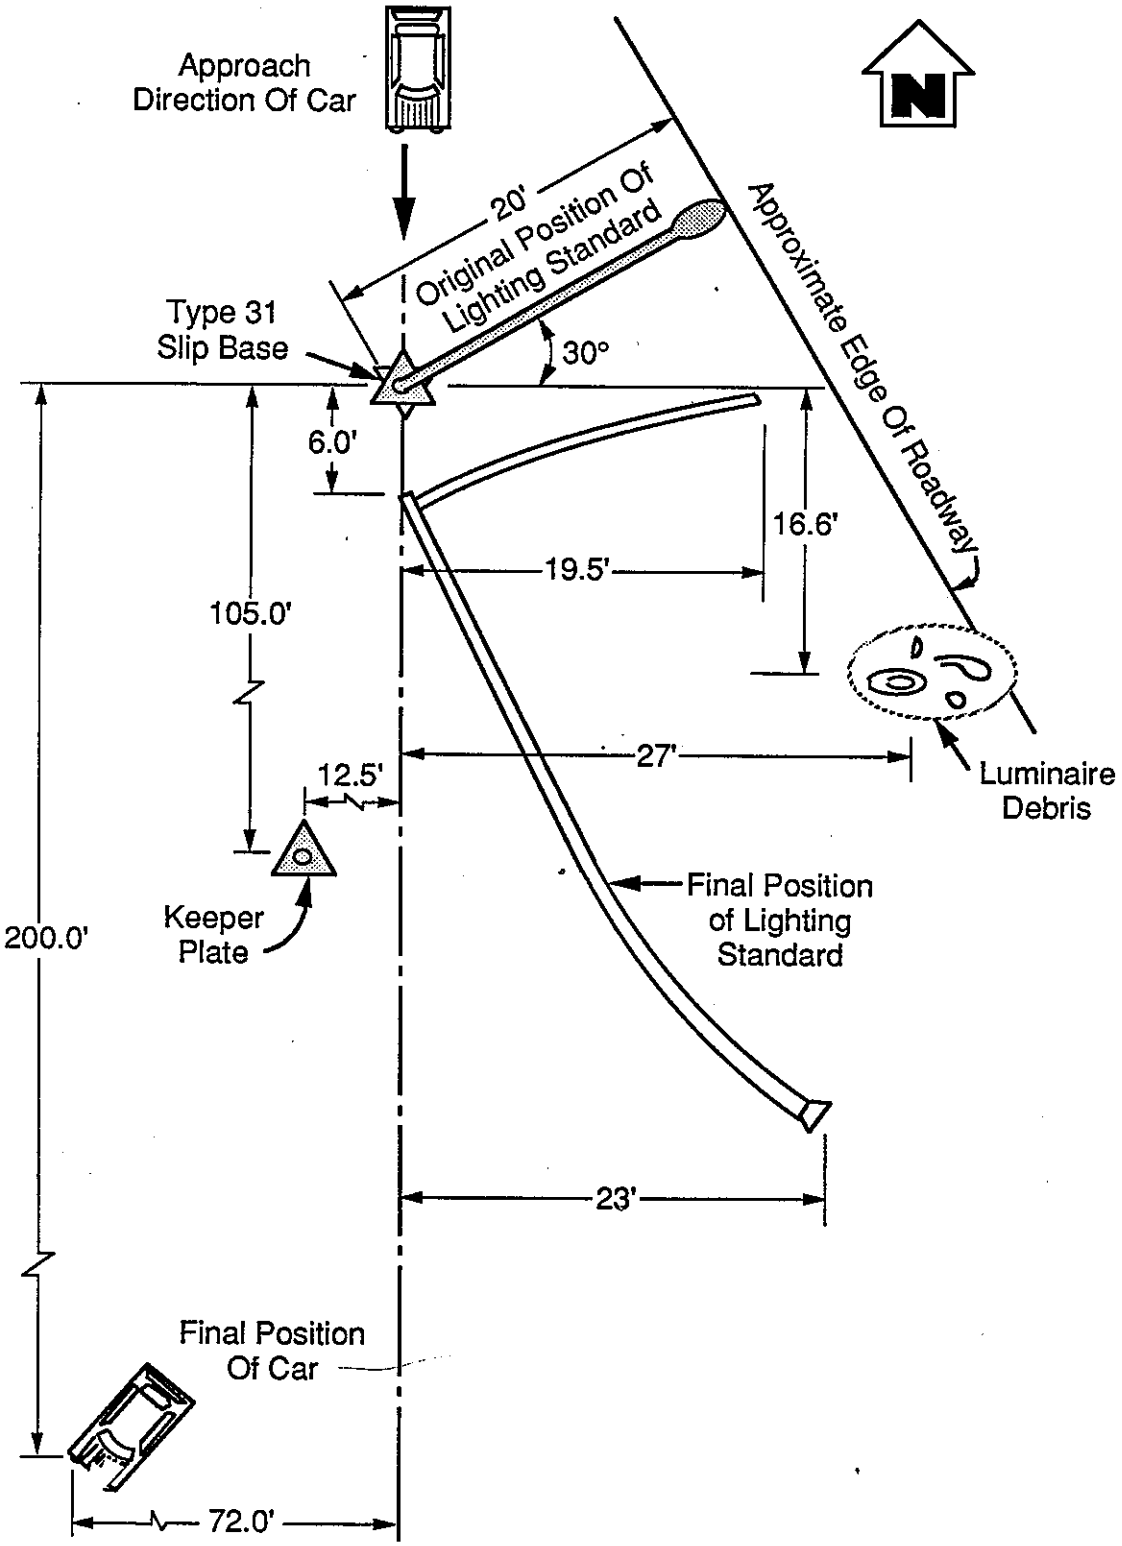
Figure 50. Test 405 Data Summary Sheet

The anthropomorphic dummy, positioned in the driver's seat, was unrestrained. There was no internal film coverage of the dummy during and after impact because the camera switch was unintentionally cut off just before impact. Other test data (dummy accelerometer and HIC data are shown in the data summary sheet, (Figure 50); however, indicate that injuries to the dummy would have been minor.

VEHICLE	1979 Honda Civic
VEHICLE WEIGHT (Including dummy & instrumentation)	2050 lb.
DUMMY RESTRAINT	None
IMPACT VELOCITY	53.9 Mph.
IMPACT LOCATION	13-5/8" Right of Centerline
OCCUPANT IMPACT VELOCITY LONG.	12.4 fps
VEHICLE DAMAGE (measured at bumper ht.)	13-5/8"
VEHICLE ACCELERATION (max. 50 msec avg.)	
LATERAL	-1.64 g's
LONGITUDINAL	-7.24g's
VERTICAL	1.36 g's
HEAD INJURY CRITERION	8

TEST NO.	405
DATE	May 23, 1985
TYPE OF LIGHT STD.	Caltrans Type 31
POLE MATERIAL	Galvanized Steel
POLE DIMENSIONS	35'-0" x 10 7/8"O.D. x 6"O.D
POLE BASE SLEEVE	None.
MOUNTING HEIGHT	37'-0"
PROJECTED LENGTH OF MAST ARM	20'-0"
TOTAL WEIGHT	883 Lb.
BREAKAWAY DEVICE	Type 31 Triangular Slip base

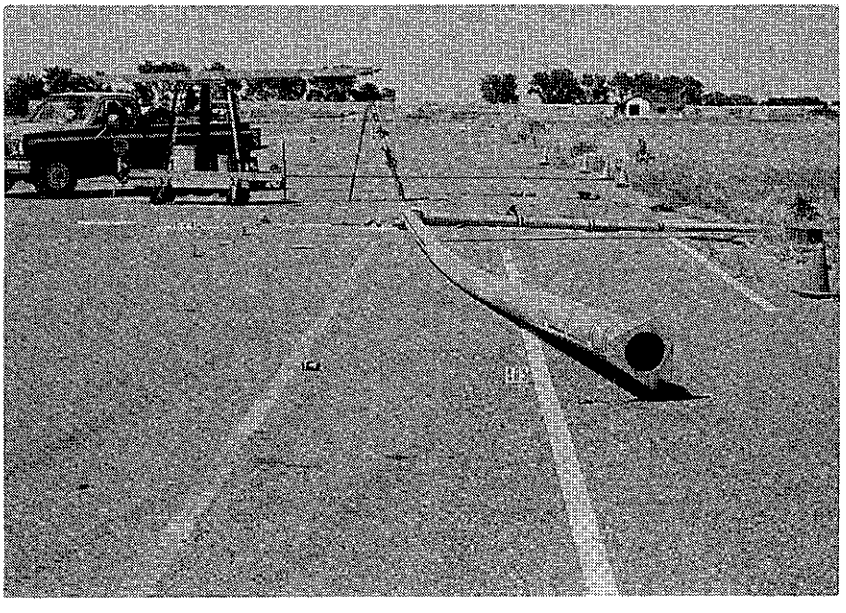
Figure 52. Lighting Standard Damage - Test 405

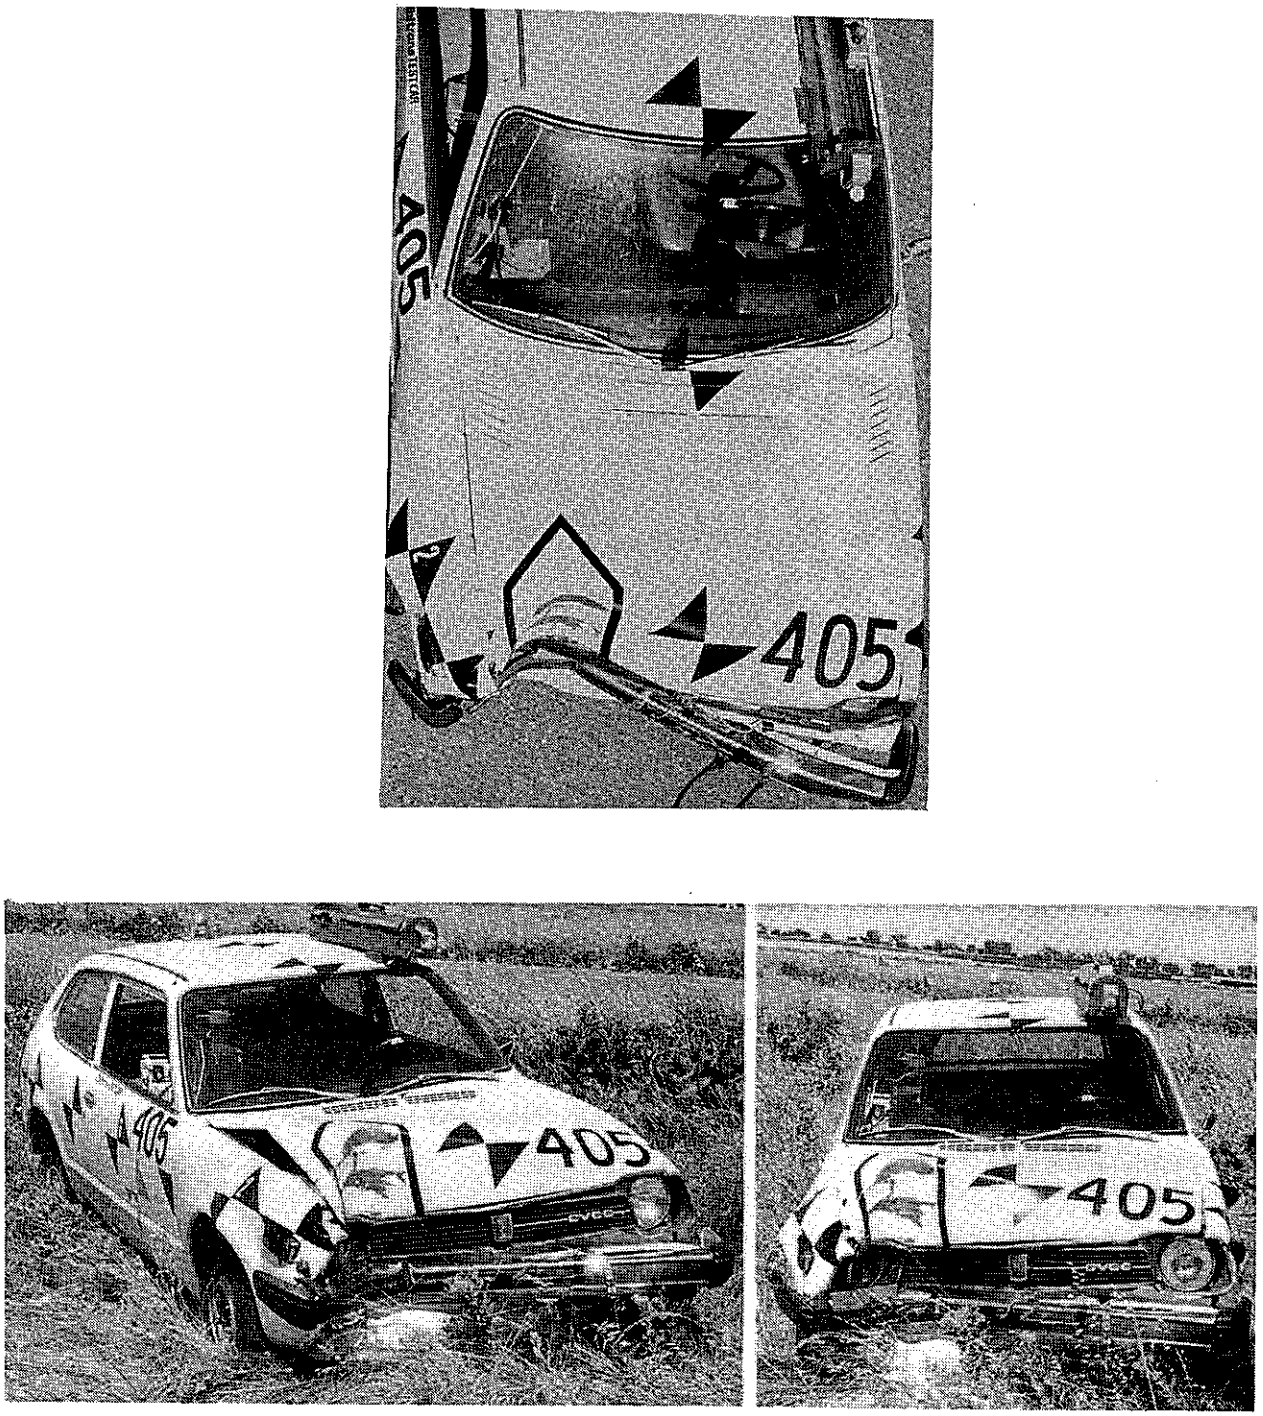
Figure 53. Test Vehicle After Impact - Test 405

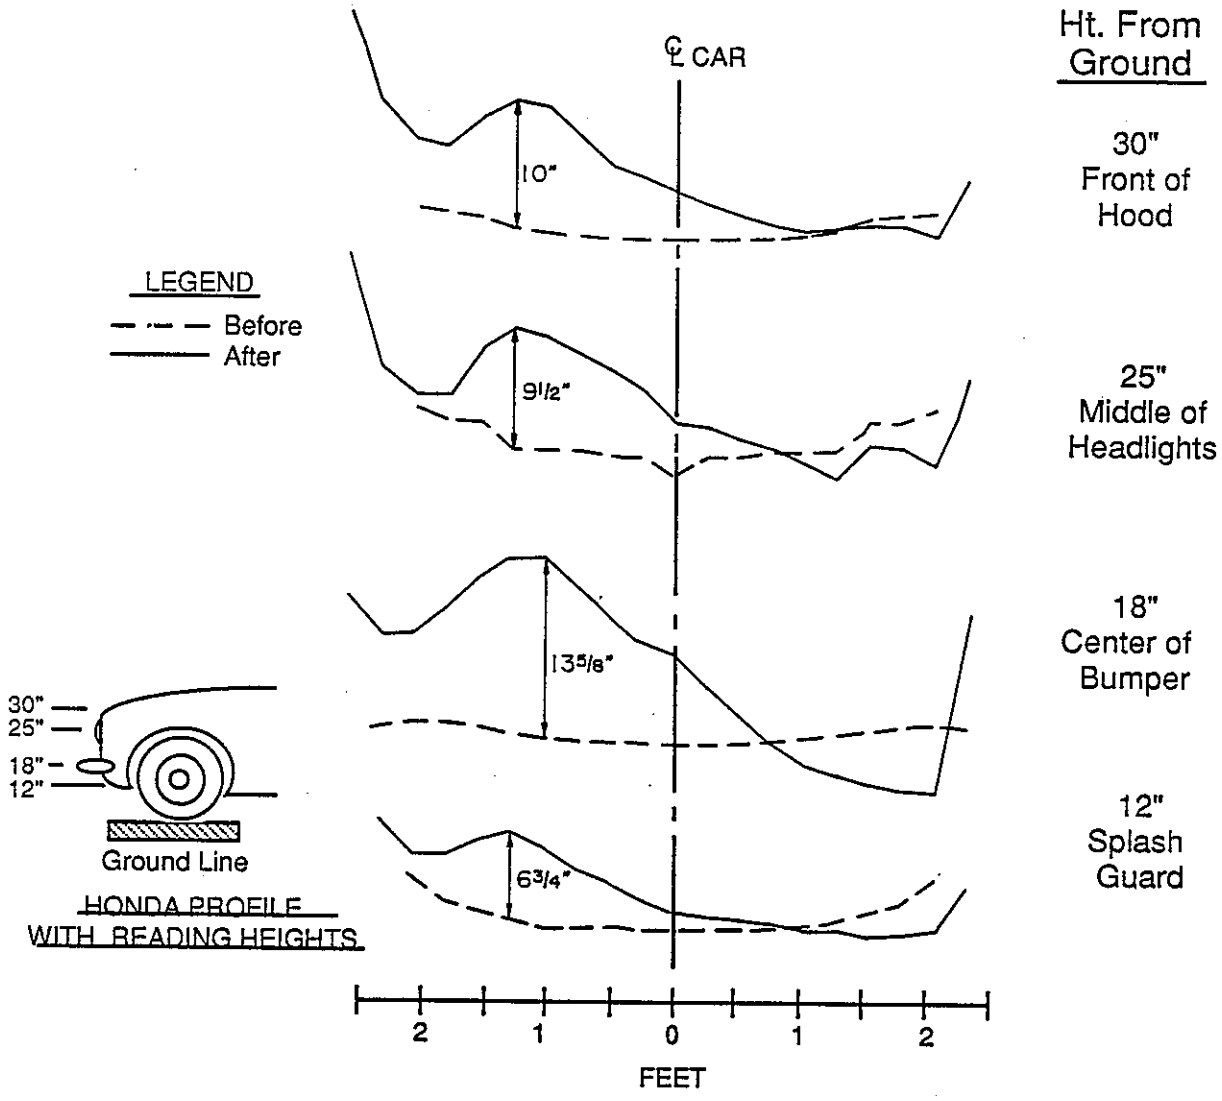
Figure 54. Crush Profiles of the Front End of Test Vehicle - Test 405

Figure 53 shows the test vehicle after the impact. The front crush profiles of the vehicle (measured in horizontal planes at different heights) are shown in Figure 54. The maximum crush of the bumper was 13-5/8 in.

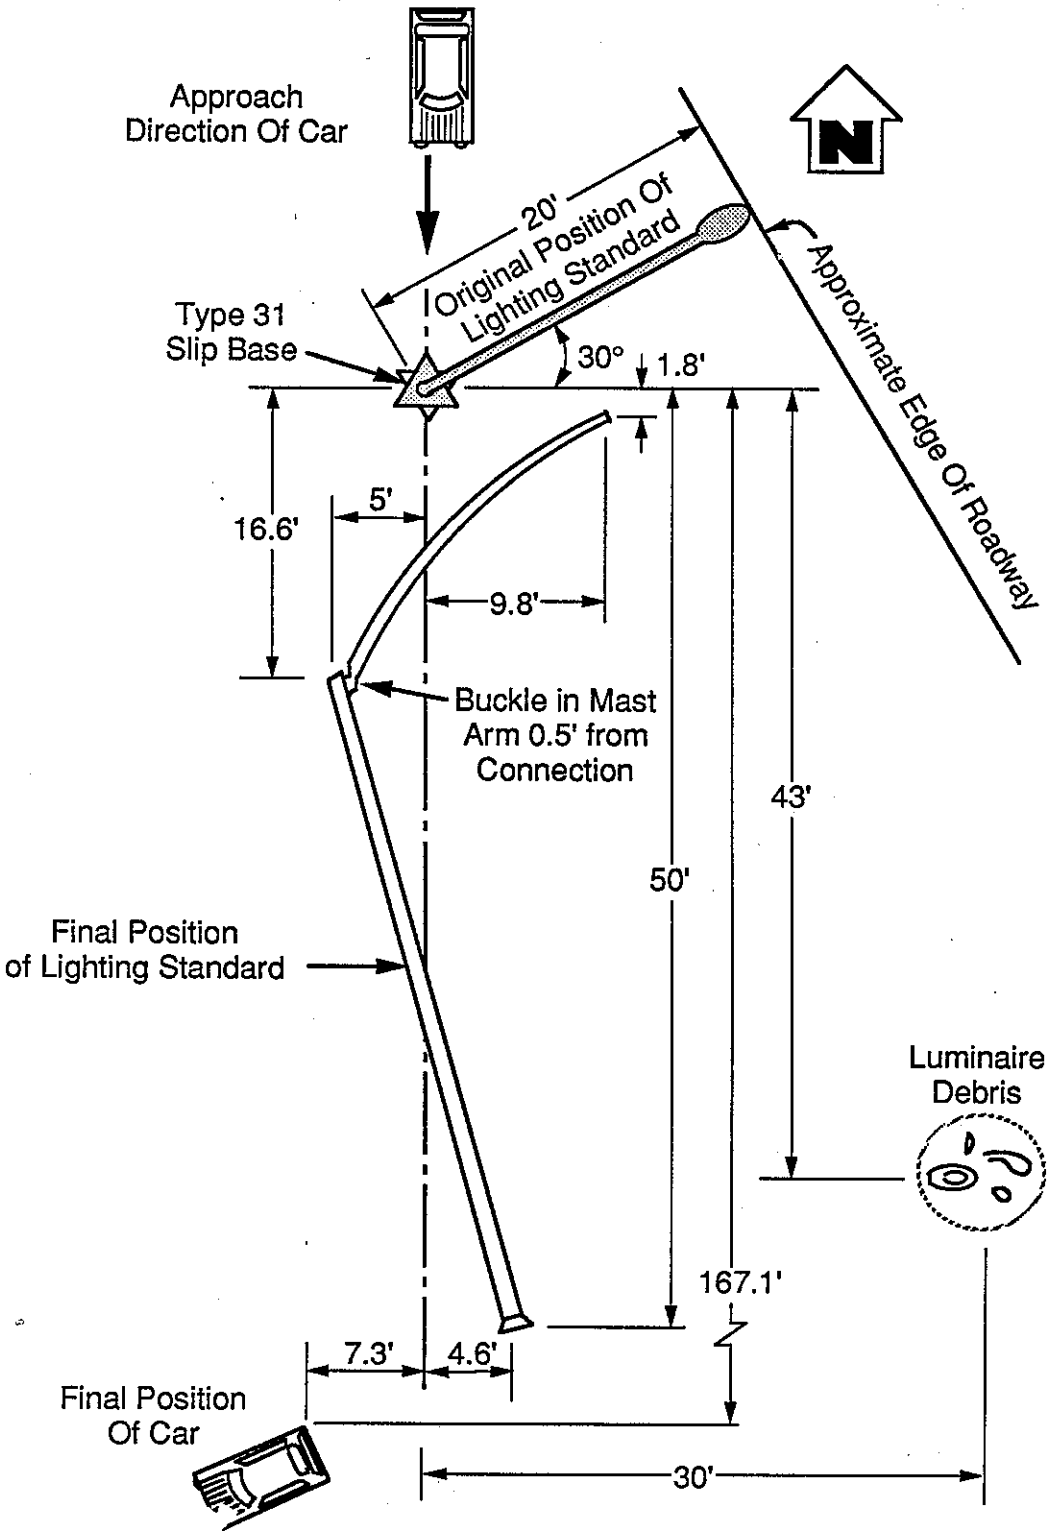
Figure 55. Test 406 Data Summary Sheet

VEHICLE	1979 Honda Civic
VEHICLE WEIGHT (Including dummy & instrumentation)	2015 lb.
DUMMY RESTRAINT	None
IMPACT VELOCITY	58.8 Mph.
IMPACT LOCATION	18-3/4" Right of Centerline
OCCUPANT IMPACT VELOCITY LONG.	13 fps
VEHICLE DAMAGE (measured at bumper ht.)	15-1/8"
VEHICLE ACCELERATION (max. 50 msec avg.)	
LATERAL	-1.49 g's
LONGITUDINAL	-7.16 g's
VERTICAL	-1.64 g's
HEAD INJURY CRITERION	7

TEST NO.	406
DATE	May 8, 1987
TYPE OF LIGHT STD.	Modified Type 31
POLE MATERIAL	Galvanized Steel
POLE DIMENSIONS	33'-0" x 10" O.D. x 5-3/8" O.D.
THICKENED POLE BASE	2'-0" x 10" O.D. x 0.25"
MOUNTING HEIGHT	39'-3"
PROJECTED LENGTH OF MAST ARM	20'-0"
TOTAL WEIGHT	627.4 Lb.
BREAKAWAY DEVICE	Type 31 Triangular Slip base

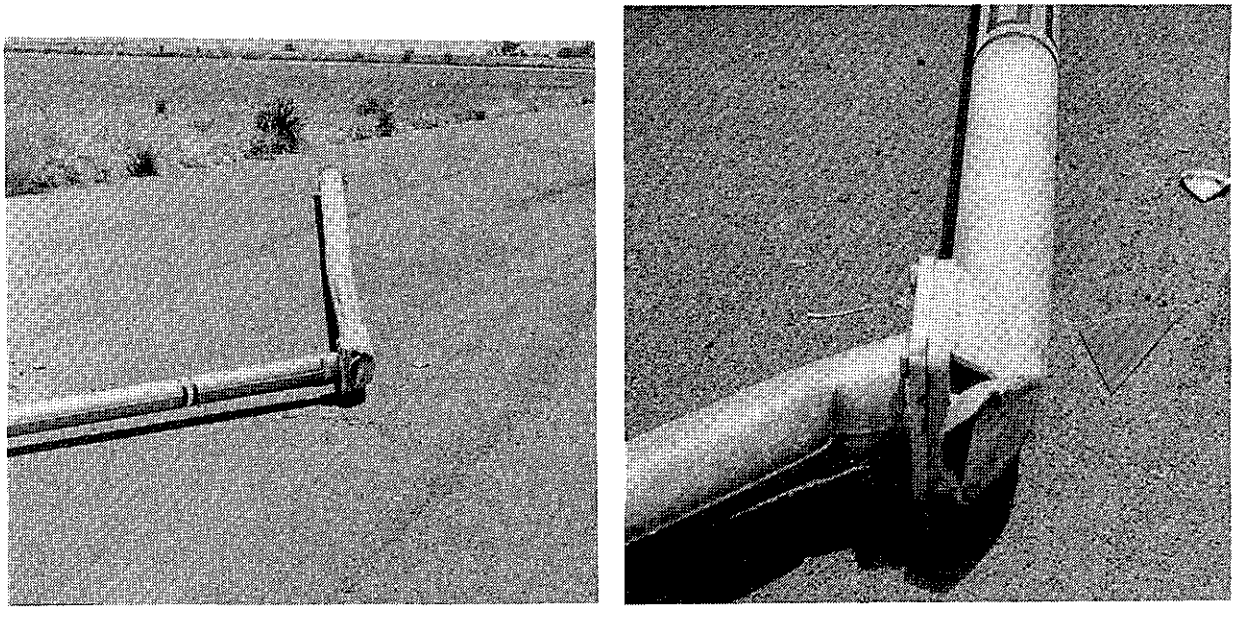
Figure 57. Lighting Standard Damage - Test 406

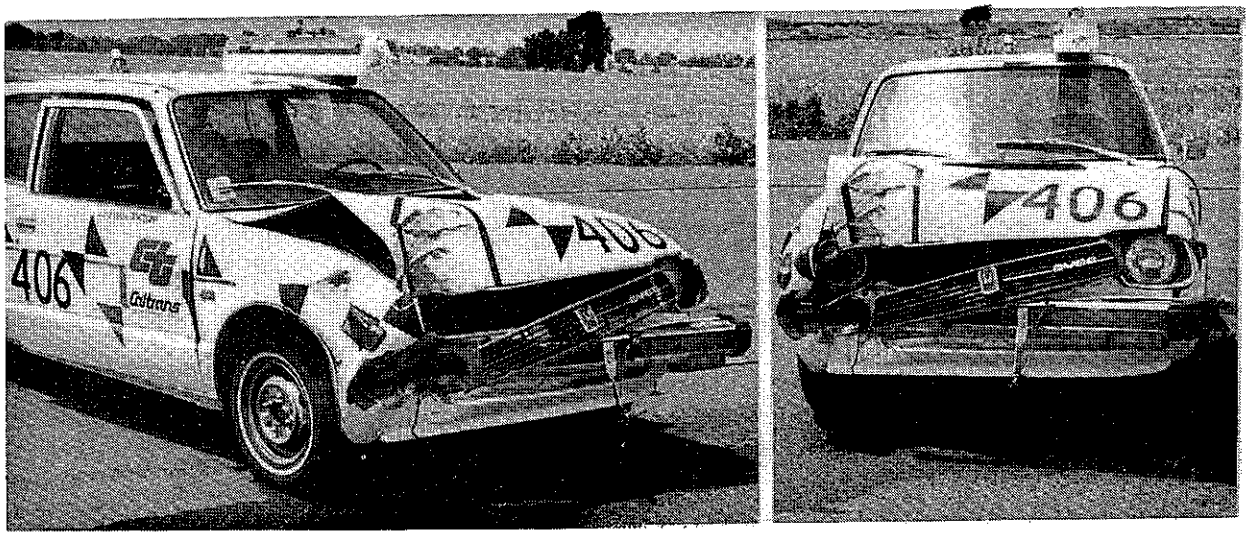
Figure 58. Test Vehicle After Impact - Test 406

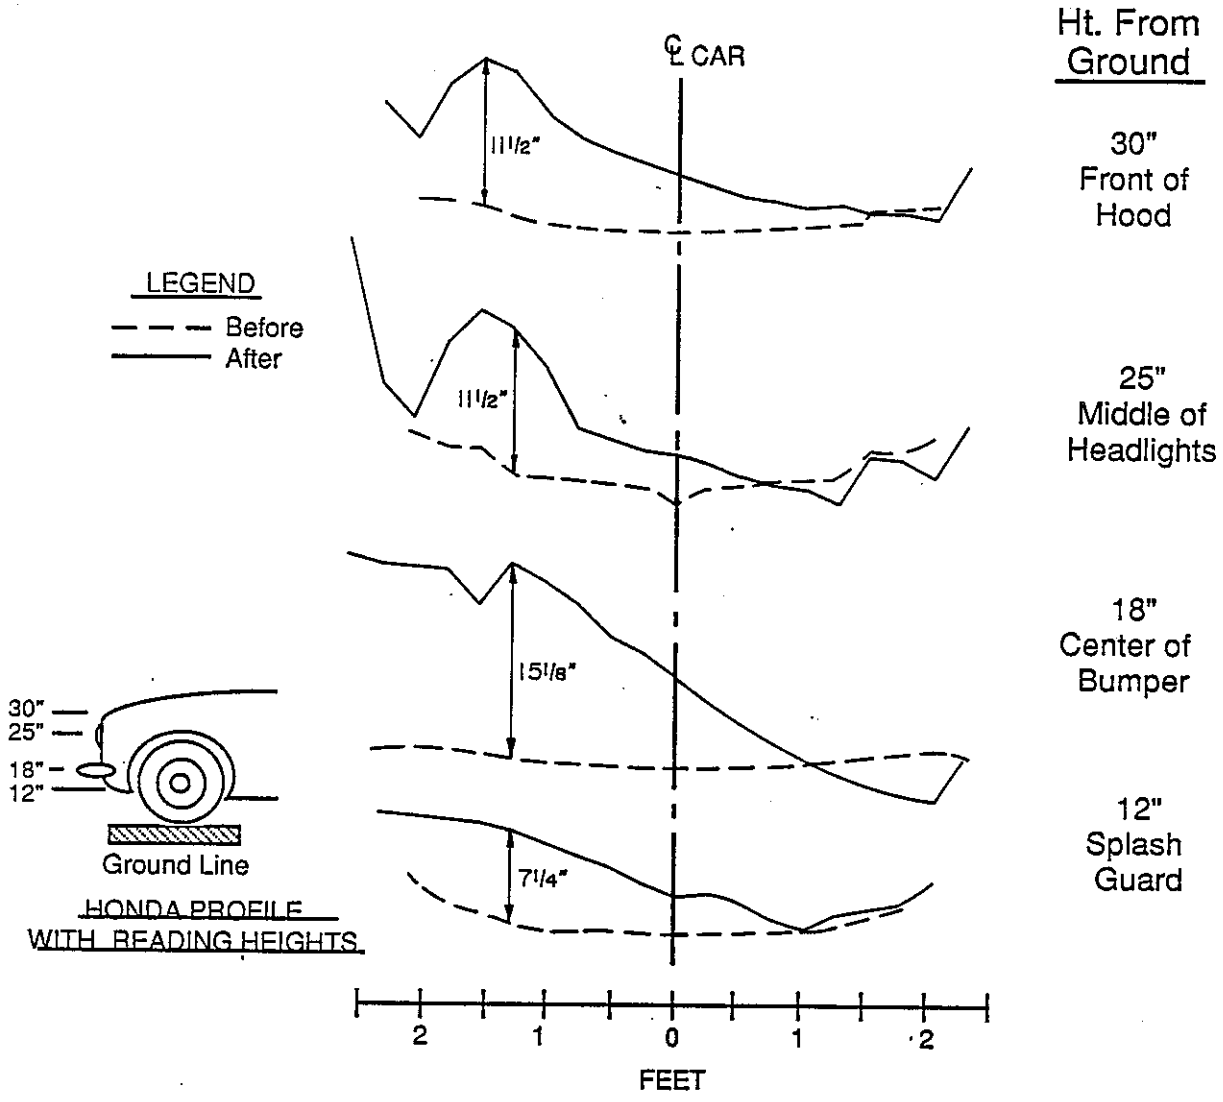
Figure 59. Crush Profiles of the Front End of Test Vehicle - Test 406

Figure 58 shows the test vehicle after the impact. The front crush profiles of the vehicle (measured in horizontal planes at different heights) are shown in Figure 59. The maximum crush of bumper was 15-1/8 in.

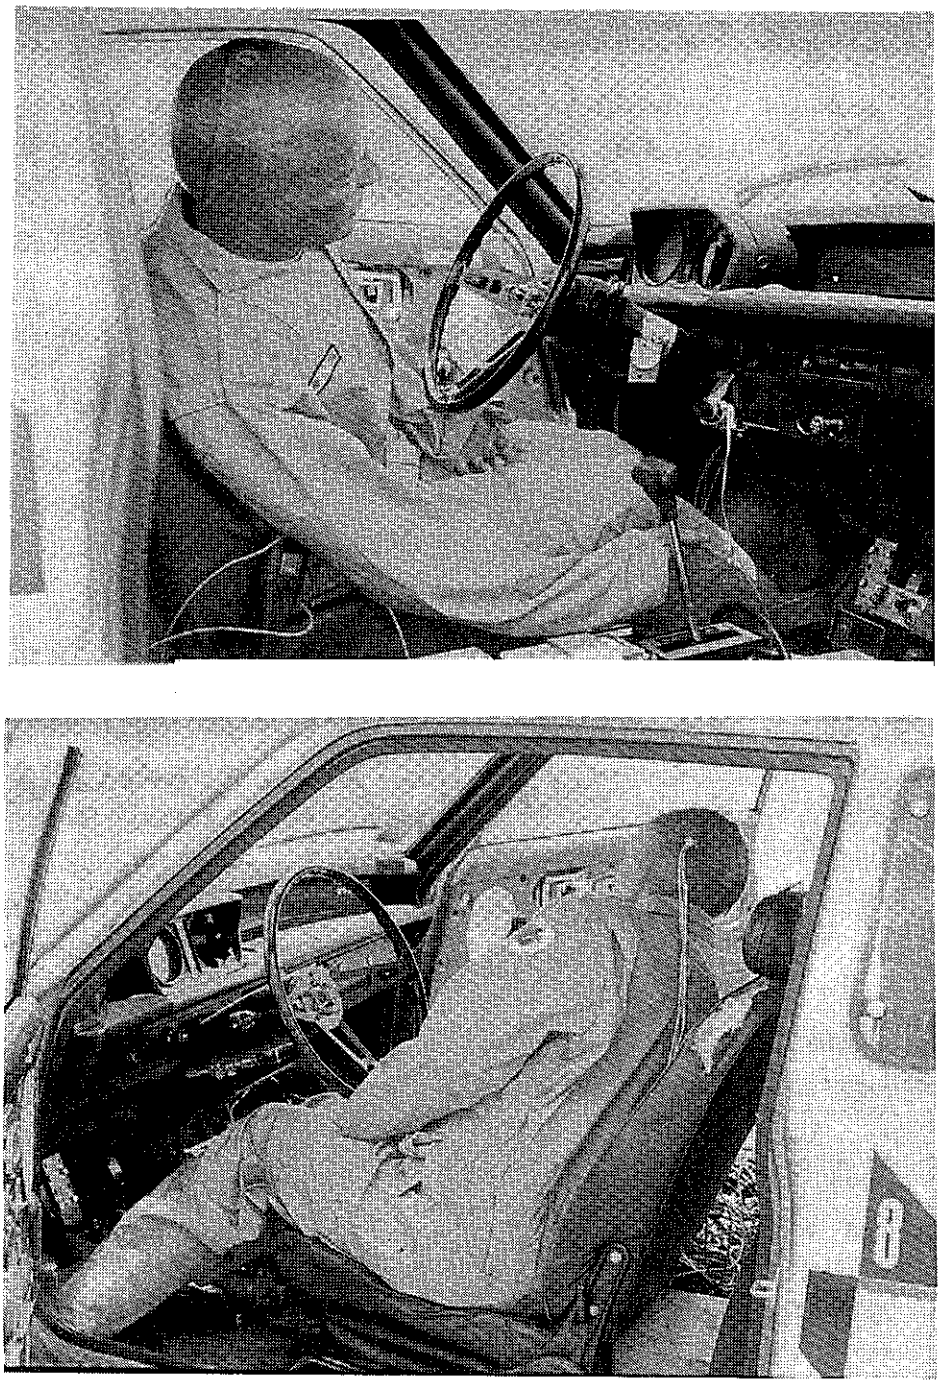
Figure 60. Dummy's Position After Impact - Test 406

The test dummy, positioned in the driver's seat was unrestrained. There was no internal camera coverage for the dummy due to a shortage of high-speed cameras. Upon initial impact, the dummy bent at the waist and the shoulders and head were thrown forward. The dummy's head hit the steering wheel. Figure 60 shows the dummy's position after the impact.

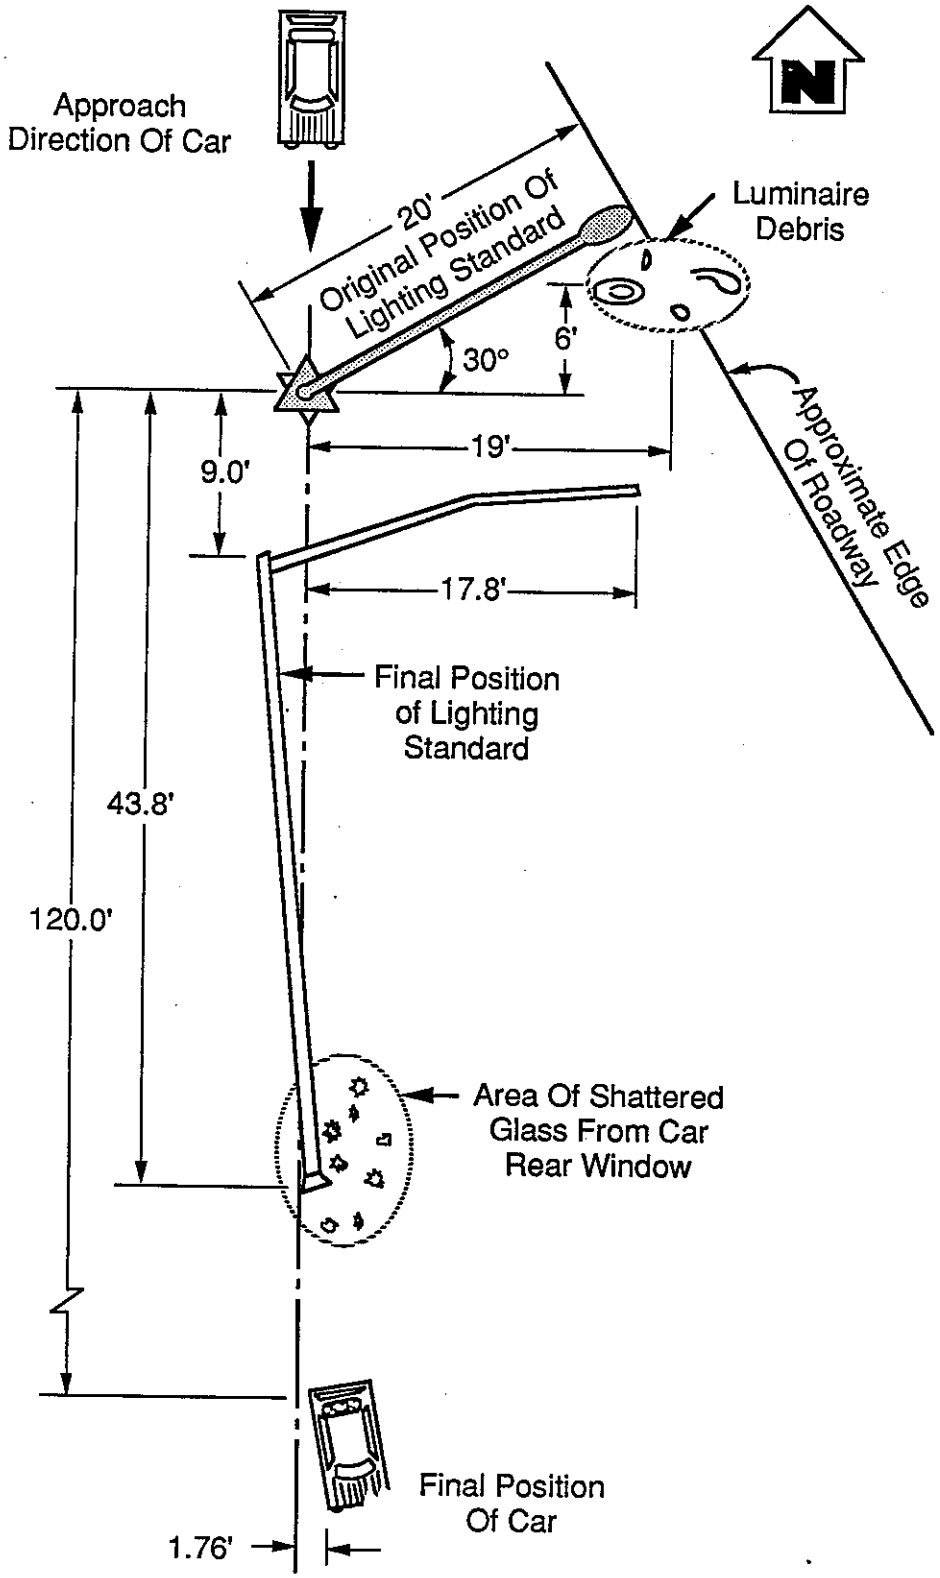
Figure 61. Test 407 Data Summary Sheet

TEST NO.	407
DATE	June 23, 1987
TYPE OF LIGHT STD.	Modified Type 31
POLE MATERIAL	Galvanized Steel
POLE DIMENSIONS	33'-0" x 10" O.D. x 5-3/8" O.D.
THICKENED POLE BASE	2'-0" x 10" O.D. x 0.25"
MOUNTING HEIGHT	39'-3"
PROJECTED LENGTH OF MAST ARM	20'-0"
TOTAL WEIGHT	639.4 Lb.
BREAKAWAY DEVICE	Type 31 Triangular Slip base

VEHICLE	1979 Honda Civic
VEHICLE WEIGHT	2005 Lb.
(Including dummy & instrumentation)	
DUMMY RESTRAINT	None
IMPACT VELOCITY	23.7 Mph.
IMPACT LOCATION	3" Right of Centerline
OCCUPANT IMPACT VELOCITY LONG.	8.6 fps
VEHICLE DAMAGE (measured at bumper ht.)	12-7/8"
VEHICLE ACCELERATION (max. 50 msec avg.)	
LATERAL	-0.54 g's
LONGITUDINAL	-5.73 g's
VERTICAL	-1.63 g's
HEAD INJURY CRITERION	2

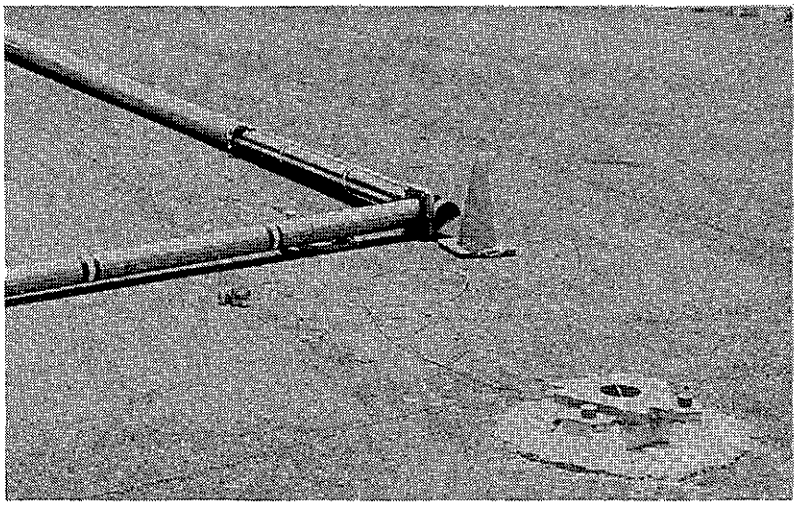
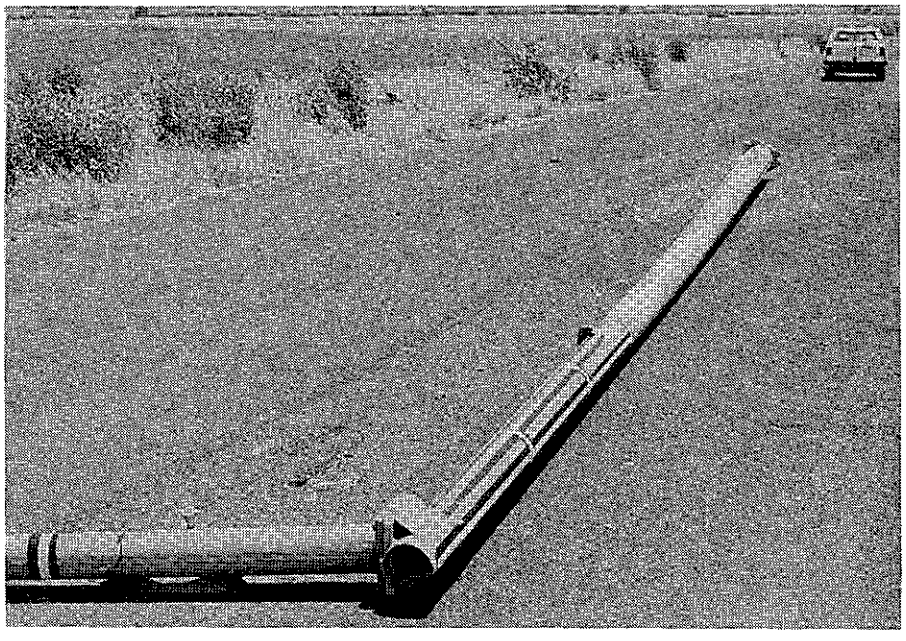
Figure 63. Lighting Standard Damage - Test 407

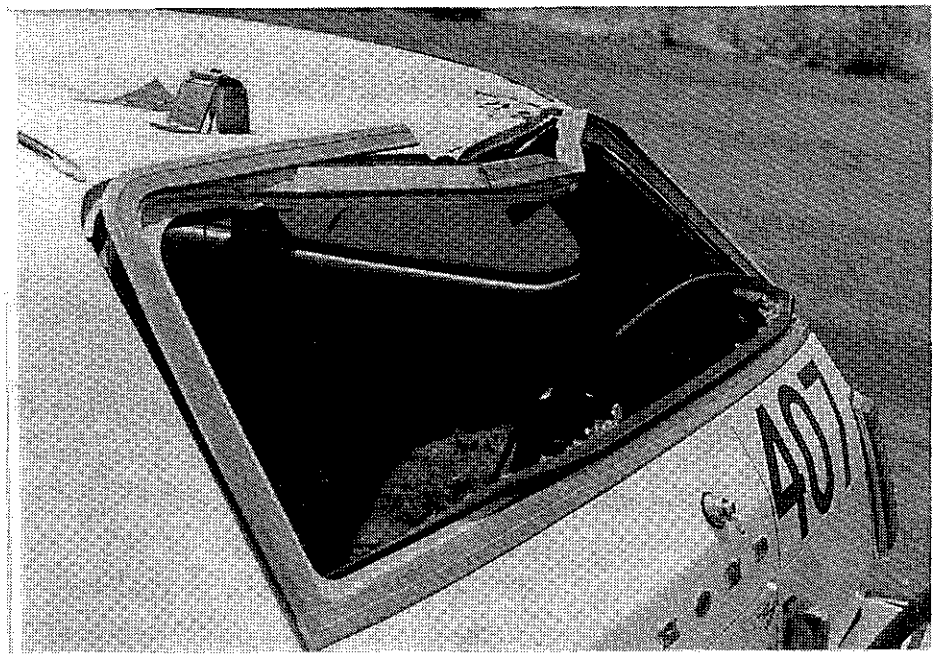
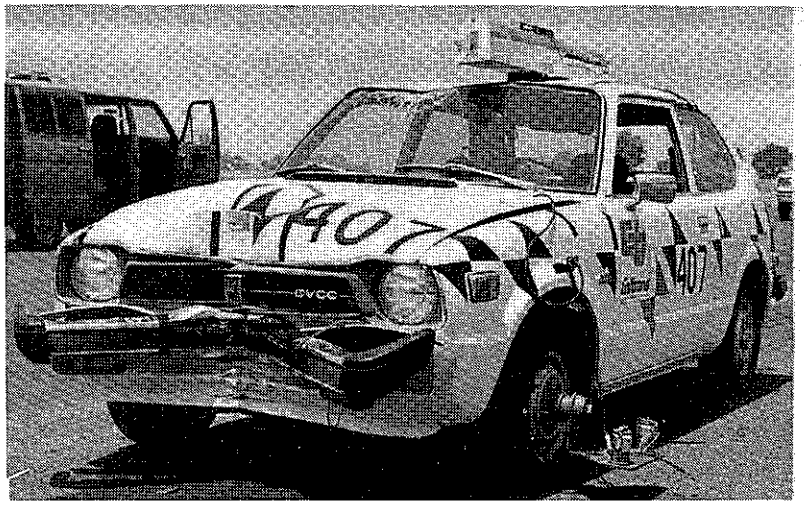
Figure 64. Test Vehicle After Impact - Test 407

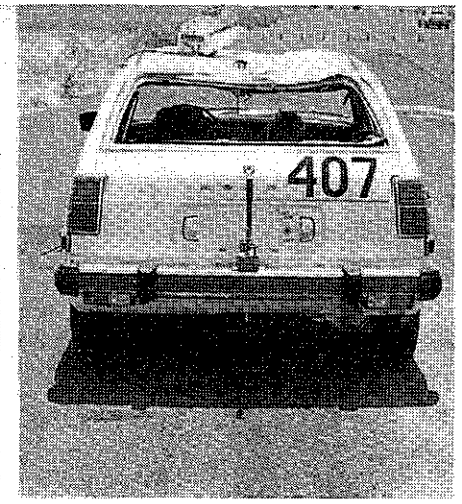
Figure 64 show the test vehicle after the impact. The crush profiles of the front end of the vehicle (measured in horizontal

The windshield cracked, and the rear window shattered as the pole rolled on the hood and roof of the car. The radiator was crushed back to the fan, but the engine did not move. The front frame members under the engine were also bent. The vehicle could not be driven away after the impact; however, it could be rolled away. There was no intrusion of vehicle or lighting standard components into the passenger compartment due to the impact.

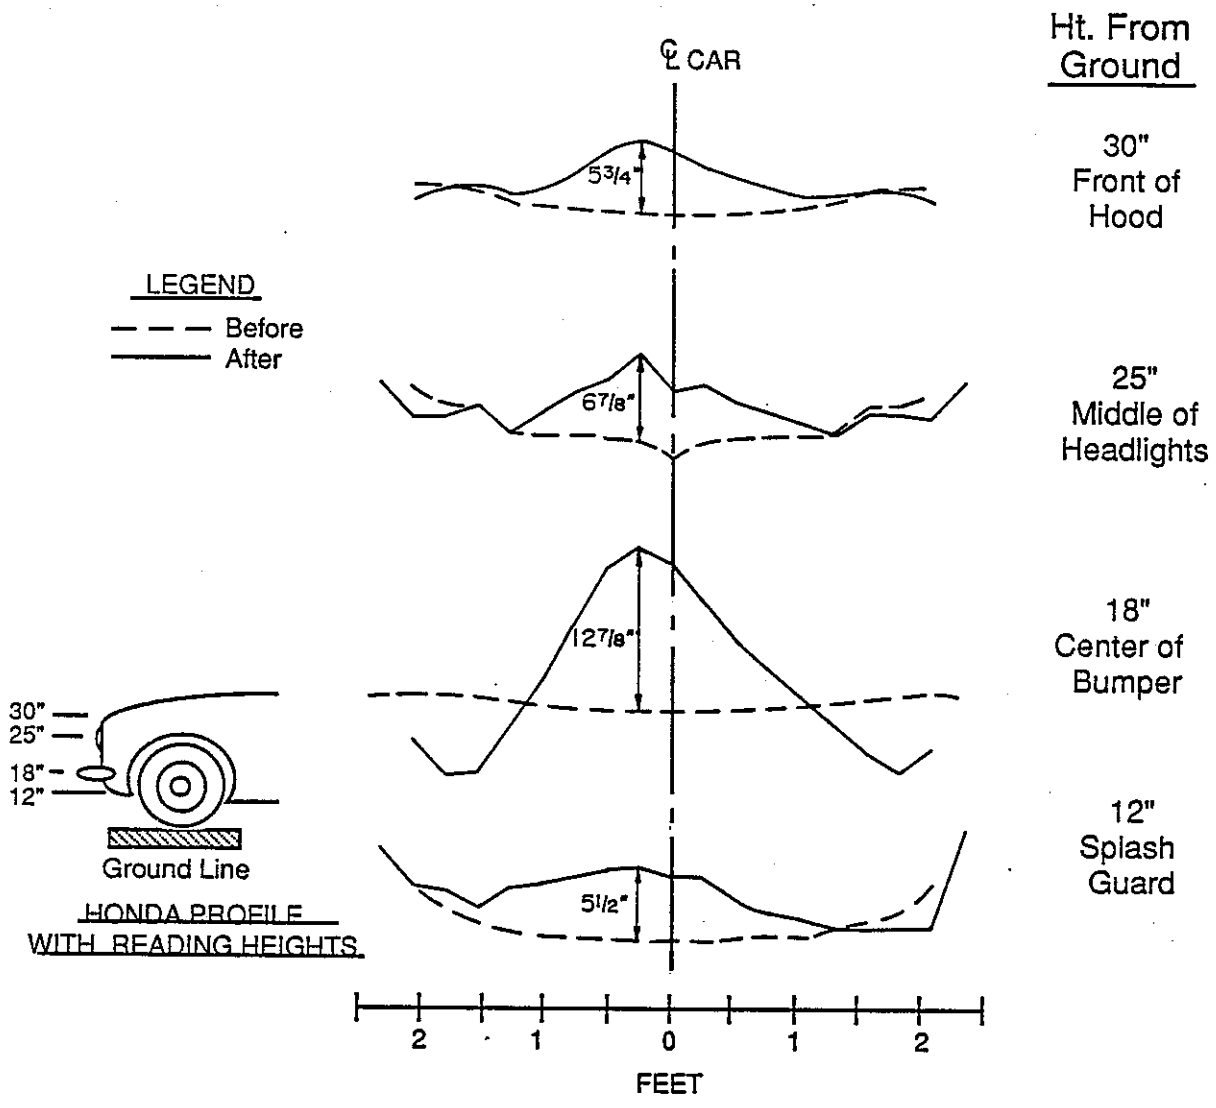
Figure 65. Crush Profiles of the Front End of Test Vehicle - Test 407

planes at different heights) are shown in Figure 65. The maximum crush of the front bumper was 12-7/8 in.

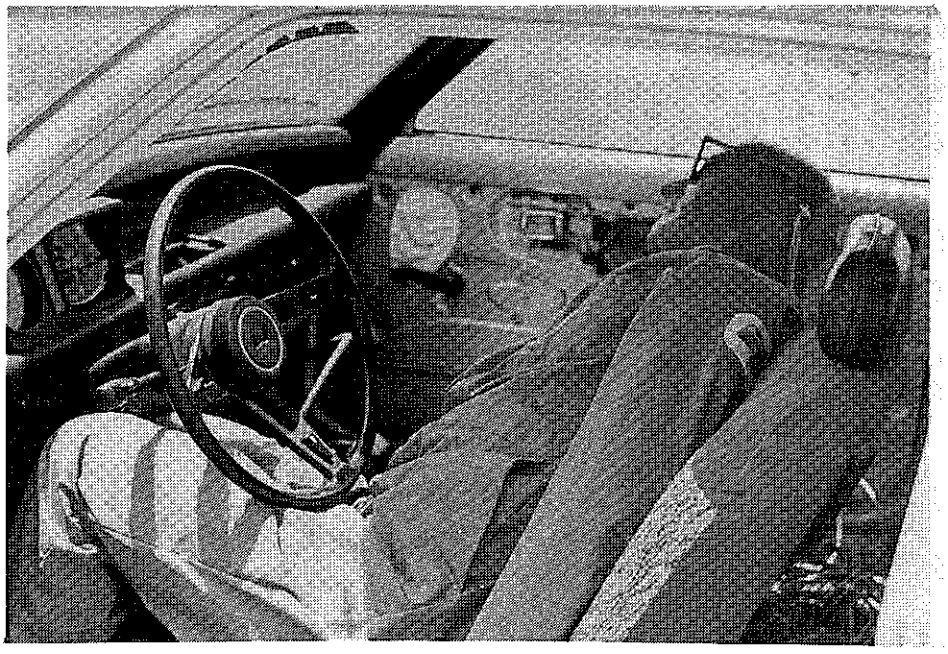
Figure 66. Dummy's Position After Impact - Test 407

The test dummy, positioned in the driver's seat during the impact, was unrestrained. There was no internal camera coverage for the dummy due to a shortage of high-speed cameras. Upon impact, the dummy leaned forward slightly but did not hit the steering wheel. Figure 66 shows the dummy's position after the impact.
