THE CONSTRUCTION AND INITIAL EVALUATION OF A SULFUR EXTENDED ASPHALT (SEA) PAVEMENT IN A COLD CLIMATE (INTERIM REPORT II)

1. REPORT NO. FHWA/CA/TL-86/12	2. GOVERNMENT ACCESSION NO.	3. RECIPIENT'S CATALOG NO
4. TITLE AND SUBTITLE The Construction and Initial Evaluation of a Sulfur Extended Asphalt (SEA) Pavement in a Cold Climate		5. REPORT DATE October, 1986
		6. PERFORMING ORGANIZATION CODE
7. AUTHOR(S) N. H. Predoehl		8. PERFORMING ORGANIZATION REPORT NO. 54324-633354
9. PERFORMING ORGANIZATION NAME AND ADDRESS Office of Transportation Laboratory California Department of Transportation Sacramento, California 95819		10. WORK UNIT NO
		11. CONTRACT OR GRANT NO. F81TL05
12. SPONSORING AGENCY NAME AND ADDRESS California Department of Transportation Sacramento, California 95807		13. TYPE OF REPORT & PERIOD COVERED Interim II - 1984-1986
		14. SPONSORING AGENCY CODE

This report details the planning, installation, and first year evaluation of the cold climate SEA test section (Benton Test Section) located on US-6 (Road 09-Mno-6-18.2/26.4) about 30 miles north of Bishop, California, that was placed May 30 to June 4, 1984.

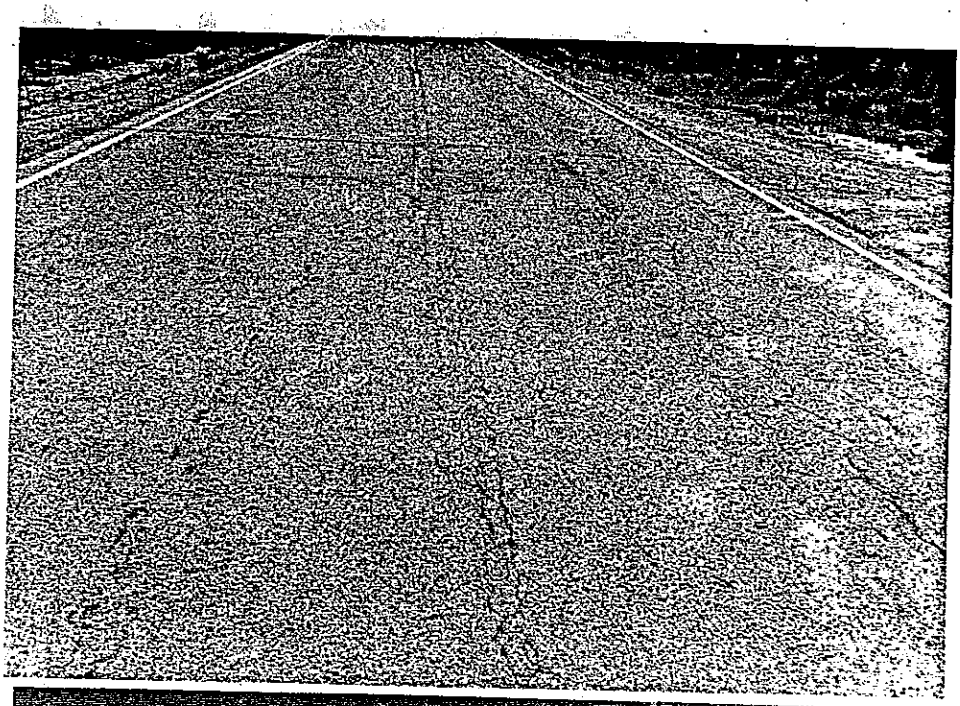
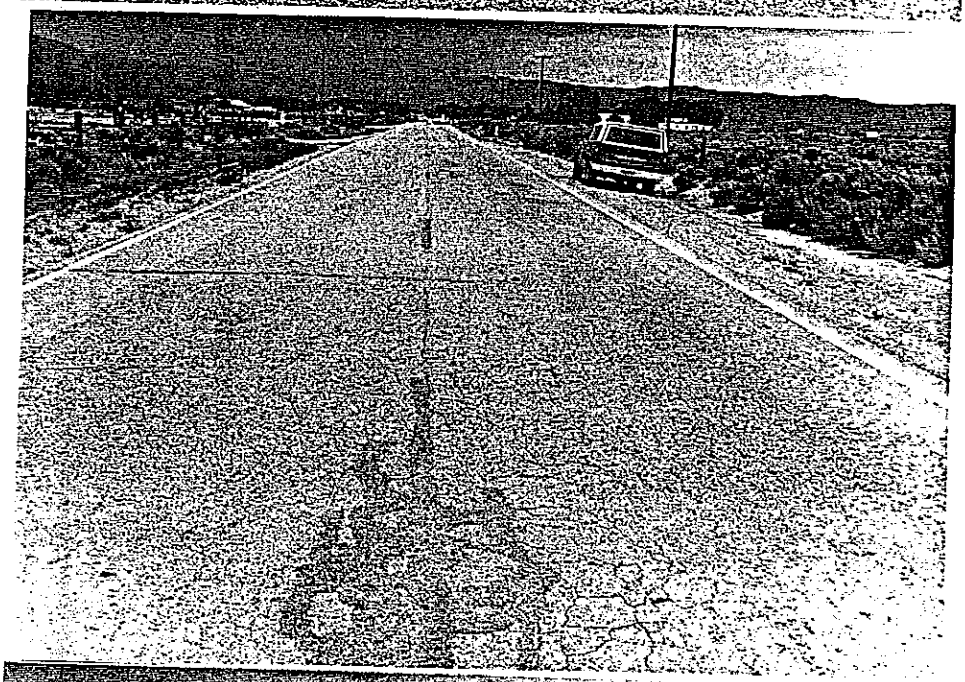
Figure 3

Pavements prior to test section installation.

SEA 40% Area

SEA 20% Area

AR-2000 Control Area

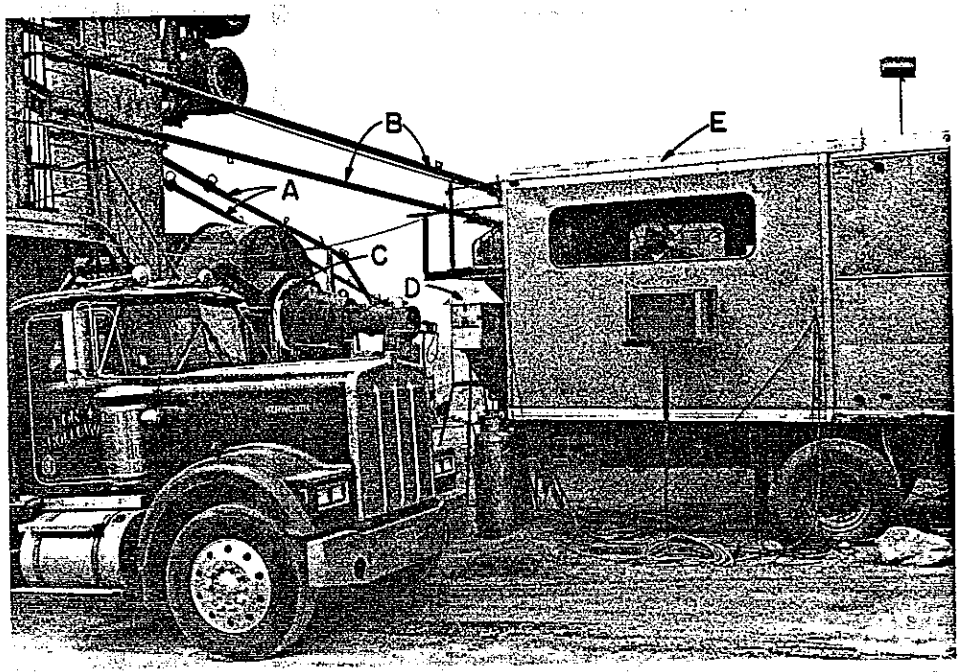
Figure 4

Mixing plant views showing sulfur piping.

View showing sulfur piping (A), regular asphalt piping (B), burner (C), high-volume air sampler ("D" for particulates), and control room (E).

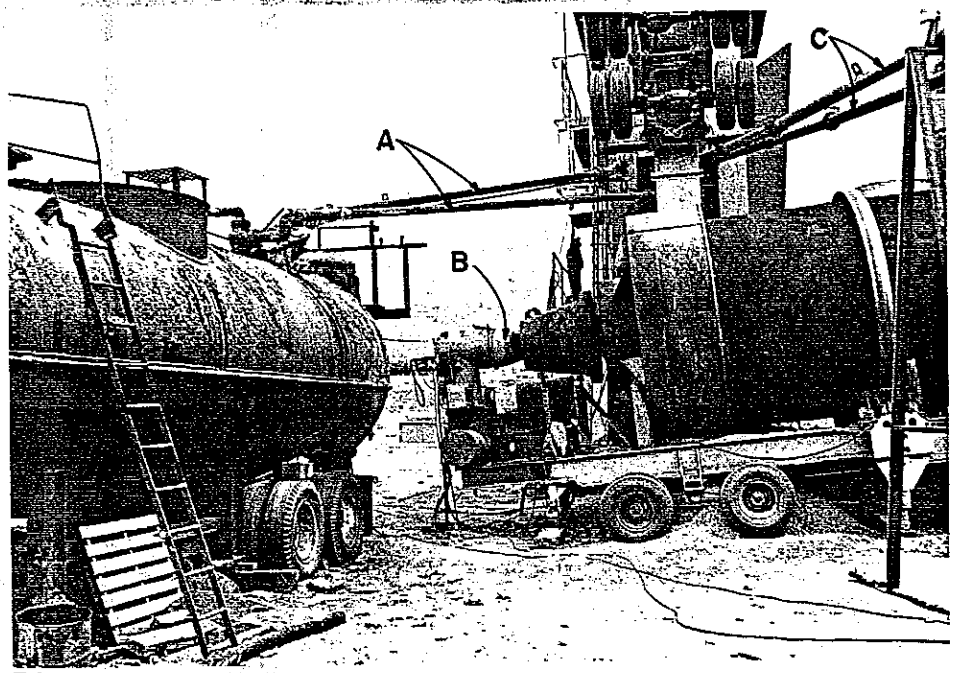
Reverse view showing asphalt tank & piping (A), aggregate dryer-burner (B), sulfur piping (C).

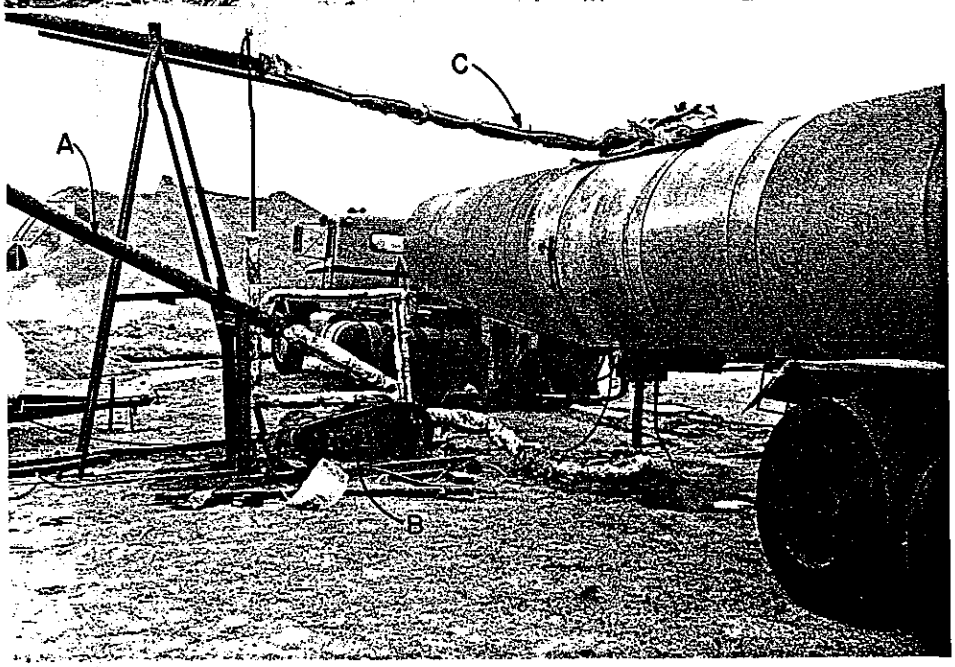
View showing piping, pump, & sulfur tank. Feed line (A), pump ("B" from bottom) and sulfur return line at top (C).

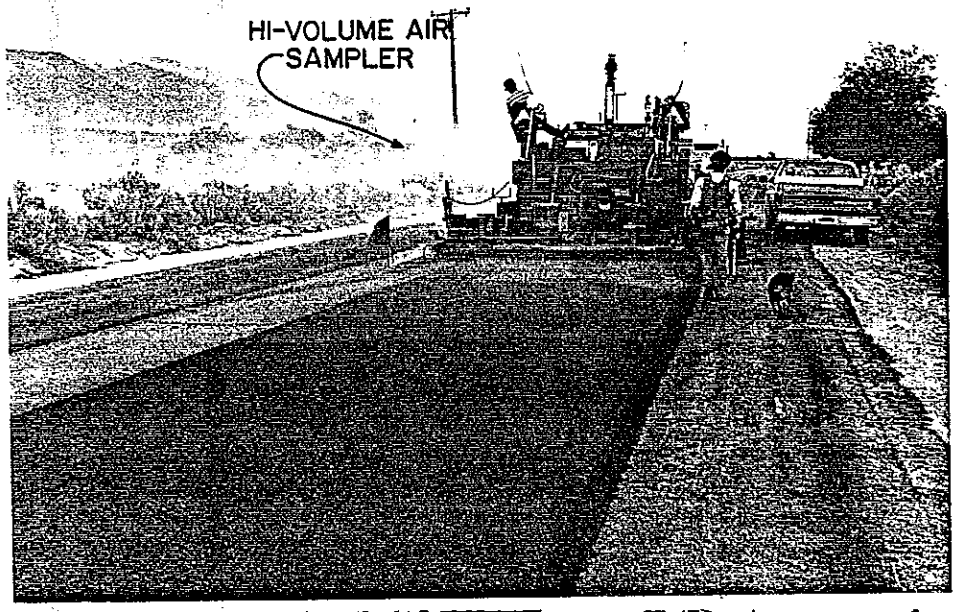
SEA Paving Views
(6-4-84)

Smoke from pavement immediately following paver.

Note Hi-Volume air sampler to left of paver across road near power pole.

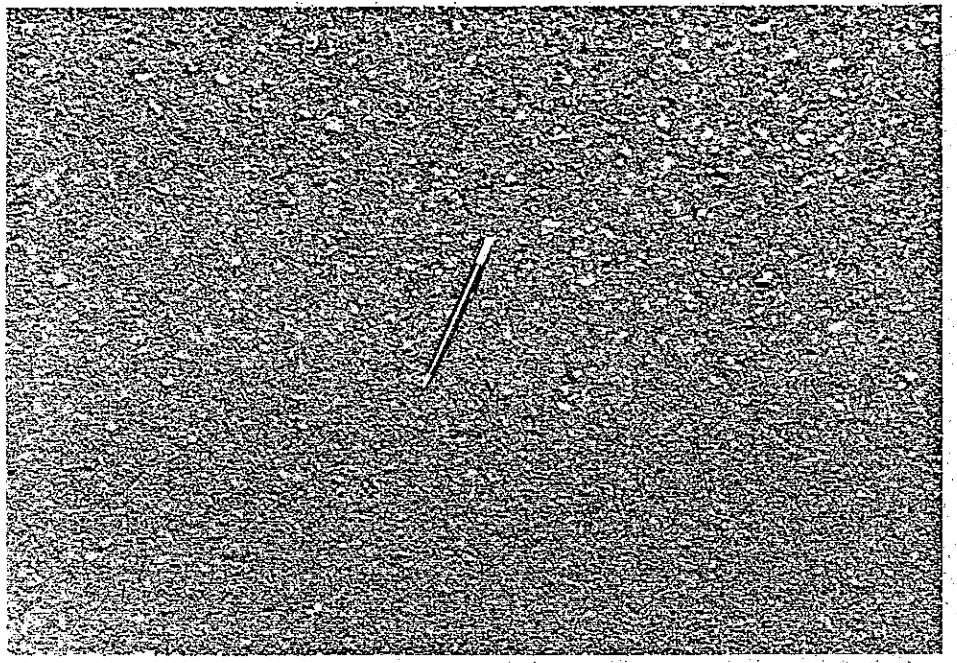
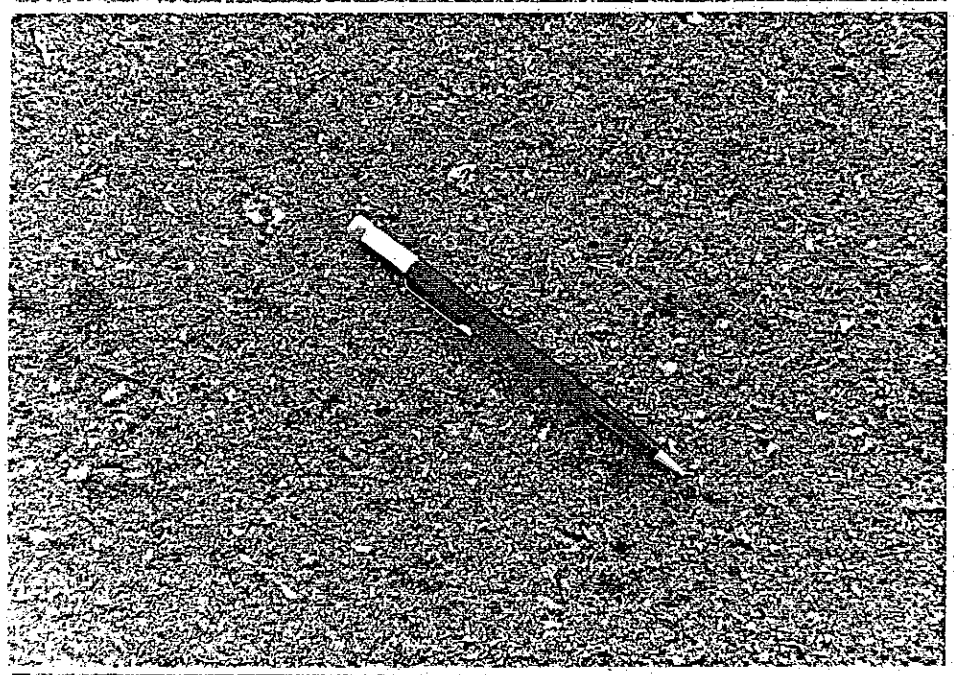
Figure 6

Surface views of AR-2000 (control) pavement.

New Pavement

NB Lane after 16 months.

SB Lane after 16 months.

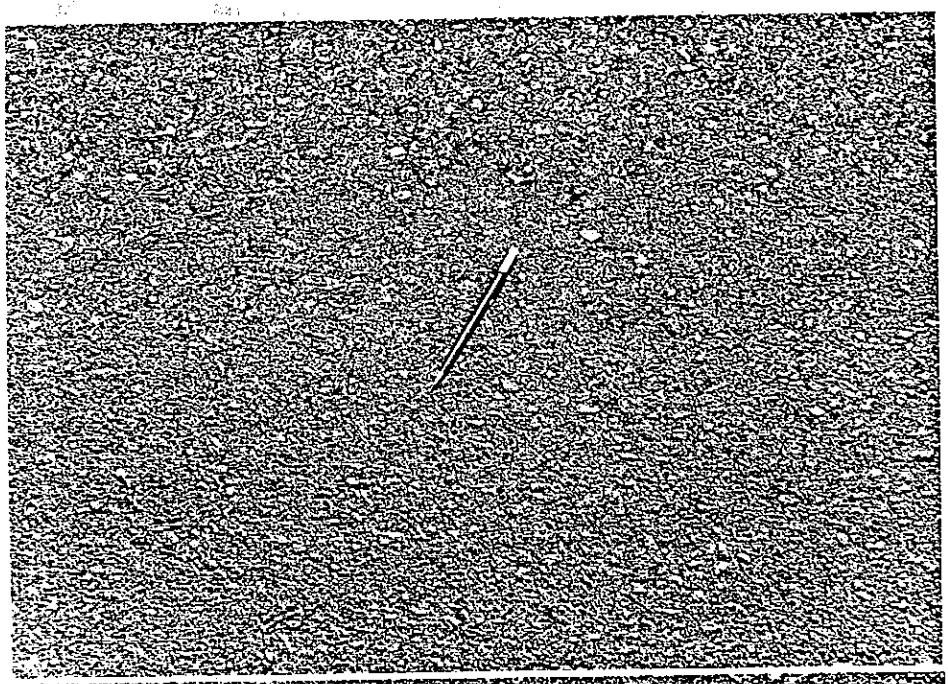
Figure 7

Surface views of SEA 20% pavement.

New Pavement

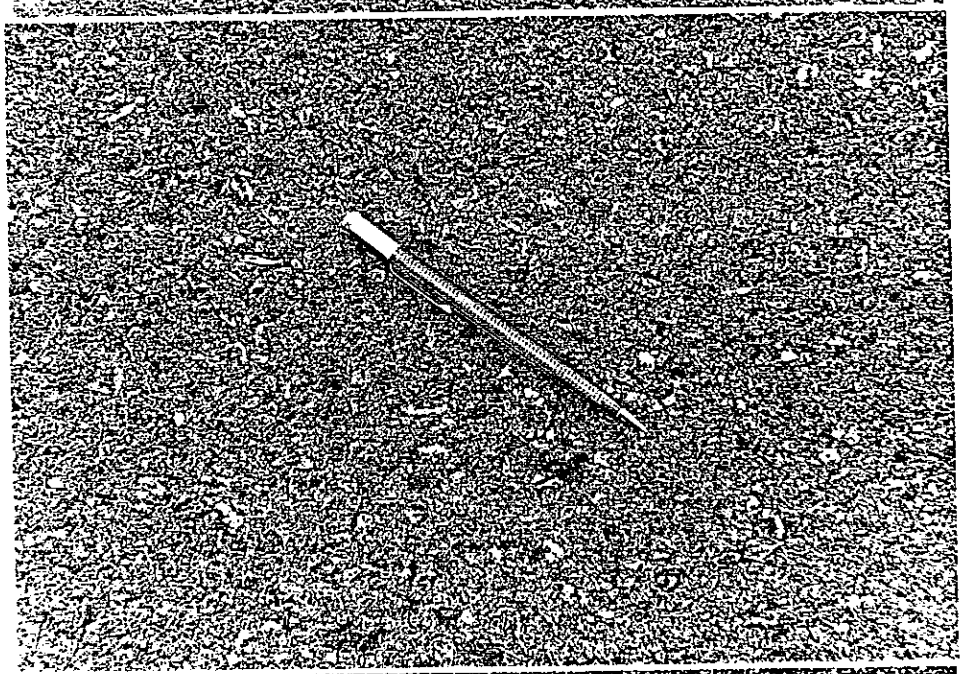
NB Lane after 16 months. (wheel track)

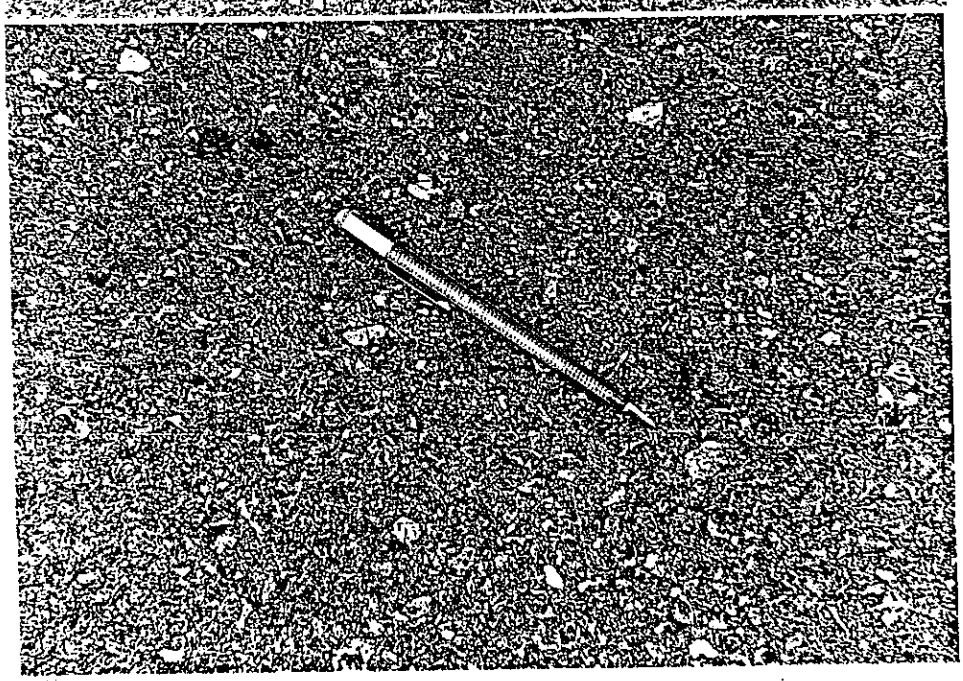
SB Lane after 16 months. (wheel track)

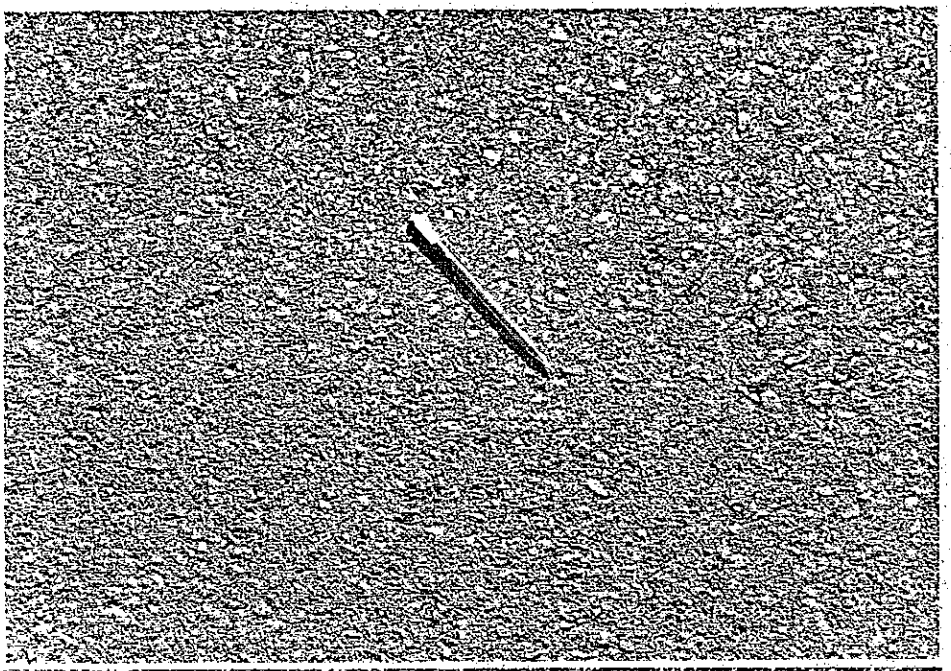
Figure 8

Surface views of SEA 40% pavement.

New Pavement

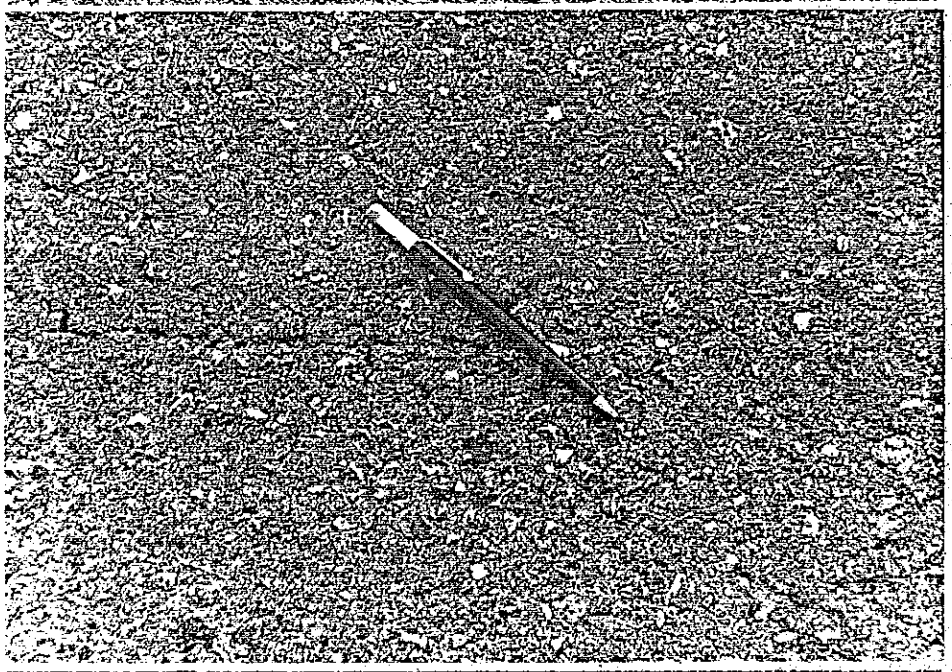
13. Significant reflection cracking of transverse cracks in the SEA 40% northbound lane (42.5%) and southbound lane (12.1%) was revealed by crack and condition surveys conducted prior to and 16 months after test section installation. Only minor cracking is evident in the SEA 20% and control lanes.

NB Lane after 16 months. (Wheel track at location of reflection crack.)

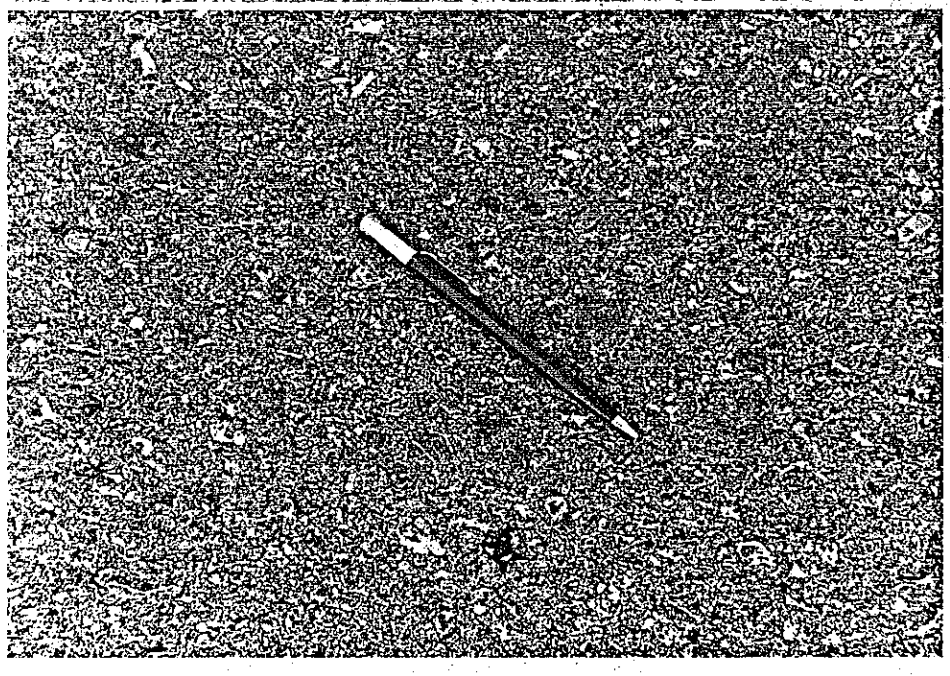
SB Lane after 16 months. (wheel track)

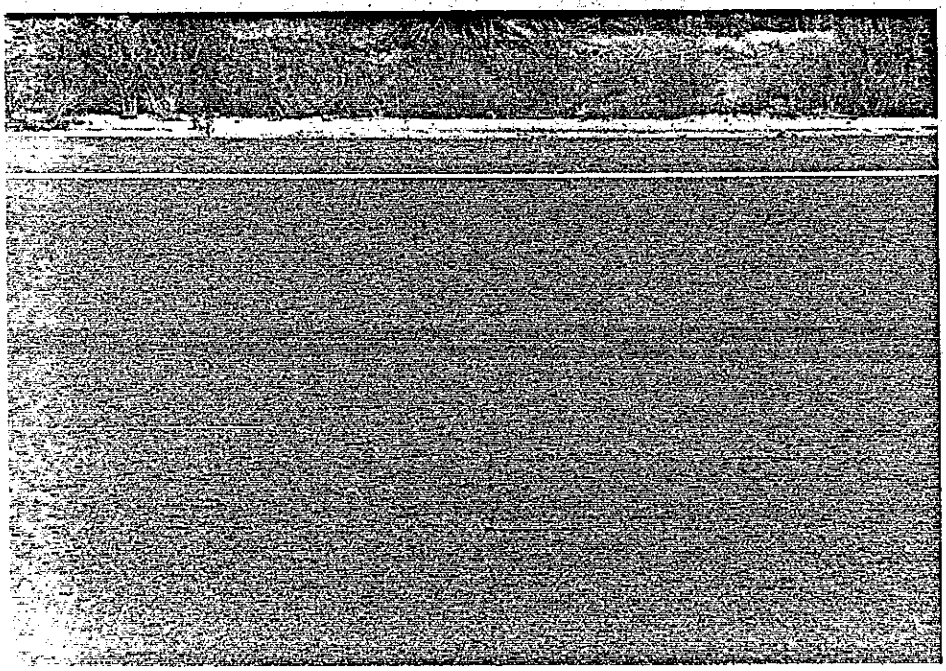
block cracking. The 16-month survey shows significant (42.5%) reflection of transverse cracks in the northbound lane of the SEA 40 percent section (12.1% reflection cracking in southbound lane)(Figure 9); also, one reflection crack near the transition of the SEA 40% to SEA 20% in the SEA 20 section. No reflection cracking is evident in the AR-2000 control section. No other cracking is evident in the SEA sections, but some longitudinal and block cracking is showing in an area of the AR-2000 control. It is felt that the greater prevalence of reflection cracking in the SEA 40% section compared to the SEA 20% section is possibly due to increased rigidity of the SEA 40% section because of the larger amount of free sulfur in the SEA 40% binder. This road receives a significant amount of heavy truck traffic during the winter months.

Prior to sawing or testing, the cores were examined and measured to accurately determine the test layer thickness. The thicknesses are shown in Table 12. The thickness data indicate that both lanes meet the design thickness, but also that the southbound lane is approximately 0.10 foot thicker. Whether this was planned or a paver malfunction is unknown, but it affords an opportunity to study a thicker section. This variation in thickness between the northbound and southbound lanes could explain the difference in reflection cracking cited previously.

Across

Close-Up
Note spalling on edge of crack.

Views of a reflection crack in SEA 40% pavement area.
