## Road Safety Assessment (RSA)

SR 84 – Niles Canyon Corridor  
Alameda Co., California  
May 2012

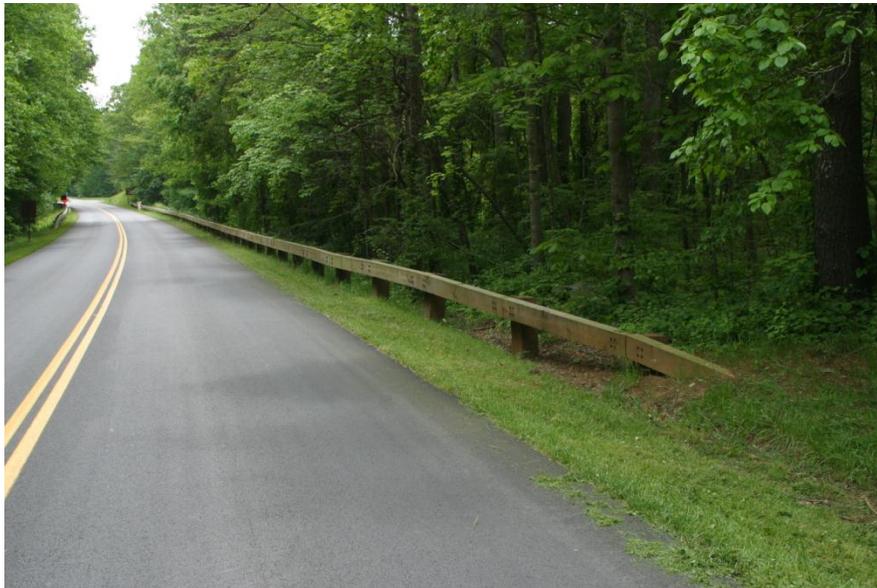
Figure 19: Roadside barrier shielding trees

For example, the row of eucalyptus trees that define “The Spot”, a site with considerable historic and community value, are very close to the edge of the traveled way and show evidence of having been struck..

Here, a properly-documented context-sensitive decision might be to spare these particular specimens by shielding them with a barrier.
