Interstate 405
PM 2.9 to PM 9.0

DOWEL BAR RETROFIT EVALUATION

DISTRICT 12
Orange County
Interstate 405
Contract Number: 12-0A1104

September 2002

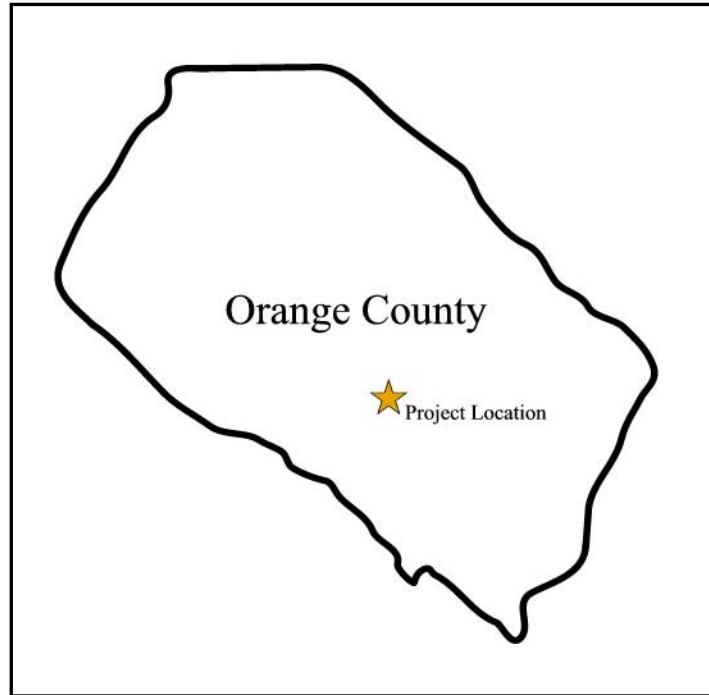
Figure 1. Project Location

A dowel bar retrofit project in District 12 on Interstate 405 (I-405), near Irvine in Orange County, began to exhibit signs of failure in the bond between the existing concrete and the backfill grout in the dowel bar slots. The project is between Sand Canyon Overcrossing and the I-405 / Route 55 separation. Recent counts show that this segment is subjected to an Annual Average Daily Traffic (AADT) from 196,000 to 275,000.

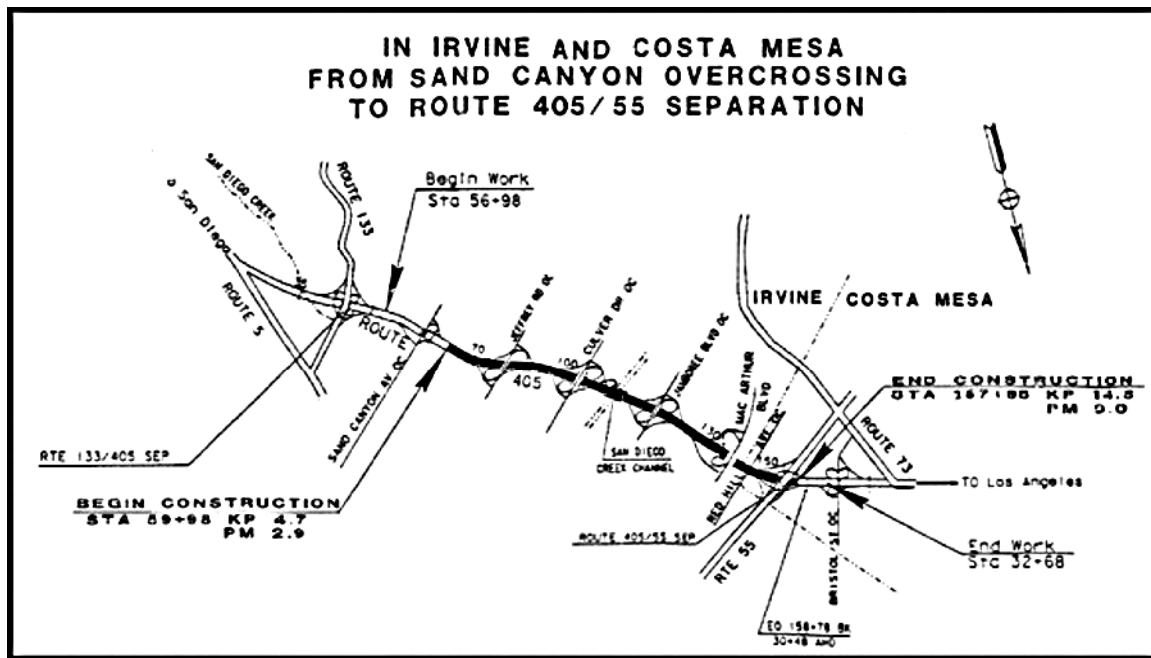
Figure 2. Project Limits

This project rehabilitated a 9.8-km (6-miles) long segment of I-405 by retrofitting the existing panels of lane 4 and grinding sections of the existing pavement in lanes 3 and 4. The project limits extended from 0.1-km north of the Sand Canyon Over-crossing (sta. 59+98) to 0.5-km north of the I-405 / Route 55 separation (sta. 157+98).

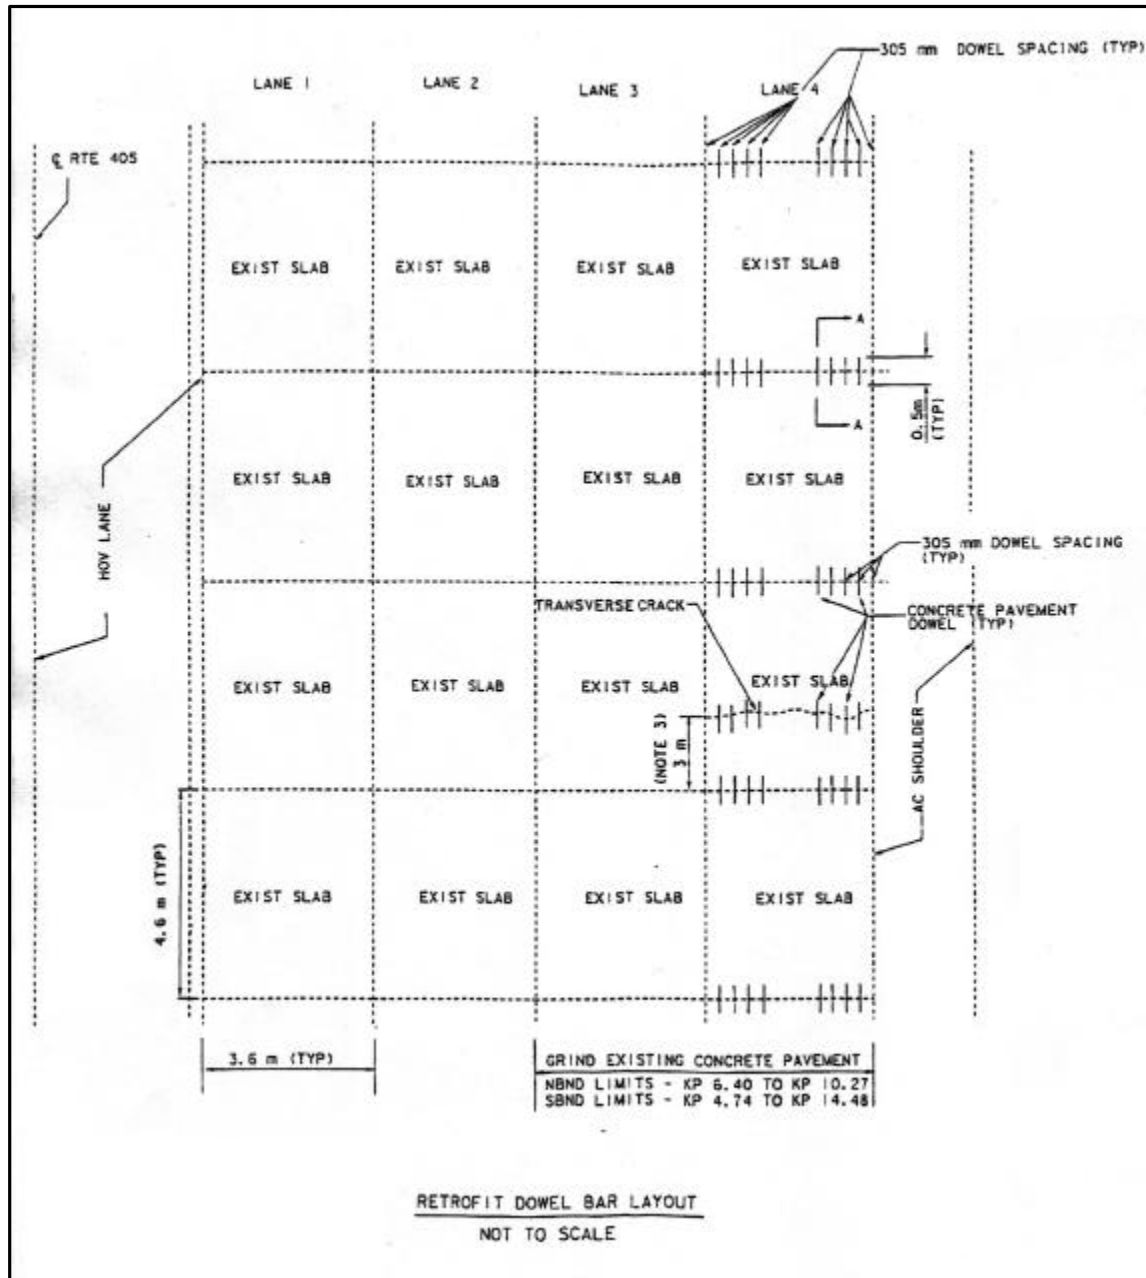
Figure 3. Dowel Bar Retrofit Plan

The rehabilitation project was completed in November 1999. The limits for the dowel bar retrofit and grinding of the existing pavement were from station 76+50 to station 115+10 in the northbound direction and from station 59+98 to station 157+67 in the southbound direction (Figure 3).

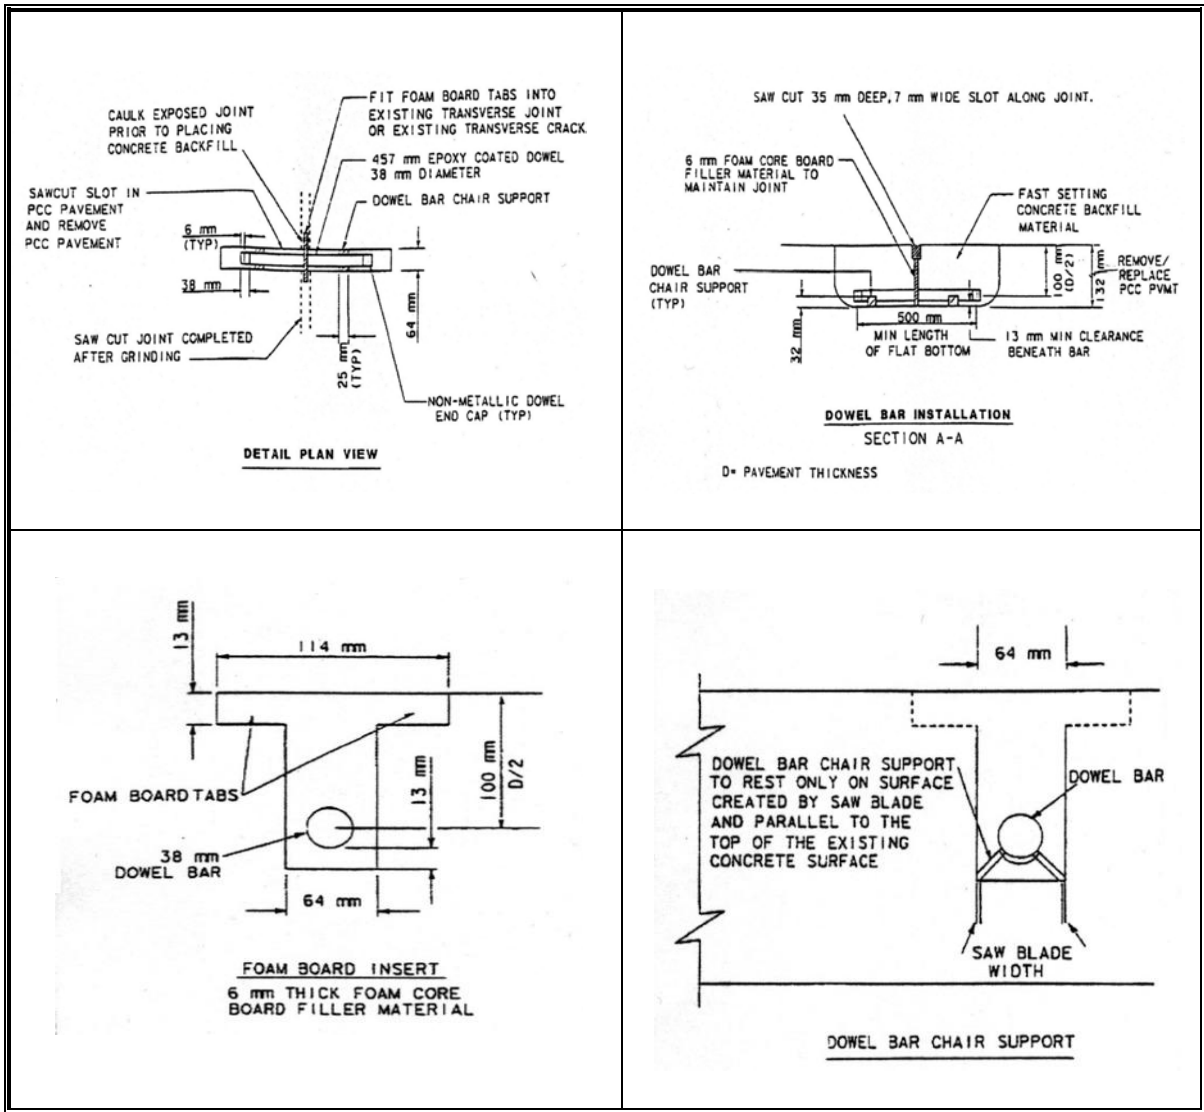
Figure 4. Dowel Bar Retrofit Details

Dowel bars were installed by saw-cutting slots parallel to the direction of traffic in the existing pavement. A dowel bar with a foam board insert and chair supports was placed in each slot. The slots were then back filled with fast setting concrete (Figure 4).

The dowel bars specified were 457-mm (18-in) long, 38-mm (1½-in) diameter epoxy-coated smooth bars evenly spaced at 305-mm (12-in) intervals, in the inner and outer wheel paths of the lane.

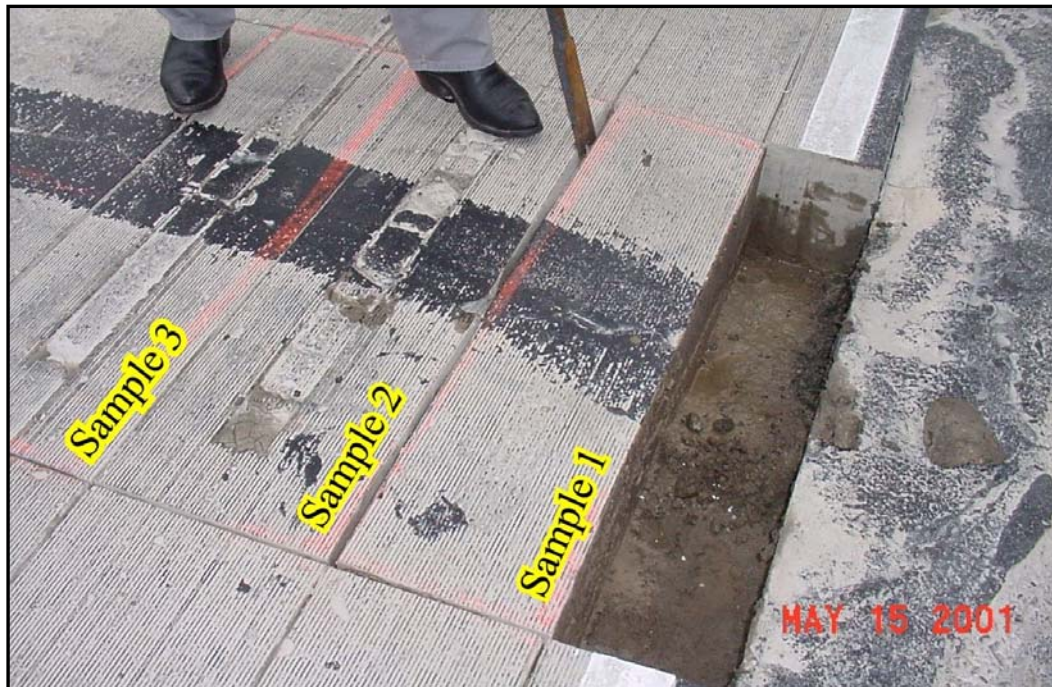
Figure 10. Preparing Samples for Removal

The dowel bar installations, shown in Figures 9 & 10, were removed from a retrofitted transverse crack in the northbound section of the project. Each of the three samples is about 1 m (3.28-ft) long, 0.3 m (1-ft) wide, and the full depth of the pavement.

Sample 1 was intact and had no noticeable damage or deterioration in the retrofit slot. Sample 2 had considerable damage/deterioration in the retrofit slot; multiple transverse cracks were visible in the backfill grout. Portions of the grout had loosened and dislodged from the slot. Sample 3 also had damage/deterioration in the retrofit slot, but not as extensive as that of Sample 2. Transverse cracks were also visible in the backfill grout. The samples were removed as shown in Figure 11 and placed on a pallet.

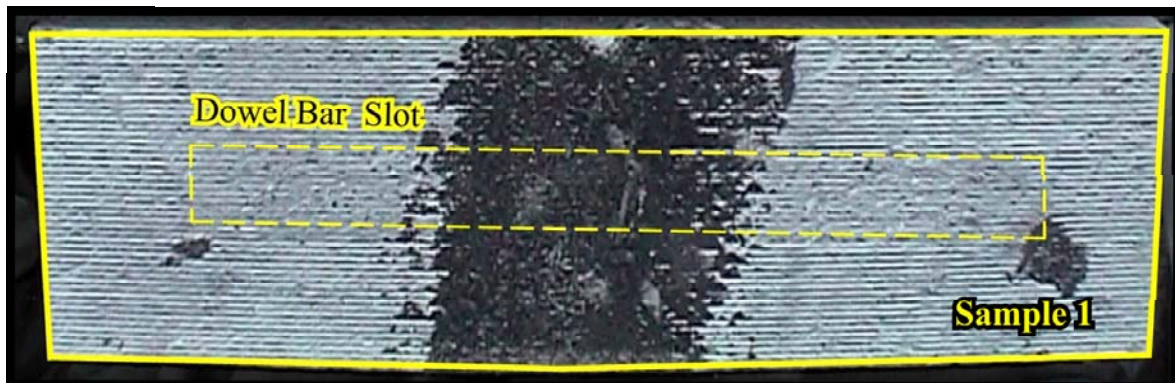
Figure 12. Sample 1 at TransLab

Upon arriving at the TransLab, the samples were examined. For the most part, the samples arrived undisturbed. Sample 1 arrived intact (Figure 12). However, the examination did reveal that the opening in the retrofitted crack had widened in Samples 2 and 3, due to handling during transit.

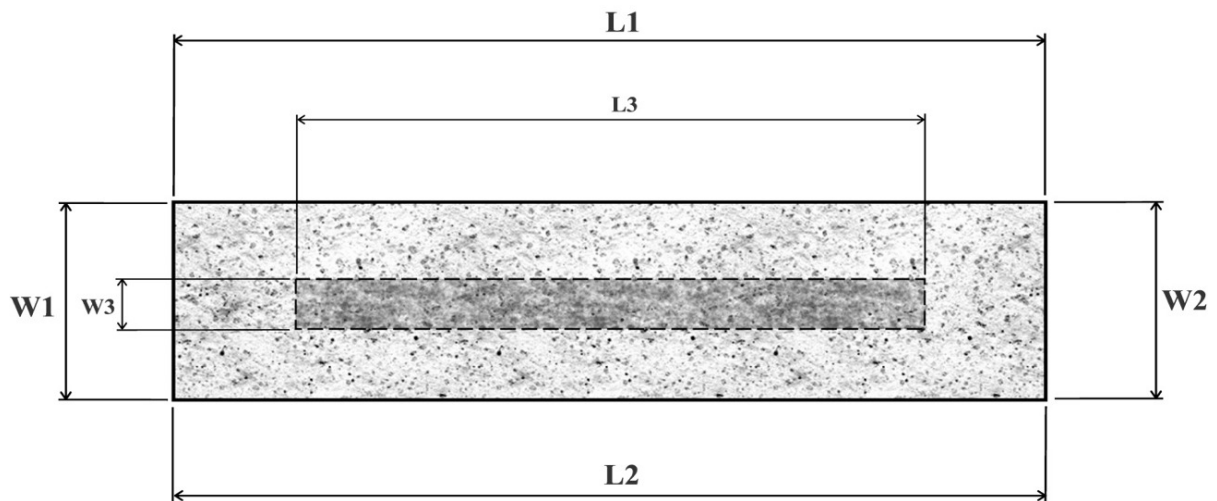
Figure 16. Top View Drawing

Measurements of the length, width, and retrofit slots for each sample were taken. Table 1 and Figure 16 summarize the measurements. All samples are 229-mm (9-in) deep.

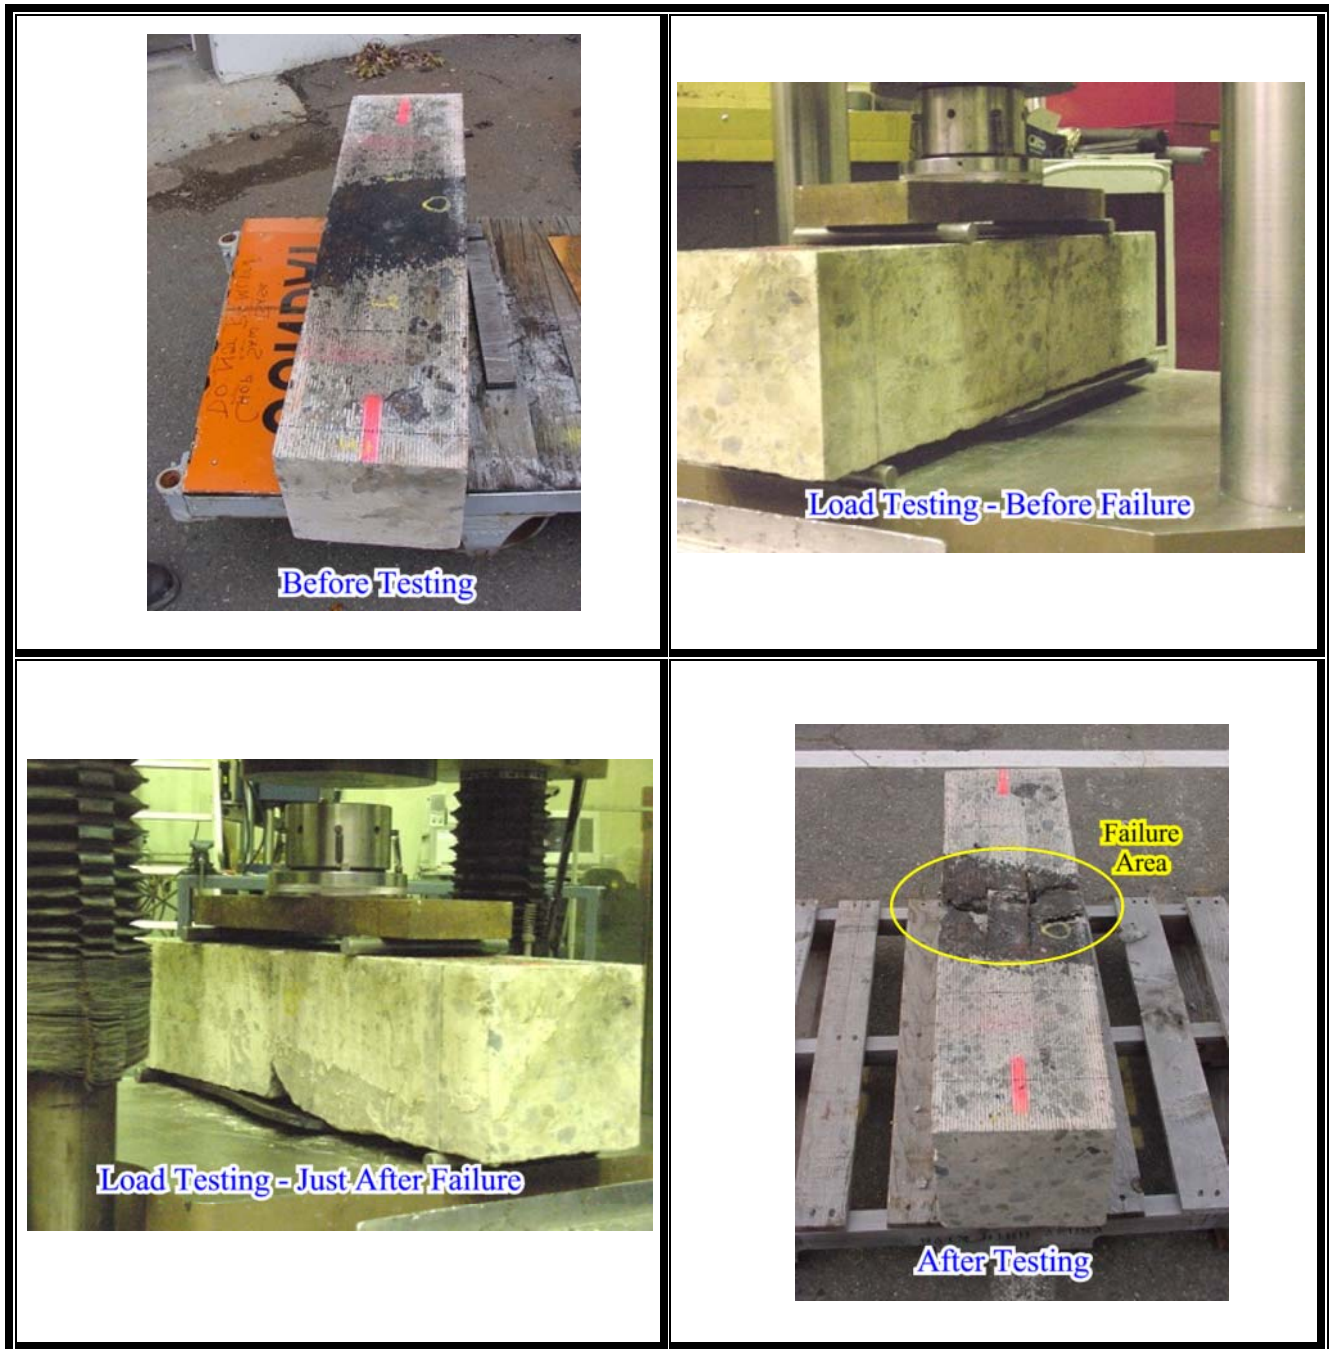
Figure 20. Bond Strength Testing - Sample 1

Because the backfill grout appeared intact, Sample 1 was tested to determine the apparent shear strength of the grout bond in its existing state (Figure 20). Loading conditions were designed for a constant moment along the entire dowel bar length (see Appendix A).

During the test, there were several times where minor drops in loading occurred (Figure 21). These drops most likely correspond to a portion of the grout breaking free and then, through sliding friction, contributing to the additional load on the sample. For this reason, the load value at first drop, $\approx 3,660$ lbf, is considered in the analysis of the apparent shear strength (Appendix A). The shear stress between the grout and concrete was determined to be 99.2 psi (684 kPa).

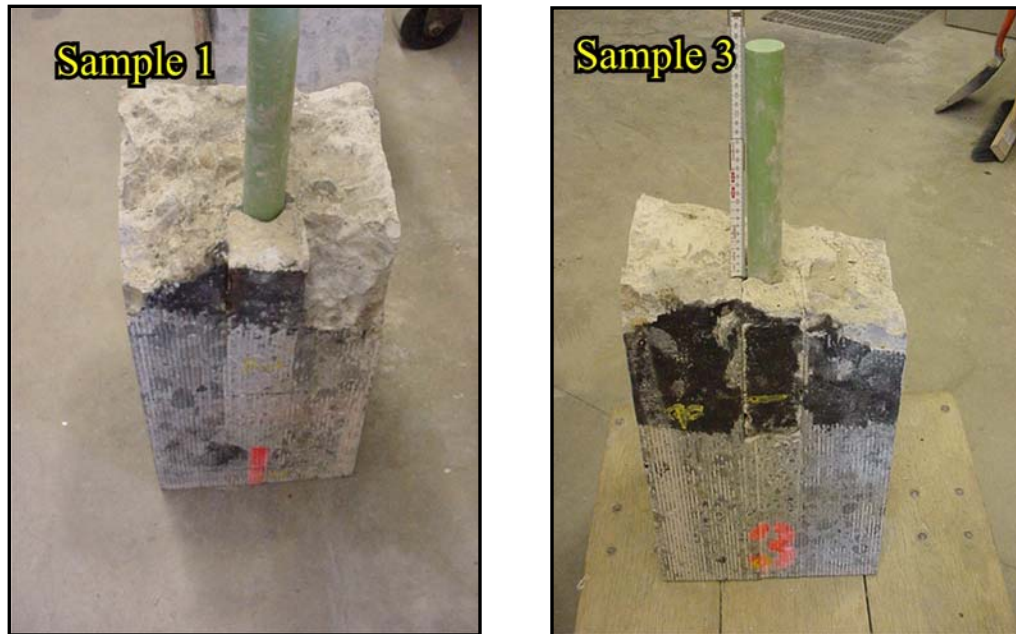
Figure 23. Separated Halves – Samples 1 & 3

The samples were pulled apart at the retrofitted crack to examine the cross-section (Figure 23). The two halves separated easily without disturbing the dowel bar or backfill grout.

Sample 1 was examined after the bond strength test. The centerline of the dowel bar was about 79-mm (3 $\frac{1}{8}$ -in) below the pavement surface; the top was 60-mm (2 $\frac{3}{8}$ -in) below.

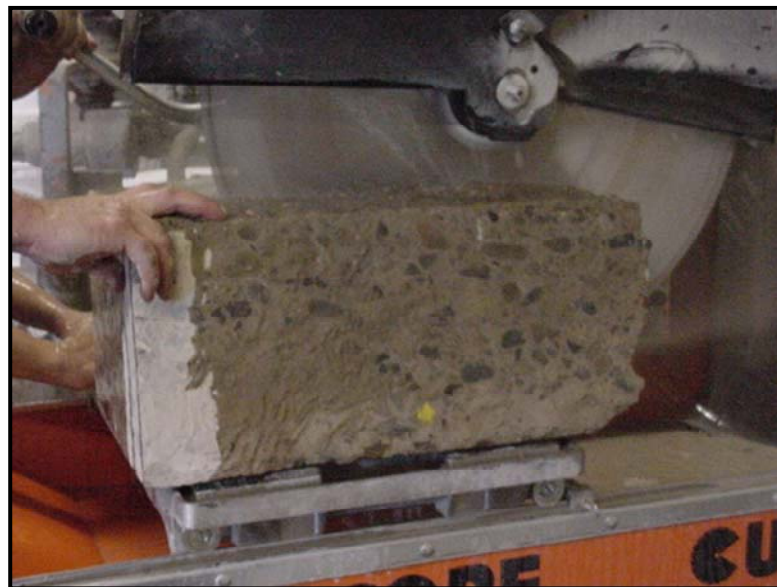
Figure 28. Saw-Cutting the Samples

To further evaluate the dowel bar installations, the samples were saw cut to examine the longitudinal cross-section (or profile) of the retrofit slots.

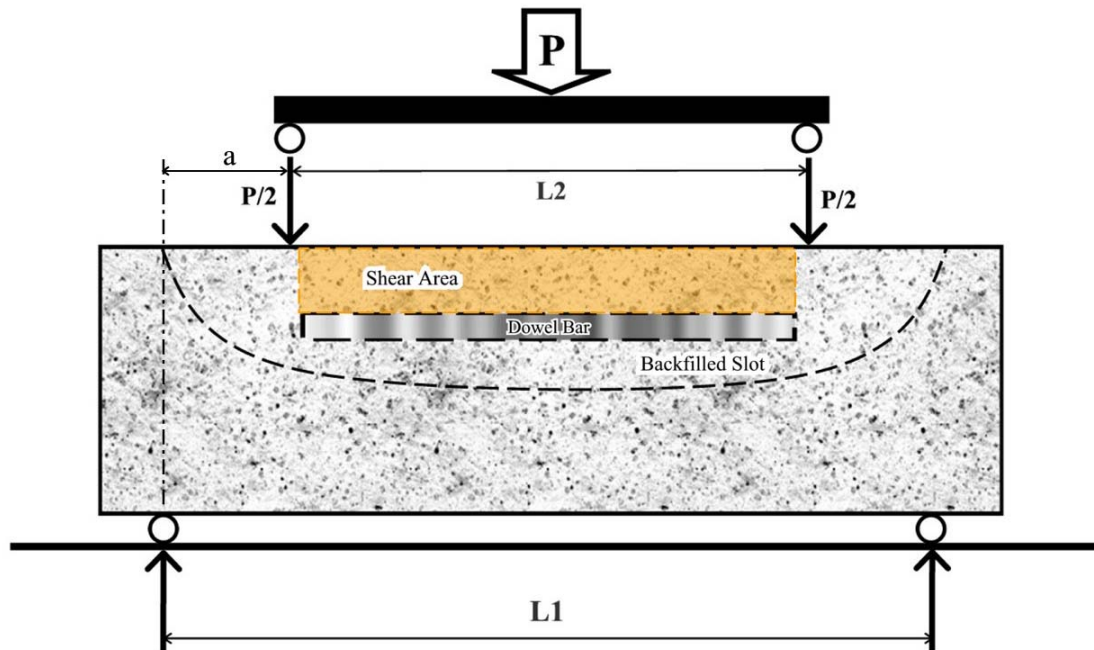
Analysis: Apparent shear strength in the bond between backfill grout and concrete of Sample 1.

Loading conditions were designed for a constant moment along the entire dowel bar length (simple beam with two loads).

Load Drop - Peak: $P_p = 7230 \text{ lb}_f$

$$\tau_{\max} = \frac{V}{A_v} = \frac{508 \text{ lb}_f/\text{in}}{6.60 \text{ in}^2/\text{in}} = \underline{\underline{77.0 \text{ lb}_f/\text{in}^2}}$$

The shear stress is **77.0 psi (531 kPa)**.
