## Lessons Learned from the February 27, 2010 Maule, Chile Earthquake

By Mark Yashinsky, Caltrans Office of Earthquake Engineering

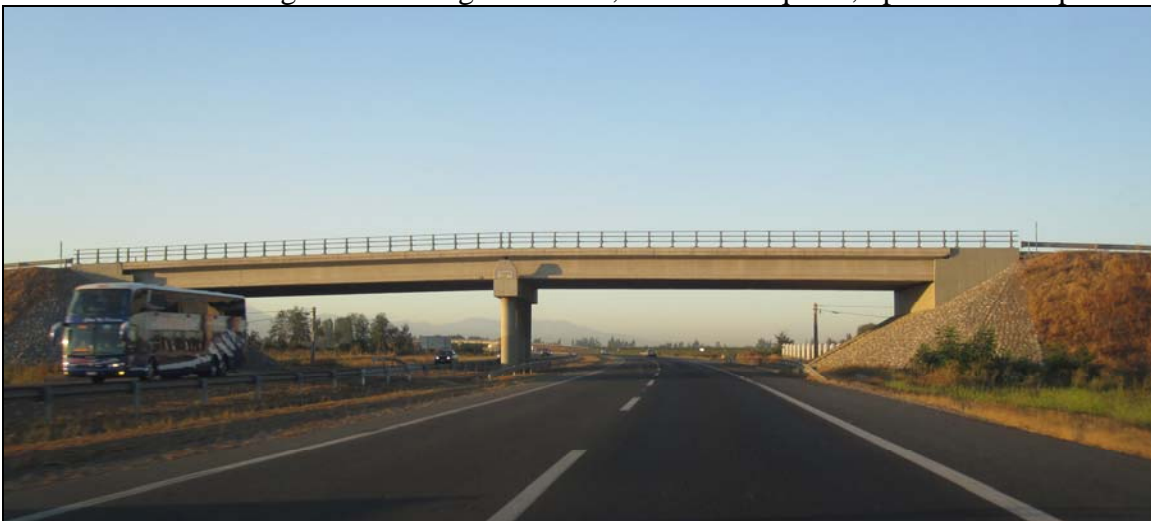
We drove hundreds of km along Route 5 without seeing bridge damage (Figure 7) from this **M8.8** earthquake. In contrast the 2008 Wenchuan Earthquake was **M7.8** and produced very large areas of complete destruction. The 1995 **M6.8** Kobe Earthquake caused damage on almost every bridge in downtown Kobe. However, bridge damage did occur over a much larger area during the Maule, Chile Earthquake, up to 700 km apart.

Figure 7. We drove long distances on Route 5 without seeing any bridge damage.
