October 30, 2007 Alum Rock Earthquake

At 8:05 PM on October 30, 2007 an earthquake struck at lat. 37.432°N and long.121.776°E, about seven miles east of the city of Milpitas. The earthquake had a moment magnitude of 5.6 and it ruptured at a depth of five miles.

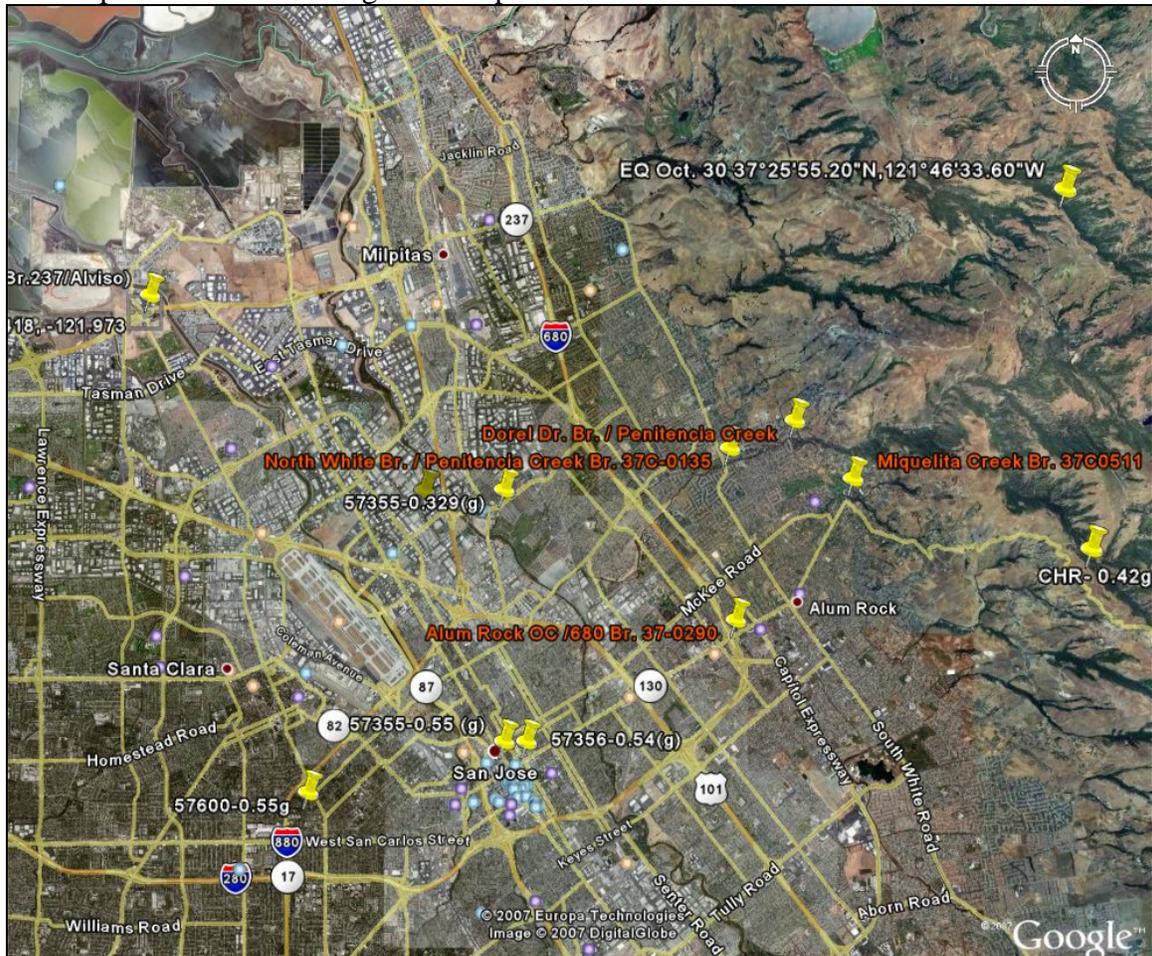
Google Map showing location of earthquake epicenter, stations that recorded high 0.3 sec. spectral accelerations, bridges that were inspected, and Alviso Overhead.

However, the bridges we investigated showed no sign of movement or damage. We are thinking that our investigation should have included bridges in downtown San Jose where the largest spectral accelerations were recorded. This downtown area is on deeper alluvium, which may have amplified the ground motion. Also, the bridges we inspected were two or three spans and less likely to show much damage or movement.
