Damage to Grier St. POC [Br. #53-1158] Post-Earthquake Investigation Team Report

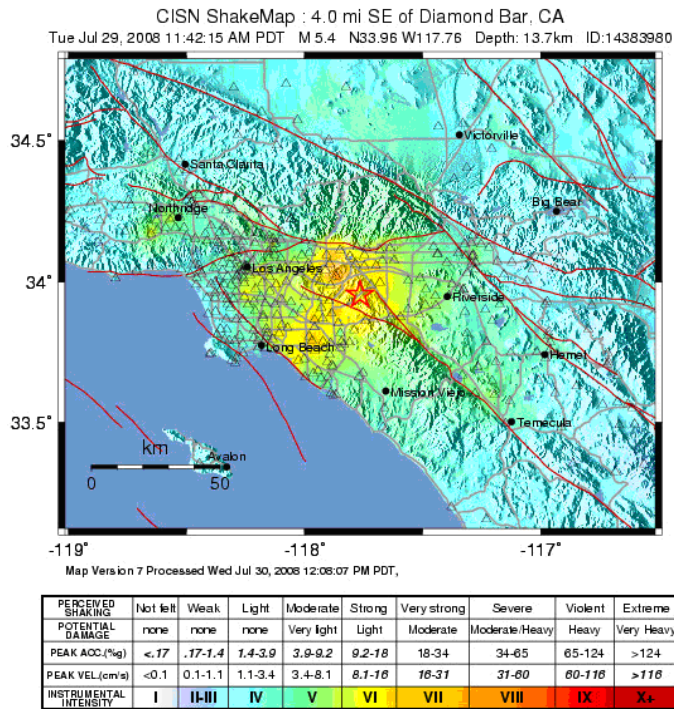
Figure 1 Shake Map.

The event was felt across southern California, with strong shaking reported to the north in the Chino Basin and to the west in the Los Angeles basin (Figure 1) California State University, Fullerton, located about 10 miles west suffered some damage in its older buildings. A minor landslide near Route 91 in the Anaheim Hills 7 miles to the south caused some traffic congestion, but no injuries or structural damage were reported.

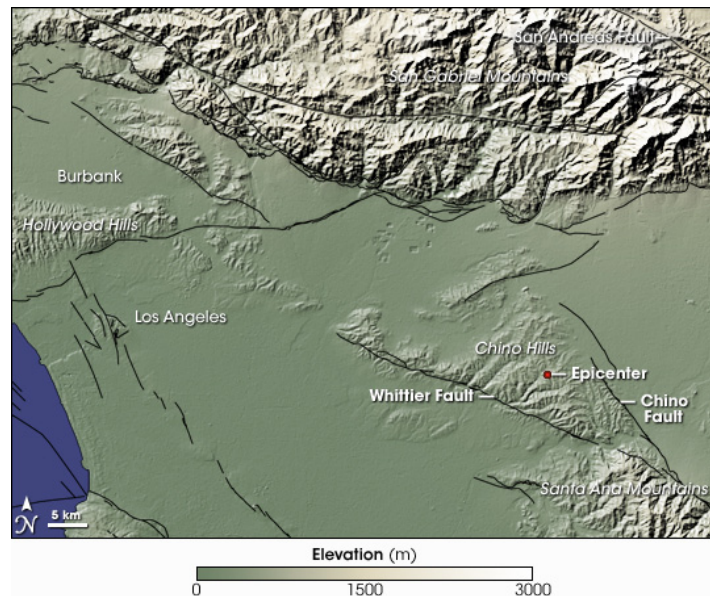
Figure 2 Location of the epicenter of the July 29, 2008 M5.4 Chino Hills earthquake.

Ground shaking predicted by the latest ground motion prediction equations developed for use in the 2008 USGS seismic hazard maps fits well with most observed recordings of this event. The greatest acceleration observed (horizontal PGA) was about 0.44 g recorded near Walnut, about 11 km northwest of the epicenter. Peak velocity measured at the Walnut station was 38 cm/sec and the duration was a few seconds. Recordings in the greater Los Angeles area had peak accelerations from 0.10g to 0.20g and peak velocities were from 5 to 15 cm/sec. There were very few reports of damage. According to Sue Hough of the USGS, the earthquake occurred in a complicated tectonic region — the wedge sandwiched between the Whittier and Chino Hills faults (Figure 2 that probably has a lot of small faults with different orientations. The current theory is that the wedge described above conceals a structure known as the Yorba Linda trend with no surface expression but identified as a linear trend of seismicity by Caltech seismologist Egill Hauksson in 1990. The moment tensor for this earthquake showed a mixture of thrust and left-lateral strike-slip faulting on a plane striking 43 deg east of north, with has a dip of 58 deg southerly. The preliminary locations of the aftershocks suggest that this is the fault plane. Updates to this information may be found at:

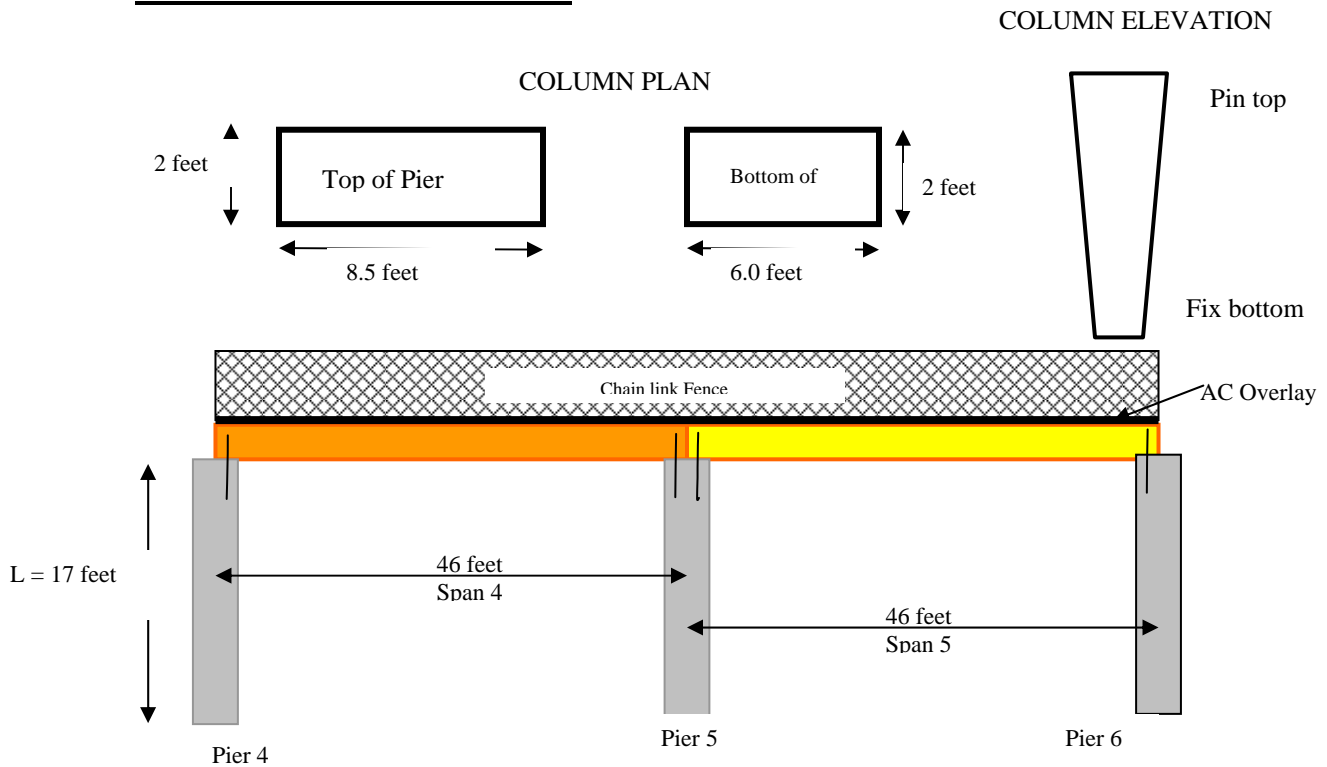
Seismic Demand Force at Pier 5

$$I_{strong} = Bh^3 / 12 = (2 * 8.5^3) / 12 = 102.3 \text{ ft}^4 \quad \text{-----} \rightarrow \text{Top of Pier}$$

$$I_{strong} = Bh^3 / 12 = (2 * 6.0^3) / 12 = 36.0 \text{ ft}^4 \quad \text{-----} \rightarrow \text{Bottom of Pier}$$
