1. REPORT NO. FHWA/CA/TL-80/16		2. GOVERNMENT ACCESSION NO.		3. RECIPIENT'S CATALOG NO.	
4. TITLE AND SUBTITLE THE EFFECTIVENESS OF HORIZONTAL DRAINS				5. REPORT DATE June 1980

THE EFFECTIVENESS OF HORIZONTAL DRAINS

Study Made by ..... Engineering Geology and  
Technical Services Branch  
Under the General Direction of ..... Robert W. Reynolds, CEG  
Under the Supervision of ..... Marvin L. McCauley, CEG  
Principal Investigator ..... Duane D. Smith, CEG  
Report Prepared by ..... Duane D. Smith, CEG

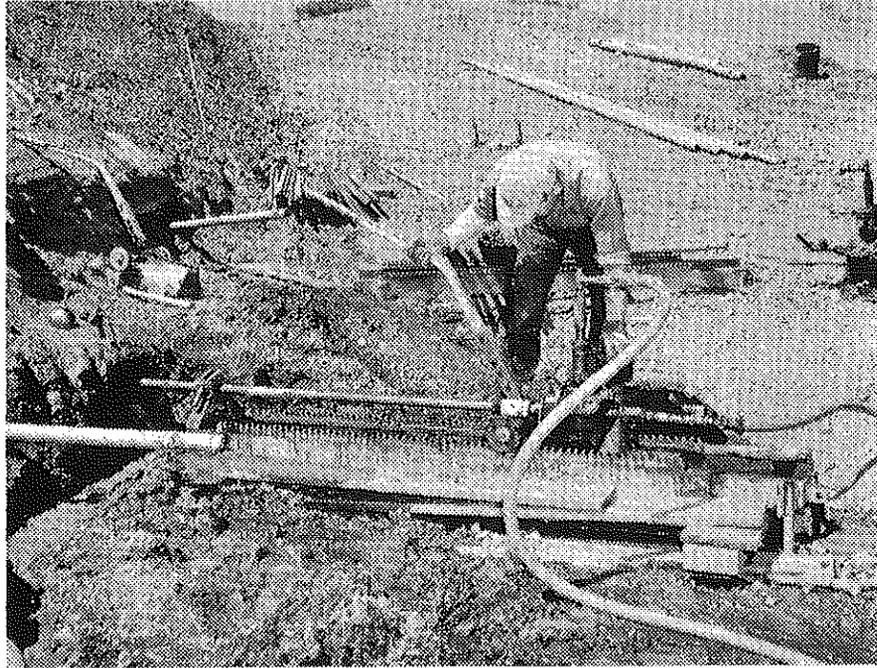
Figure 3. "Hydrauger" first used in 1939 to install horizontal drains by California Division of Highways.

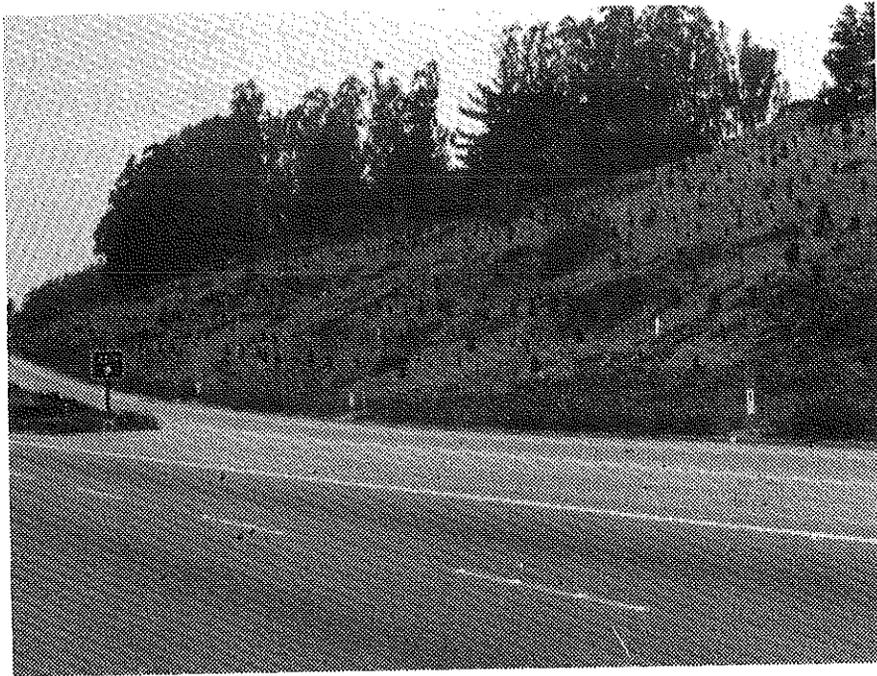
The establishment and maintenance of a central file on all drain installations as well as the placement of paddle markers (Figure 21) or other means of marking each drain in the field such as well marked steel posts or signs, is a good practice.

Figure 21. Paddle markers used to mark drain outlets at La Selva Beach.

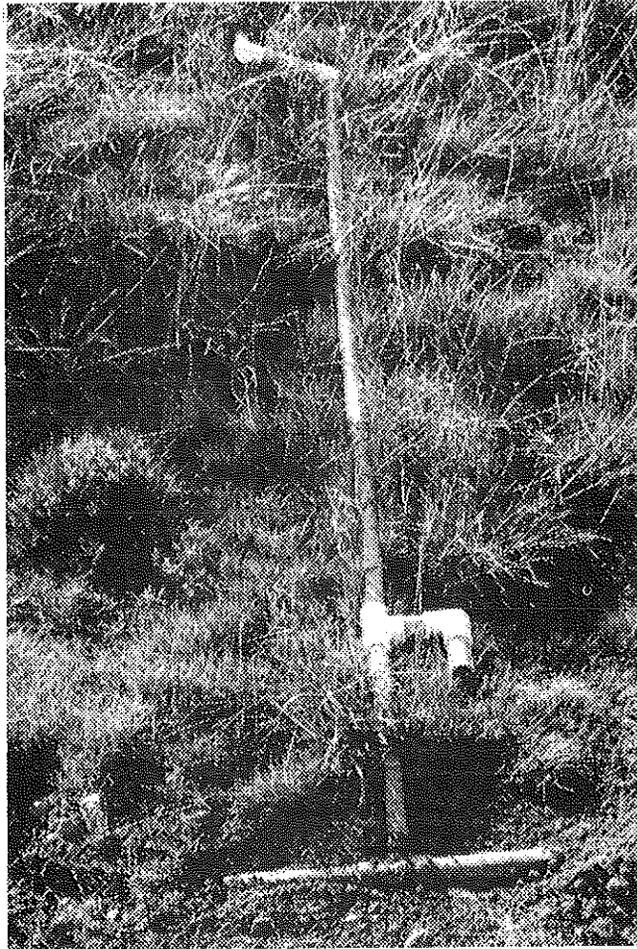
Figure 22. Drain outlet and collector system.

traveled way. A good practice is to protect the PVC casing at the outlet with a galvanized pipe sleeve which slips over the PVC casing and is inserted into the drilled hole approximately 10 feet. The exposed end of the metal pipe is then connected to a cleanout plug with an elbow which allows the surface pipe to lie adjacent to and parallel with the slope (Figure 22). This pipe is then connected to a buried collector system located at the base of the slope. Cleanouts should also be provided for the collector system.

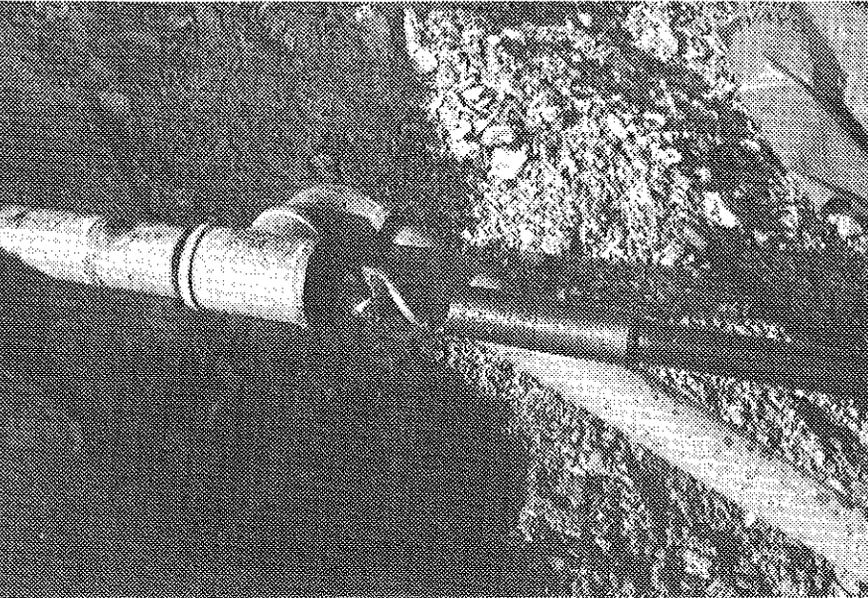
Eventually a cleaning system consisting of an air-driven motor, 5 foot sections of "E" rod, and a fishtail shaped cutting bit was developed (Figures 24 through 27). Power was supplied to the air motor by a small compressor with a capacity of about 125 psi. As the rod and bit were rotated, water was circulated through the rod by means of a small pump, usually the equivalent of a 2-inch trash pump.

Figure 24. Bit and "E" rod formerly used to clean horizontal drains.

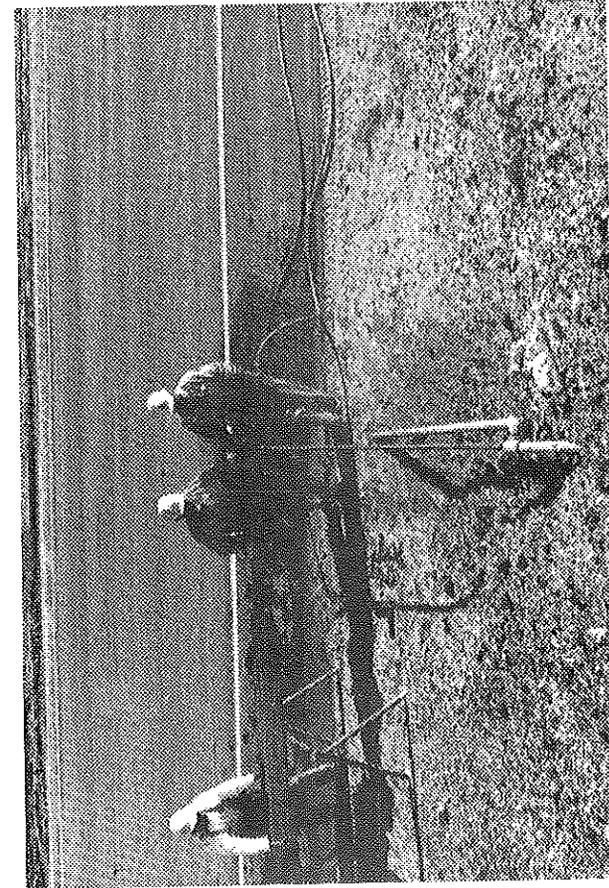
Figure 26. Drain cleaning operation at San Andreas, 1975.

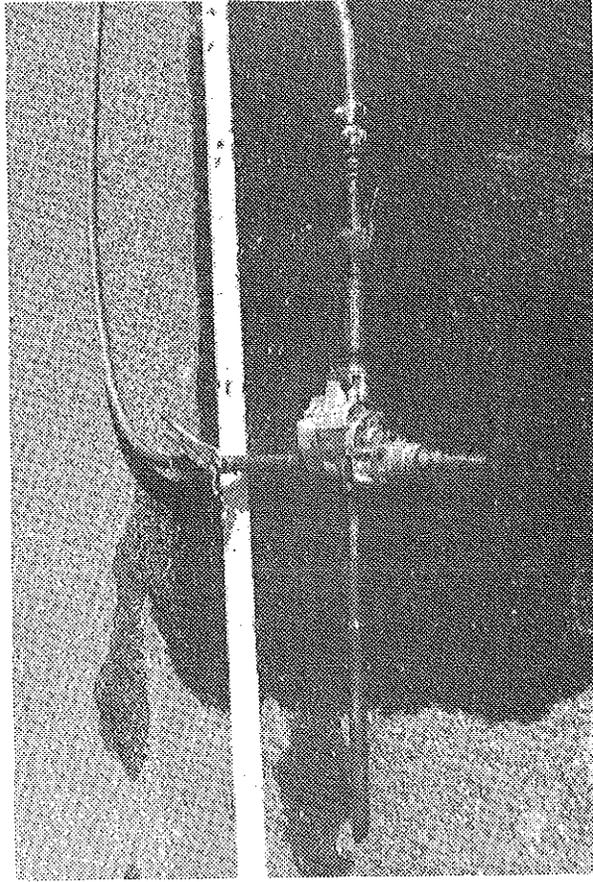
Figure 27. Close-up of air motor.

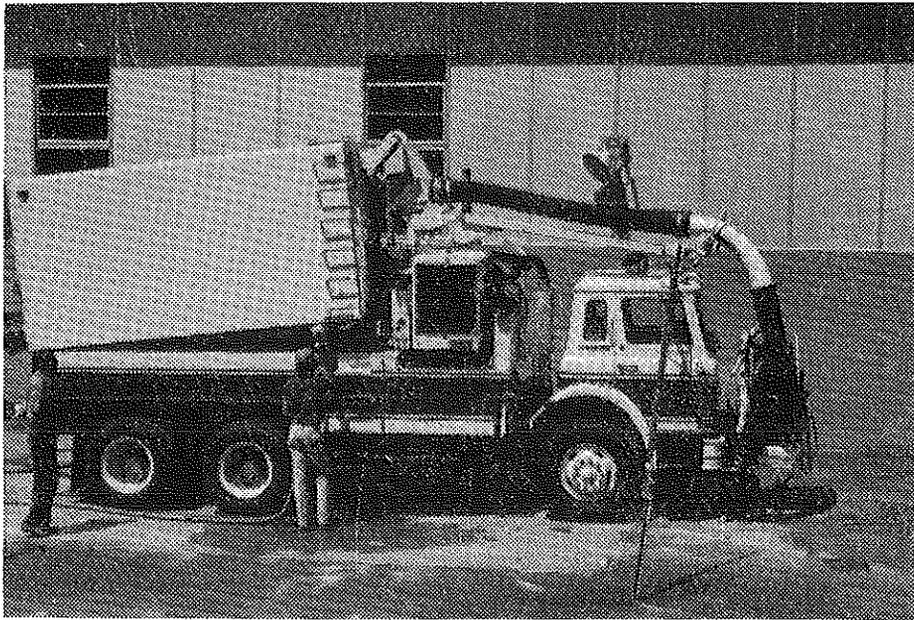
During the summer of 1976, arrangements were made for the demonstration of a high pressure water system at the Whitmore Maintenance Station. The truck-mounted system called the Vactor Jet-Rodder was designed and built by the Myers-Sherman Company of Streator, Illinois. This vacuum and jetting equipment was also designed for sewer and culvert cleaning and had a 1,500 gallon water tank for jetting, a 16 cubic yard tank for refuse collection and a variable pressure pump producing up to 1,650 psi with a patented pulsating or jack hammer action.

The demonstration was impressive. Several drains were cleaned within a two hour period. Because of the high pressure, the hose was self-feeding into the drains. A 300 foot drain could be cleaned with relative ease within about a 20 minute time period.

Figure 28. Vactor Jet-Rodder - truck, tank, pump and reel at Whitmore Maintenance Station.

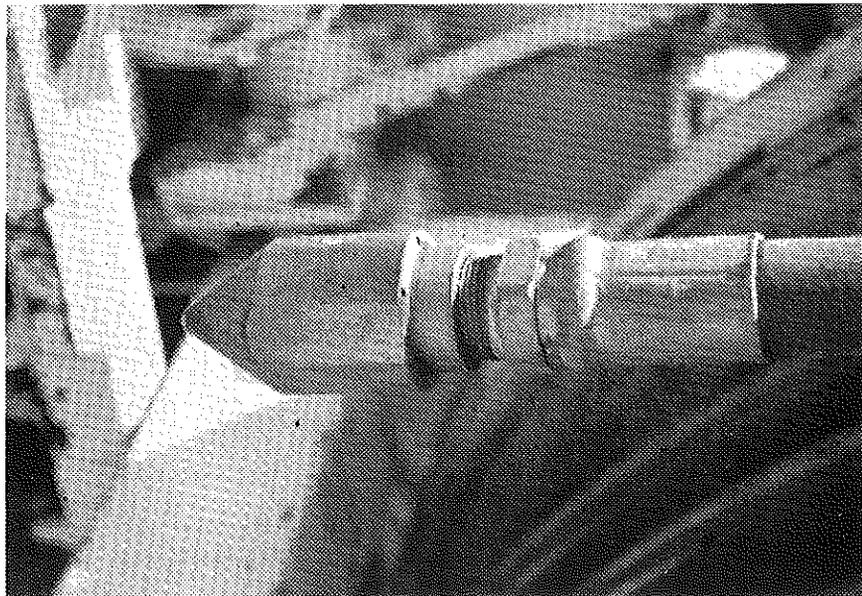
in unplugging culverts. Components included a high pressure pump with a capacity of 600 to 800 psi, a reel-mounted hose, a water tank and a vacuum system for retrieval of the water and debris. Initial modifications for drain cleaning consisted of reducing the hose size to one inch and the use of a smaller nozzle on the end of the hose (Figures 28 and 29).

Figure 29. Close-up of Vactor Jet-Rodder hose and nozzle.

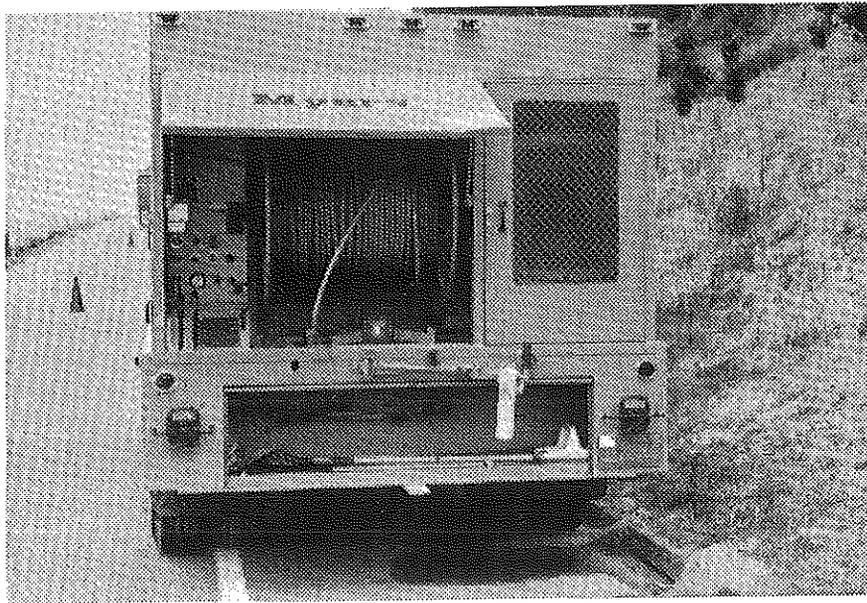
The equipment consisted of a diesel powered Myers pump which can be varied in pressure from 100 to 2,000 psi, 1,000 feet of 1-inch hose mounted on a hydraulically operated reel located on the rear of the truck and a 2,000 gallon water tank (Figure 30). The hose nozzle was constructed with six equally spaced holes drilled on 15 degree angles with the axis of the base (Figure 31) and a single hole at the tip of the head. Water passing through the six holes propelled the hose into the drain and at the same time flushed the sand out of the casing. Water discharged from the center of the nozzle was designed to loosen and erode any blockage in front of the hose.

Figure 30. Myers drain cleaning equipment at La Selva Beach.

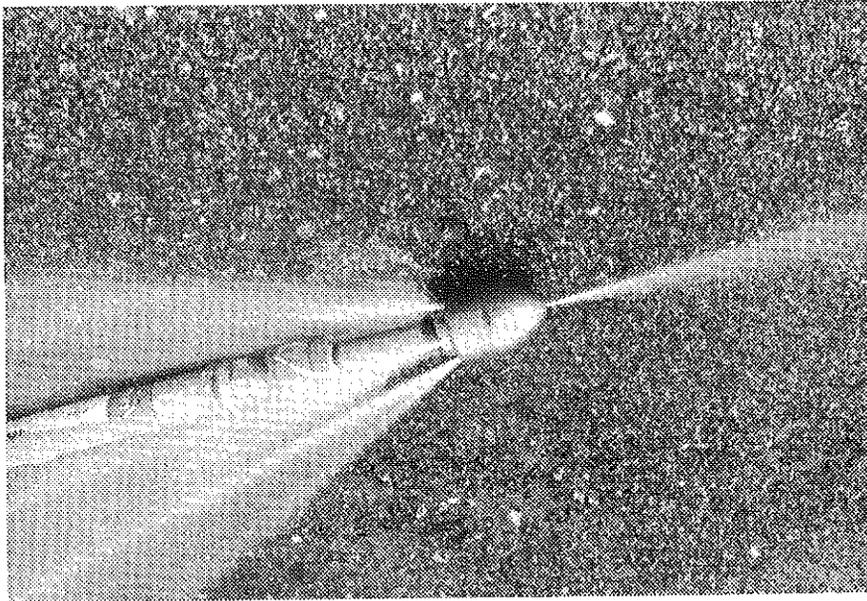
Figure 31. Myers hose and nozzle in operation.

This system appears to be very effective. During the demonstration, the outer galvanized pipe sleeve was removed from the slotted PVC casing of a drain. As the nozzle was passed through this section of pipe, the high pressure water could be observed spraying out of each slot, clearing any obstruction that may have been there.
