# **INFORMATION HANDOUT**

**For Contract No. 06-0Q2404**

# MATERIALS INFORMATION HANDOUT

Cold In-Place Recycling  
Hot Mix Asphalt

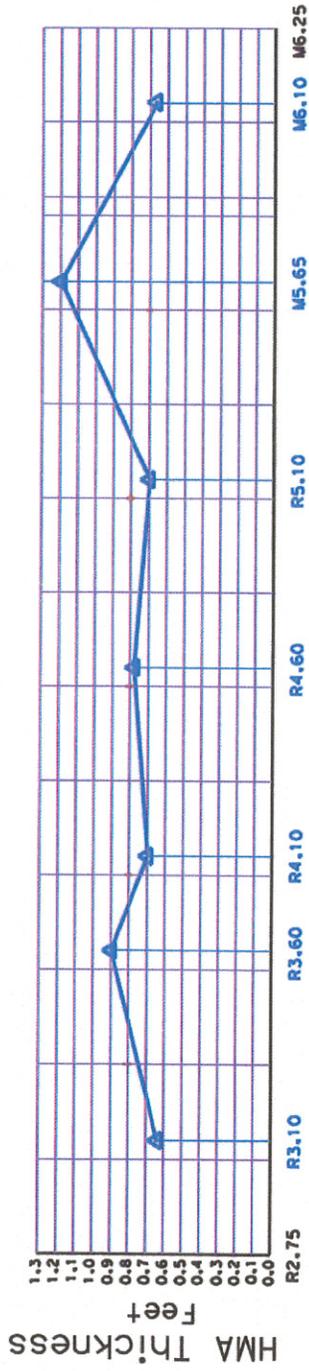
Fre-41PM R3.0/M6.1 Northbound Cores

The existing HMA appears to have some rutting, pumping failures, transverse and longitudinal cracking. There are some occasional dig outs in the wheel path, and isolated alligator cracking within the project limits.

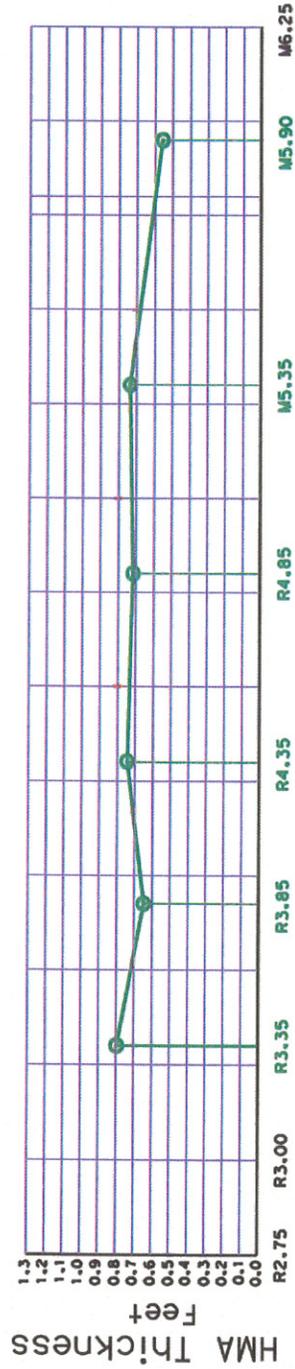
Fre-41PM R3.0/M6.1 Southbound Cores

4	Fre-41 SOUTHBOUND LANE 1 - PM M 5.35	Chip Seal	0.74'-DGAC		0.66'-CTB	Aggregate Base	1.40'	The Core was taken at PM M5.35 Southbound. The total core was 1.40' in thickness. The top layer was chip seal and 0.74' of the core was DGAC, remaining 0.66' was CTB. Core was Delaminated @ 0.74' and 1.04' from the top. The base materials was Aggregate Base.
5	Fre-41 NORTHBOUND LANE - PM R 5.10	Chip Seal	0.70'-DGAC			Aggregate Base	0.70'	The Core was taken at PM R 5.10 northbound. The total core was 0.70' in thickness. The top layer was chip seal and the rest of the core was DGAC, core was Intact. The base materials was Aggregate Base.
6	Fre-41 SOUTHBOUND LANE 1 - PM R 4.85	Chip Seal	0.72'-DGAC			Aggregate Base	0.72'	The Core was taken at PM R4.85 Southbound. The total core was 0.72' in thickness. The top layer was chip seal the rest was DGAC, and intact. The base materials was Aggregate Base.
7	Fre-41 NORTHBOUND LANE - PM R4.60	Chip Seal	0.78'-DGAC			Aggregate Base	0.78'	The Core was taken at PM R4.60 Northbound. The total core was 0.78' in thickness. The top layer was chip seal and the rest of the core was DGAC, core was Intact. The base materials was Aggregate Base.

8	Fre-41 SOUTHBOUND LANE 1 - PM R4.35	Chip Seal	0.75'-DGAC		0.25'-CTB	Aggregate Base	1.0'	The Core was taken at PM R 4.35 Southbound. The total core was 1.0' in thickness. The top layer was chip seal and 0.75' of the core was DGAC, remaining 0.25' was CTB. Core was Delaminated @ 0.75' from the top. The base materials was Aggregate Base.
9	Fre-41 NORTHBOUND LANE - PM R 4.10	Chip Seal	0.70'-DGAC		0.25'-CTB	Aggregate Base	0.95'	The Core was taken at PM R 4.10 Northbound. The total core was 0.95' in thickness. The top layer was chip seal and 0.70' of the core was DGAC, remaining 0.25' was CTB. Core was Delaminated @ 0.75' from the top. The base materials was Aggregate Base.
10	Fre-41 SOUTHBOUND LANE 1 - PM R 3.85	Chip Seal	0.65'-DGAC		0.30'-CTB	Aggregate Base	0.95'	The Core was taken at PM R 4.10 Northbound. The total core was 0.95' in thickness. The top layer was chip seal and 0.65' of the core was DGAC, remaining 0.30' was CTB. Core was Delaminated @ 0.38' from the top. The base materials was Aggregate Base.
