SAN FRANCISCO-OAKLAND BAY BRIDGE
EAST SPAN SEISMIC SAFETY PROJECT

PILE INSTALLATION DEMONSTRATION PROJECT
(PIDP) CONSTRUCTION REPORT

CONTRACT 04-012084
04-A1a-80-0.0/0.5

APRIL 2001

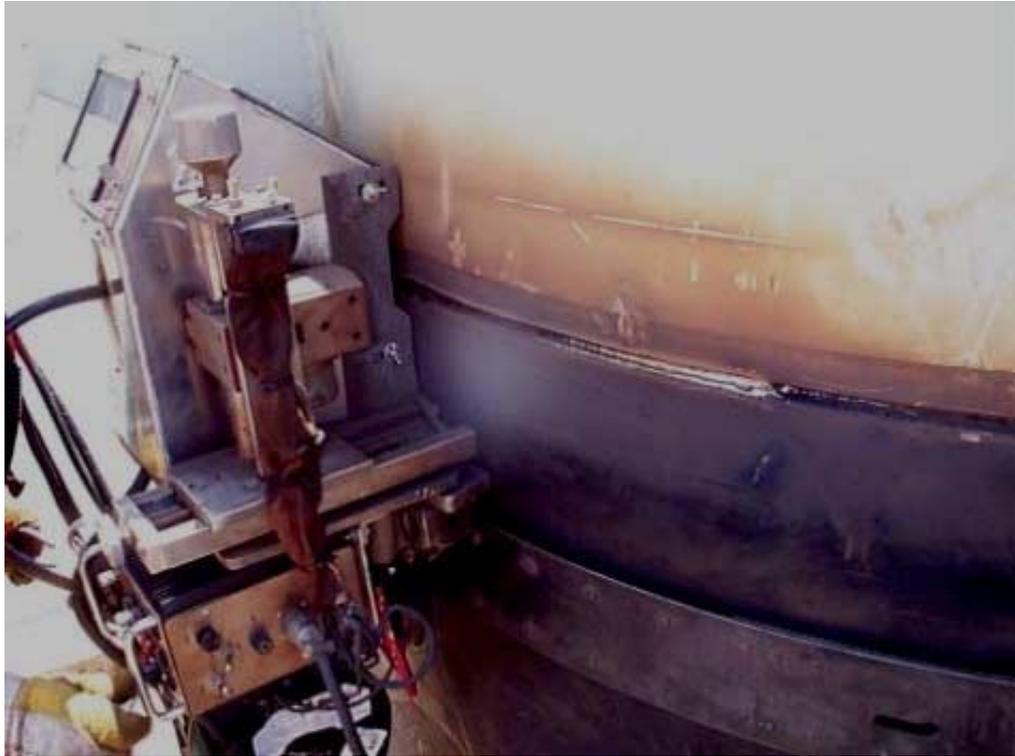
Figure 10 - Proprietary FCAW system

The Contractor hired a Welding Consultant to provide the welding system, prepare the Welding Quality Control Plan, and train welders to use the consultant's welding system. The welding consultant's system was a CO₂ shielded FCAW_G system of his own design (Fig. 10 and 11). The welding consultant began demonstrating this proprietary welding system and training the Contractor's welders on smaller piles at the Redwood City Lonestar Cement terminal about the first of August. The welds on these piles were found to be flawed and subsequently repaired. The Contractor's welders continued to train on the machines in Manson's Richmond yard until the middle of September, when the welding consultant performed the first PQR for this contract.

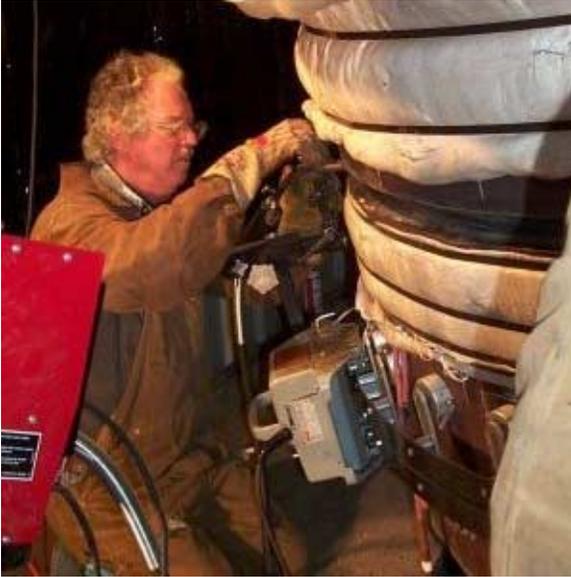
Figure 14 - Preparing to weld the Mock-up

The Contractor brought in their own welding engineer and four new semi-automatic Lincoln FCAW_G welding machines. The guns were fixed on a tracked buggy assembly (Fig. 14 and 15). The Contractor proceeded to run a Maximum-Minimum Heat Input PQR in accordance with AWS D1.5 section 5.12.2. Because the joint detail which the Contractor chose had standard features, they were able to perform these PQRs on flat 1-inch thick plate instead of the full sized pipe. By running a Maximum-Minimum Heat Input PQR, the Contractor was able to use a wider range in their essential variables for the final WPS than was permitted with the previously attempted PQRs. The Contractor used a T-9 wire for this attempt and the production welds. The final WPS, written based on this third PQR, was approved within two weeks of the start of welding.
