DESIGN INFORMATION BULLETIN NO. 83 - 03
CALTRANS SUPPLEMENT TO FHWA CULVERT REPAIR
PRACTICES MANUAL

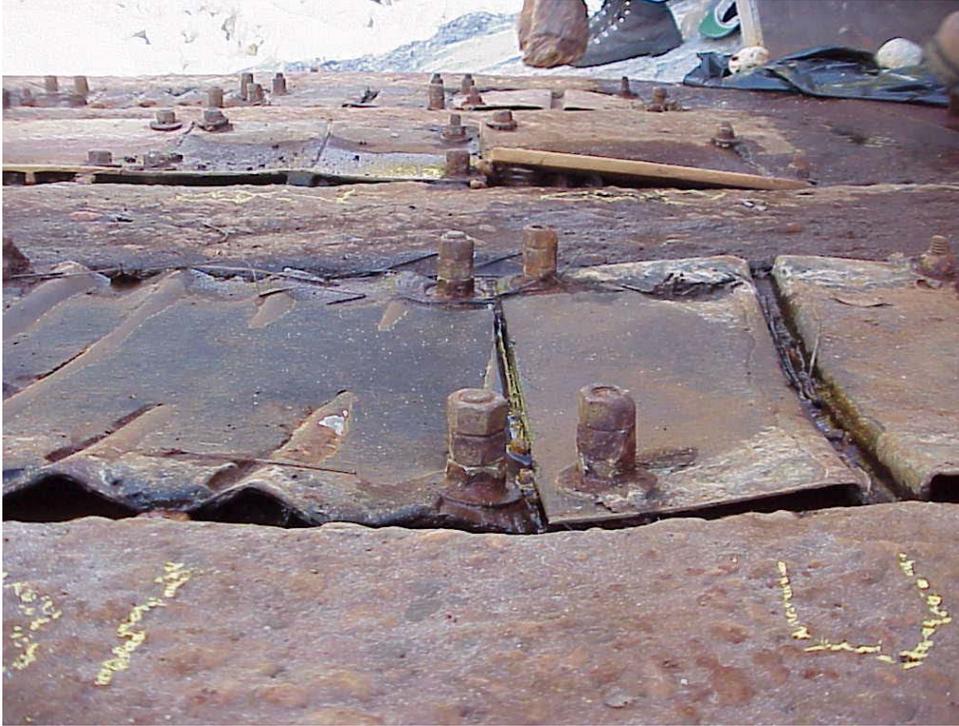
Various Culvert Material Test Panels Shown Above After 1 Year Of Wear At Site With Moderate To Severe Abrasion (Velocities Generally Exceed 10 ft/s, See Table Next Page). Note: the significant wear to abrasive resistant protective coatings, which, would typically not be recommended under these conditions (see table next page). The bed load material composed of 90% quartz sand. Also note the wear on the leading edges (right) of the steel nuts.

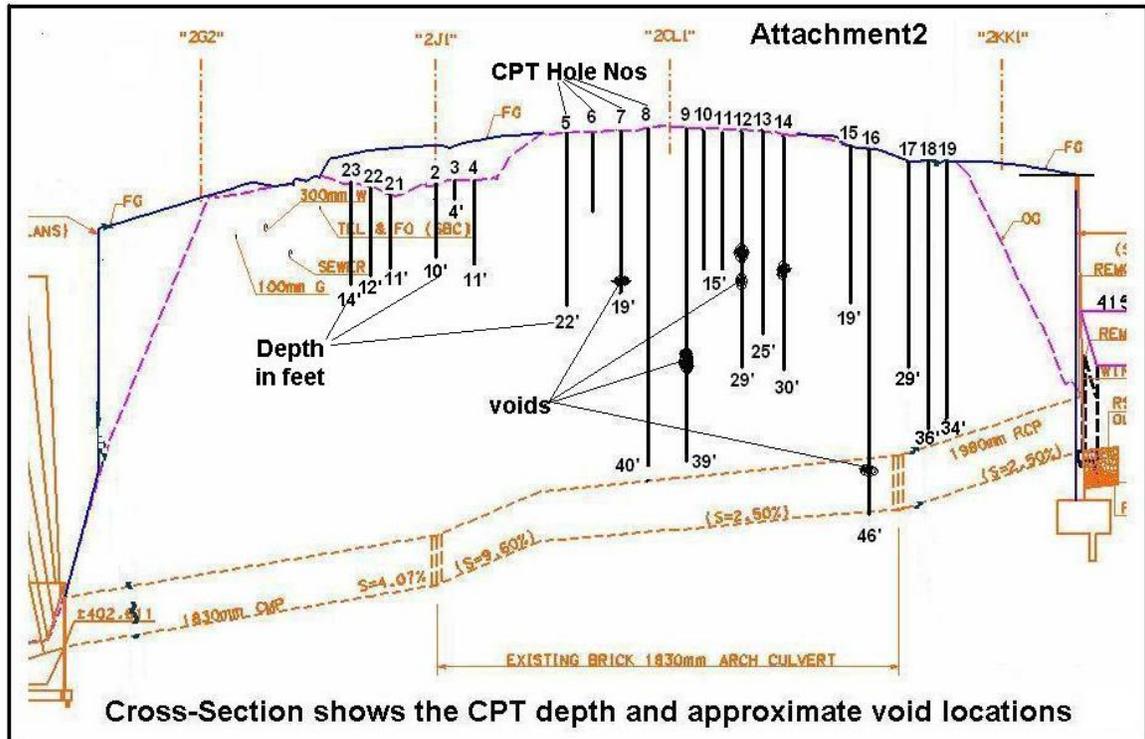
When the water table is higher than the culvert invert, water may seep into the culvert between storms. Infiltration can occur during flood events by suction from pressure differentials in inlet control culverts. If voids in the backfill are discovered during the field review, the most likely cause of soil loss is the migration of soil fines from infiltration - either through a worn invert or leaking joints. It is important to investigate the full extent of the voids. In human entry culverts this may simply involve performing hammer soundings (if metal pipe) along with a thorough evaluation of the roadway and the embankment for cracks, depressions, sinkholes, scour or piping. In non-human entry culverts that are inspected by camera, if symptoms such as a worn invert or open joints are present, the same thorough evaluation of the roadway and the embankment must be performed. However, if the full extent of the voids or their cause (e.g. groundwater) is still unknown, further investigations by Geotechnical Services may be needed. See below.

Void Detection in the Roadway Prism by Geotechnical Services with Cone Penetrometer

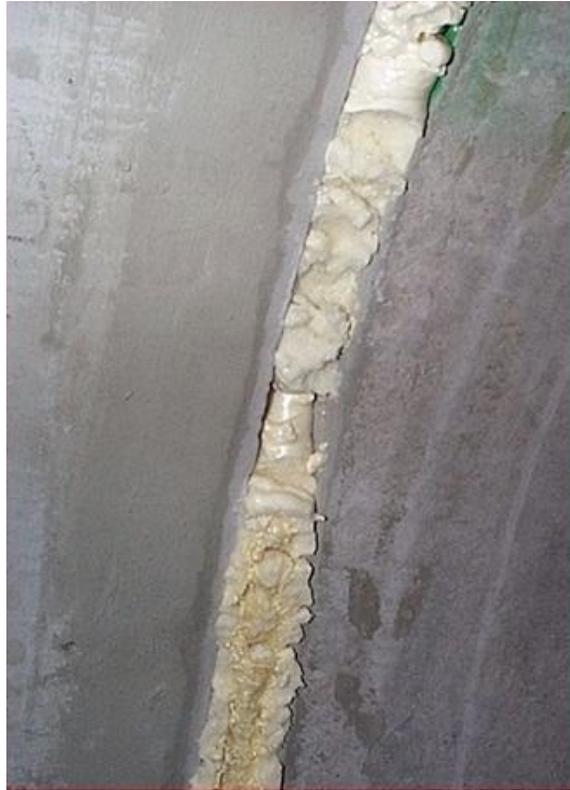
Internal Chemical Grouted Joint (RCP)

Chemical grouting is a commonly used method for sealing leaking joints in structurally sound, sewer pipes that are under the groundwater table. It will not provide structural repair, and it is inappropriate for longitudinal or circumferential cracks, broken or crushed pipes. However, other methods such as using repair sleeves in combination with chemical grouting are appropriate for such repairs (see discussion towards end of this section). Attempting to seal joints that are not leaking or infiltrating during the sealing process has produced questionable results. Some types of chemical grouts have failed in arid regions where the grout has dried up during periods of low groundwater and in coastal regions where the ground is subject to tidal fluctuations. The long-term service life for chemical grouting is unknown. One study concluded the life expectancy for chemically grouted joints was no more than 15 years, other references indicate a 20 year service life, and it is known to last even longer in other applications such as sealing tunnels and dams.

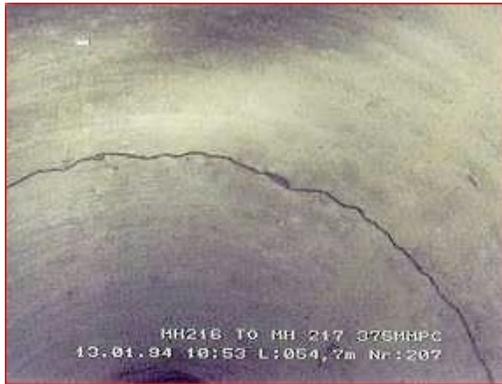
Circumferential Cracking

For all culverts cracks less than 0.01 inch in width are minor and only need to be noted. Cracks greater than 0.01 inch in width but less than 0.1 inch should be noted as possible candidates for routing a 0.25 inch wide minimum by 0.5 inch deep maximum V-Grind, then patching or sealing (see Appendix D). Cracks greater than 0.1 inch in width may indicate a serious condition and the Underground Structures Unit within the Division of Engineering Services should be contacted.

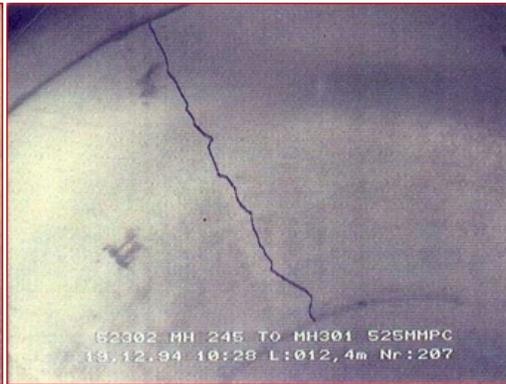
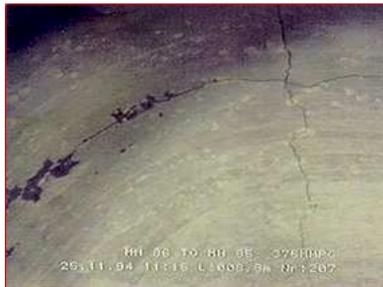
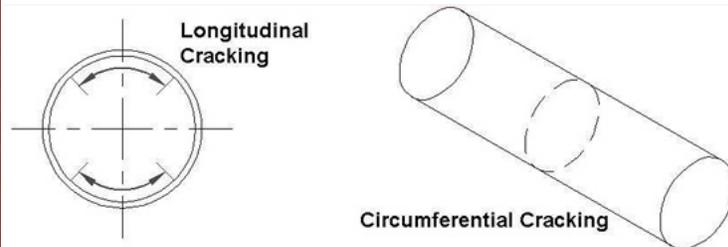
**Longitudinal Cracking**

**Typical Locations for Longitudinal Cracking can be Found in the Crown and Invert.****5.1.1.2.1 Longitudinal Cracks**

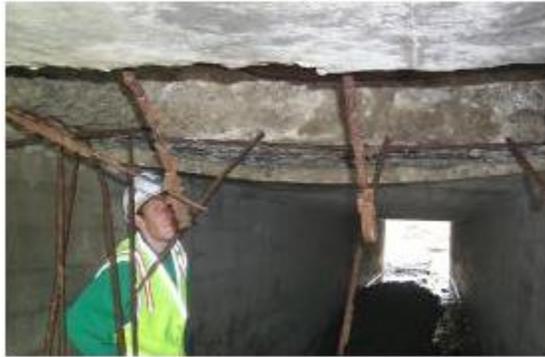
Failed Crown in Reinforced Concrete Box Culvert

Precast concrete culverts may sustain damage in their crown section due to the depth of cover being too shallow to adequately support and distribute vehicle live loads. The result may be cracking, spalling and distortion in the crown area. Some information on procedures that may be used to repair such problems is provided in Appendix B-37 of FHWA Culvert Repair Practices Manual Volume 2. For severe cases of crown deterioration (see photo), replacement may be necessary.

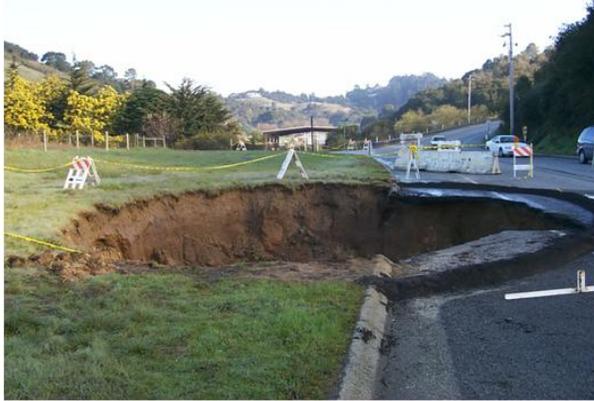
A variety of external loads and changing soil conditions may cause joints to open allowing backfill infiltration and water exfiltration, however, this is unlikely if the proper bands are used. Key factors in the inspection of joints are indications of backfill infiltration and water exfiltration causing erosion of surrounding soil resulting in surface holes or pavement deflections. See Index 11.1.1.

Sink Hole Damage (Location Unknown)

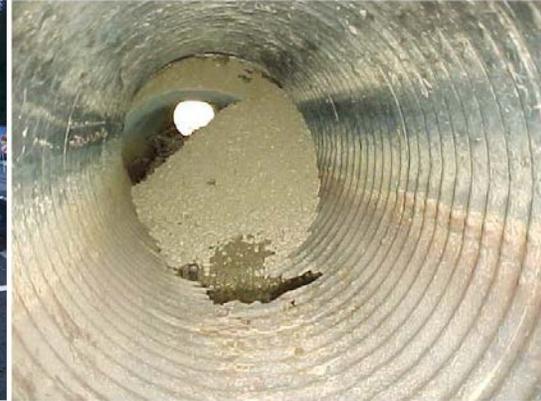
Loss of Backfill Fines

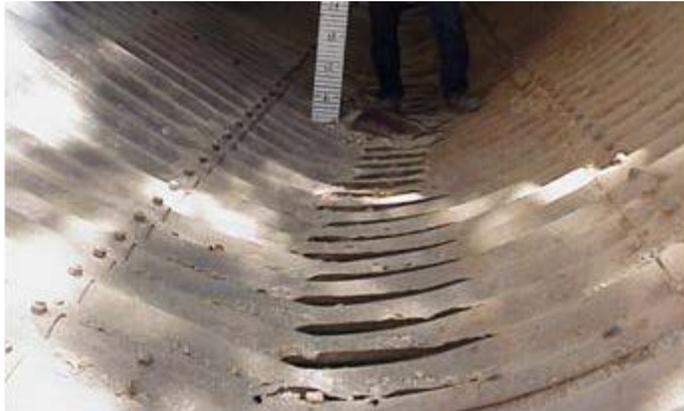
Worn Invert on Leading Edge (To Flow) of Corrugations Caused by Abrasion

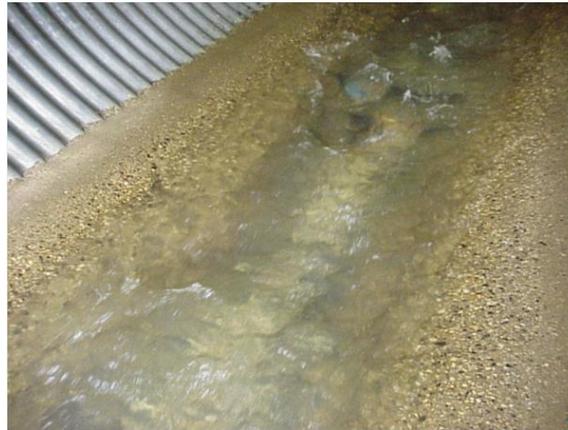
(Above) Example of Insufficient Concrete Invert Paving Design Thickness for Abrasion Level 6

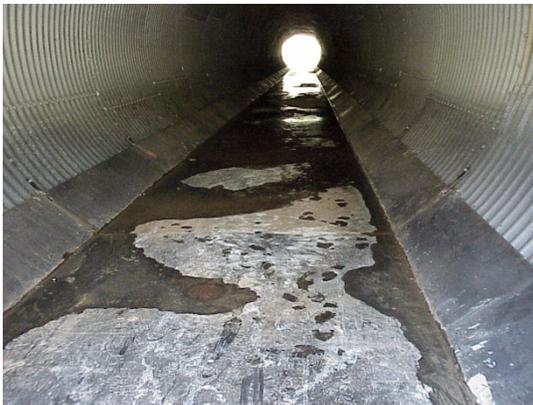
Finished 0.375-inch Thick Steel Plate Invert

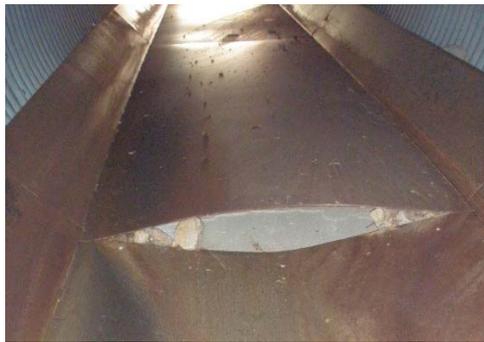
Example Steel Armor Plating Detail. To prevent piping under the steel plate, it is important to provide end treatment details – particularly at the upstream end. See details below and post-construction photo of 120 inch SPP on Sbd 330 where end treatment was not part of the design.

Insufficient Anchorage with No End Treatment

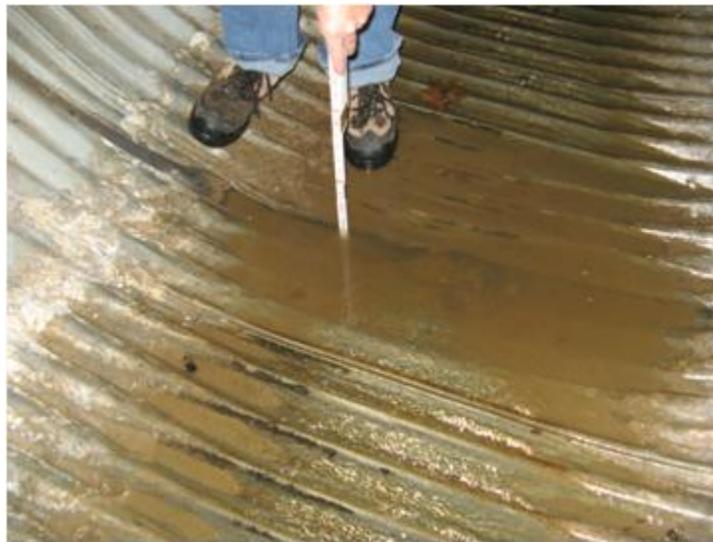
Backfill Fines Infiltrating Through CMP Joint

As a remedial measure for such anticipated conditions, depending on the amount of shape distortion, cementitious grouting, or a combination of expansion rings (refer to previous discussion for sealing culvert joints with expansion ring gaskets or repair sleeves under Index 5.1.1.1.3.2), and Slurry Cement pressure grouted backfill in lieu of Structure Backfill, or a combination of Structure Backfill with Filter Fabric (only if external access is feasible) is recommended. See Index 6.1.2. Grouting Voids in Soil Envelope. Also see appendices B-26 and B-34, FHWA Culvert Repair Practices Manual Volume 2 for procedures for sealing culvert joints and repair at a distorted section.

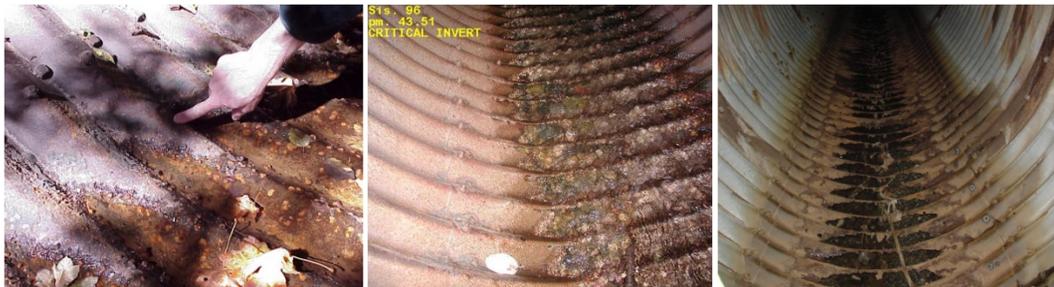
Corroded inverts in metal pipe will visually appear much differently than those worn by abrasion. Corrosion will first manifest itself inside the culvert as rust with nodules and pitting. See first photo below. The first perforations may appear in a much wider area related to the flow-line compared to when abrasion is the primary wear factor. For example, in the middle photo below, the first perforations are occurring on either side at the outer edge of the darker wear zone. The wear pattern of a severely corroded CMP invert will appear to have rough edges and often has strands of metal remaining at 6 o'clock. See third photo below.

Progressively Corroded CMP Inverts

The dark, stained, wear zone present in most worn metal pipes usually indicates the limit of exposed steel where the galvanizing layer has worn away. Even in nonabrasive flows, most galvanizing exposed to frequent flow generally lasts a maximum of 10 years.

Corrosion on the backside may be present if rust stains inside the pipe are present around joints and seams outside (i.e., above) the general flow zone. See third photo above.

One of the most effective ways to rehabilitate corroded and severely deteriorated inverts of human entry CMP (i.e., 42-48 in. or larger) is by paving them with reinforced concrete or shotcrete. Refer to Index 5.1.2.2.1.

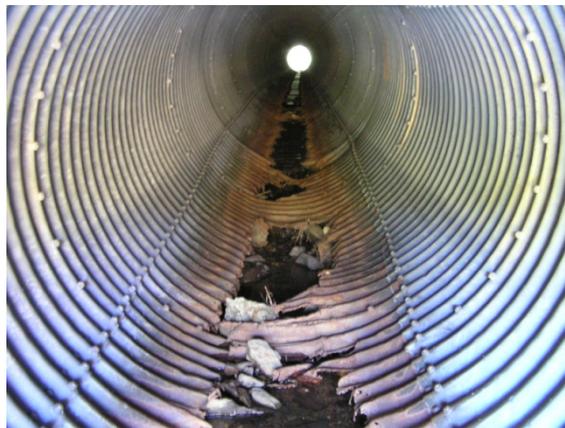
The overall condition of the culvert should be assessed, as well as the soil-pipe conditions that caused the deformation to occur (e.g., corrosion, abrasion, poor compaction, open joints, etc...). Symmetrical deflection of the crown may be indicative of problems with support of the bottom of the culvert or insufficient backfill/cover over the top of the culvert. Unsymmetrical deformation of the top of the culvert may be the result of loss of soil support on one side of the bottom (potentially from problems due to infiltration, infiltration and piping at joint(s) or perforated invert) or improper compaction of the backfill on one side of the culvert. Thus the shape may not be symmetrical for either the entire length of the culvert or individual sections of it. Therefore, the conditions that caused the deformation must be assessed and the rehabilitation plan must include correcting the underlying problem. See Appendix B-34, FHWA Culvert Repair Practices Manual Volume 2, for procedures for repair at a distorted section.

Shape Distortion Caused by Backfill Soil Loss

The decision to repair (re-compact embedment material, grout voids, repair joints or line invert) versus replace the culvert by trenching and cover or by other trenchless methods such as jacking or pipe-ramming, is dependent in part on the structural integrity of the culvert. If the culvert must be replaced, the decision to replace by trench and cover versus other trenchless methods will be influenced by cost, the need to maintain traffic during

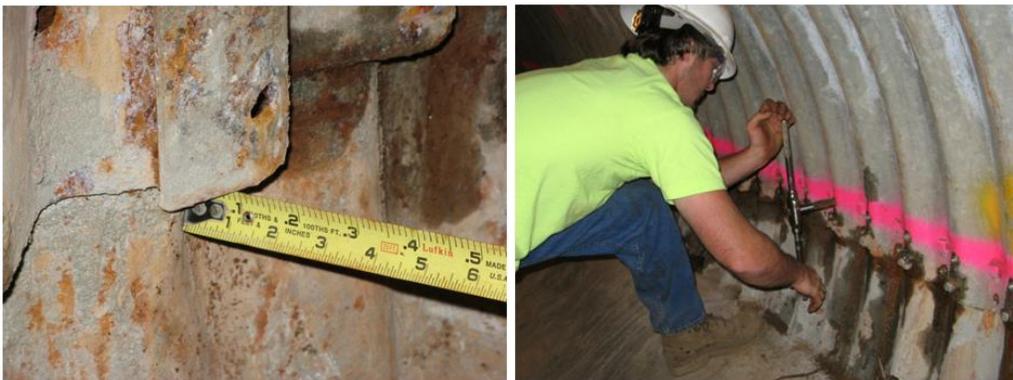
Longitudinal or transverse seams in structural plate assemblies may deteriorate due to sheared or corroded connector bolts, lost or corroded nuts, or plate tears.

Repairs are made by splicing, re-bolting (see pictures below) or welding with reinforcing steel to the inside corrugation valleys at the location of seam distress. See Appendix B-38, FHWA Culvert Repair Practices Manual Volume 2.

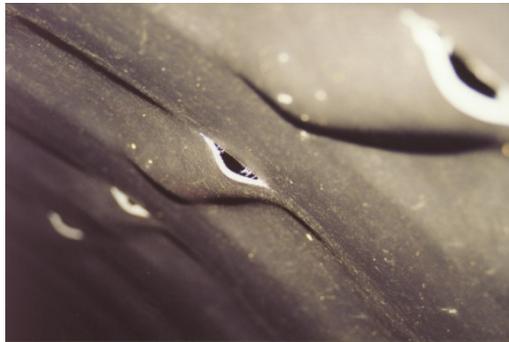
Splitting of 60 inch Diameter Pipe. This Pipe was Installed in 1996 by Another State

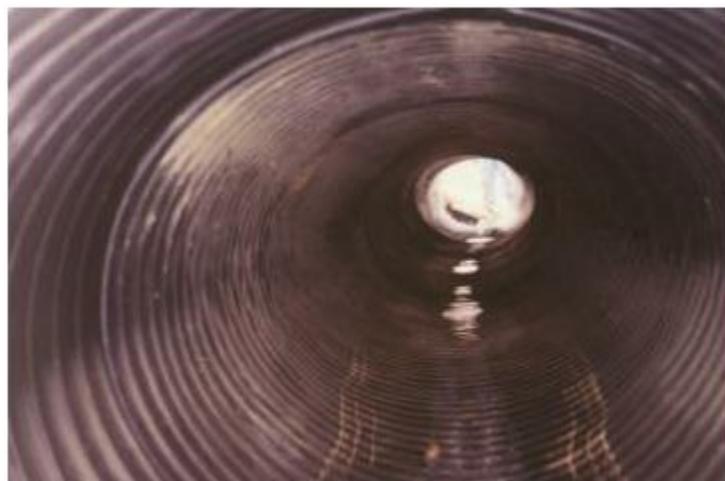
Profile of pipe: Note wall buckling and obvious oval shape. This 42 inch diameter pipe was installed in 1994. The pipe is 82 feet long and has a maximum cover of

about 10 feet. Separations of the joints ranged from 1 to 3 inches. Rippling of the sidewalls is apparent throughout the length of the pipe (see below).

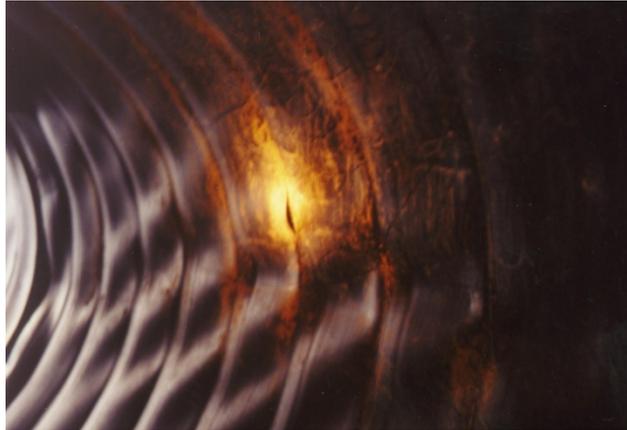
Small Crack and Wall Rippling

Some of the problems that have been outlined for plastic pipe may be monitored, such as deflection (see Index 5.1.2.2.4). However, pipes with excessive deflection will need to be replaced or lined with a rigid material that is capable of supporting all ground and traffic loads. See Index 11.1.1.

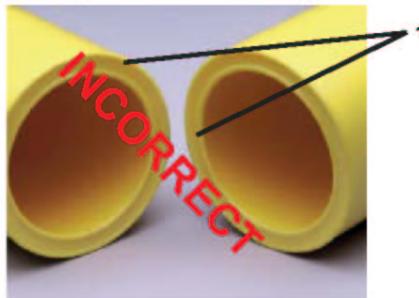
Figure 2 Unacceptable Concave Melt Appearance

A concave melt surface is unacceptable; it indicates pressure during heating. (See Figure 2). Do not continue. Allow the component ends to cool and start over at Step 1.

1. Unacceptable concave melt appearance.

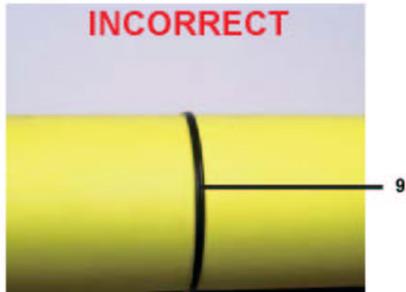
9. Insufficient heat time; melt bead too small

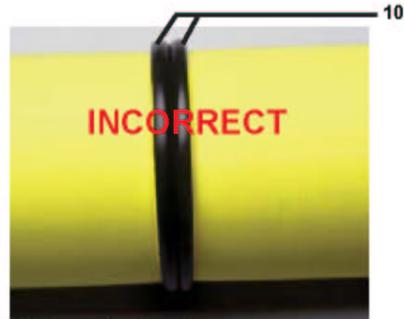
10. Excessive heat time or pressure applied during heating; melt bead too large

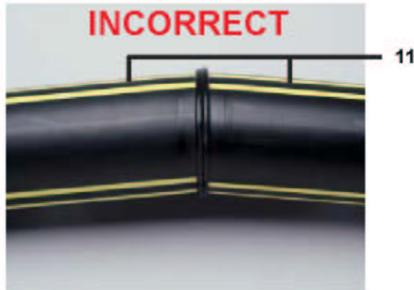
11. Pipe angled into fusion unit

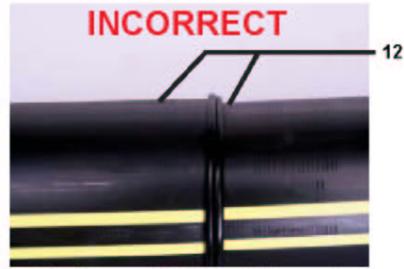
12. Improper "High-Low" alignment

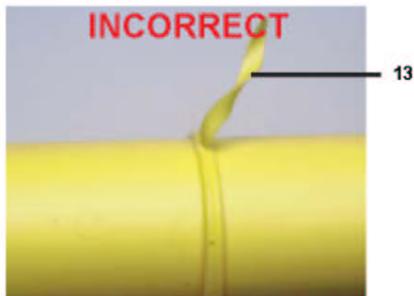
13. Incomplete face off or failure to remove faced off ribbons

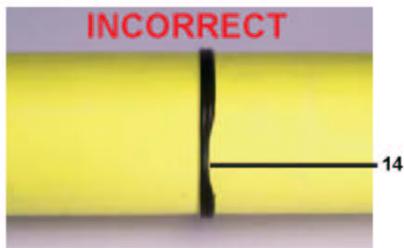
14. Incomplete face off

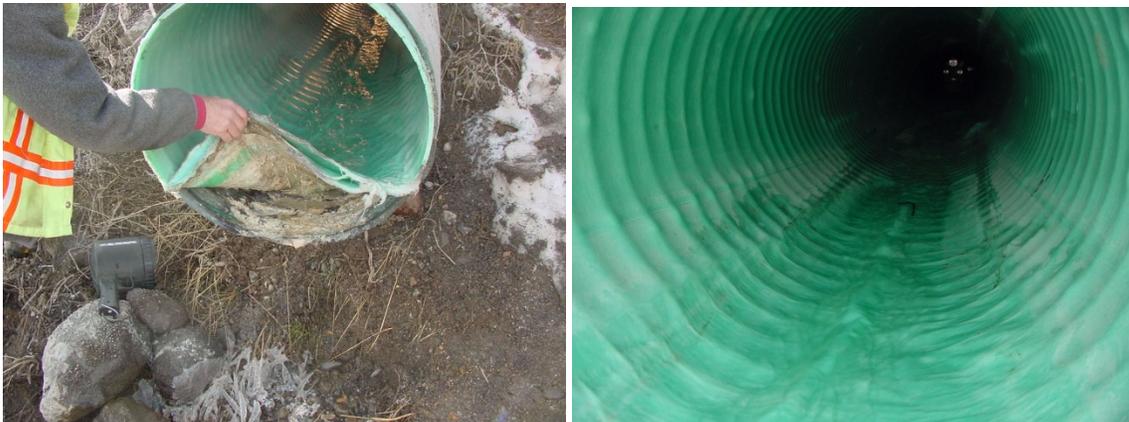
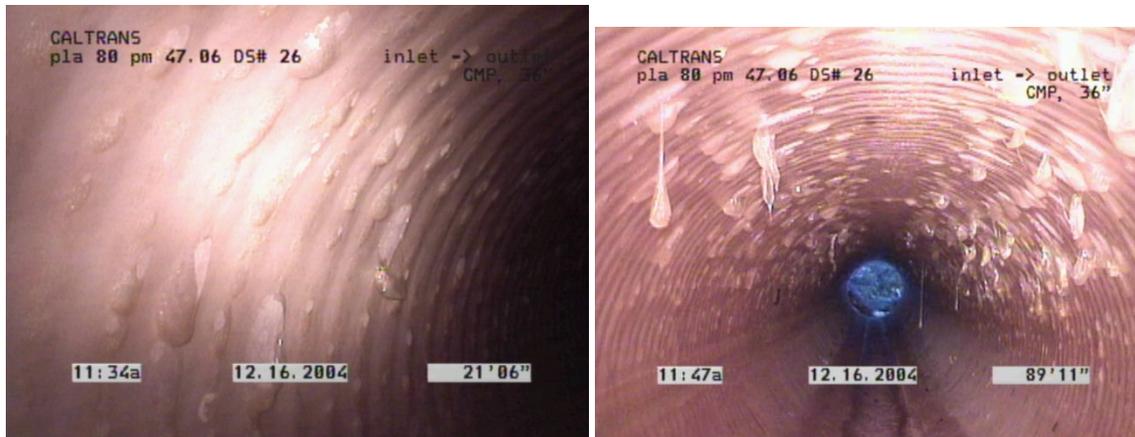
Examples of Delamination, Bubbling and Rippling in Lined CMP Host Pipes

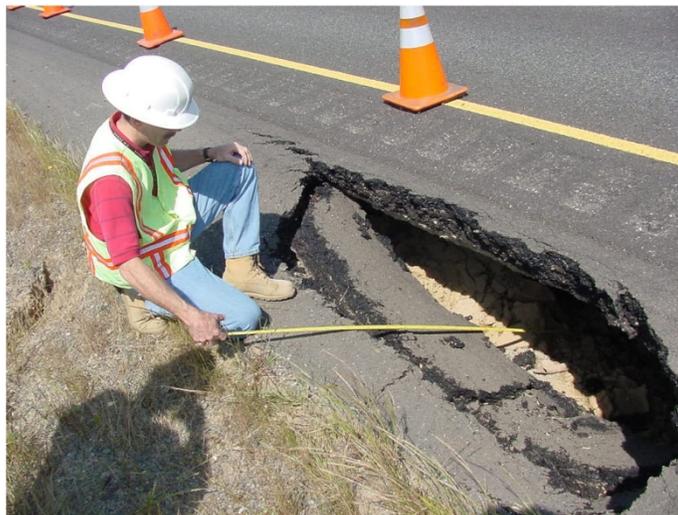
In June 2003, a sinkhole was identified by maintenance adjacent to the number one lane of the westbound traveled way on Highway 50 in El Dorado County at Post Mile 14.0 just east of El Dorado Road Overcrossing (Br. No 25-76) in the vicinity of a 96 inch Structural Steel Plate Pipe (SSPP). This section of Highway 50 was constructed 35 years prior. The 820 foot long SSPP was constructed as a cross drain for Indian Creek which was realigned from its original location to the east and uphill. A 230 foot long 36-inch diameter bitumen coated CMP connects into the SSPP at the center in the median and a 56 foot long 18-inch diameter CMP connects into the SSPP approximately 150 feet from the outlet. Both pipes collect drainage from the north side of the freeway and outlet into the SSPP.

Measuring the Sinkhole

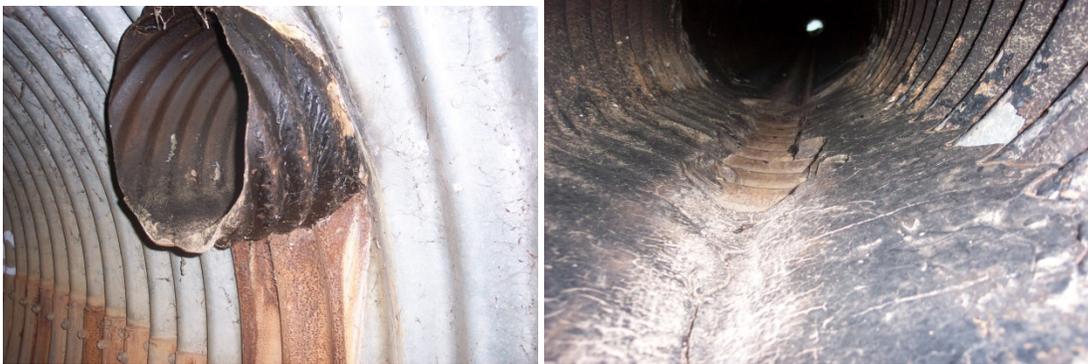
36 Inch Bitumen Coated CMP Tie-In. Note rust stain below from perforated invert. Perforations in invert to 36 inch CMP allowed water to leak behind 96 inch culvert

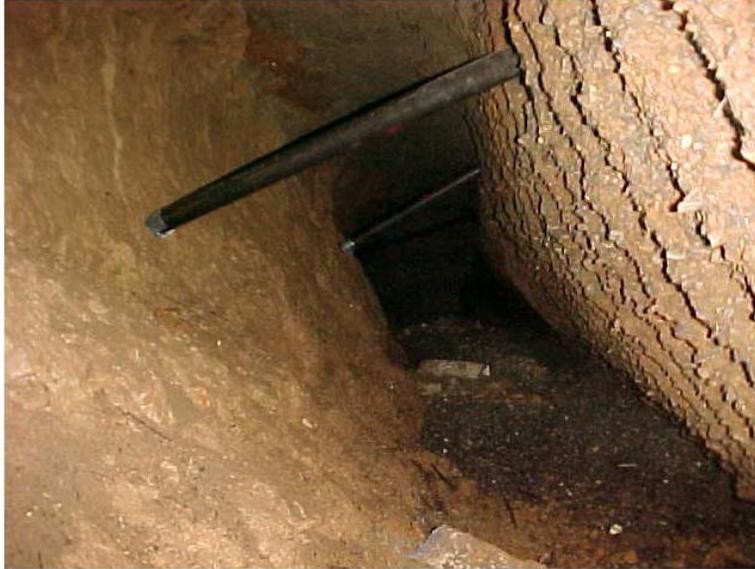
Probing revealed the presence of a large, long void in the backfill between the sinkhole beginning near the midpoint and ending approximately 620 feet from the inlet at the 4

o'clock position. After shotcreting was completed it was decided to core some additional ports and fill the large void with a 3-sack sand slurry prior to contact grouting work previously described. In addition, the long void that was found through probing extended to the surface near the original sinkhole and was also filled with slurry placed from the surface. See below.

Large, Long Void That Was Located By Probing. Note corroded back side of culvert on right side of picture.

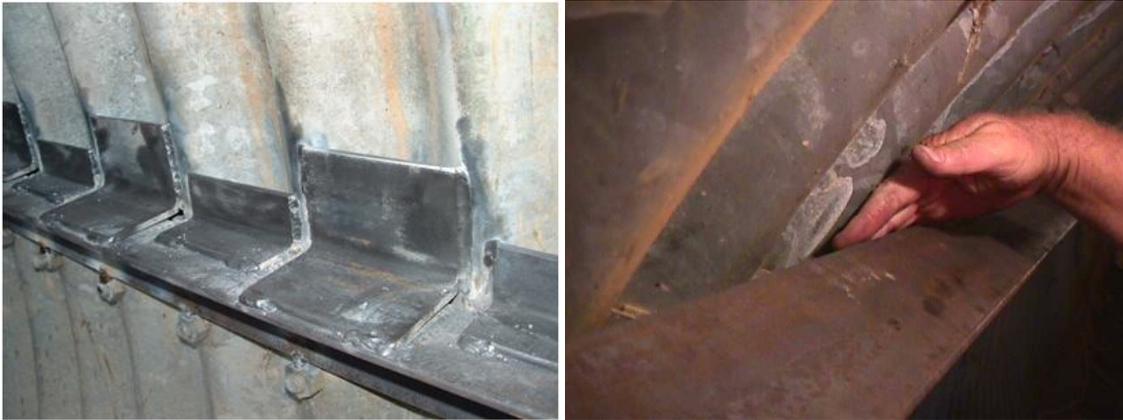
- Thrust transfer design was labor intensive and vertical angle iron design needed modifying in the field to make better contact with pipe (see pictures above); the original design did not work for the field conditions because the deformed host pipe resulted in several areas of poor contact with the longitudinal angle iron (see picture with hand). Therefore, it is incumbent for the designer to make sure their design will meet field conditions.

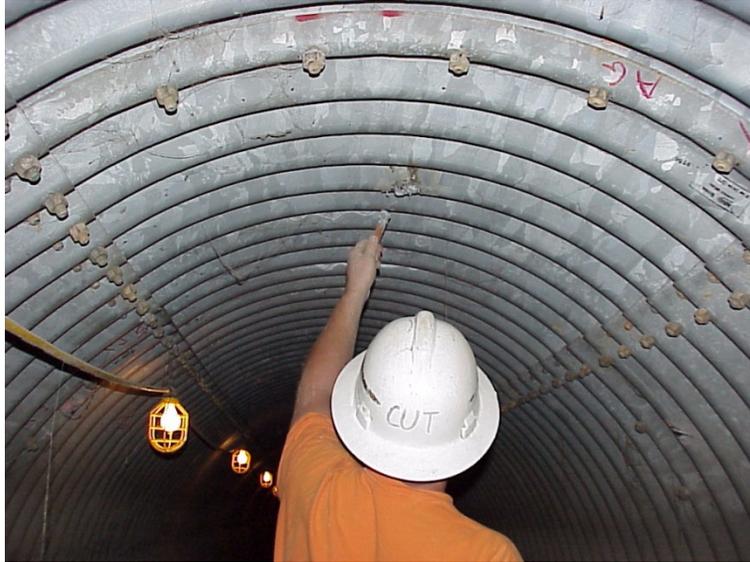
- Repairs from CPT testing damage should be included in contract (see picture next page):

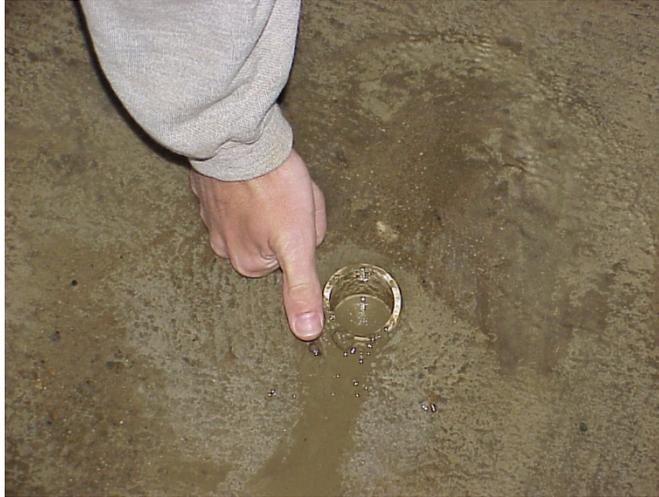
- Design changes made in field by Construction without communication to other units: 3- sack sand slurry in lieu of contact grout design used to fill largest void and decision to introduce “weepholes” in invert that were not shown on the plans (see pictures on following page):

PVC Pipe “Weep” Placed in Rock Below Invert. Later, larger weeps were “cored” in addition in addition to these.

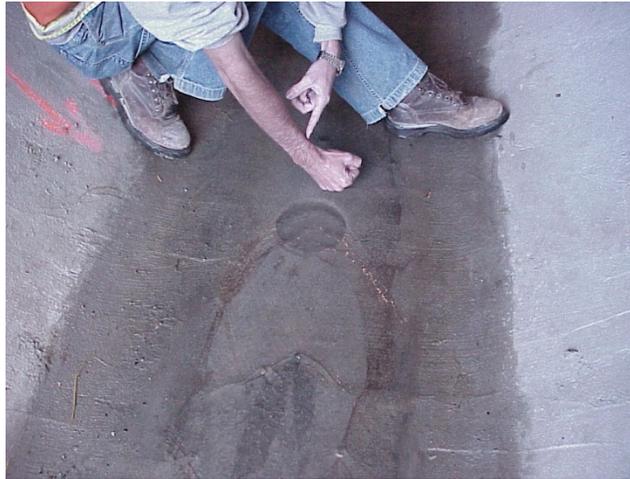
Cored Weep in Shotcrete Invert

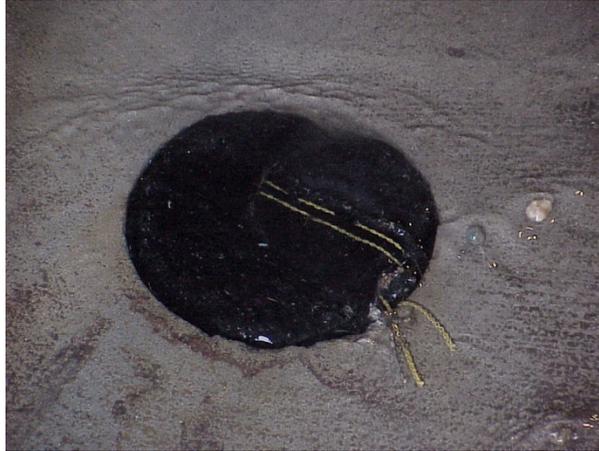
Installed Gravel Filter Bag in Invert Weep

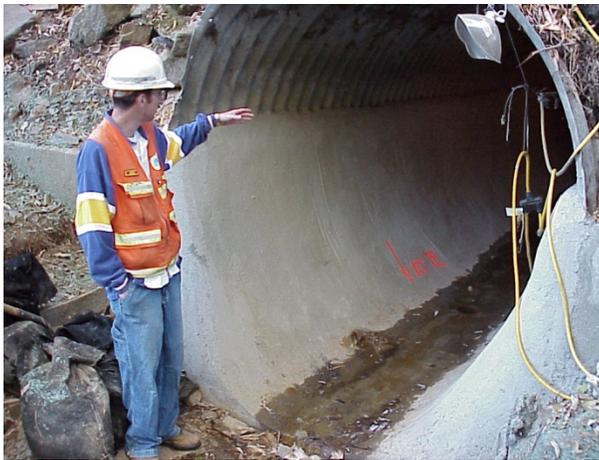
Outlet of 96-inch Pipe After Repair

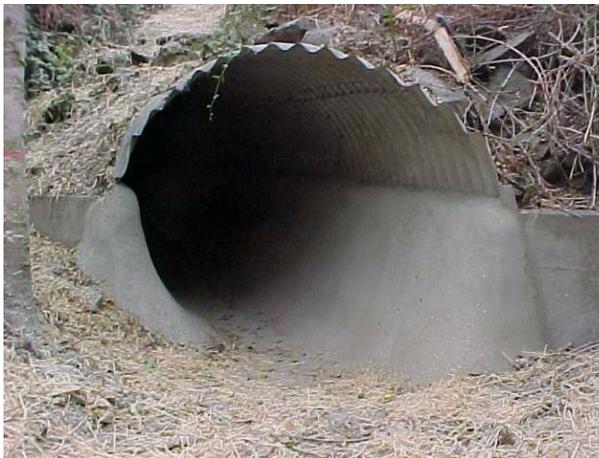
Inlet of 96-Inch Pipe After Repair

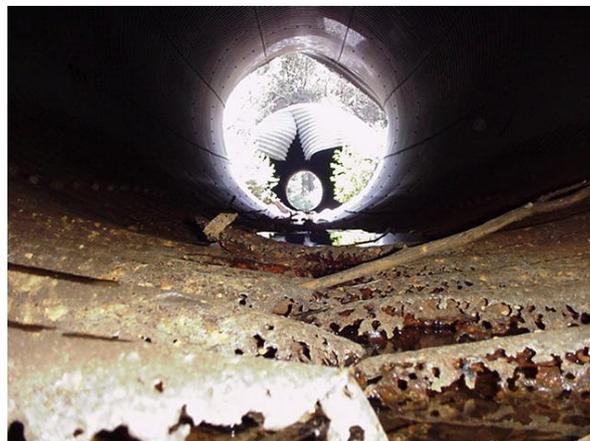
Corroded and Overlapping Invert. Note oval shape of pipe

Due to the deterioration of the invert plate and the subsequent loss of hoop strength, these culverts were deforming at the invert as revealed by a wide variation in chord length measurements (eastbound: 0-15 inches, westbound 0-13 inches) between the edges of the two plates (one edge on either side of the bottom or invert plate) that overlap the invert plate. The loss of chord length represented the amount of deformation in the bottom of the culvert due to external pressures that were no longer resisted by the hoop strength of the culvert at the invert.

Over the years the bottom of the culvert had deteriorated - possibly due to corrosion from de-icing salts placed on the roadway above during winter. Once the pipe had perforated, stream flows could then pass beneath the pipe carrying away soil fines (either within the stream flow or by moving outward into the voids of the courser graded surrounding highway fill material). The as-built plans indicated the freeway fill was constructed with 'shot rock' consisting of larger diameter material than the finer grained and potentially erodible backfill adjacent to the pipes.

It was concluded that corrosion was far more problematic than abrasion as a contributor to the invert perforation. Invariably, the corrugation valleys were what was perforated and not the corrugation crests. In addition, while there was some wear apparent on the connecting nuts/bolts that were in the invert, the extent of upstream side wear was very slight - again indicating that while there is/was enough abrasion to remove the zinc coating, it was not severe and some chemical action is attacking the steel.

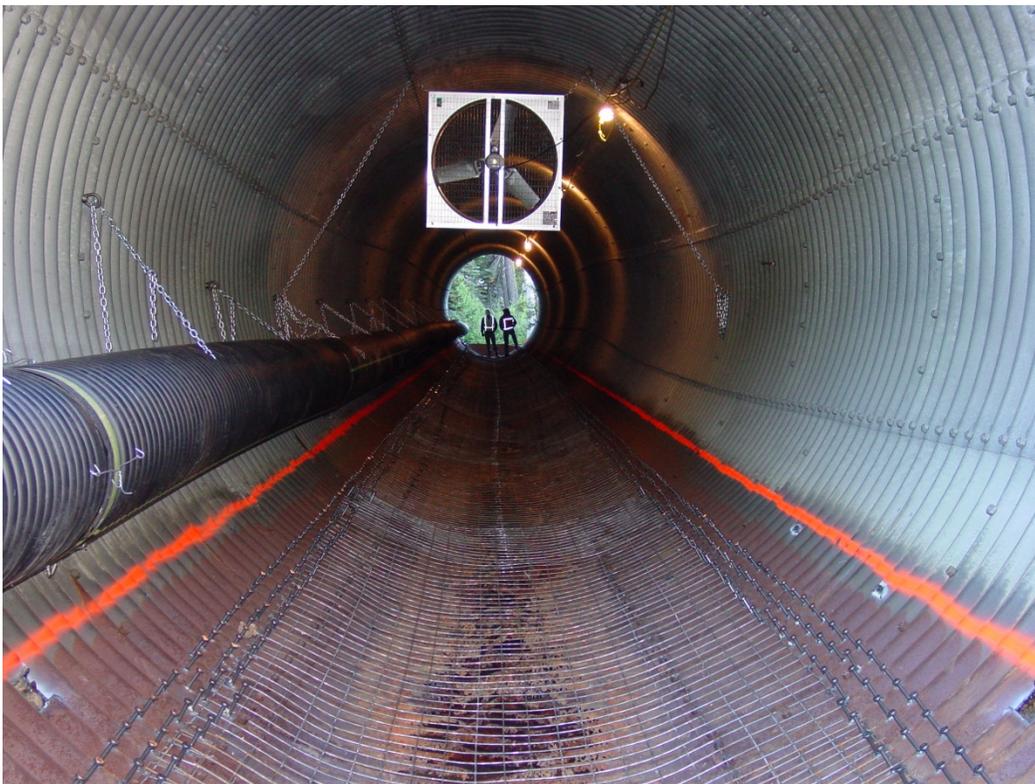
Eastbound Pipe Prior to Concrete Placement with Temporary HDPE By-Pass, WWM and Nelson Studs

The original plan by Maintenance Engineering was to place a reinforced concrete invert lining in each of the culverts with no thrust connection. However, District Hydraulics expressed concerns that the loss of hoop strength may continue to allow these pipes to collapse even farther, therefore, a structural stiffening system was considered in the invert to regain the lost hoop strength.

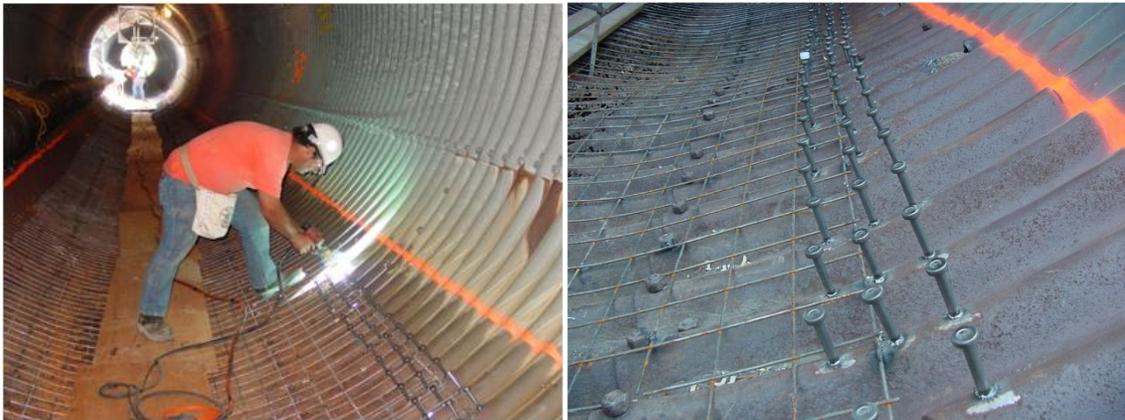
Shear connector welding studs (Trade name Nelson Headed Anchors and Nelson Threaded Studs are acceptable structural fasteners. Nelson studs are regularly used in bridge superstructure construction. They are relatively inexpensive (roughly 25 cents each) and depending upon the overfill height and culvert pipe thrust, Nelson Headed Anchors can function to anchor and transfer the culvert thrust load from the wall into the concrete invert lining through shear transfer. In addition, they are welded electrically which avoids the gaseous fumes resulting from normal structural welding. Six longitudinal rows of studs (3 running left of center and 3 running right of center) 6 inches apart on each corrugation were installed. Approximately, 4300 studs were installed in a few days at a cost of about \$7,000.

A structural bond to the host pipes can be achieved by using shear connector welding studs (Nelson Studs) attached with a stud welding gun as shown below:

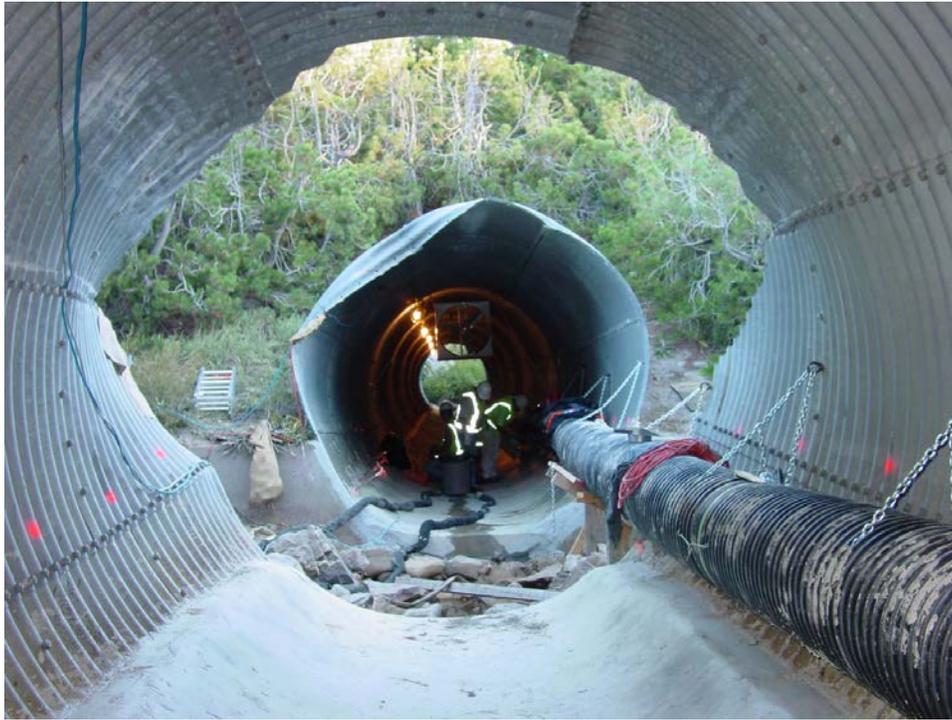
View of Both Pipes After Concrete Invert Paving

The concrete design for the invert included a 4000 psi compressive strength and 3/8 inch aggregate along with air entraining for the freeze-thaw conditions. The 4-inch thick minor concrete invert lining was limited to the lower quadrant of the culvert (i.e., 90 degrees coverage from the 4:30 to 7:30 clock positions).

The voids directly below the invert were filled with the same concrete.

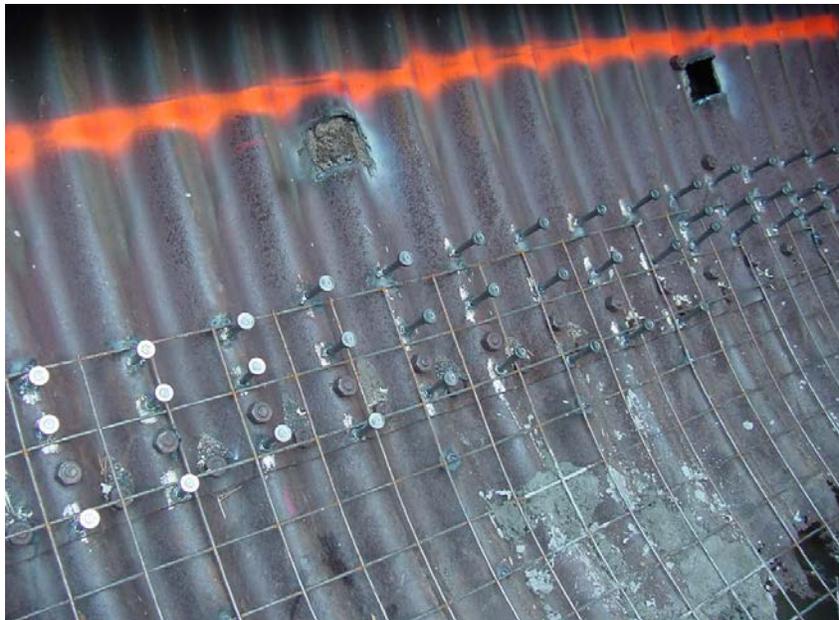
Before paving the invert, coupons were cut into the culvert wall in order to probe for voids. Most of the voids found were below the springline, however, a significant void was discovered near the outlet of the eastbound pipe above the springline at the 10 o'clock position. In both pipes the most significant voids were found at the inlet.

Coupons Cut in Sidewall of Culvert for Probing and Grouting

A decision was made to use polyurethane foam grout rather than cementitious grout to fill the voids behind the culvert. The decision to use polyurethane grout was based primarily on the fact that an agreement with the cementitious grouting contractor regarding Force Account rates could not be reached. Furthermore, the District already had a Maintenance service contract with a company called Uretek for slab jacking and had some success with the material for jacking operations (including this site in January 2003). Although the foam has been used in PCC slab raising work for several years on many California State Highways, there were concerns that the Uretek foam may have environmental impacts and durability issues, since it had not been used for this type of application. The Resident Engineer explained the environmental concerns with cementitious grout migrating into the creek during placement and stated that Uretek had provided data showing the foam to be inert and that it would not leach into the creek. This material is supposed to be inert in a live stream environment and will not absorb water. When first placed, high-density polyurethane rigid closed cell hydro-insensitive grout is supposed to form a mechanical seal by expanding twelve times its liquid volume in 8-12 seconds.

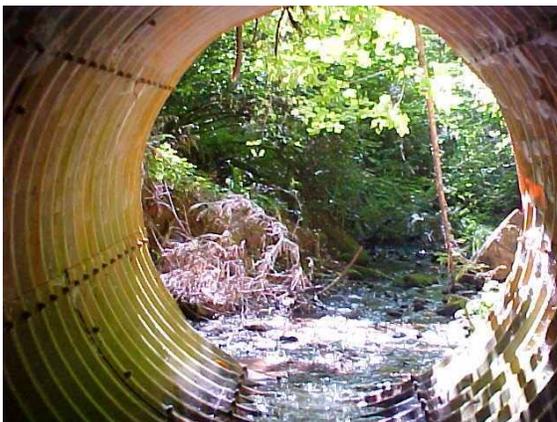
Inside the culvert, corrosion, a perforated invert (up to 0.5 inch perforations) and missing nuts and bolts from the steel plating were observed as a result of the corrosion. Also, the bolt pattern of the steel plates were originally constructed "in-line" with each adjacent plate instead of being offset, which might have contributed to structural weakness.

Inlet of Original Pipe

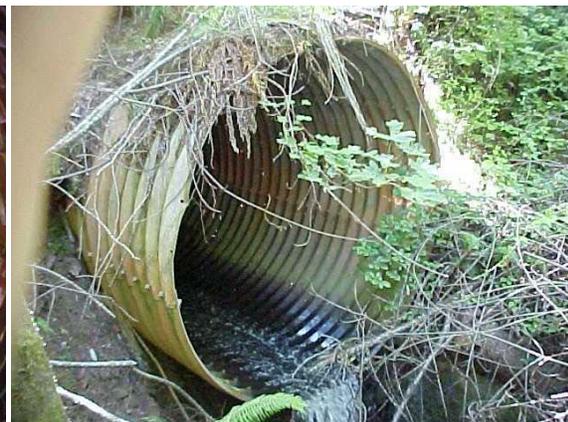
Outlet of Original Pipe

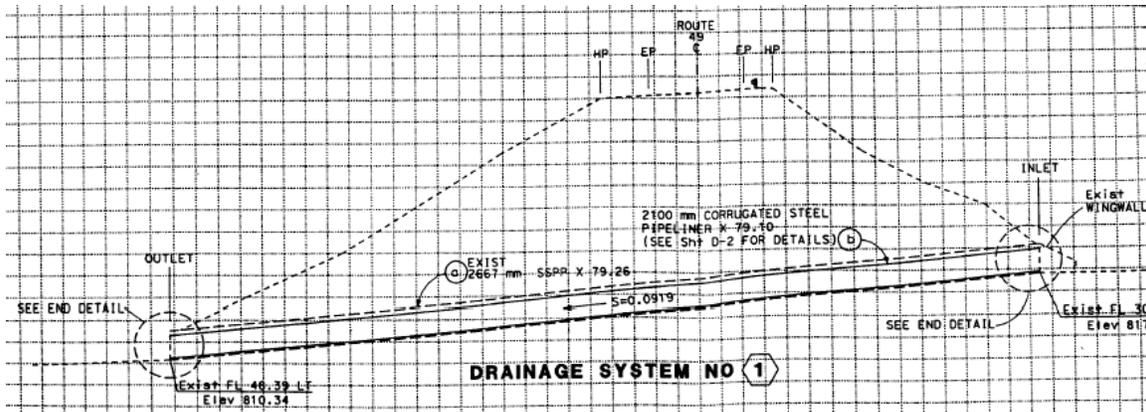
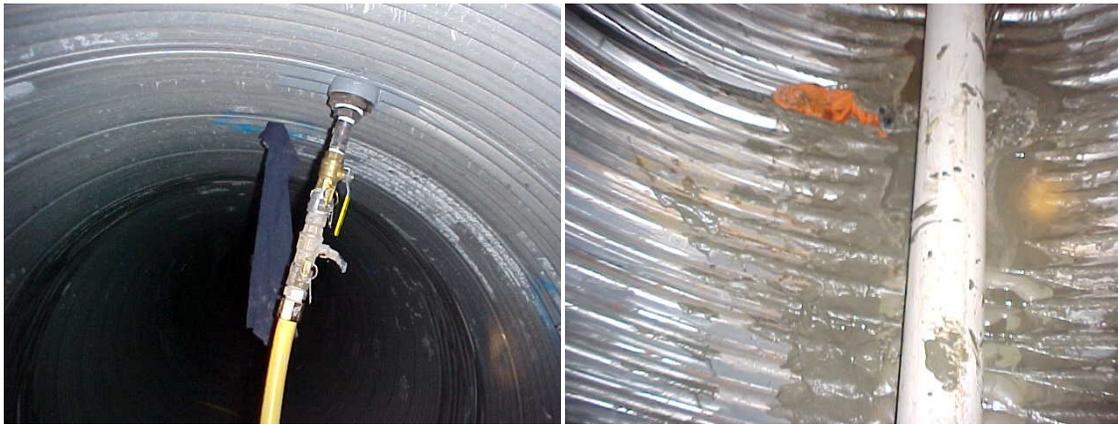
The resulting hydrostatic pressure at the downstream end from continuous grouting of the annular space between the existing culvert and the 84-inch CSP liner placed inside caused the liner to float and buckle with grout leaking out of the liner’s joints which had been specified as watertight with gaskets. The grouting operation was immediately stopped and a Contract Change Order (CCO) was developed.

Grouting Through Grout Port in Soffit of Liner Grout from Leaking Joints in Invert

The CCO modified the design to welded joints for the CSP liner and the grouting from continuous to grouting in 3 sections (lifts). The continuous grouting was originally anticipated to take 2 days. The sectional grouting took 6 days. The installation of 8 welded skirts as shown on the plans (see end view) was omitted to avoid additional welding.

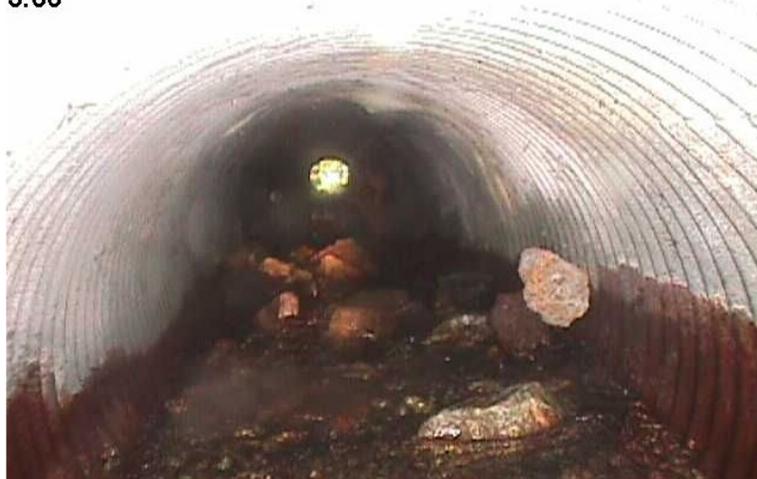
Video Inspection Photo

Originally installed in 1974, a 10 gage CMP has a maximum cover of approximately 50 feet, and a slope of 12.3%. Inspection photos taken in 2004 indicate a stained invert but no perforations. The culvert barrel shape and joints were deemed “in good condition”. In 2007 a video inspection was performed and the inspection report indicated:

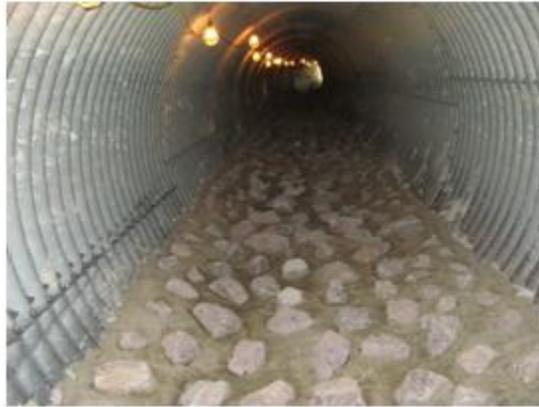
Worn Invert (Abrasion) Before and After Repairs

In this case there was enough available headwater elevation at the site to accommodate a concrete invert lining thickness of up to 15 inches and concreted rock slope protection with ‘facing’ selected for the concreted rock grading from Section 72 of the Standard Specifications because it compared well with the maximum bedload size (see photos).

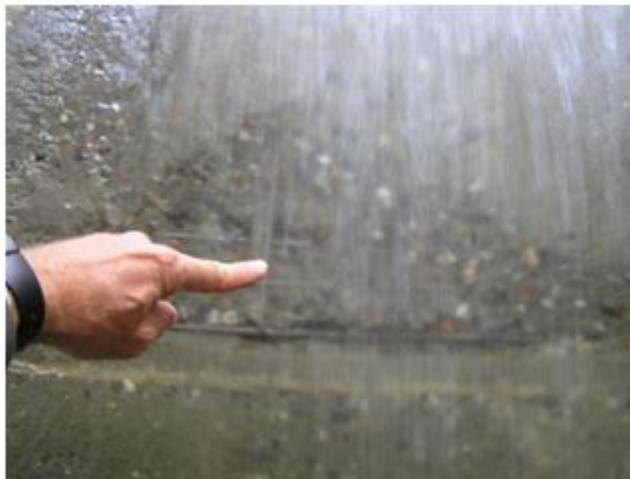
By 2011 the new pipe barrel was prematurely experiencing excessive invert wear and some of the steel reinforcement was exposed immediately downstream of the last joint. Therefore the RCP had already reached the end of its 'maintenance free' service life after just 5 years and the concrete had worn at least an inch and was in need of repairs. See photo below.

Exposed Steel Reinforcement
