DESIGN INFORMATION BULLETIN NO. 83 - 03
CALTRANS SUPPLEMENT TO FHWA CULVERT REPAIR
PRACTICES MANUAL

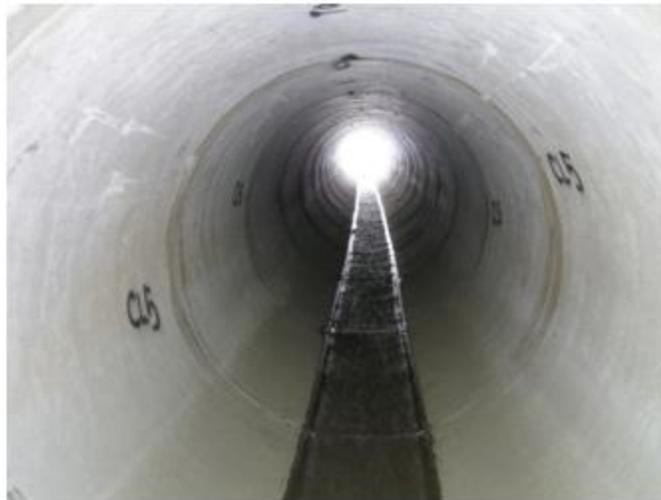
For the existing RCP (see photo below), the estimated wear rate of the 1-inch concrete cover was a simple calculation based on 5 years until first exposure of the steel reinforcement. The estimated wear of the concrete is 1-inch/5 years or 200 mils/year (0.2 in/year).

Existing 84 inch RCP Replacement at 5 years

From HDM Tables 855.2D and 855.2A, 1.9 mils/year anticipated wear for the steel indicates the abrasion level was 5 and RCP is generally not recommended. Therefore, to provide the required 50 year service life for repairs to the RCP invert, the following options were recommended:
