Sandstorm Investigation in Coachella Valley Between Garnet and Thousand Palms on Road VIII-RIV-26-D Station 720+- to Station 810+-

August 1963

D.R. Whetsel

State of California
Department of Public Works
Division of Highways
Materials and Research Department

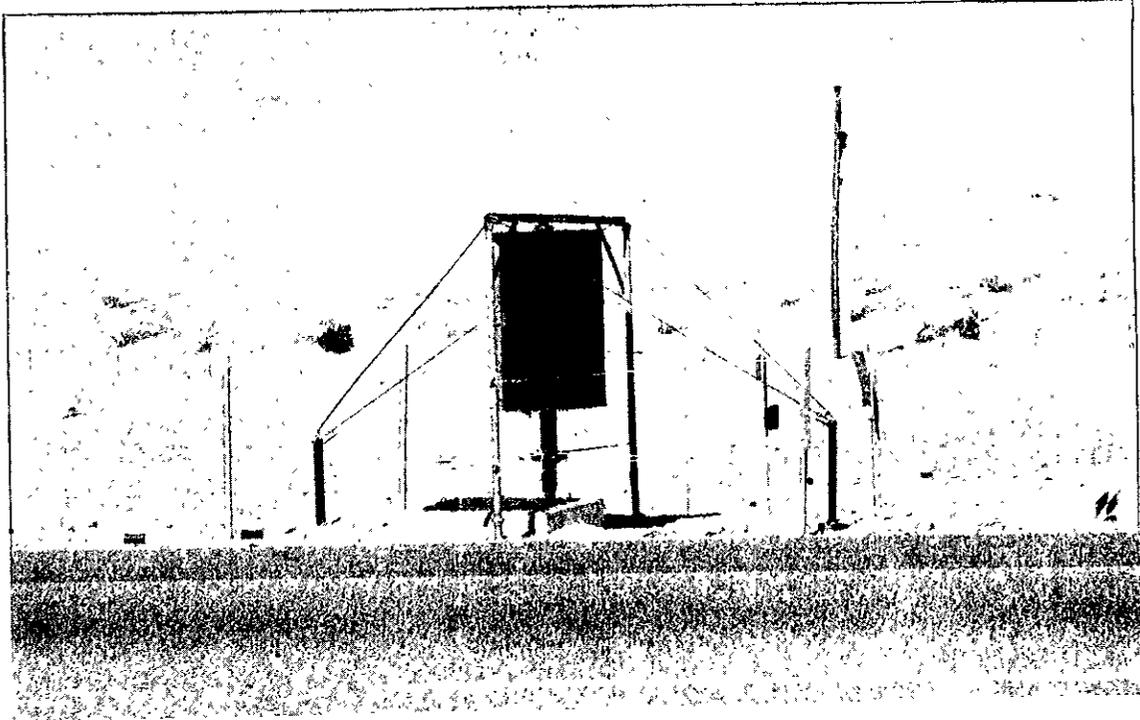
Fig. 3. Rotary Sandstorm Device
Installed at the Test Site.

Design and construction of the rotary sandstorm device was carried out by personnel of the Materials and Research Department. The rotary devices developed consisted essentially of four main parts: (1) a vertical, dust free, bearing shaft, (2) a wind blade cage which propelled the device at speeds depending upon the velocity of the wind, (3) a mounting for the painted metal test vanes or impact arms, and (4) a concrete base which would support the device and house test instruments. Photographs of a rotary sandstorm measuring device are shown in Fig. No. 3 and 4.

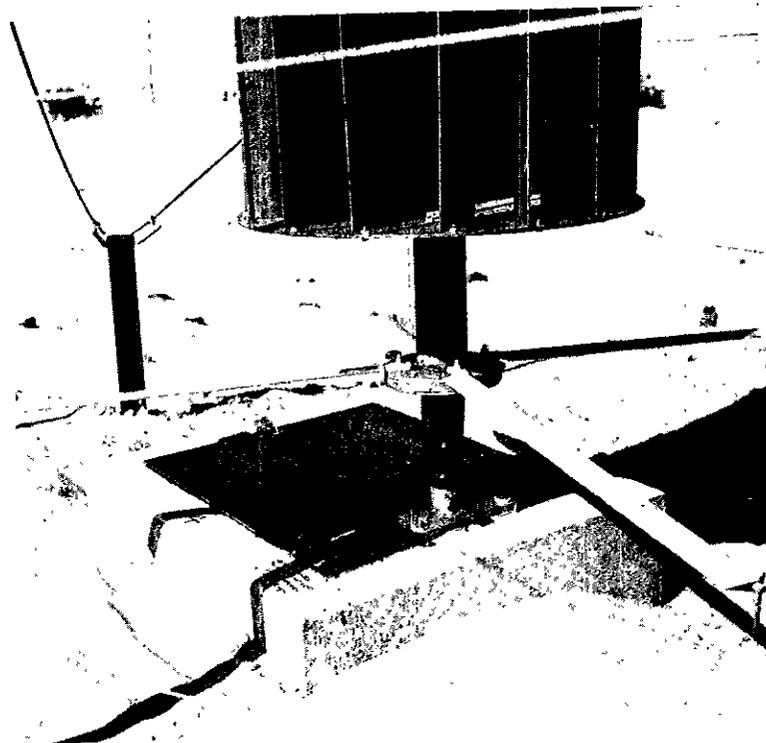
Fig. 4. Details of Impact Arm Mounting

The impact arms were mounted on the lower portion of the devices as shown in Fig. 4. These arms could be removed for observation and measurement of the abrasive damage after periods of severe blowing sand. The impact arms were painted with six layers of contrasting colored automobile paint.

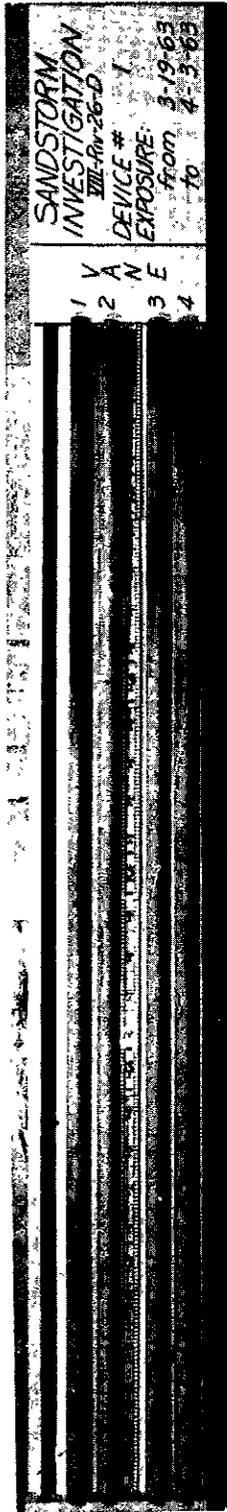
Exposure Period 4

The damage sustained by the impact arms is shown on the record photographs, Fig. No. 6 through Fig. No. 13. The exposure periods indicated on the photographs correspond to the periods given in the above table. The scale shown on the photographs represents distance in feet and tenths of feet from the axis of rotation of the devices.

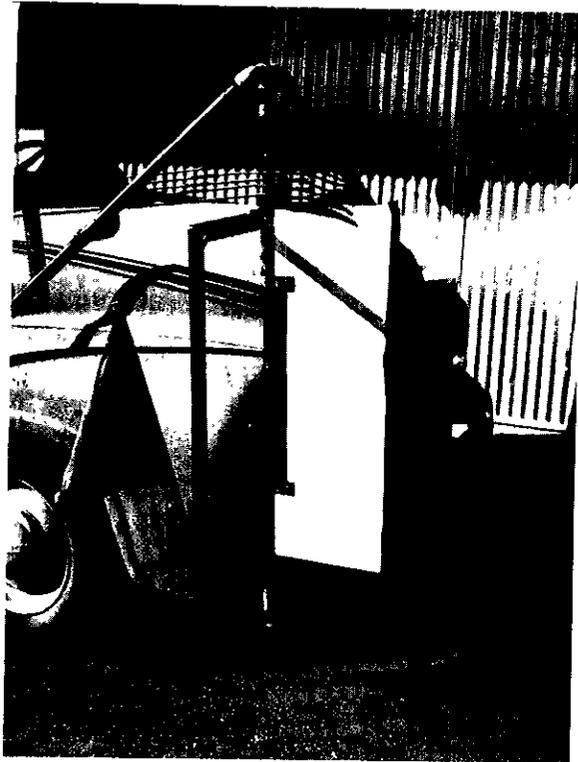
Fig. 18. Vehicle Mounting of Painted Test Panels

Further verification of the results shown by the rotary sandstorm devices was obtained from test runs made with vehicle mounted test panels. The equipment used for these tests was constructed by the District. This equipment consisted of a special frame mounted on the front of a pick-up truck as pictured on Fig. No. 18. A series of painted metal panels were hinged to this frame in such a way that the panels could be exposed to the blowing sand for controlled intervals as the vehicle traveled along the roadway. Details of the panel mountings and the exposure control levers are shown on Fig. No. 19. The control rods, also shown in these figures, were operated from the cab of the vehicle.

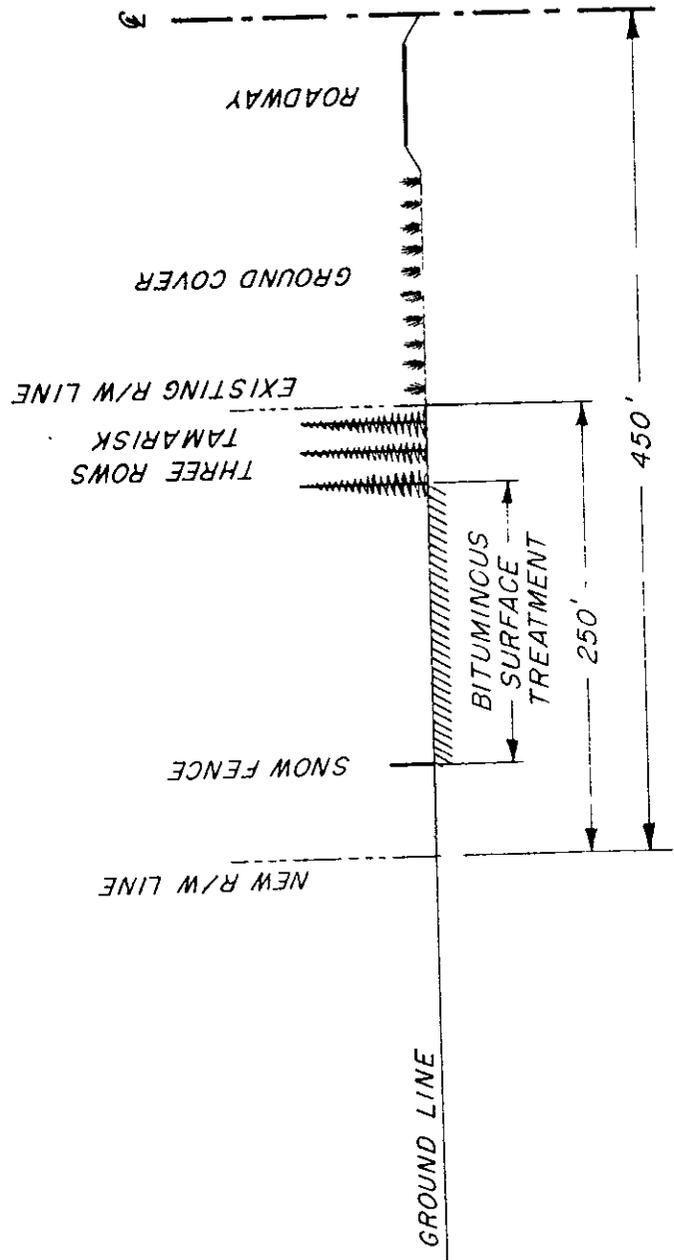
TYPICAL SECTION

Proposed Sand Control Treatment VIII - Riv. - 26 - D

Such a planting program will necessitate developing a substantial water supply and installation of necessary pipe lines and sprinklers. Operating costs for irrigation of the plantings will include pumping costs and upkeep of the pumps, pipe lines and sprinklers.

If the treatment is applied on those portions of the project where sand blast damage has been most severe it will be necessary to treat the following areas in the manner described above, on the right between Station 416+00 and Sta. 650+00, and on the left between Sta. 600+00 and Sta. 856+00. This means approximately 9.3 miles of roadside treatment, but due to the overlap represents protection along approximately 8 miles of highway. It is estimated that the annual operating and maintenance cost will be near \$100,000 per year, of which the major expenditure will be for water. There is little reason to believe that tamarisk trees or any other type will ever become self-sustaining in this area; at least the reported depth of some 500 ft. to the water table makes such a possibility seem very unlikely. The estimated cost of the treatment within these limits would be between \$1,000,000 and \$1,500,000 including watering of the plants for one season. This estimate of cost is based on information contained in Mr. C. V. Kane's letter to Mr. G. T. McCoy, attention Mr. F. N. Hveem, dated August 1, 1958. No treatment is considered necessary on the lee side of the highway, nor on certain portions of the project where the sand blast damage is much less severe, namely Station 186+00 to Sta. 416+00, and Sta. 856+00 to Station (E)16+00, the end of the project.
