California Pavement Faulting Study

Interim Report

HIGHWAY RESEARCH REPORT

MATERIALS AND RESEARCH DEPARTMENT
RESEARCH REPORT
NO. M & R 635167-1

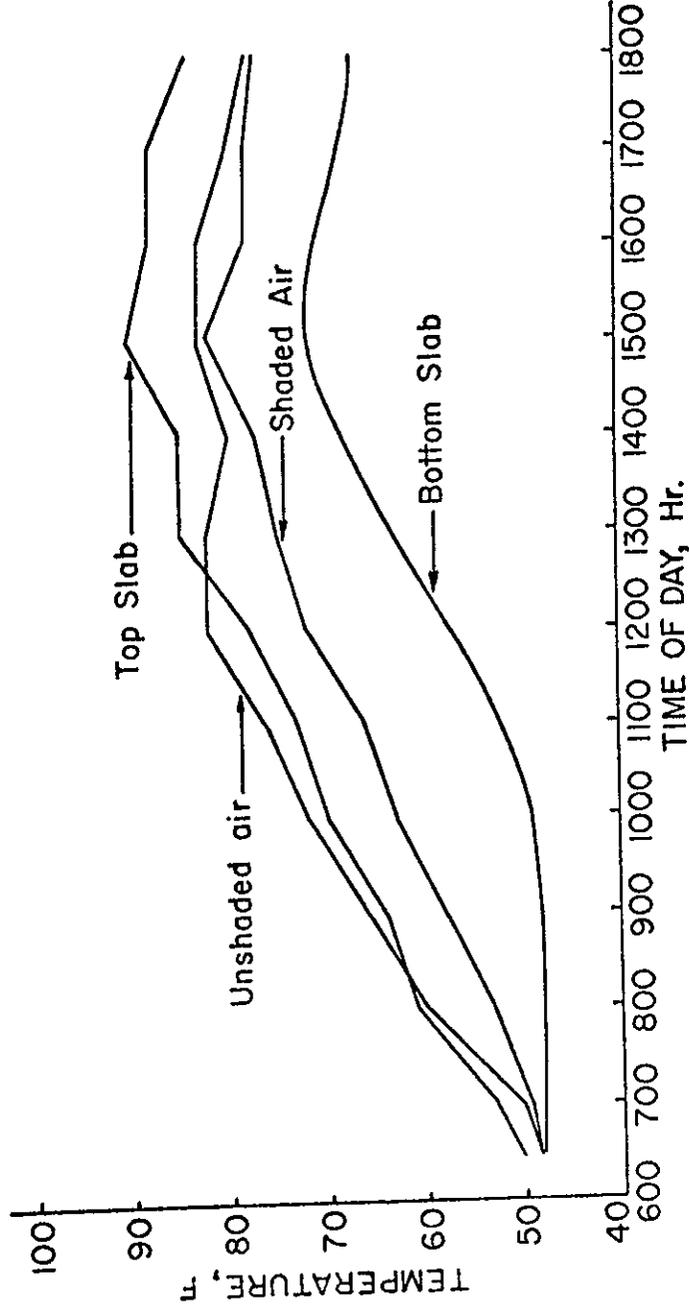
FIG.20- TEMPERATURE RELATIONS

To determine typical corner curling values for the California pavements, exploratory measurements were made at the Sacramento test location. Temperature measured during the daylight hours are given in Figure 20 and corresponding changes in slab corner curl are given in Figure 21. It was assumed that the area of contact between slab and subbase was greatest when the corner curl measurements were minimum. This established zero datum. However, this does not indicate that the slab was in complete contact with the subbase at this time as pavement slabs are usually curled upward to some extent during the entire lifetime of the pavement.

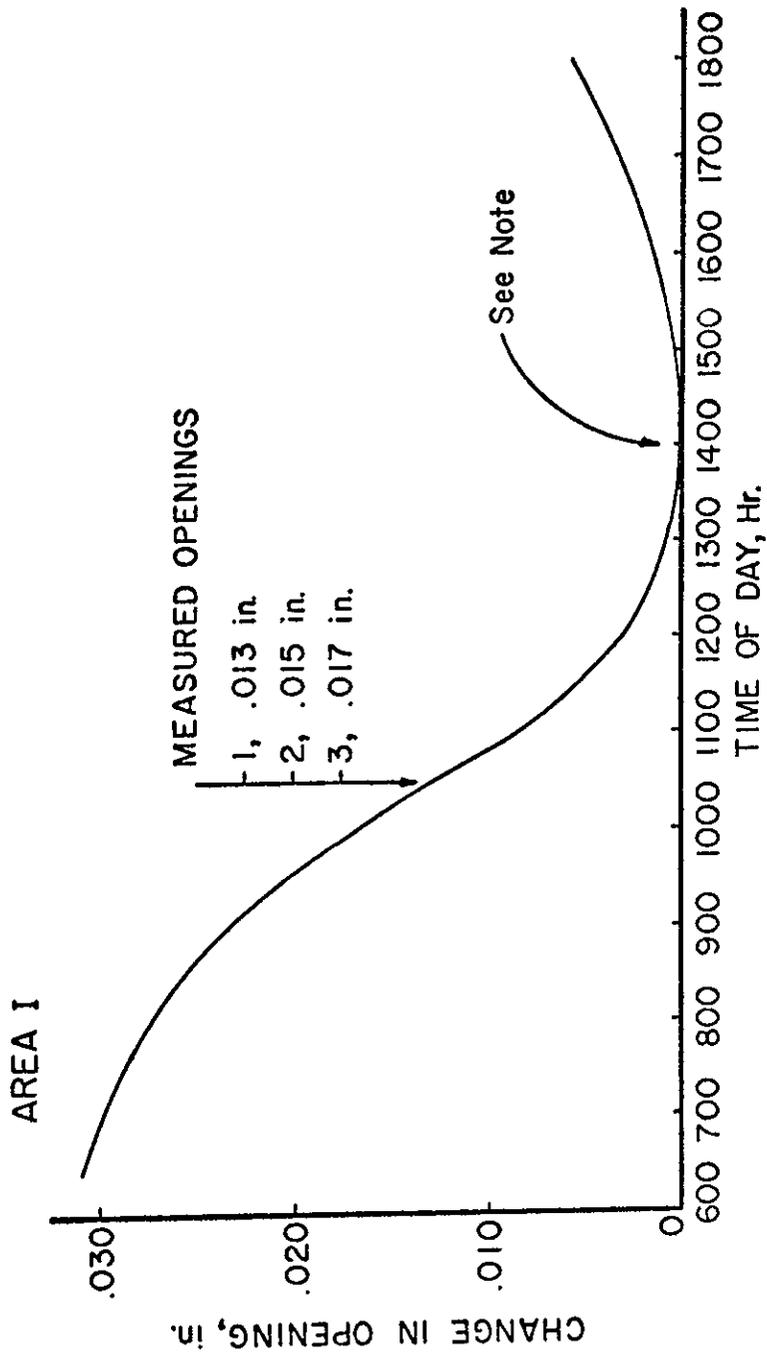
FIG.22- JOINT OPENING

A temperature increase also causes pavement slabs to expand and joint openings to close. Joint openings measured at joint No. 2 (see Table 1) at Sacramento are given in Figure 22.

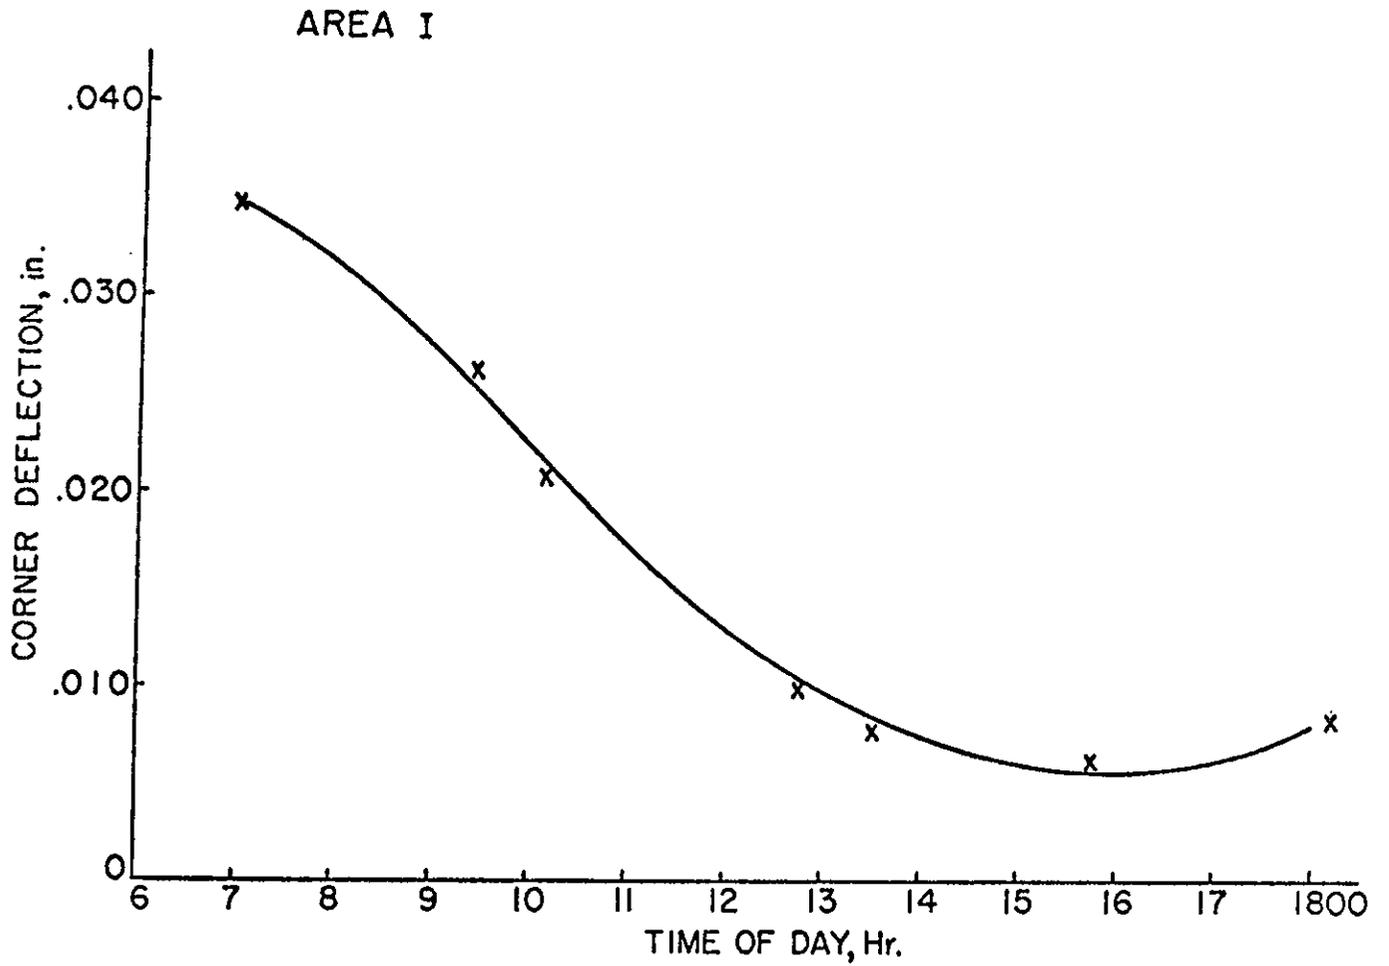
FIG.23-EFFECT OF CORNER CURL ON LOAD DEFLECTION
(CREEP SPEED)

To investigate the effect of magnitude of corner curling on load deflections and strains, moving load tests were conducted on the new pavement at Sacramento during different times of the day between 7:00 am and 6:00 pm. Load was applied by the PCA truck moving at creep speed with the outer tire tread 2 inches from the pavement edge. The axle load was 18,130 lbs. Corner deflections were measured at the three joints selected for test and strains were measured by top surface gages at the longitudinal edge 5 feet from the joints. Average deflections from at least two load tests at each joint for each time period are given in Figure 23. Load deflections decreased from 0.035-inch at 7:00 am to 0.006-inch at 3:00 pm. It was shown in Figure 21 that upward corner curl decreased 0.120-inch between 6:30 am and 2:00 pm. Thus, early morning deflections were nearly six times those obtained in the afternoon, demonstrating the very significant influence of slab curling on the magnitude of corner load deflection. Edge load strains measured during these same tests ranged from 37 to 41 micro-inch per inch and showed no correlation with time of day.

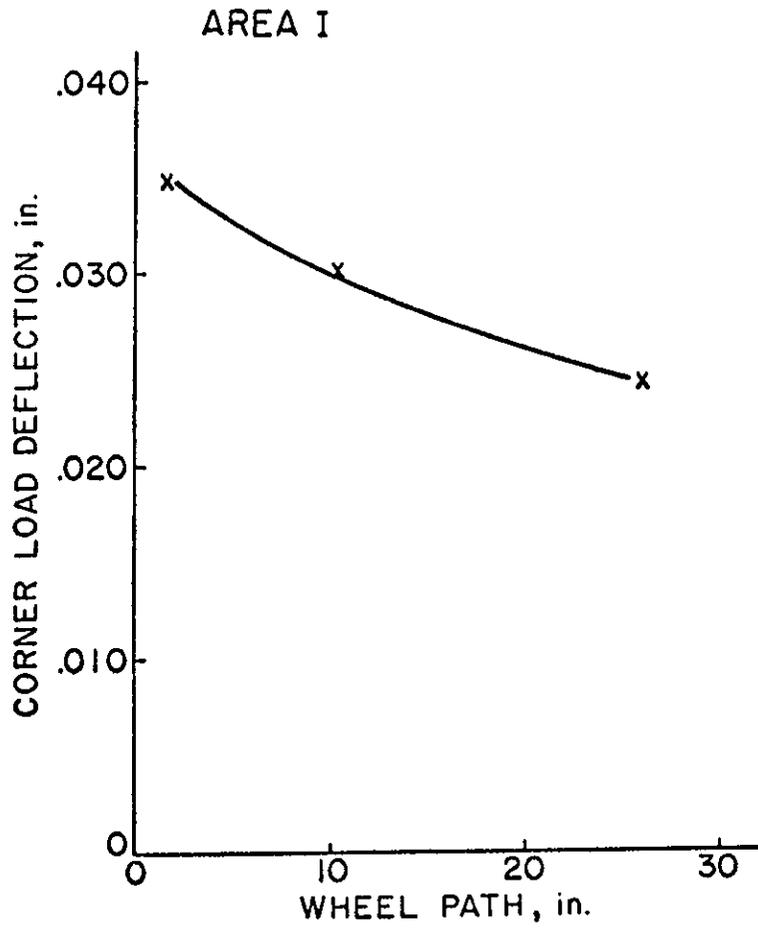
FIG.24- EFFECT OF WHEEL PATH ON
CORNER LOAD DEFLECTION
(CREEP SPEED - EARLY A.M.)

The influence of wheel path on corner load deflection and edge strain was also investigated at Sacramento. These tests were conducted in the early morning at 7:00 am. The load truck was driven at creep speed with the outer tire tread 2, 10, and 26 inches inward from the pavement edge. Average deflections from the three test joints, as given in Figure 24, indicated that values in the 26-inch wheel path were 31 percent less than those in the 2-inch wheel path. Edge load strains measured during these same tests, as given in Figure 25, indicated that values in the 26-inch wheel path were 69 percent less than those in the 2-inch wheel path.

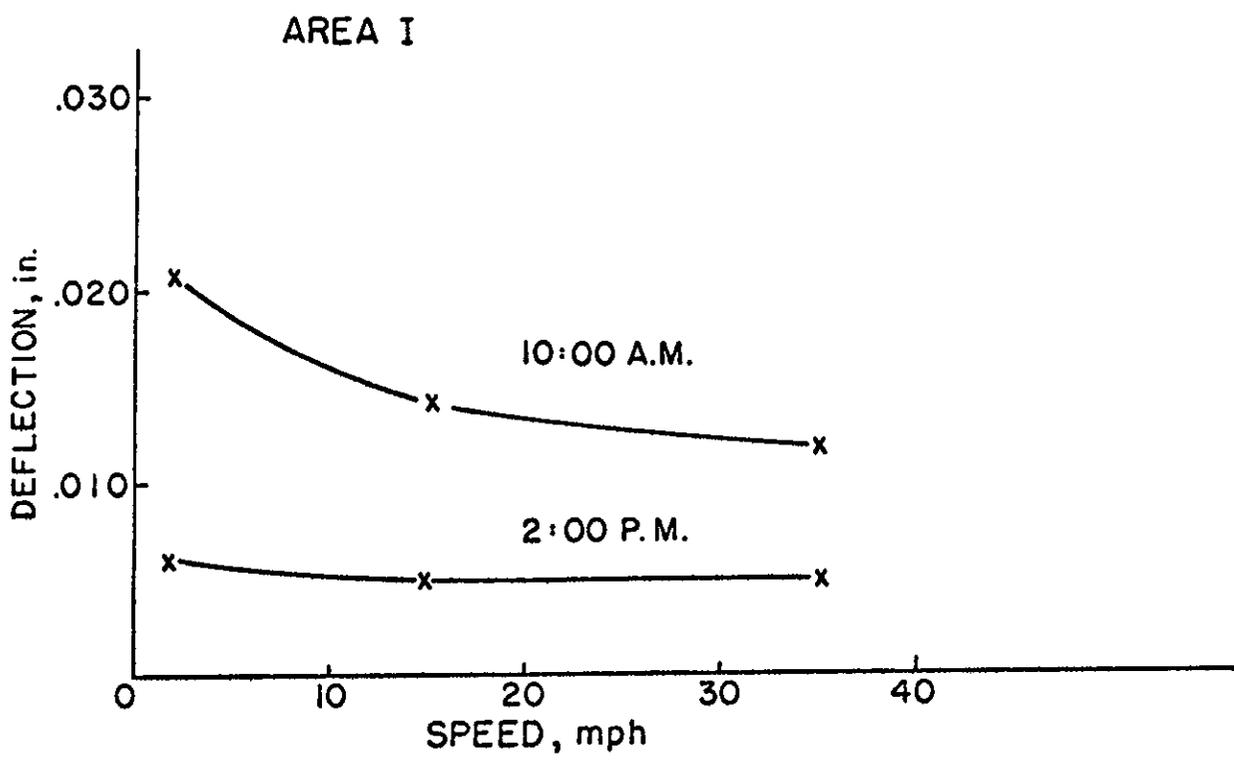
FIG.26- EFFECT OF SPEED ON LOAD DEFLECTION
(NEW PAVEMENT; 10-in. WHEEL PATH)

The influence of vehicle speed on corner load deflection and edge strain was also investigated at Sacramento. These tests were conducted at both 10:00 am and 2:00 pm. The load truck was driven at speeds up to 35 mph with the outer tire tread 10 inches inward from the pavement edge. Average deflections from the three test joints, as given in Figure 26, indicated that late morning load deflections decreased 43 percent as speed increased from 2 to 35 mph. By comparison, the early afternoon deflections decreased only 17 percent as speed increased from 2 to 15 mph and then remained unaffected by additional increase in speed. Edge load strains measured during these same tests, as given in Figure 27, indicated that strains decreased 30 percent as speed increased from 2 to 35 mph. As previously stated, strains measured in the early

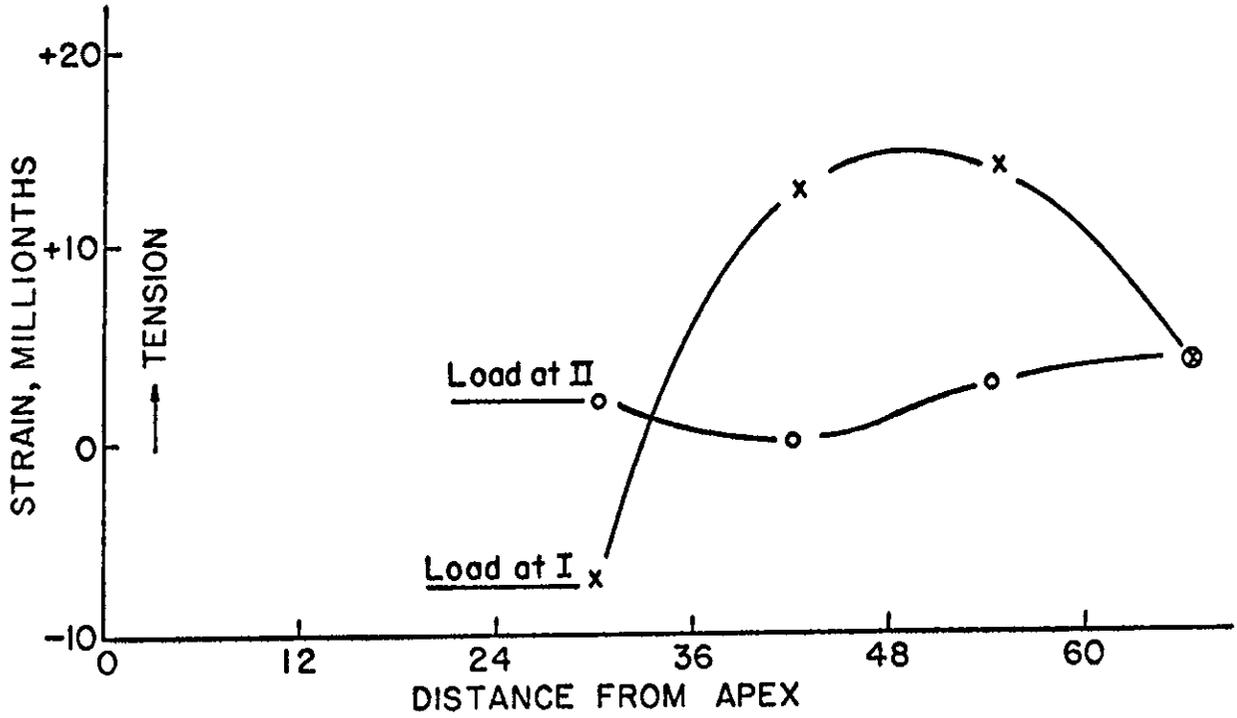
FIG.30- LOAD STRAIN ALONG CORNER BISECTOR

At Truckee, load tests were conducted at 10:00 am on the approach slab and at 1:00 pm on the leave slab. Load-strain results for each load position at Truckee are shown in Figure 30. Maximum strain was located approximately 4 and 5 feet from the apex of the approach and leave corner, respectively. Maximum strains in the morning on the approach slab were approximately 15 micro-inch per inch and maximum strains in the afternoon on the leave slab were approximately 5 micro-inch per inch. These values are about one-half of the maximum strains measured at Sacramento.
