Evaluation Of Grooved Traffic Stripes On Portland Cement Concrete Highways

EVALUATION OF GROOVED TRAFFIC STRIPES ON PORTLAND CEMENT CONCRETE HIGHWAYS

CA-HY-MR-5193-1-72-31

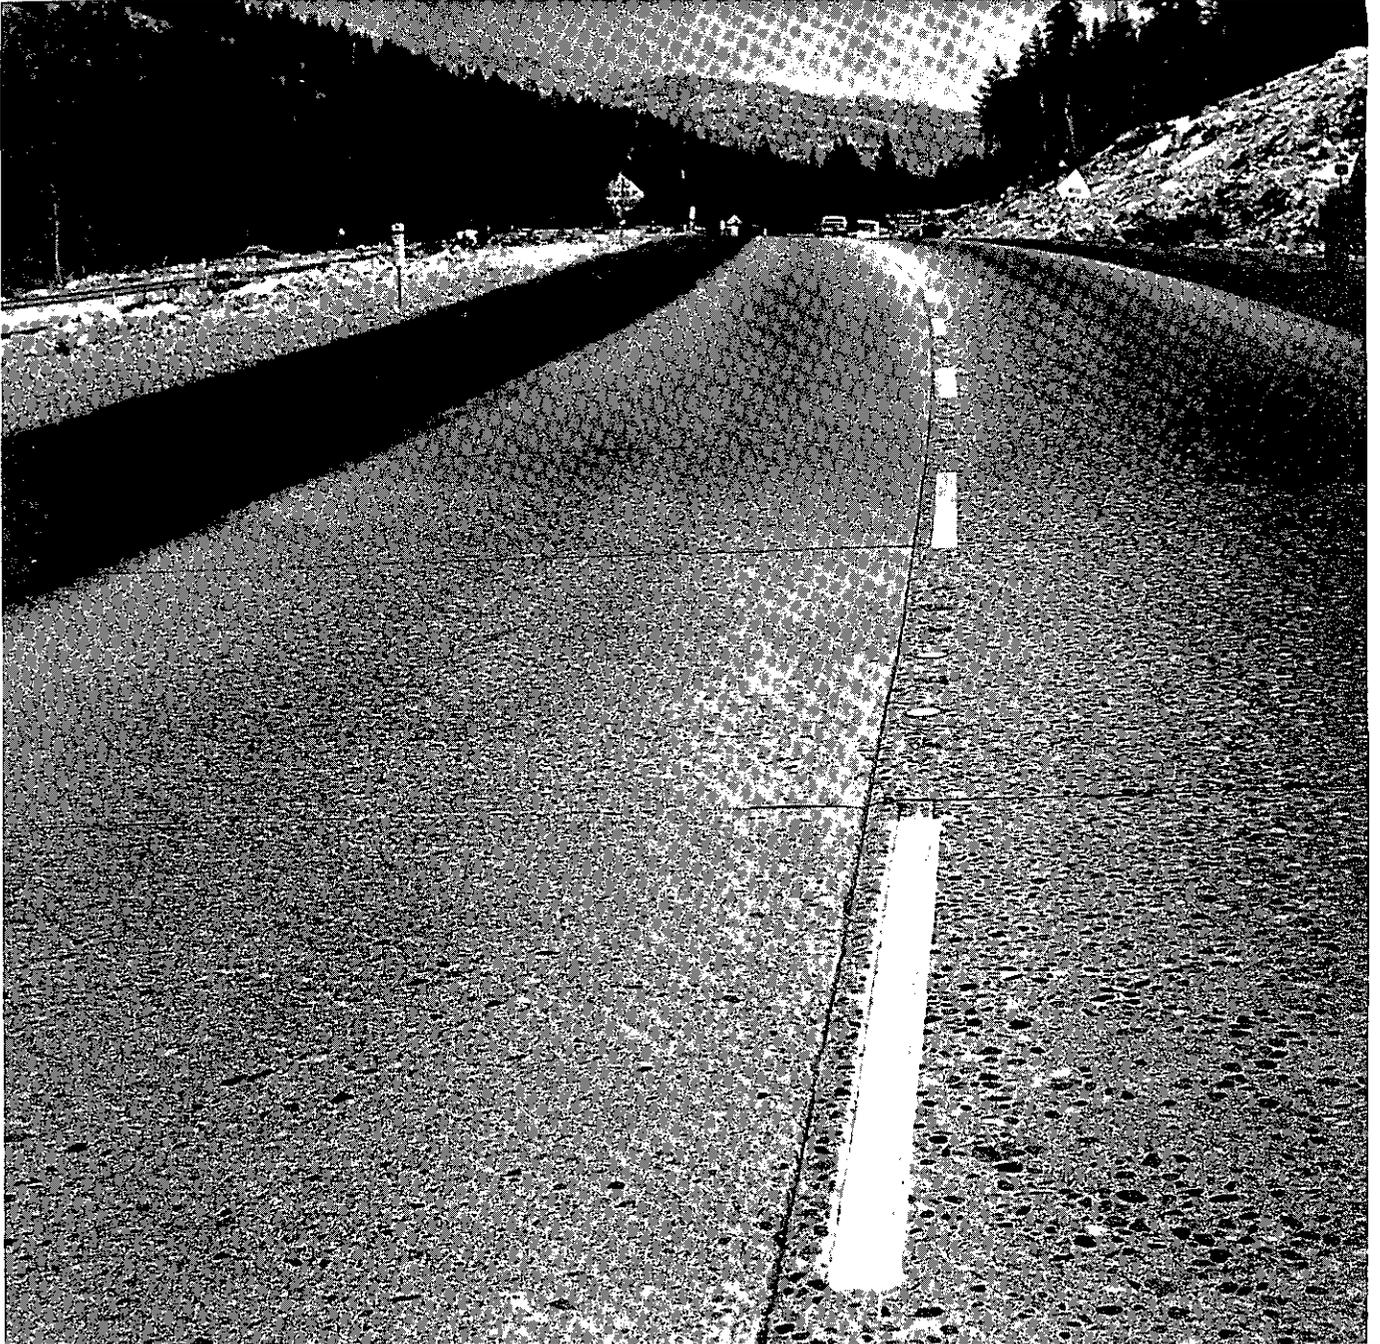
Figure 2

Transverse drainage cuts were made on the eastbound section only from PM 111 to 1/4-mile east. Two cuts were made for each 9-foot grooved line at right angles to the groove and toward the shoulder. Each transverse groove was 2 feet in length and took about 5 seconds to cut (Figure 2).

Grooved Traffic Line Showing Transverse Cut
