FHWA-CA-TL-78-13

2. GOVERNMENT ACCESSION No.**3. RECIPIENT'S CATALOG No.****4. TITLE AND SUBTITLE**Vehicular Impact Tests of Precast Concrete Median Barriers
With Corrugated Ends And Tensioned Cables**5. REPORT DATE**

R.L. Stoughton, D.M. Parks, J.R. Stoker and E.F. Nordlin

9. PERFORMING ORGANIZATION NAME AND ADDRESSOffice of Transportation Laboratory
California Department of Transportation
Sacramento, California 95819**10. WORK UNIT No.****11. CONTRACT OR GRANT No.**

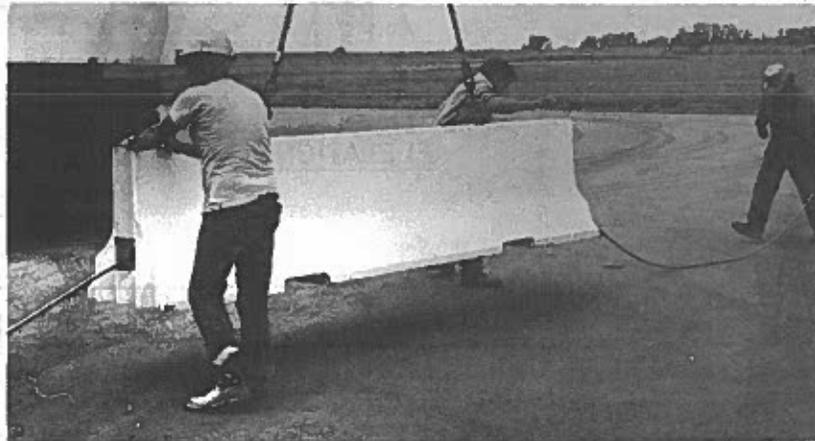
Figure 1, Typical Test Barrier Segment

Figure 1 shows a typical test barrier segment. Key structural elements and design features for each test barrier are shown in Figure 2 for comparison. Complete details of the test barriers are contained in the Appendix, Figure 15A.

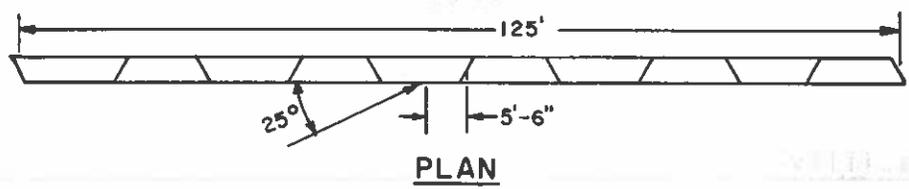
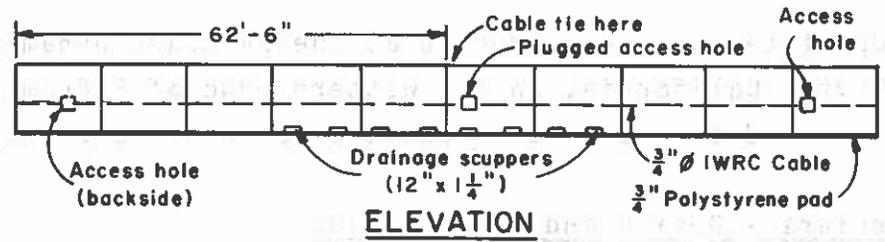
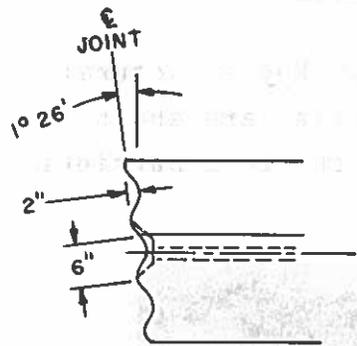
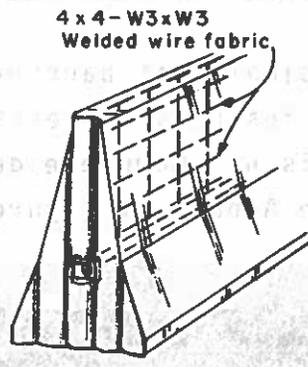
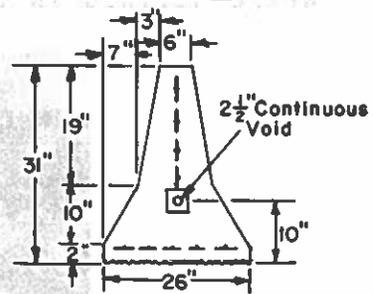
Figure 2, PRECAST TYPE 50V CONCRETE MEDIAN BARRIER DESIGNS (1,2)

- 12'-6" Barrier segments
- Corrugated vertical concrete shear key
- Welded wire fabric: (4x4-W3xW3) 16"x12'-0" placed vertically along \bar{C} & 20"x36" placed above drainage scuppers.
- Cable tie at middle of barrier
- Barrier placed on continuous $\frac{3}{4}$ "x26" polystyrene pad (1-lb/ft³)
- Cable tension prior to impact:
Upstream-17,640lbs.
Downstream-14,780lbs.
- Temporary barrier installation

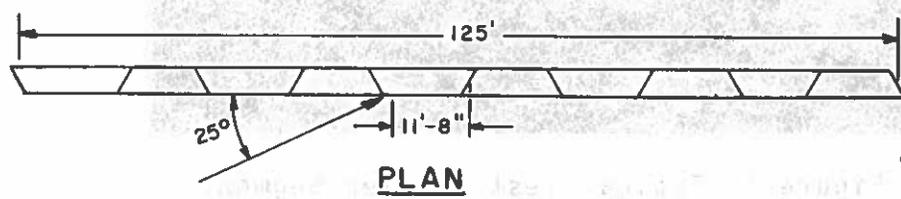
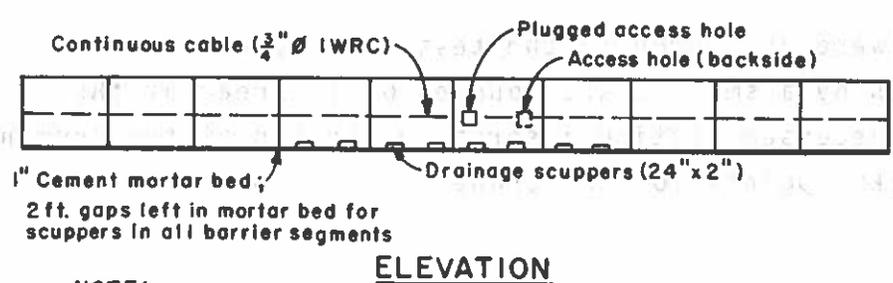
- 12'-6" Barrier segments
- Corrugated vertical concrete shear key
- Welded wire fabric: (4x4-W3xW3) 16"x12'-0" placed vertically along \bar{C} & 20"x12'-0" placed above drainage scuppers.
- Barrier placed on 1" cement mortar bed
- Continuous cable
- Cable tension prior to impact 4,880lbs.
- Permanent barrier installation

NOTE:
The plan and elevation views of the end of the barrier segments and the typical section are the same as those shown for test 331 except as noted in design features.

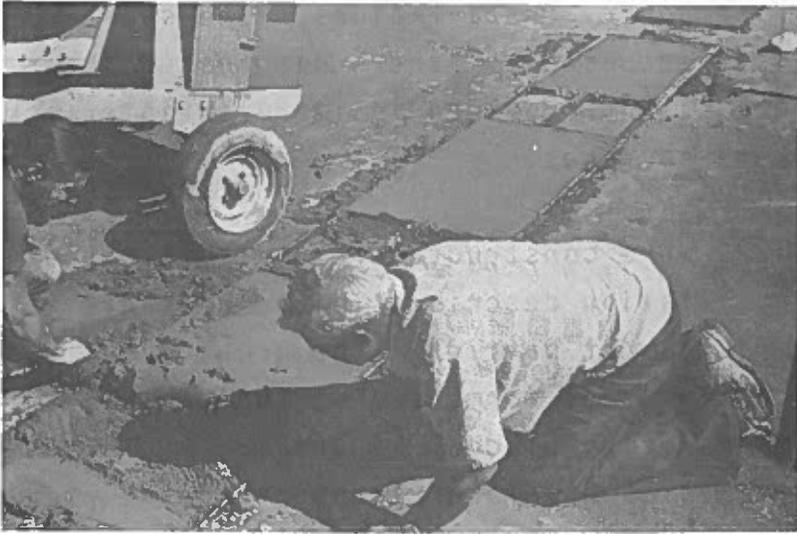
Figure 4. Grout Bed Construction, Test 332.

Grout pads used for Test 332 were constructed in the same manner as those for the field installation described in the Appendix in an attempt to exactly simulate that barrier. The grout was mixed in a small mixer and placed in steel forms two or three barrier lengths ahead of the segments being placed, Figure 4. The AC pavement was swept but not wet down before placement of the grout. The grout was fairly stiff and as noted by post test observations did not slump enough to achieve active contact over the complete bottom area of all barrier segments. No leveling blocks were used to control segment height above ground.

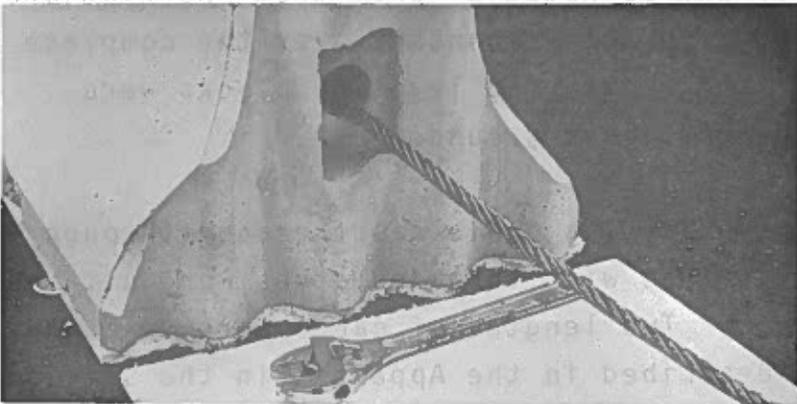
Figure 5. Cable Threaded Through Barrier Segment.

As the segments were being placed, a cable was threaded through them, Figure 5. Swaged fittings with threaded stubs were attached to the cable ends, Figure 6. Two lengths of cable were used and spliced at mid-length as described in the Appendix in the section on electronic instrumentation. Steel bearing plates and nuts were used to tension the cables. The tightening was done with a large crescent wrench, Figure 5. For Test 331 a long steel pipe was used over the wrench to increase leverage. Considerable effort was required by two husky workers to reach the final cable tension. For Test 332 the cable was tensioned using the wrench without a pipe extension. It was tightened only to the point where extra effort was needed which simulated the tensioning method used for the field installation.

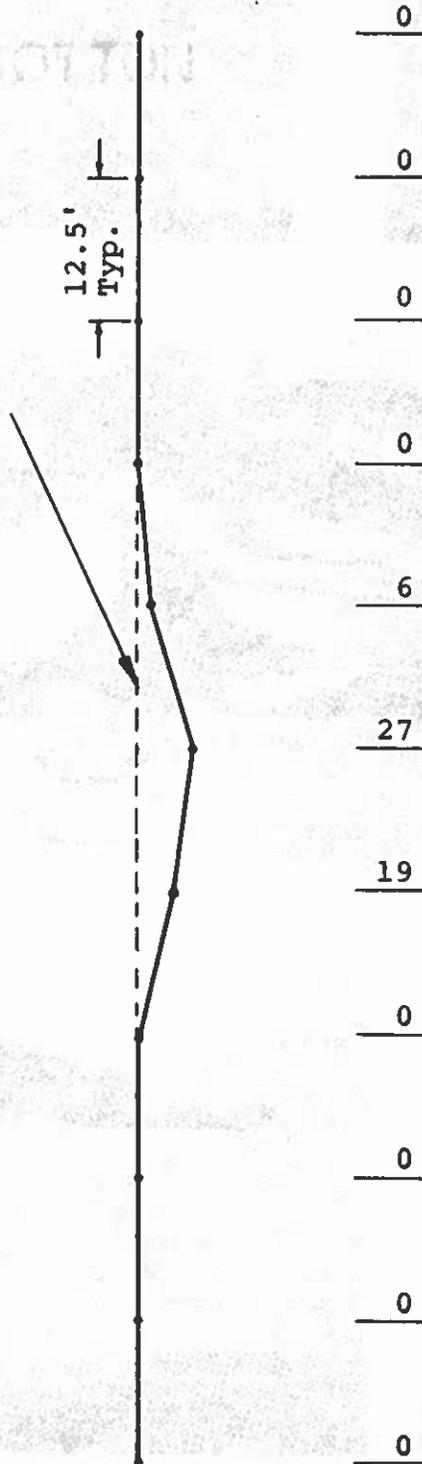
TEST 331

- A lateral barrier deflection of 27 inches (0.69 m) caused the test vehicle to become airborne and straddle the top of the barrier following initial impact.
- Extensive concrete spalling occurred at the corners of the barrier segments.
- The continuous expanded polystyrene pads used to provide base restraint did little to prevent barrier movement.
- Even though the tensioned cable absorbed an added average load of 9400 lbs (41.8 kN) during impact, it did not prevent barrier movement.

b. Barrier Movement and Damage - Four barrier segments were displaced laterally during impact. Maximum deflection of 27 inches (0.69 m) occurred at joint 5, the first joint downstream from the point of impact, Figure 7. Analysis of the high speed film data revealed the barrier segments tilted back less than 6° (0.11 rad) during impact. The barrier deflection data in Figure 12A which are reliable for the initial portion of the impact confirm that there was minimal tilting.

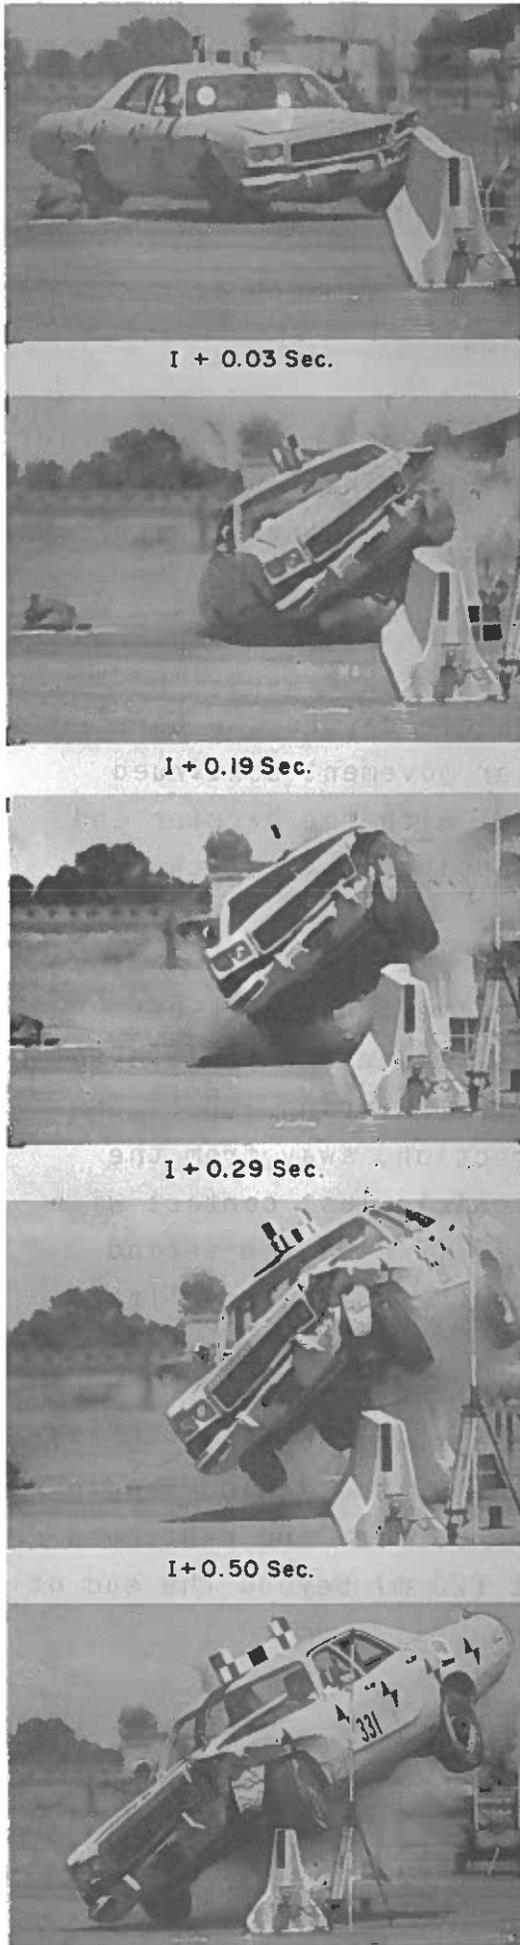
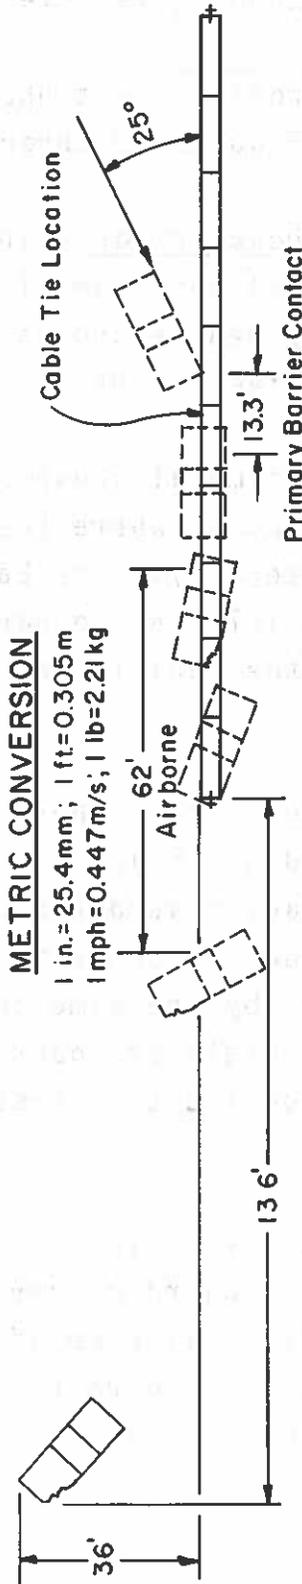
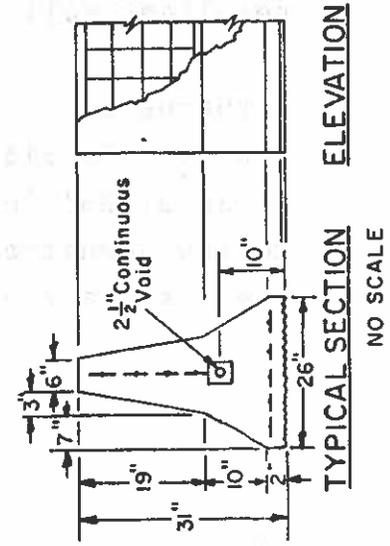
Figure 12,

Test No. 331
 Date 5/4/77
 Vehicle 1973 Dodge Polara
 Vehicle wt. 4680 lbs. (w/dummy & Instrumen.)
 Impact speed. 63 mph
 Impact angle. 25°
 Vehicle Damage: TAD...LFQ-5 VDI-10LFEW3

Barrier Unanchored Precast Type 50V CMB on continuous polystyrene with cable tie joint connection 2-in deep corrugated vertical shear key with 6 in. pitch Segment/barrier lengths ft. 12.5/125 Cable tensions (upstream/downstream) Load before impact, lbs. 17,640/14,780 Max. Load increase during impact. 10,000/8,800 Max. Perm. lateral joint displ. 27 in Vehicle deceleration (max. 50m sec. avg) Lateral 5.0g's Longitudinal 4.5g's Dummy restraint Lap belt Max. Vehicle rise/roll. 6.2ft/32°

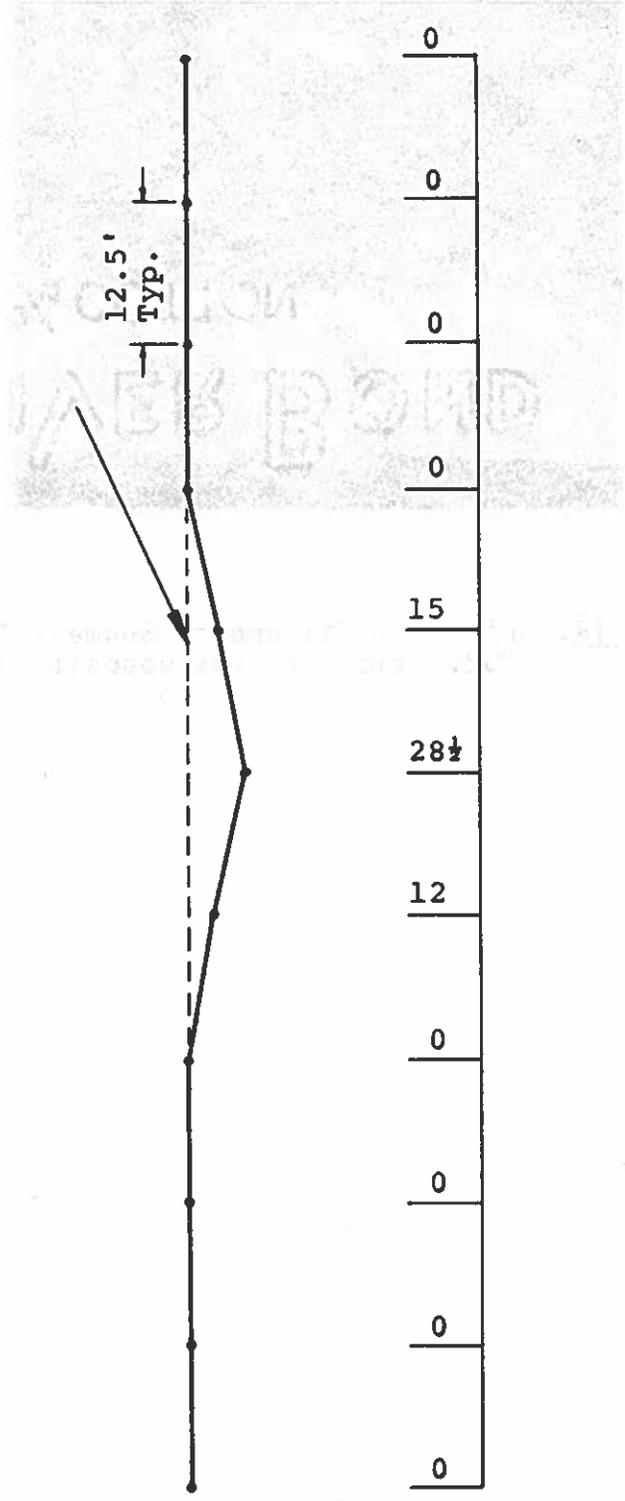
TEST 332

- Maximum lateral deflection of 28 1/2 inches (0.72 m) occurred during impact.
- The vehicle trajectory also probably would have been hazardous, similar to Test 331, if the test vehicle had not run over the cable guidance post prior to impact, causing the vehicle to roll toward the barrier.
- A flexural failure occurred in one of the barrier segments along with extensive concrete spalling at the corners of the barrier segments.
- There was poor bonding between the grout bed and the bottom of the test barrier. The grout bed as designed and built was ineffective in providing restraint for the barrier against lateral movement.
- The tensioned cable did not significantly help to restrain the barrier against lateral movement.

b. Barrier Movement and Damage - Four barrier segments were displaced laterally during the impact. Maximum deflection of 28 1/2 inches (0.72 m) occurred at joint 5, the first joint downstream from the point of impact, Figure 13. Analysis of the high speed film data revealed the barrier segments did not appear to tilt back at all during impact.

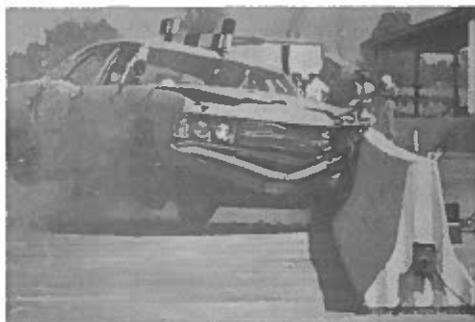
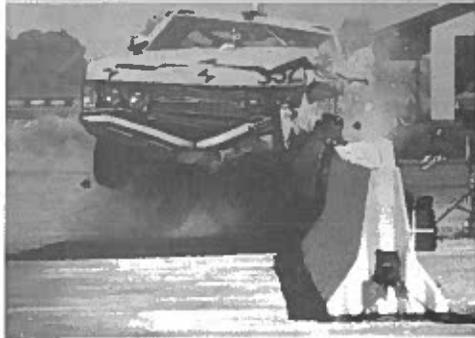
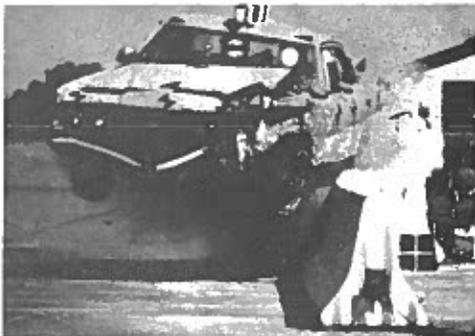
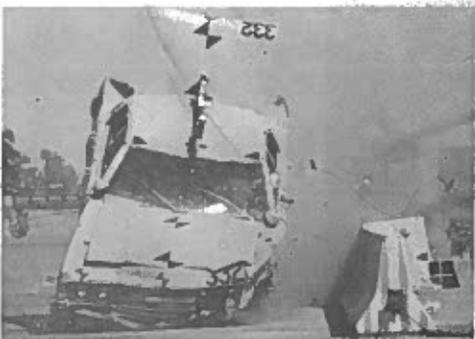
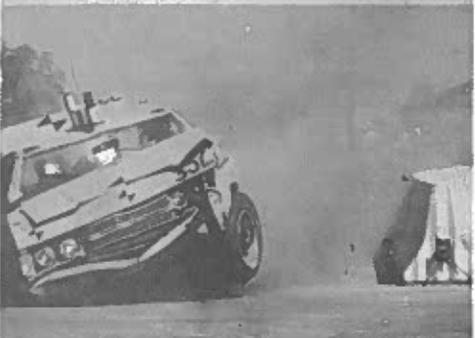
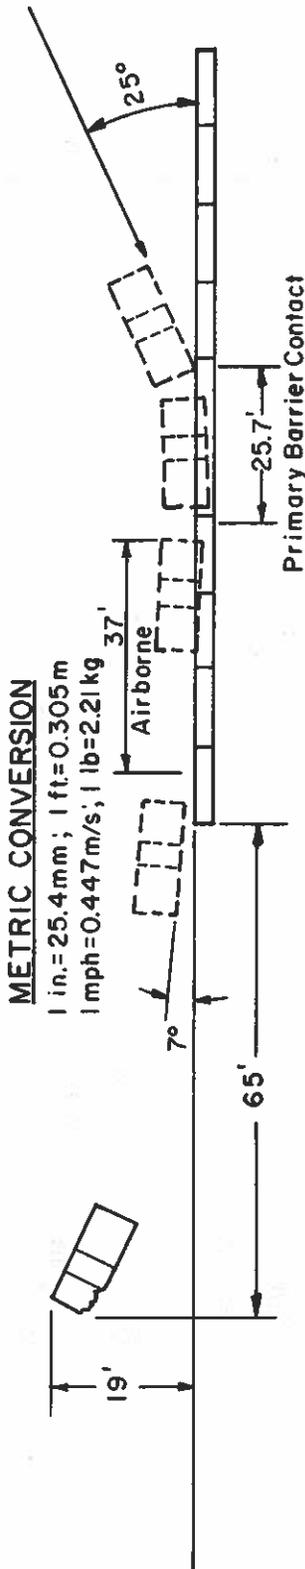
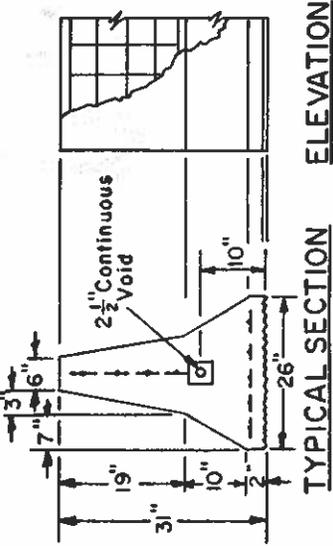
Figure 19,

Barrier . . . Precast Type 50 V CMB on 1" Grout Pad
 with continuous 3/4" Ø WRC Cable
 Joint Connection . . . 2-in. deep corrugated
 vertical shear key with 6-in. pitch
 Segment/barrier lengths, ft. 12.5/125
 Cable Tension
 Load before impact, lbs. 4880
 Max. load increase during impact, lbs. 2720
 Max. Perm. lateral joint displ. 28.5 in
 Vehicle Acceleration (max. 50m sec. avg.)
 Lateral 9.0g's
 Longitudinal 4.9g's
 Dummy Restraint Lap belt
 Max. Vehicle Rise/Roll 5.3ft/-13°

Test No. 332
 Date 10/4/77
 Vehicle 1970 Ford
 Mercury Monterey
 Vehicle wt. 4600 lbs
 (w/dummy & instrument)
 Impact speed 60 mph

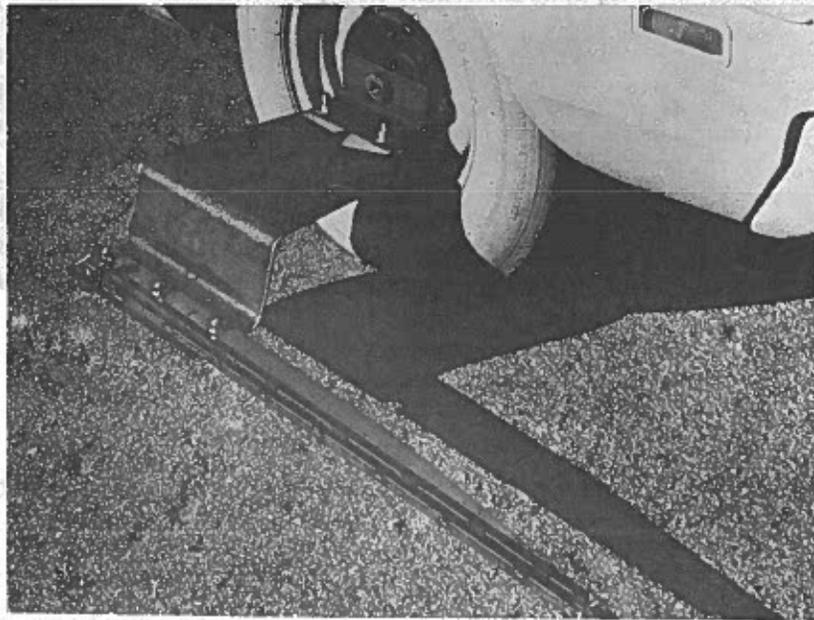
Figure 1A, Slipbase Guide Bracket Used for Test 331

7. A cable guidance system was used to direct the vehicle into the barrier. The guidance cable, anchored at each end of the vehicle path, passed through a slipbase guide bracket, Figure 1A, bolted to the spindle of the right front wheel of the vehicle. A steel angle bracket, Figure 2A, anchoring the end of the cable closest to the barrier to a concrete footing, projected high enough to knock off the guide bracket, thereby releasing the vehicle from the guidance cable prior to impact.

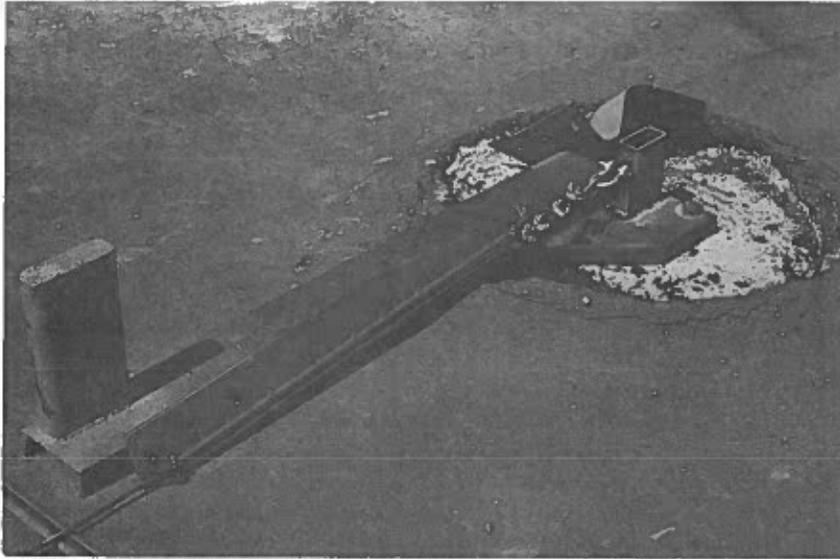
Figure 2A, Steel Knockoff Bracket

Prior to impact the right front wheel rode over the knock-off post for the cable guidance bracket. This caused the vehicle to roll about 13° (0.23 rad) toward the barrier. During impact the vehicle typically rolled the opposite direction, away from the barrier. Consequently, by the time the vehicle lost contact with the barrier at an exit angle of about 7° (0.12 rad) the second rolling motion had cancelled the first and there was very little resultant roll.

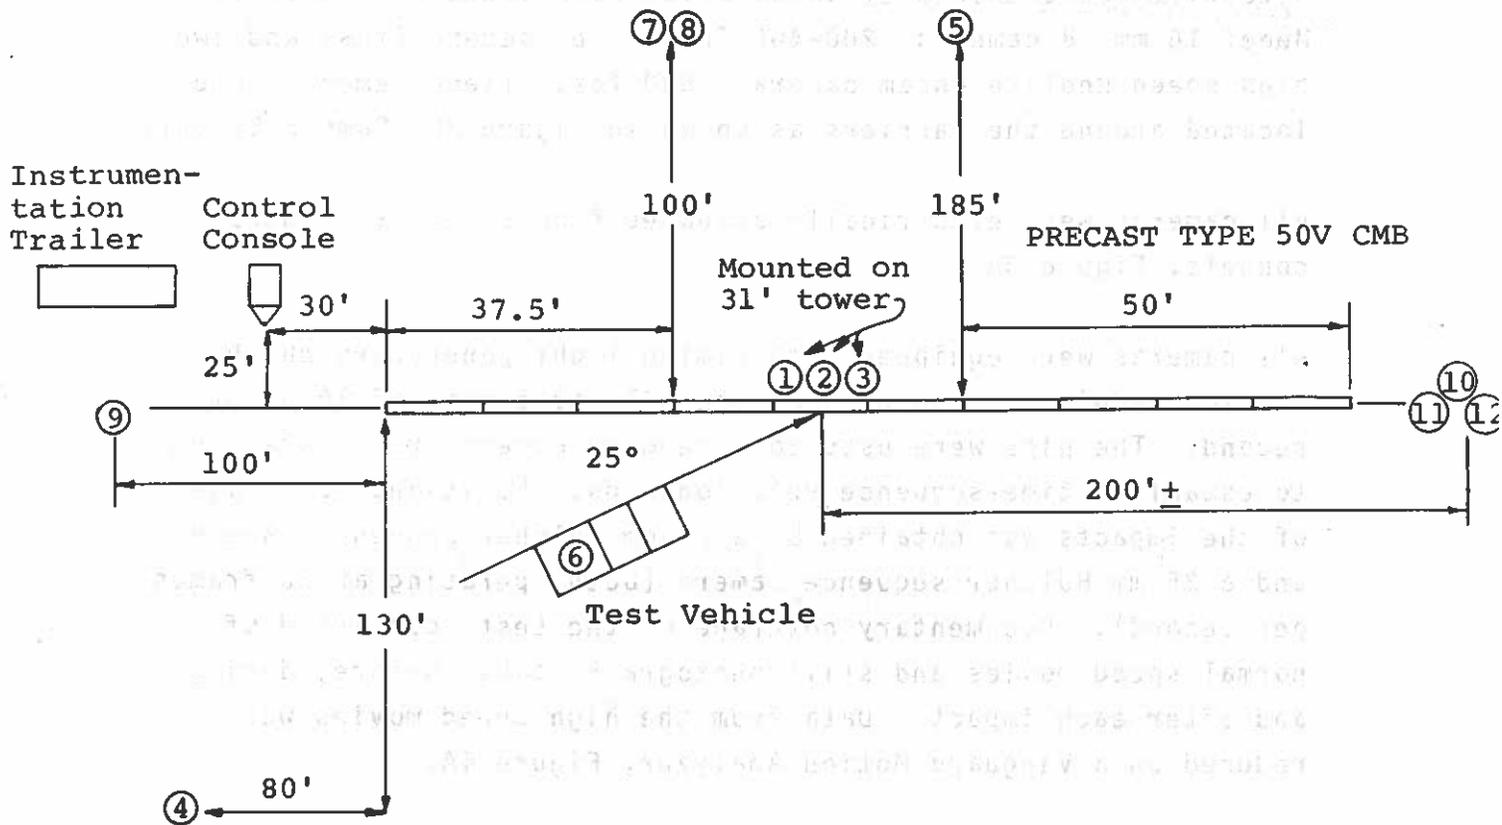
Figure 3A. CAMERA LAYOUT³

Data film was obtained by using seven high speed Photo-Sonics Model 16 mm-1B cameras, 200-400 frames per second (fps) and two high speed Redlake Locam cameras, 500 fps. These cameras were located around the barriers as shown in Figure 3A, Camera Layout.

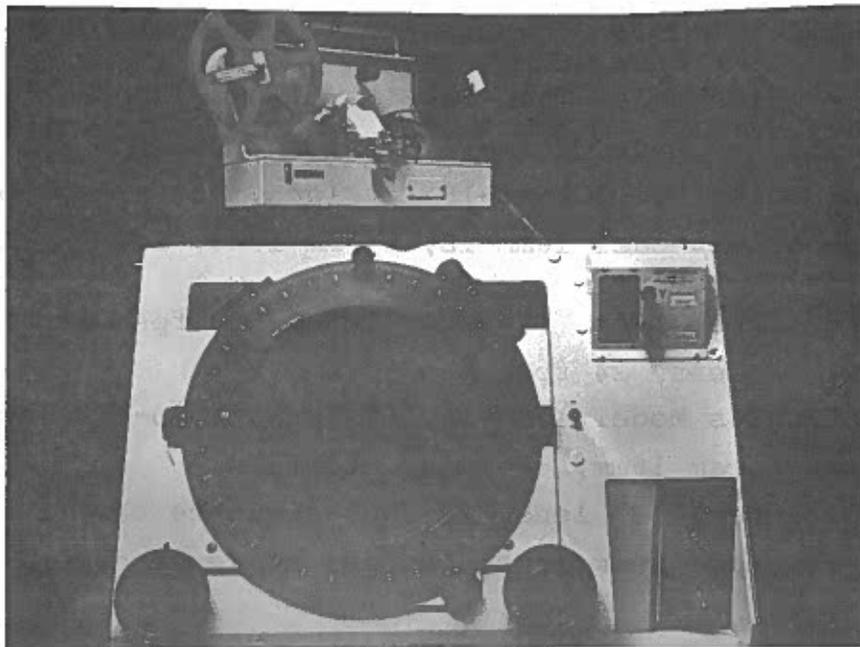
Figure 4A, Vanguard Motion Analyzer

All cameras were equipped with timing light generators which exposed reddish timing pips on the film at a rate of 1000 per second. The pips were used to determine camera frame rates and to establish time-sequence relationships. Additional coverage of the impacts was obtained by a 70 mm Hulcher sequence camera and a 35 mm Hulcher sequence camera (both operating at 20 frames per second). Documentary coverage of the tests consisted of normal speed movies and still photographs taken before, during, and after each impact. Data from the high speed movies was reduced on a Vanguard Motion Analyzer, Figure 4A.

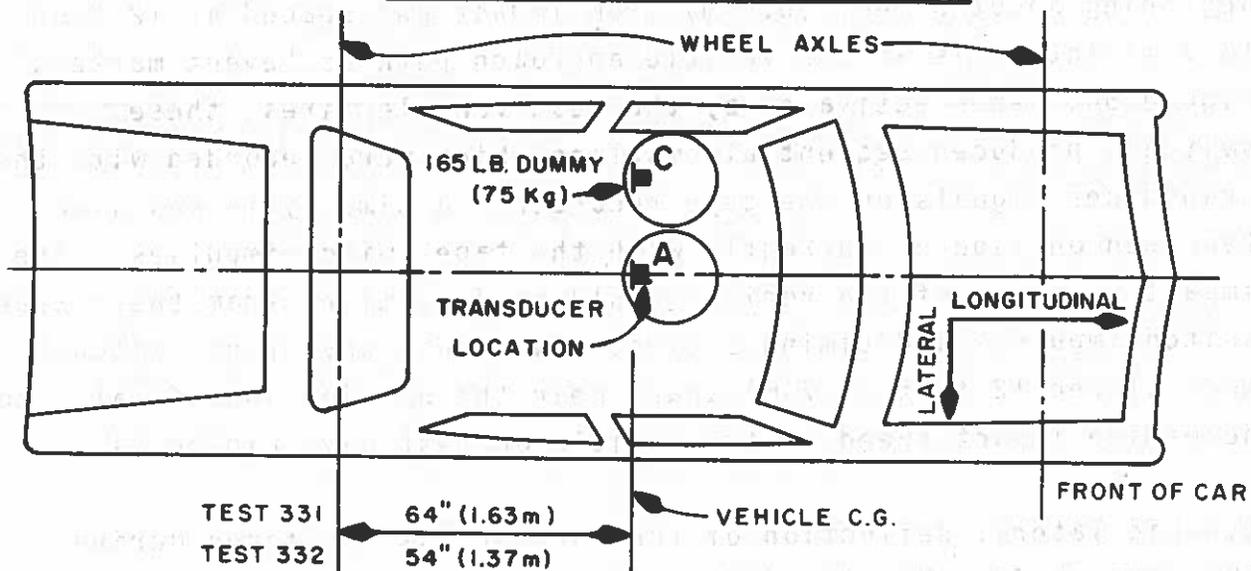
Figure 6A, VEHICLE INSTRUMENTATION

Figure 6A shows the locations of all transducers mounted in the test vehicles. A total of four Statham accelerometers, of the unbonded strain gage type, and three Endevco Model 2262-200 piezo-resistive accelerometers were used for deceleration measurements. Three were mounted in the head cavity of the anthropomorphic dummy. The other accelerometers were mounted on the floorboard of the test vehicle. One seat belt transducer was installed on the dummy's lap belt for each test.

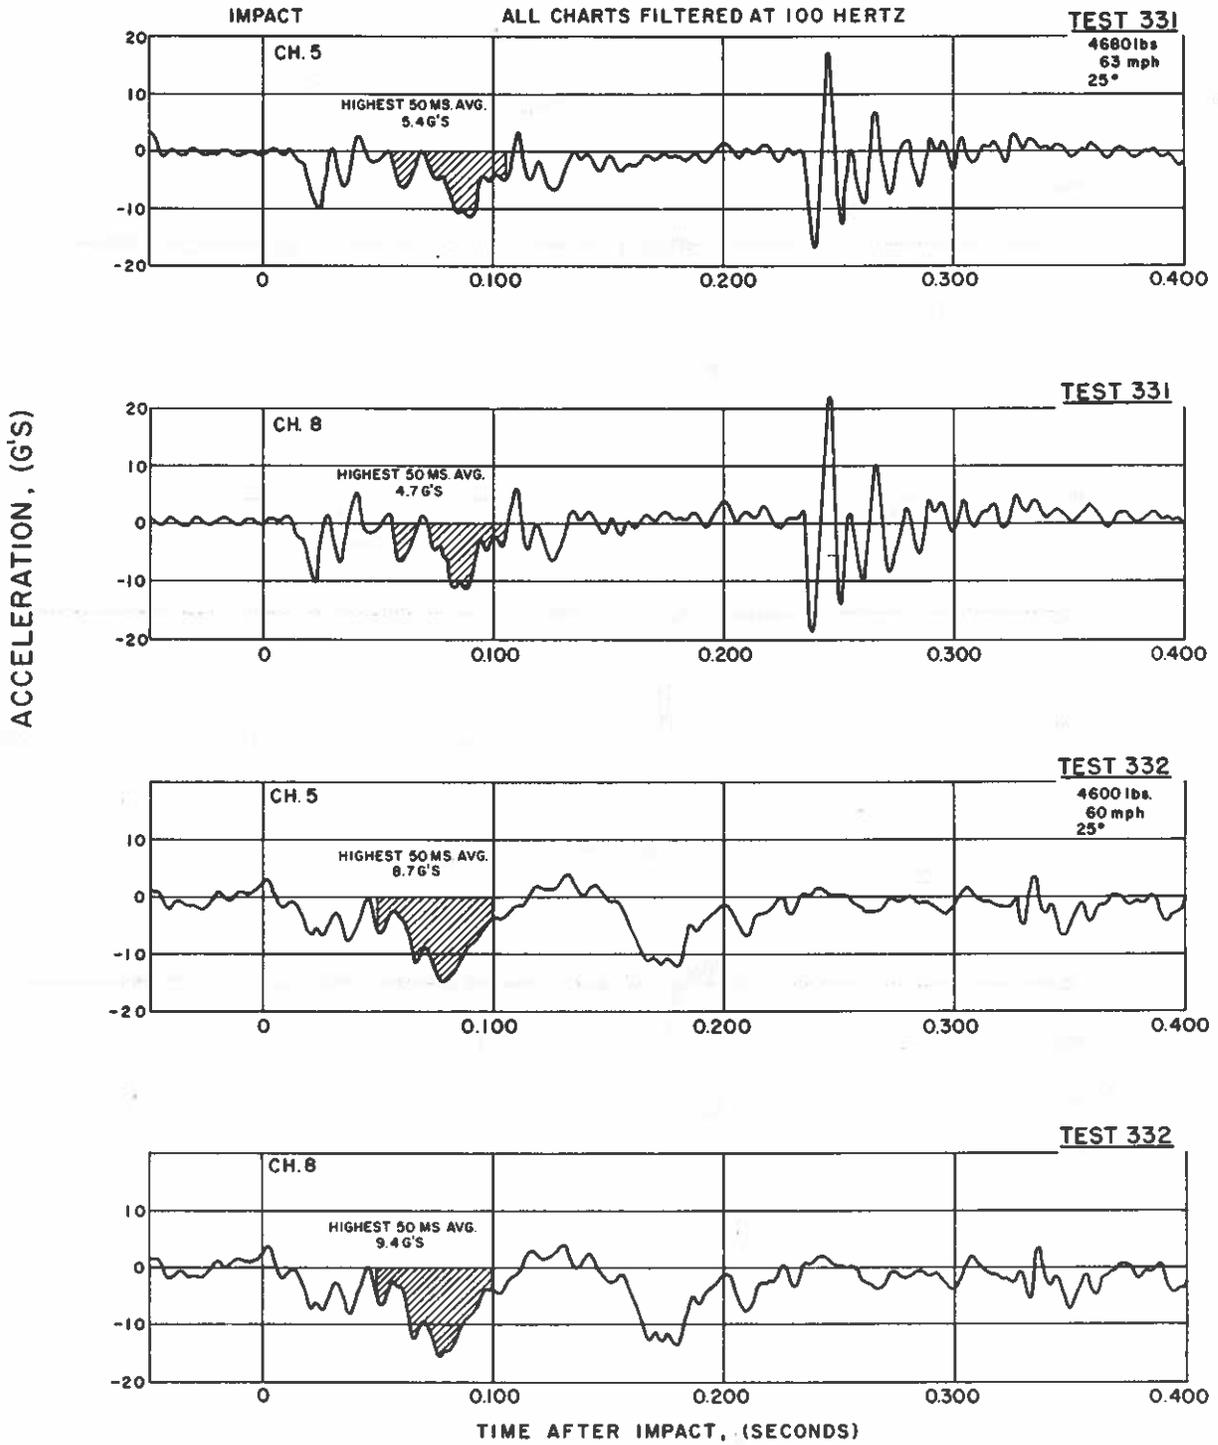
Figure 9A, DUMMY ACCELERATION VS TIME

Use of a dummy is considered optional in NCHRP Report 153. An anthropomorphic dummy was used in both tests, and the electronic data from them is included as a further indication of impact severity. Deceleration versus time traces for accelerometers mounted in the head cavity of the dummy are included in the Appendix as Figures 9A and 10A. Lap belt load versus time traces are also contained in the Appendix as Figure 11A. None of the lap belt loads exceeded the 5,000 lb (22.3 kN) limit specified by Federal Motor Vehicle Safety Standard 208 which is a guideline cited in NCHRP Report 153. It is unclear why the maximum lap belt load in Test 332 was so much higher than that for Test 331. This may be due simply to the peculiarities of the vehicle trajectories.

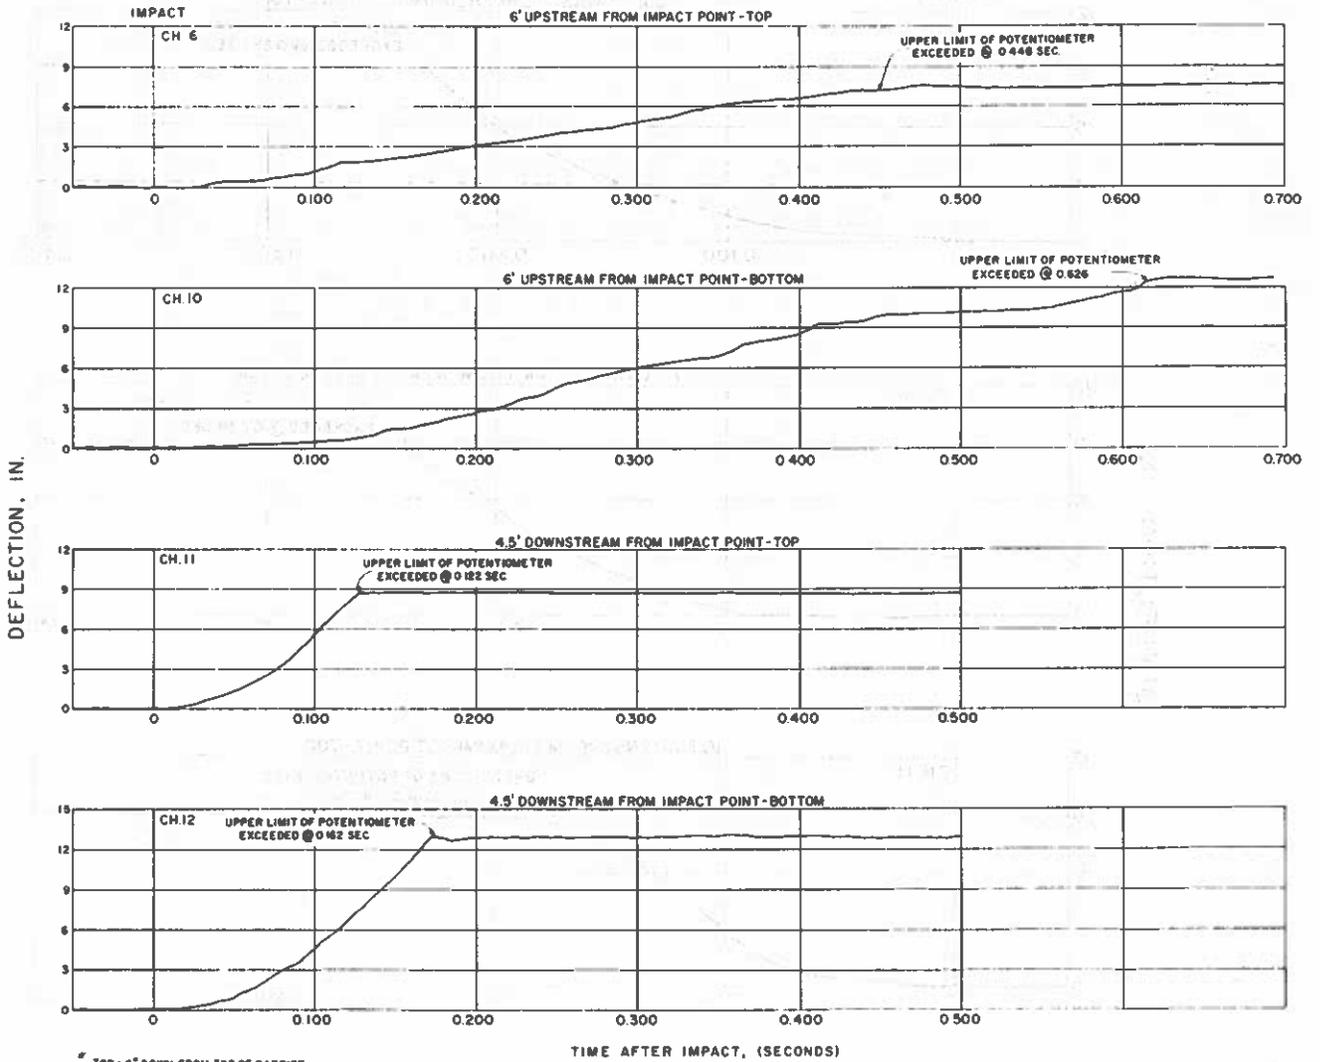
Figure 12A, BARRIER DEFLECTION VS TIME*

TEST 331. 4680lb. VEHICLE, 63 mph. 25°
 PRECAST TYPE 50V CONCRETE MEDIAN BARRIER
 WITH TENSIONED CABLE
 ALL DATA UNFILTERED
 HOUSTON DEFLECTION POTENTIOMETERS*

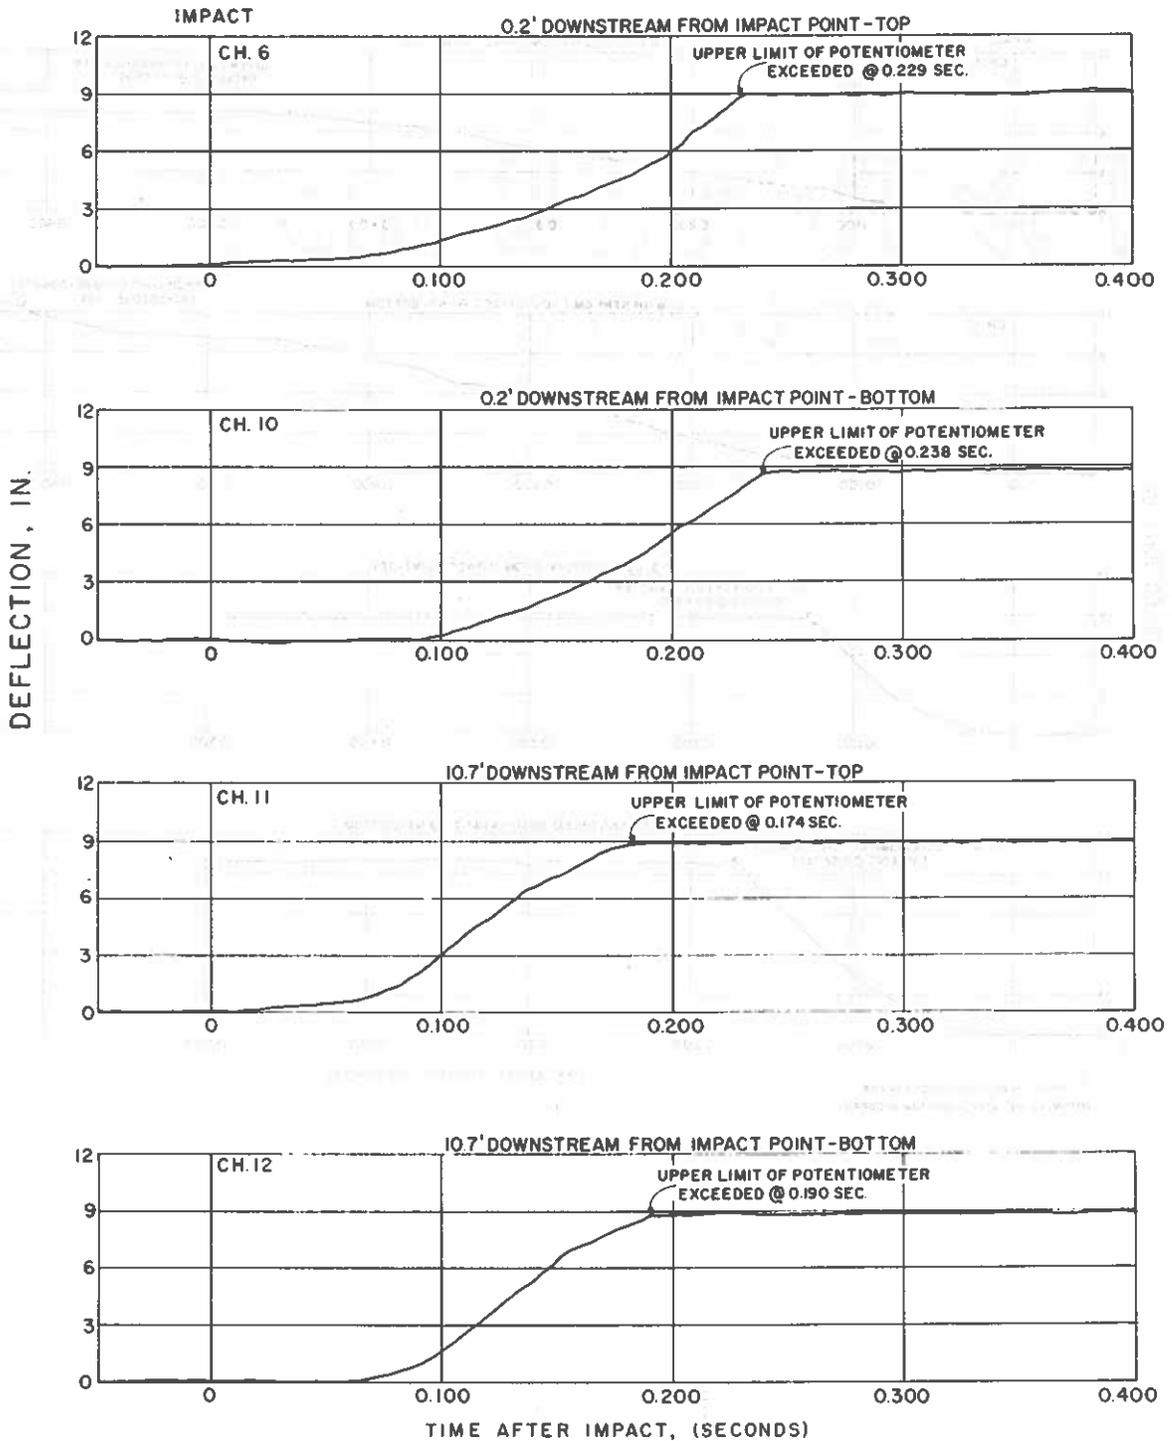
Figure 13A, BARRIER DEFLECTION VS TIME

TEST 332. 4600 lb. VEHICLE, 60 mph, 25°
 PRECAST TYPE 50V CONCRETE MEDIAN BARRIER
 WITH TENSIONED CABLE

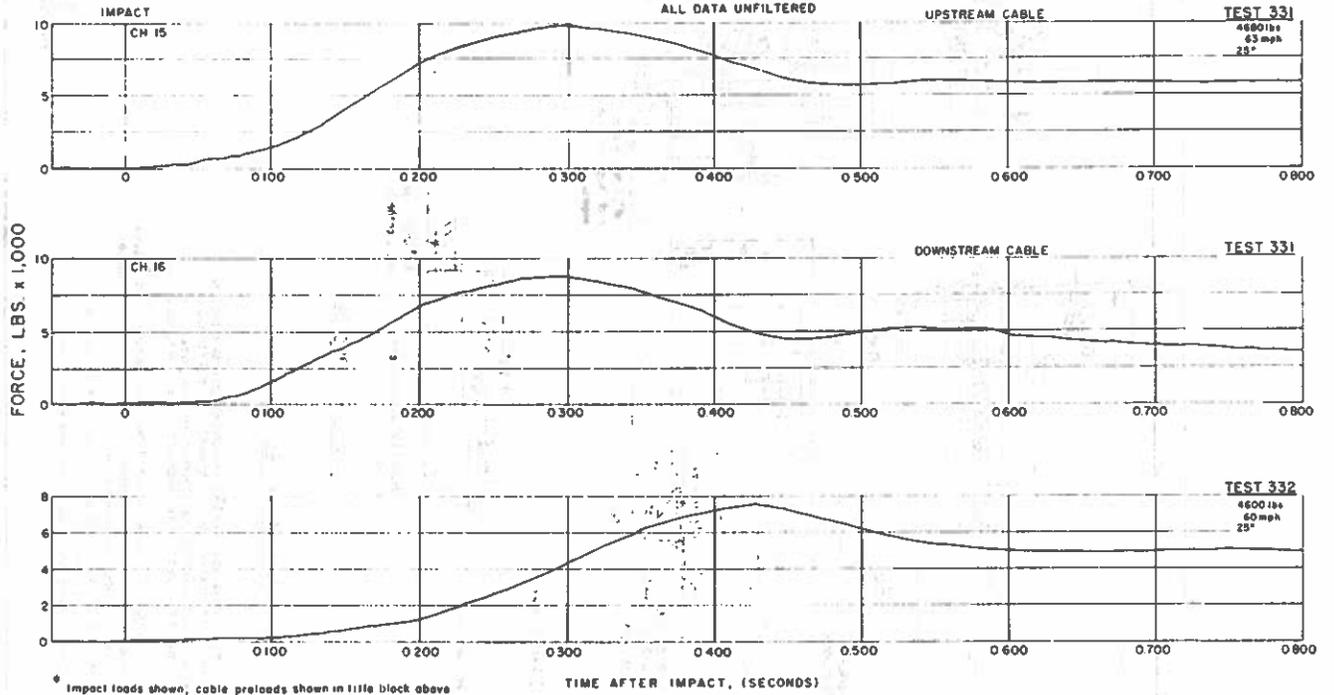
Figure 14A, LOAD IN 3/4" Ø IWRC CABLE VS TIME*

The upstream and downstream sections of cable which was spliced at mid-length had an increase in load of 10,000 lbs (44.5 kN) and 8,800 lbs (39.2 kN) respectively as they stretched into the deflected barrier profile. Load data is contained in Figure 14A in the Appendix. The reason for the load differences in the cable is contained in the Appendix under Electronic Instrumentation.
