FHWA/CA/TL-81/14

Vehicular Impact Tests of Breakaway Wood Supports for Dual-Support Roadside Signs

R. L. Stoughton, J. R. Stoker, and E. F. Nordlin

Office of Transportation Laboratory
California Department of Transportation
Sacramento, California 905819

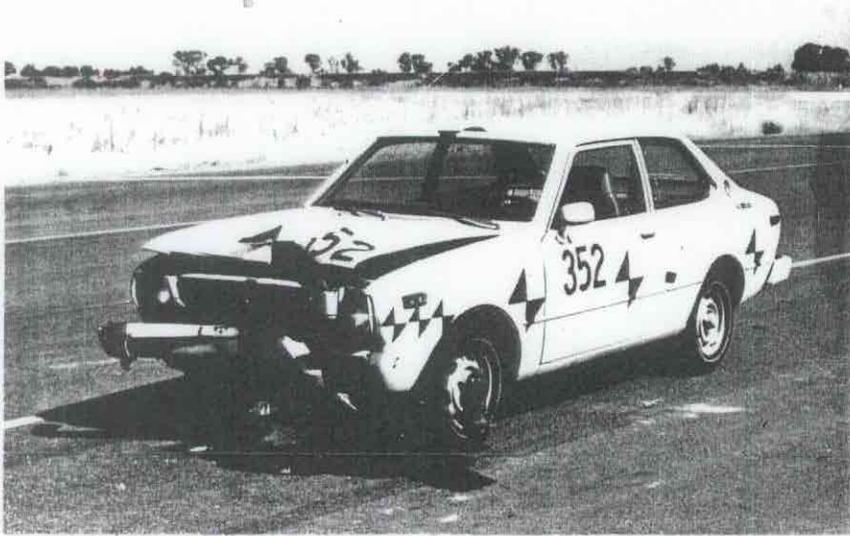
Figure 18

Vehicle After Impact

The front of the test vehicle was bent around the 6 in. x 8 in. post during impact. Maximum vehicle crush, measured at the centerline of the vehicle at the top edge of the bumper, was about 9 inches, slightly more than in Test 351. Fluid was leaking from the radiator which was pushed back to the engine block during impact. The cross member supporting the radiator was pushed back about 4 inches by the dislodged post segment. The vehicle could not be driven away after impact. There was no intrusion of vehicle or sign components into the passenger compartment after impact.

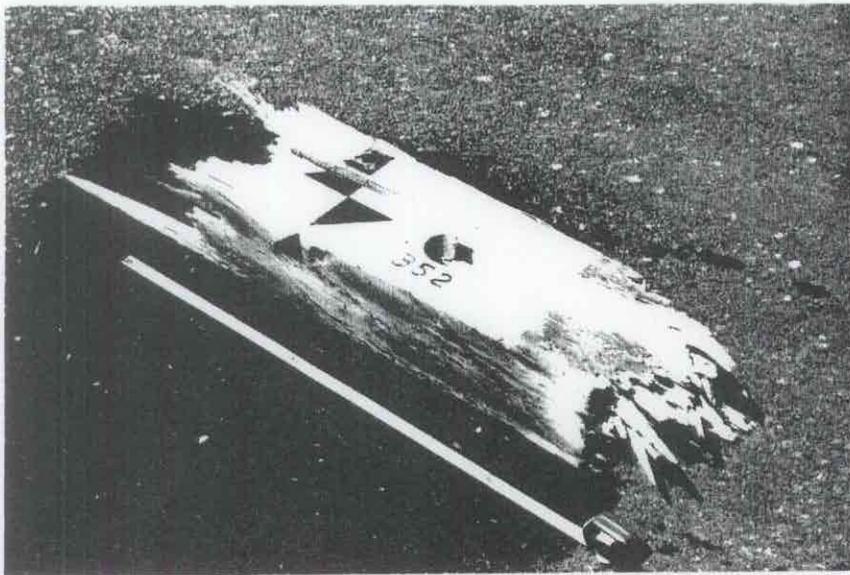
Post Segment

The broken post segment which was lodged underneath the vehicle was 28 inches in length. This segment split lengthwise in halves initially during impact similar to

the post in Test 351. These two halves failed in bending below ground as the car bumper loaded the top of the post segment.

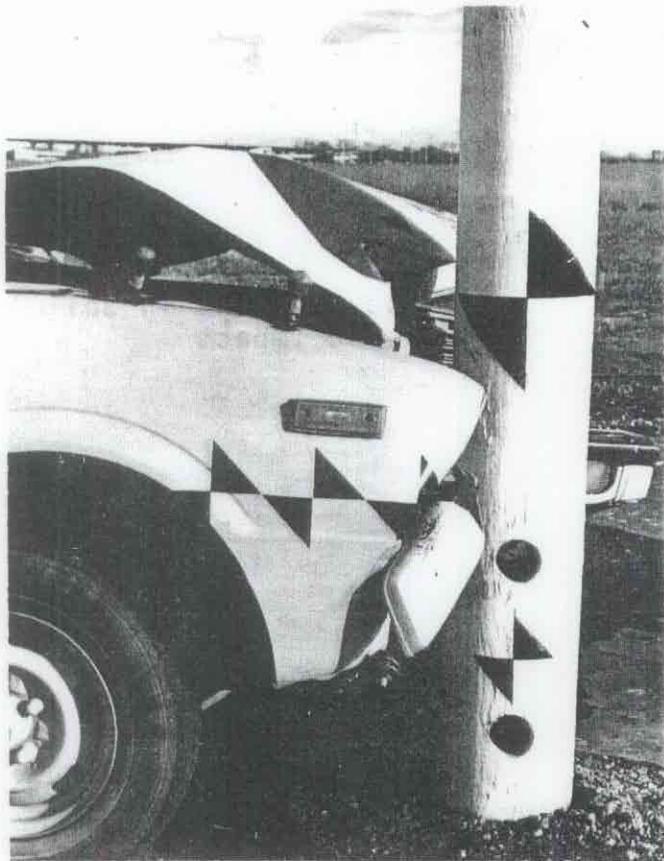
Figure 22

Test Vehicle and Test Sign After Impact

Scuff Marks
Due to Impact

The test vehicle suffered major front-end damage during the test. Frontal crush of the vehicle was 16 inches, maximum. The right front wheel of the test vehicle was pinned back against the wheel well. The tie rods on this side of the vehicle were also bent. The front bumper, the hood, and the radiator of the test vehicle were all pushed back into the engine block. The radiator was also punctured during the test and fluid started to drain after the impact.

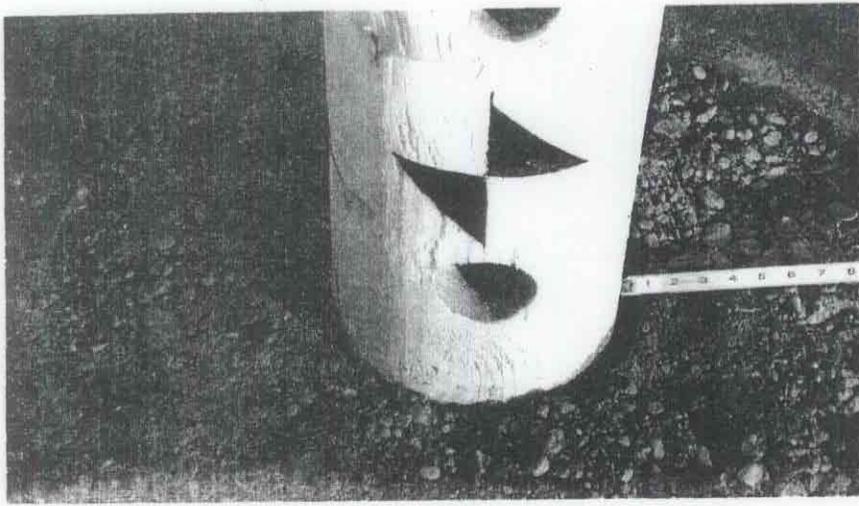
Figure 23

Post Movement in Soil
Due to Impact

The roadside sign suffered virtually no damage during the impact. The impacted pole was dented and scuffed slightly in the vicinity of the impact zone. There was also a hair-line fracture extending between the breakaway holes in the pole. The high speed movie film showed a crack opening up between the ground and the lower sole in the impacted pole for a few milliseconds after impact and then closing. Both timber poles were pushed forward slightly during the impact. Groundline movements of the impacted pole and the adjacent pole were 3/4 inch and 3/16 inch respectively.

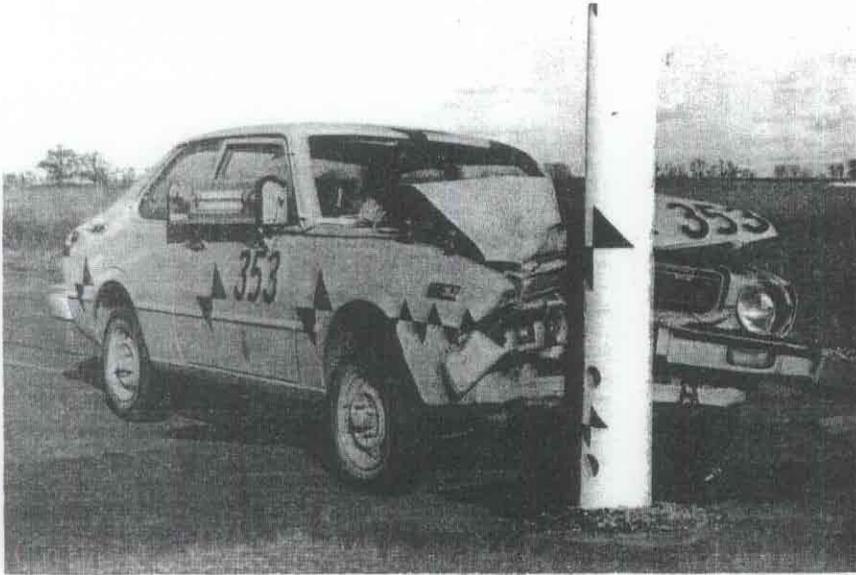
Test Vehicle and
Test Sign After Impact

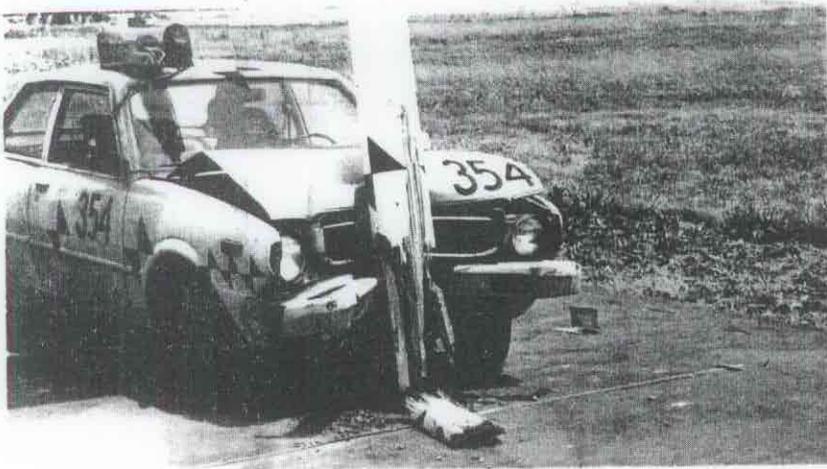
Figure 26

Test Vehicle and
Test Sign After Impact

The front of the test vehicle crushed around the pole to a maximum depth of 13 inches measured 21 1/2 inches above the ground at the bumper midpoint. Fluid was leaking from the radiator which was crushed back to the engine block. The front of the vehicle was not crushed back at all on the left and right sides. It was not possible to drive the car away. There was no intrusion of vehicle or sign components into the passenger compartment.

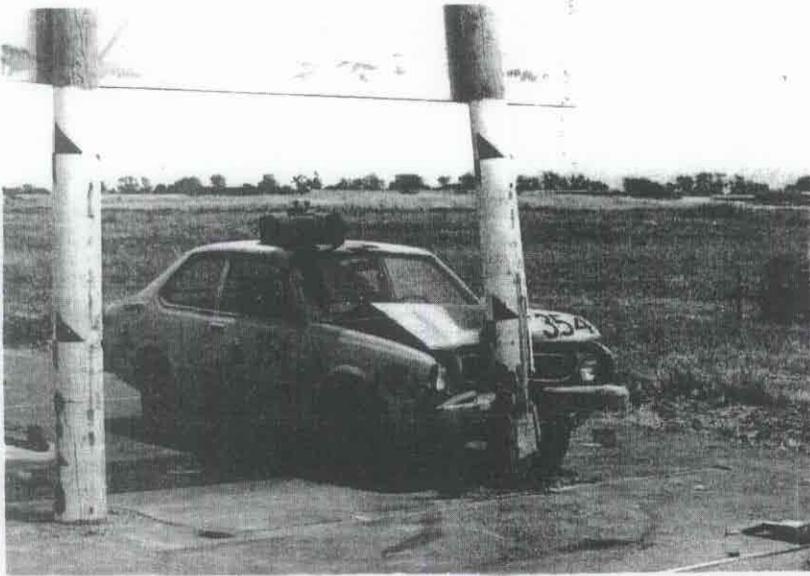
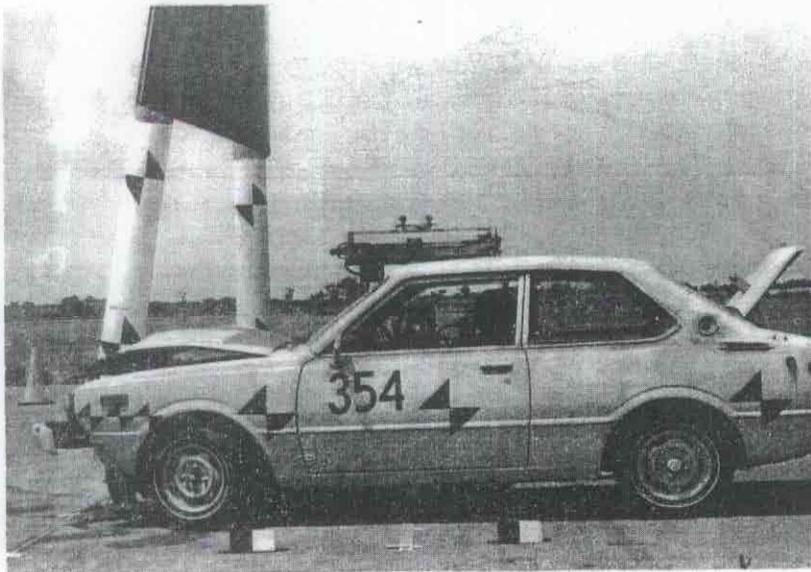
Figure 27

Test Sign After Impact

The sign panel buckled diagonally starting at the top of the panel, three feet in from the impacted pole, and continued to the bottom of the panel at the nonimpacted pole. The lag screws fastening the sign panel to the poles did not pull out; however, minor bending of the washers and dimples in the panel were observed. Torsional shear cracking occurred in the nonimpacted pole from the ground to the upper breakaway hole. There were also some cracks noted at the holes which opened up to 1/16 inch. The split pieces of the broken out pole segment landed 3 to 12 feet downstream of the original sign location, but did not lodge under the car in this test. There was no displacement of either pole in the soil.

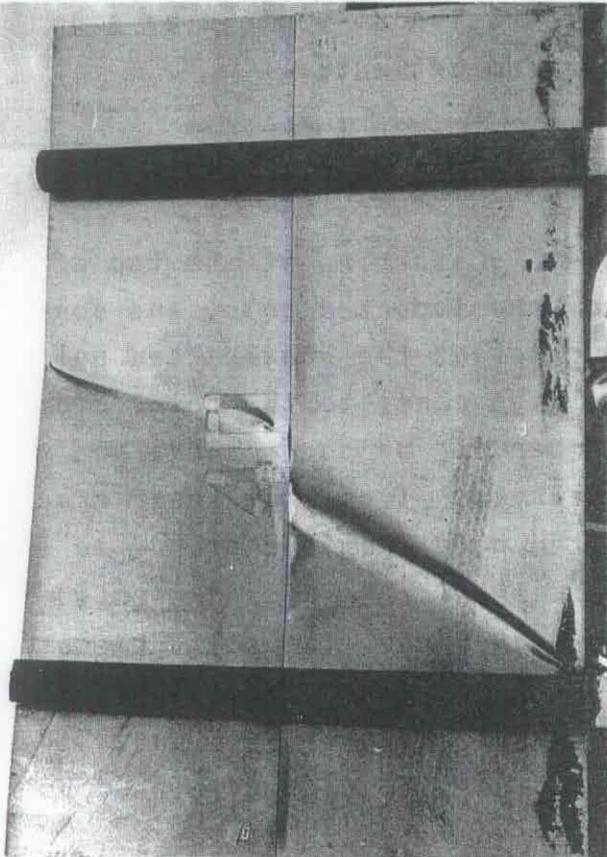
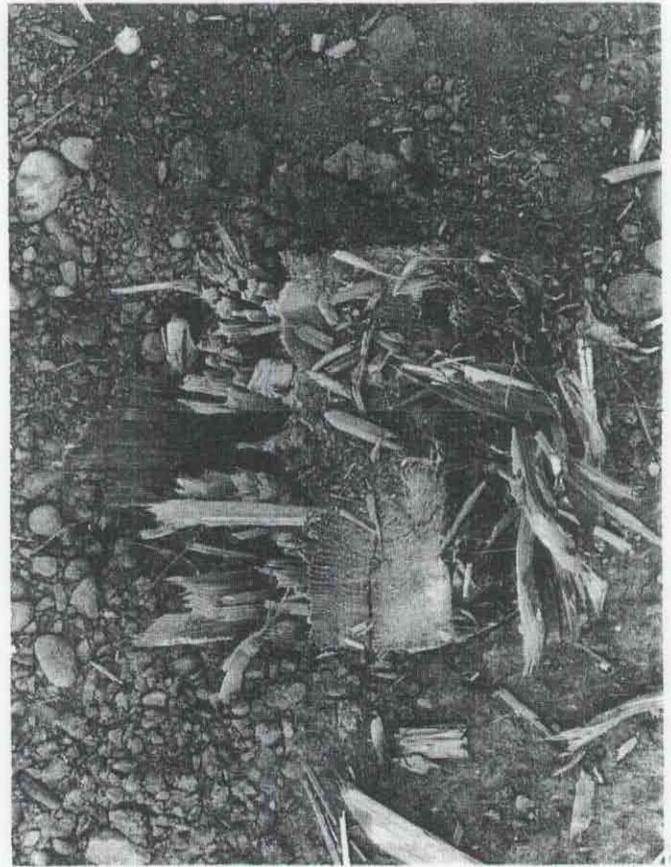
beyond the original pole location with a yaw of 14°. The vehicle traveled in a circular path to the right as it pushed the pole ahead. The segment of the pole between the bored holes separated from the main pole and split into several pieces approximately 20-30 inches long. The final position of the vehicle and test sign are shown in Figure 50 in Section 5.3.4. Accelerometer data plots are shown in Figures C1-C6 in Appendix C.

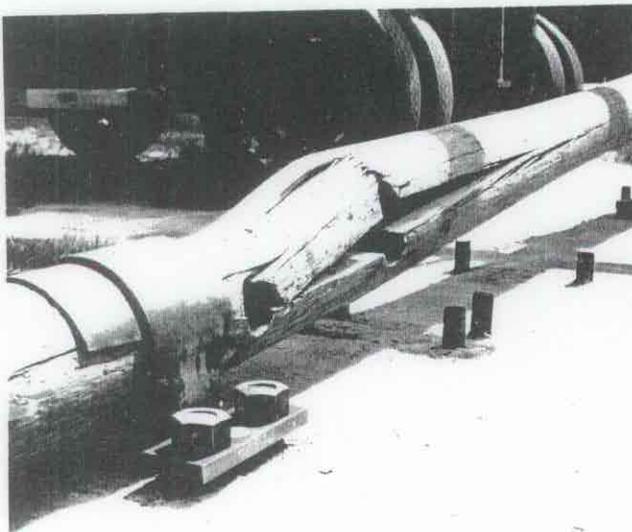
Pole After Test

The failure mode was different for each of the three poles tested. In Test 1 the pole split beyond the upper hole in the same plane as the sawcut between the two holes, a distance of over seven feet beyond the hold down clamp. The upper segment of the pole between the 4-inch holes buckled up, forming a hinge at each hole, thus failing in bending.

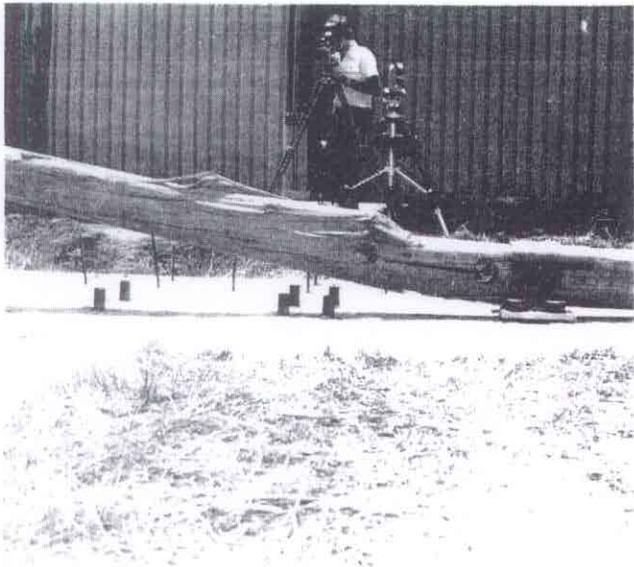
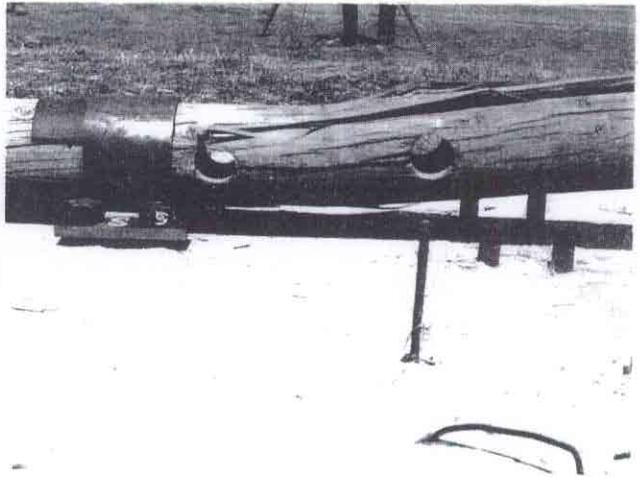
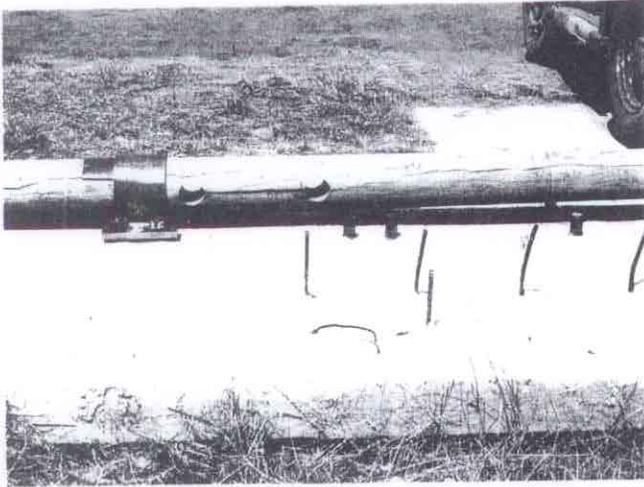
Pole After Test

In Test 2 the pole failed in compression close to the upper hole. Long strips of wood on the top side of the pole buckled up, failing along deep pre-existing longitudinal cracks in the wood.

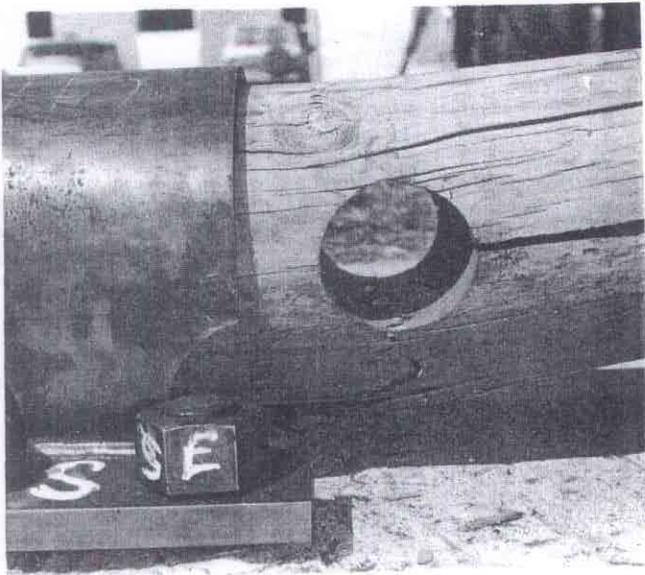
Pole After Test

In Test 3 the pole failed in tension at the lower hole. There were two tight knots in that area which probably weakened the section somewhat.

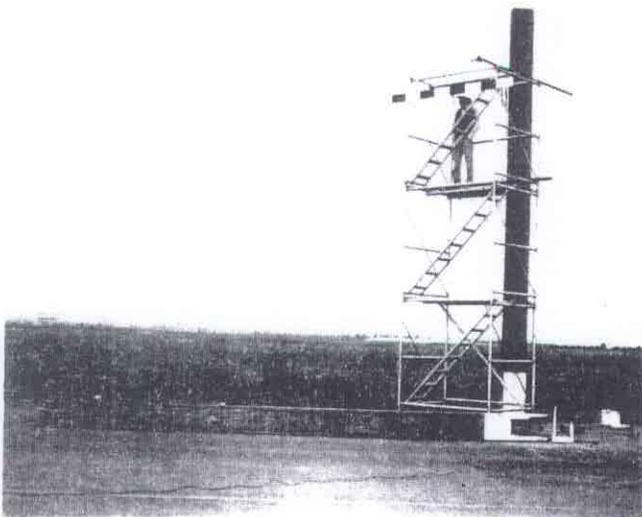
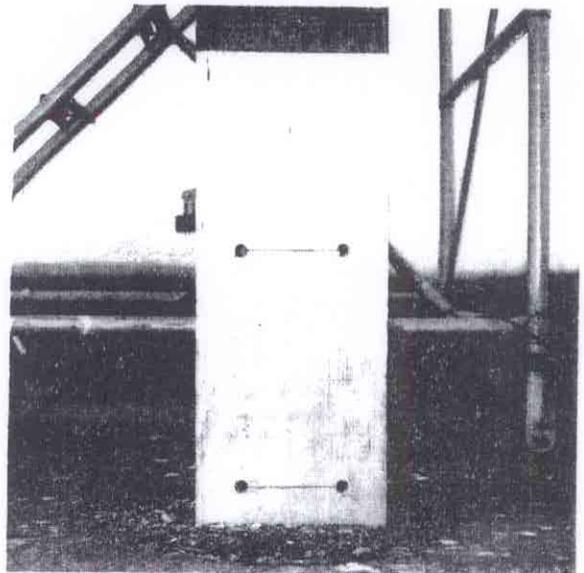
Post on Ground After Test

1-inch Diameter Holes Sawcuts in Box Section

first as usual. The first signs of distress in the post were splits between the upper and lower 1-inch holes on the upstream side, and a split going down to the ground from the lower downstream 1-inch hole. Then most of the post sheared off through the lower holes and sawcut. The upstream flange up to the upper hole was pushed over by the car. Only this flange and some splinters were passed over by the car which was not snagged or delayed in any way. There was virtually no pitch of the vehicle during impact. It continued to stay in contact with the post and pushed it around in a circular path to the left. About the time the post was 15° off a vertical line and the car was three quarters of its length over the post stub, cracks appeared in the left hand post. These cracks progressed up the post and became wider and wider as the post was subjected to bending and torsion. Eventually this post was twisted off near its base at the lower sawcut. As the impacted post was pushed ahead by the vehicle, it rotated down and finally pivoted about the right front corner of the roof. At this point it landed on the sliding weight device which was mounted on the roof and projected over the windshield. This device was pushed down into the windshield and cracked it. The post alone probably would not have cracked the windshield. The vehicle passed under the post as the post was rotating, and stopped just beyond the fallen sign. As the left hand post came down following the impacted post, the sign panel buckled severely in the middle and delaminated. The test vehicle came to rest approximately 28 feet beyond the original sign location, in line with the left hand post, and with final yaw angle of 42°. Final positions of the test sign and vehicle are shown in Figure 50 in Section 5.3.4. Accelerometer data plots are shown in Figures C7-C9 in Appendix C.

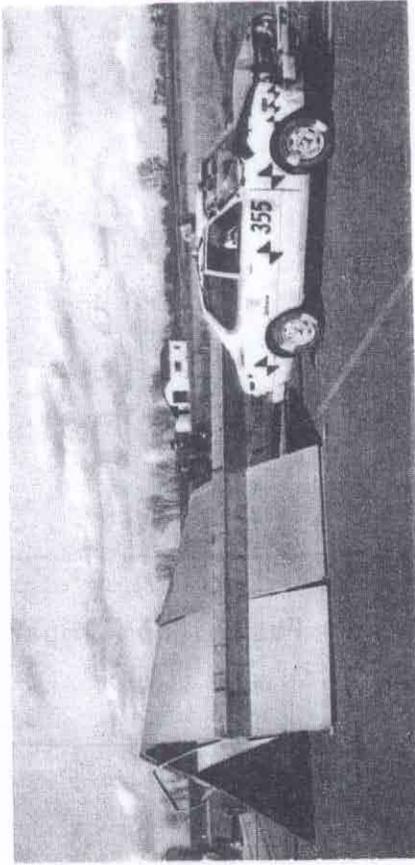
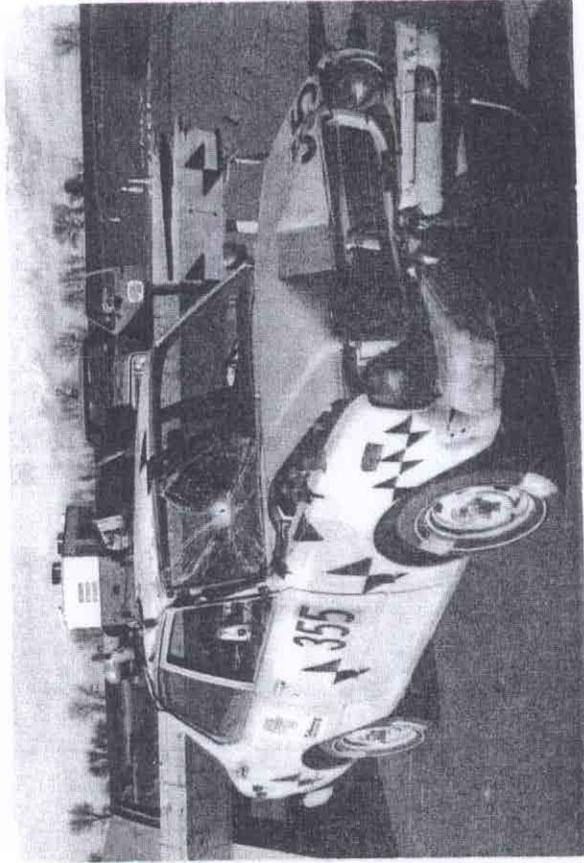
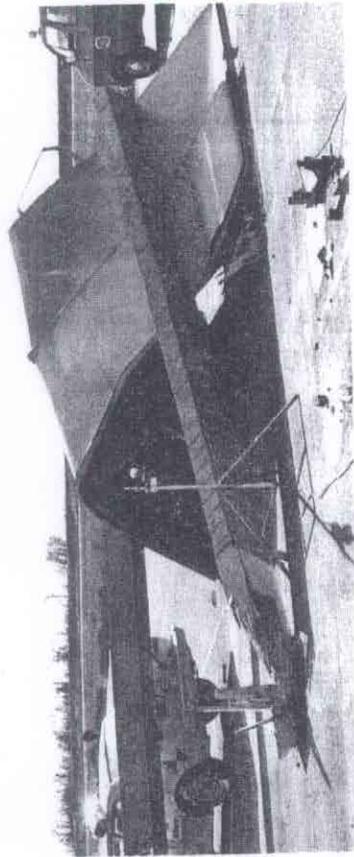
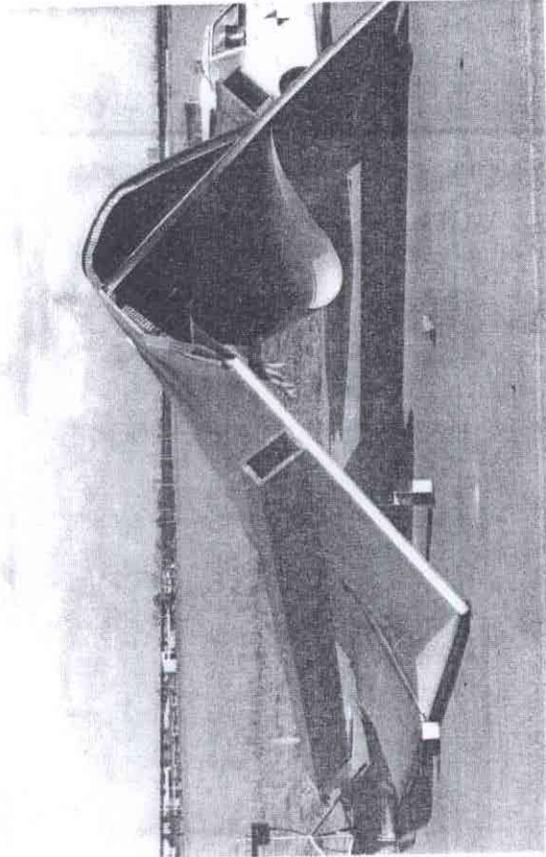
Figure 38 Test 355 Test Vehicle and Test Sign After Impact

Maximum front vehicle crush was 4 inches. The radiator was pushed back to the fan; the engine block did not move. The doors were not jammed and the tires were intact, but the vehicle could not be driven away due to the front crush. There was no intrusion of vehicle or sign components into the passenger compartment during impact. Overall the damage was relatively light.

The test sign was a total loss since both posts failed near the ground, and the sign panel was badly buckled. The through bolts kept the posts attached to the sign panel throughout the impact and did not pull out. There was very little soil movement behind the embedded post stubs. The posts and sign panel fell directly beyond the original test sign location.

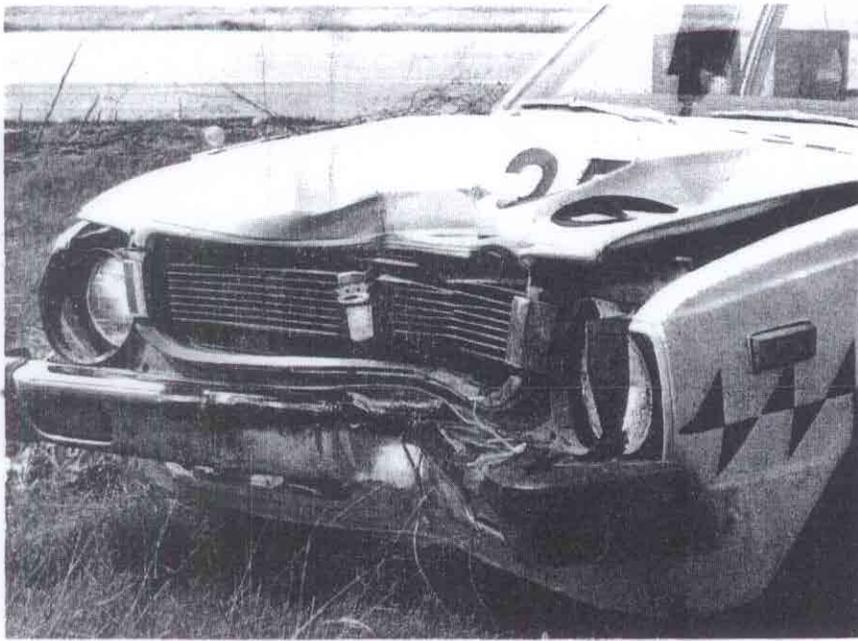
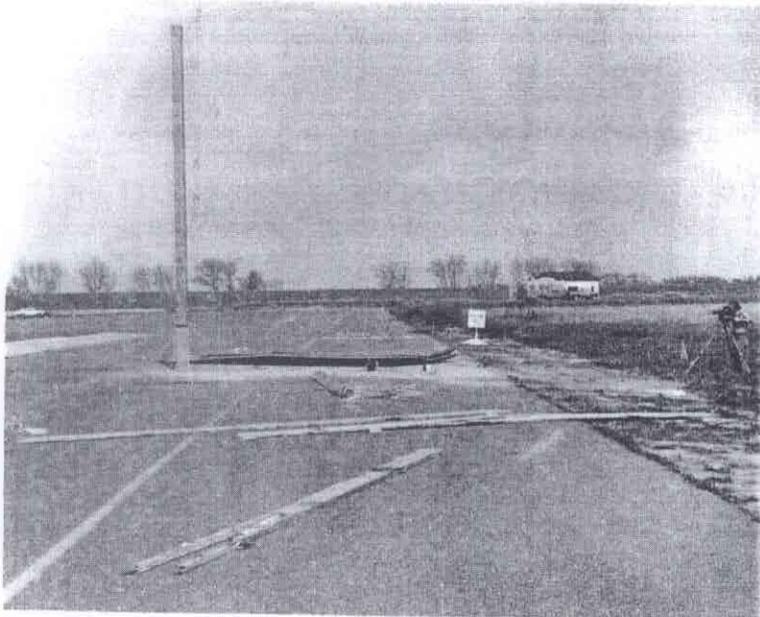
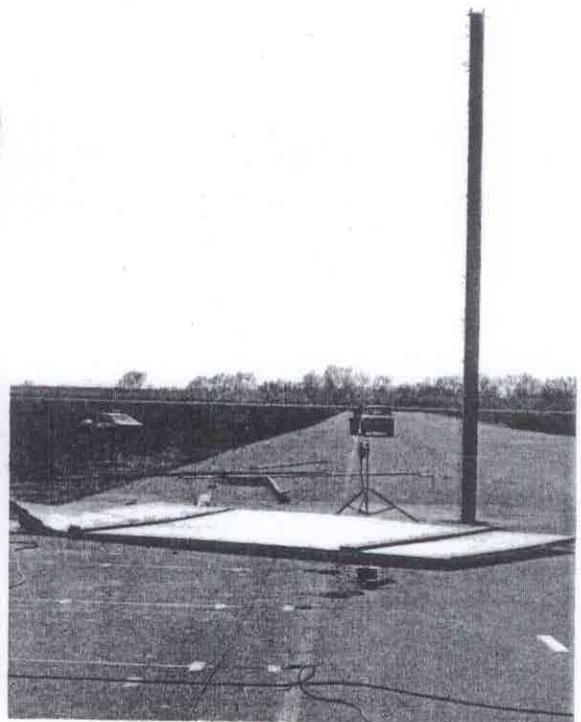
Figure 42

Test Vehicle and
Test Sign After Impact

View Looking Upstream Shows
Final Location of Flange and
Web Pieces From Box Section Post

View Looking Downstream
Shows Final Location of
Sign Panel and Test Vehicle

The impacted post was separated into four flange and web pieces. The other post probably would need replacement since the upper upstream flange was torn off. There was no pullout of the lag screws connecting the sign panel to the box section flanges. The sign panel was damaged mainly at the corner where it first struck the ground. It was bent and had delaminated in this area. There was very little soil movement or displacement behind the posts.

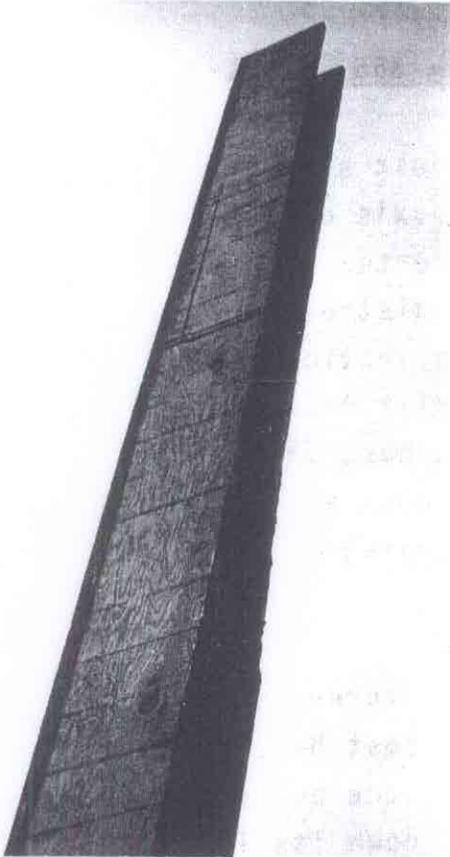
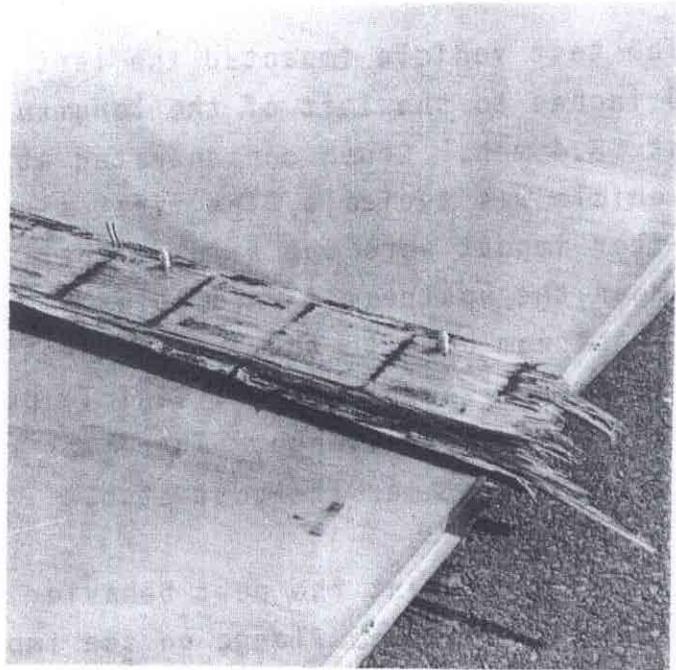
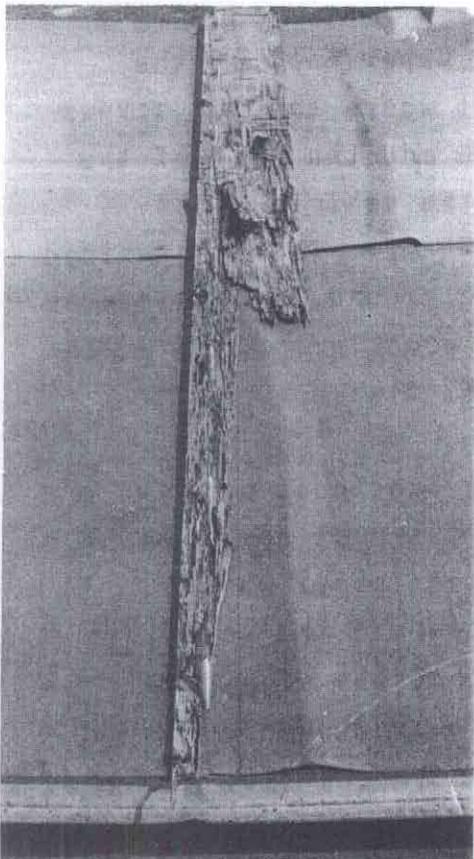
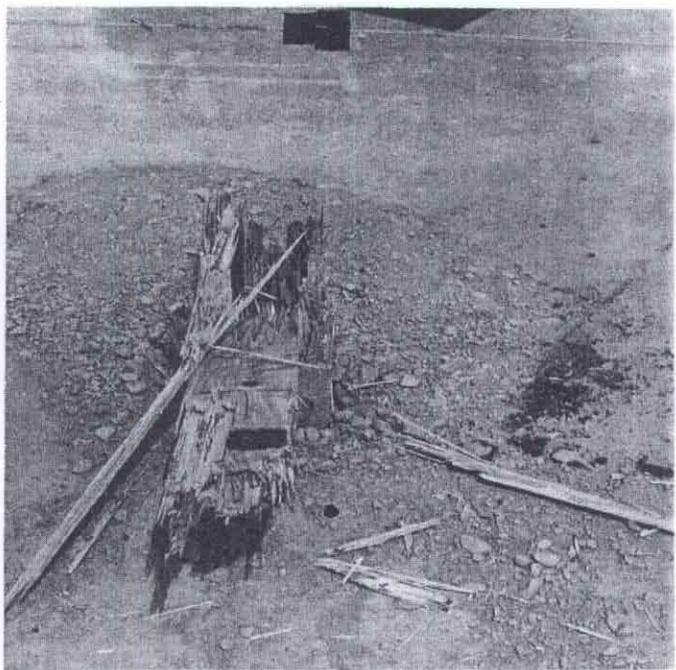
Figure 43

Left: Non-Impacted Post With Upper Flange Stripped Off

Above: Upper Flange Attached To Sign Panel

Left: Upper Flange From Impacted Post Attached to Sign Panel

Above: Impacted Post Stub

Meanwhile the upstream flange of the right hand post split away from the box section from the top of the post downward. The split continued to the bottom of the sign panel which rotated about this point and eventually tore off the post. The upper flange piece was firmly attached to the sign panel by eight lag screws. The right hand post opened up cracks 1/4-1/2 inch wide at the upstream and downstream web to flange

joints for heights of 2 to 3 feet above ground. These splits closed up after the sign panel was torn off this post. The right hand post remained standing and appeared to be undamaged except for the cracks at the bottom and the upper 10 feet of the upstream flange which was torn off with the sign panel.

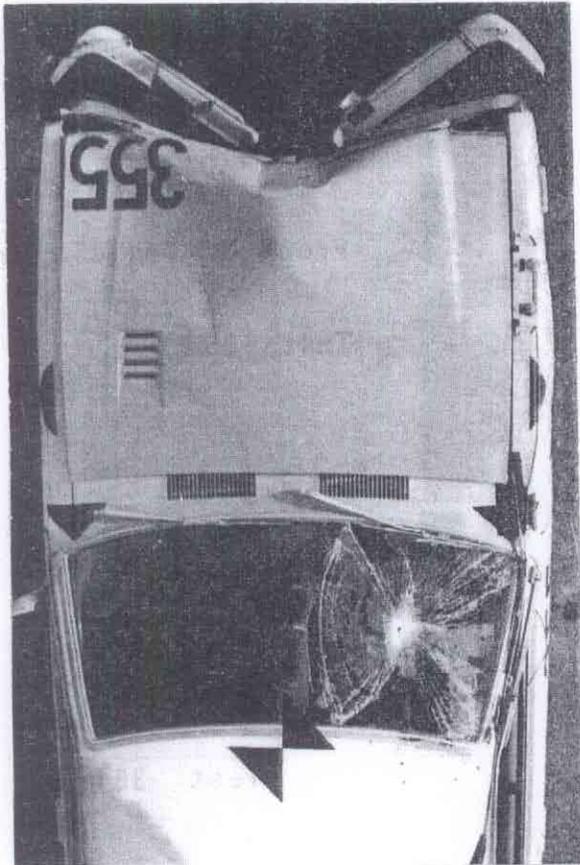
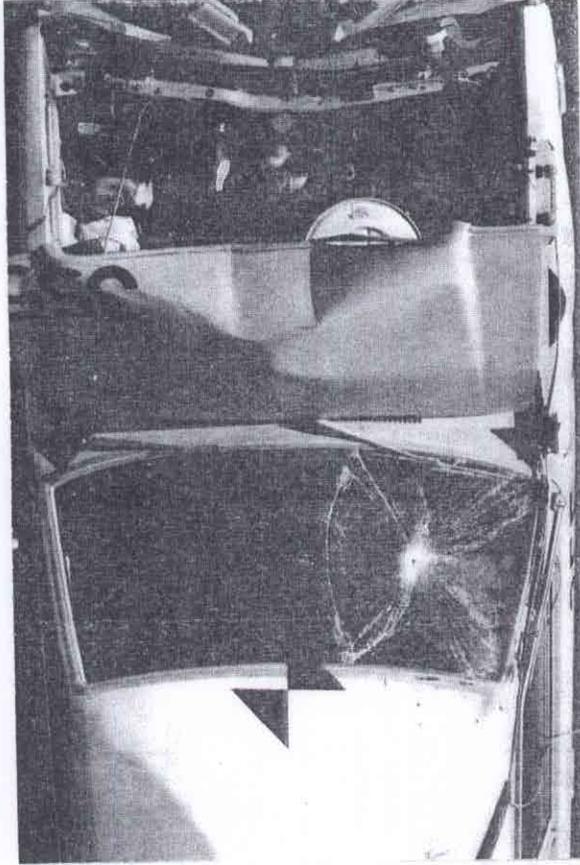
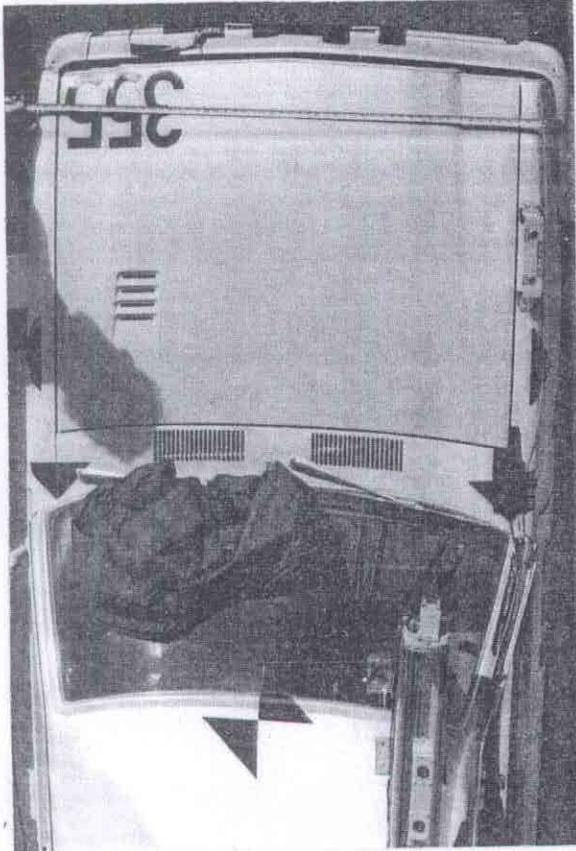
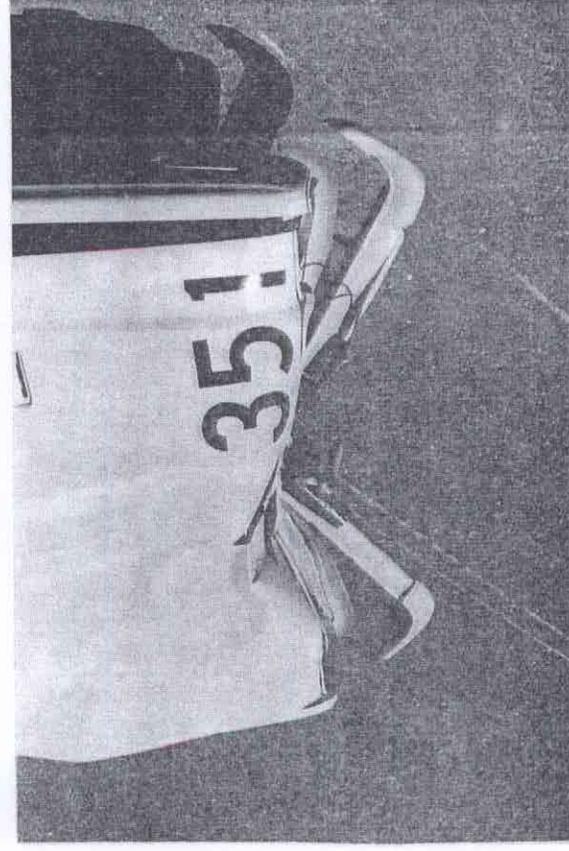
Figure 44 Front of Vehicle Crush

Front vehicle crush is one measure of the adequacy of a breakaway device. Figures 44-46 shows the crush profiles of the test vehicles. Much more crush was encountered in Tests 353 and 354 using timber poles than in the other tests. The TAD (14) and VDI (15) vehicle damage scales are given on the data summary sheets for each test.

Top and Bottom - Test 355
Box Section/19.2mph

Top - Undamaged Vehicle
Bottom: Test 351-6"x8" Post/19.8mph

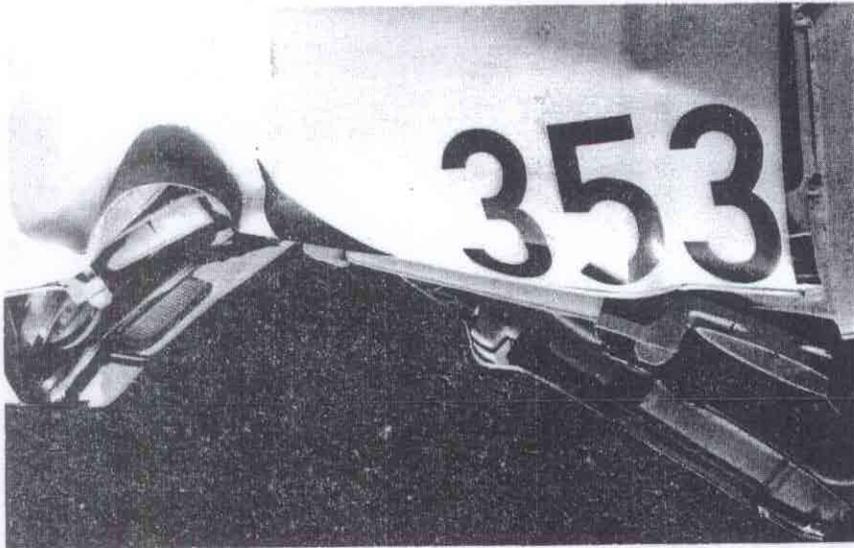
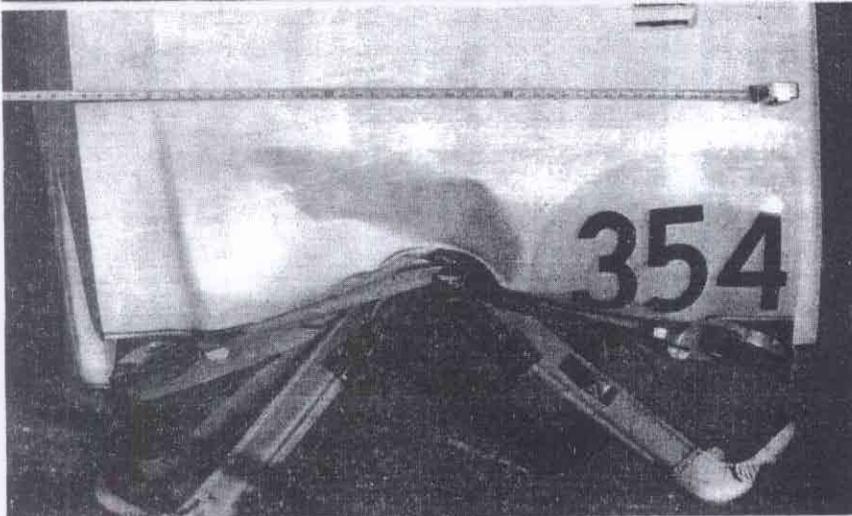
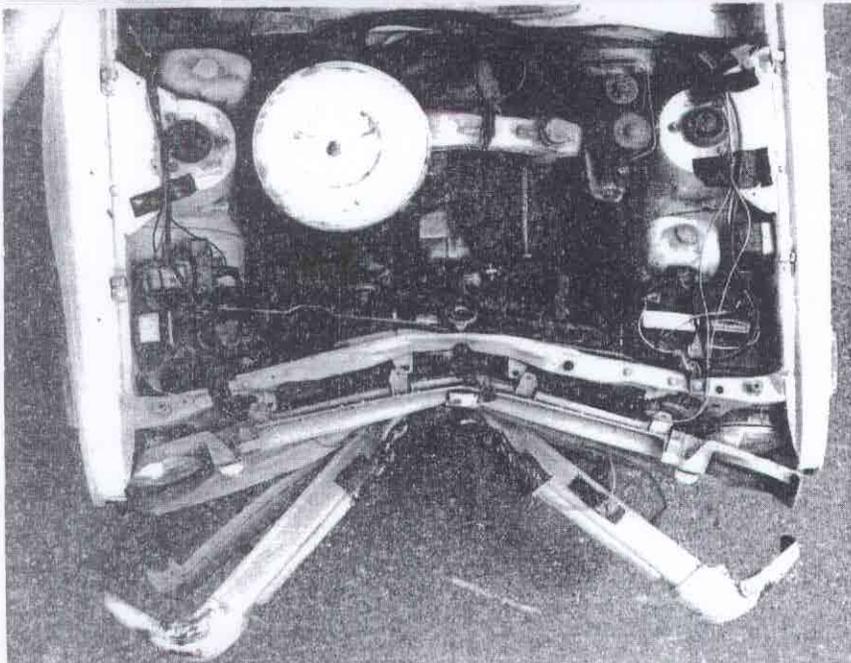
Figure 45

The pendulum tests conducted at SWRI showed that the breakaway performance of timber poles could be improved by increasing the breakaway hole diameter, increasing the distance between holes, and connecting the holes with a sawcut. Crash Test 354 showed that although the most promising design tested at SWRI improved the breakaway performance of the timber pole over that in Test 353, the pole was still overly stiff when used in a dual-support sign.

Test 353

Test 354

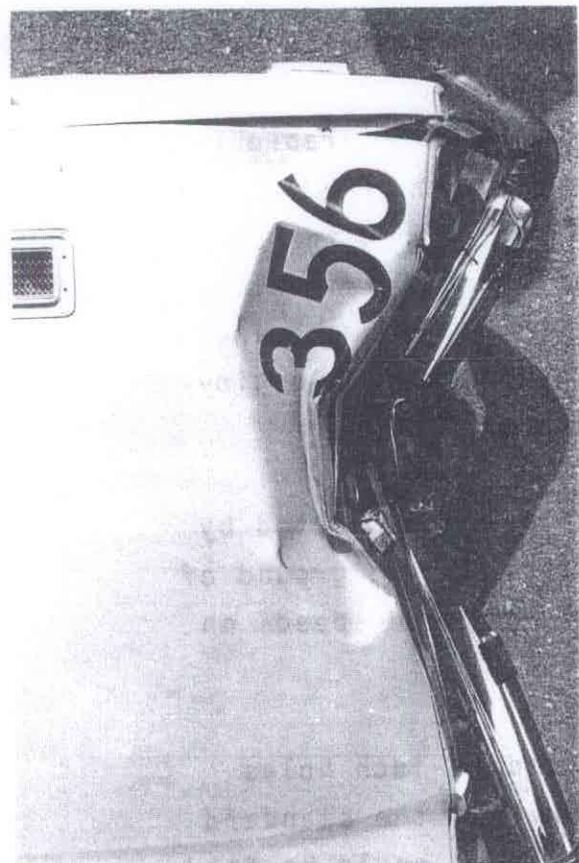
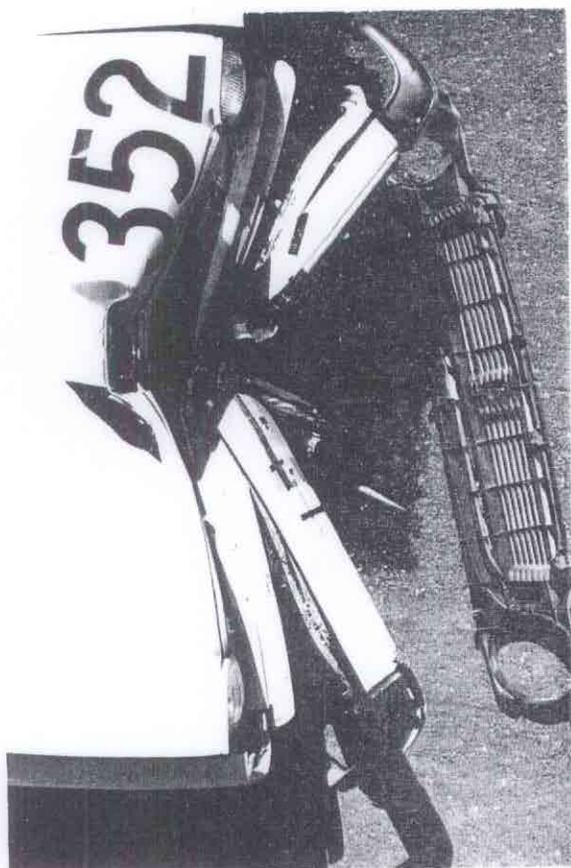
Figure 46 Front of Vehicle Crush

Test 356 - Box Section/58.4mph

Test 352 - 6"x8" Post/57.1mph

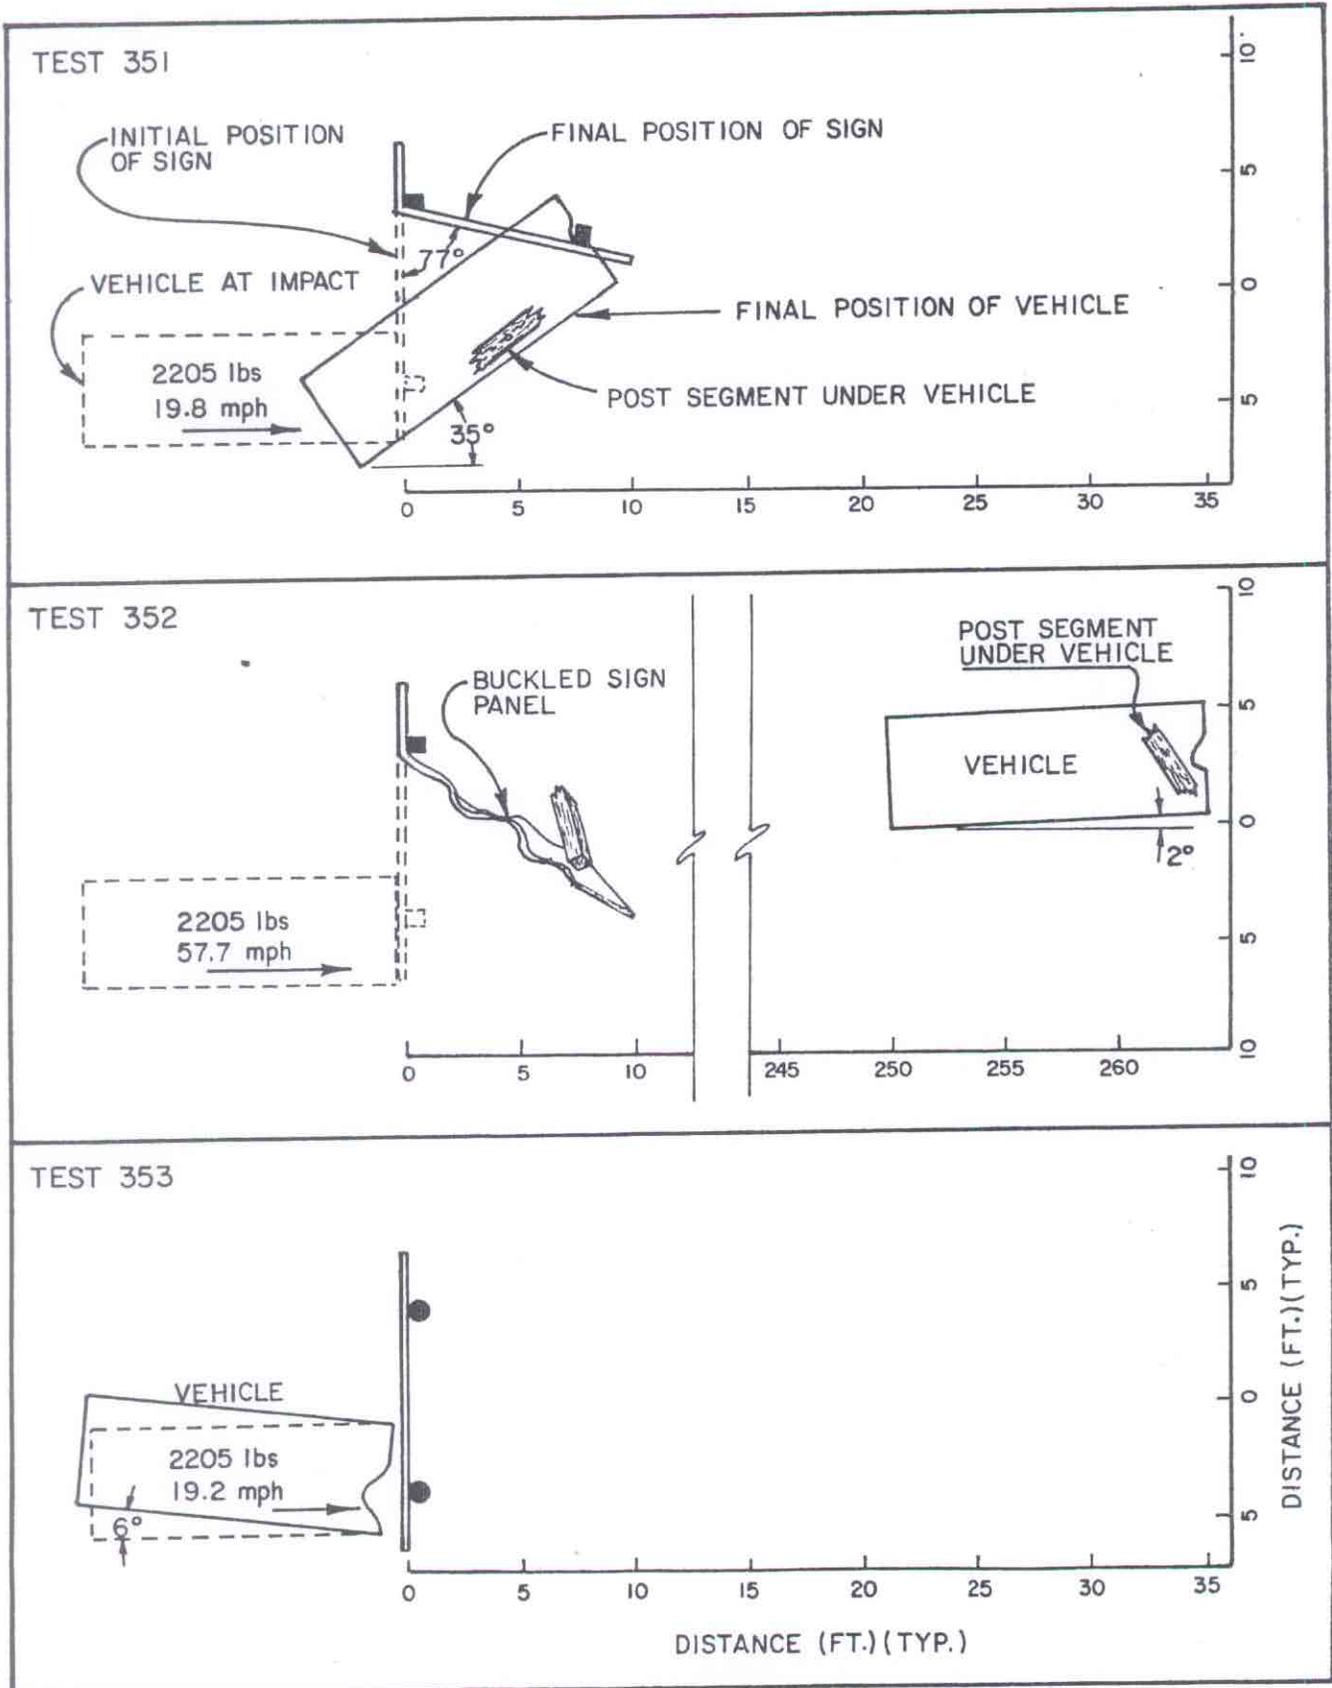
FIGURE 50

The sign panel ended face down on the ground, directly upstream of the original test sign location. The vehicle continued straight downstream, then steered to the left when the brakes were applied remotely. Final positions of the test sign and test vehicle are shown in Figure 50 in Section 5.3.4. Accelerometer data plots are shown in Figures C10-C12 in Appendix C.

(4) In Test 356 the shattered pieces of the box section post projected a maximum of approximately 15 feet to the left of the left hand post. These pieces might have projected into the traveled way if it was located close to the sign. Since these "planks", which were 1 inch and 1 1/2 inch thick, were laying flat on the ground, they would pose more a psychological hazard than a real hazard to oncoming traffic. This condition would be more likely than the hump backed sign in Test 355 because in that test the through bolts held the posts and sign panel together. The lag screws used in Test 356 allowed the flange to peel away from the rest of the box section and the sign panel which dropped flat on the ground.

FINAL POSITION OF TEST VEHICLE AND SIGN TESTS 354-356

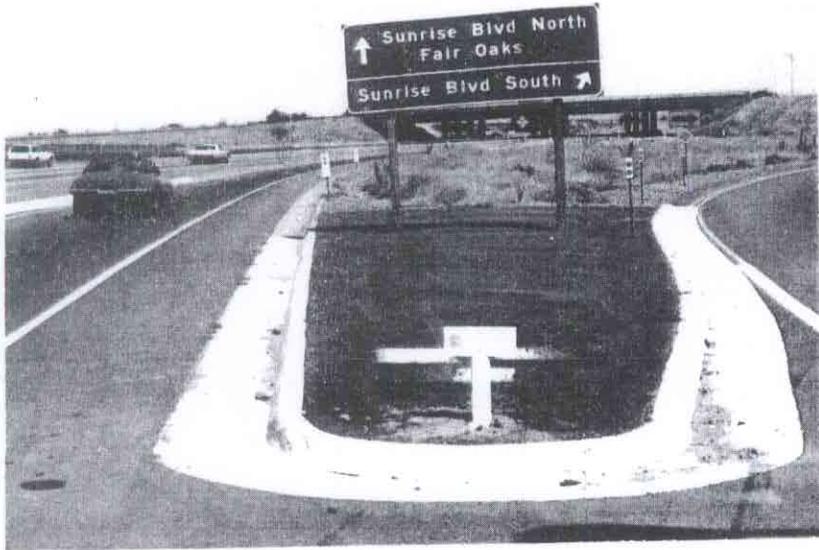
Figure 52

upper hole diagonally down to the downstream face of the lower hole with considerable splintering. This mode of failure was probably influenced by the asphalt concrete surface that surrounded the base of the post. The adjacent post was not damaged. The impacting vehicle struck the post about 8 inches off-center. The vehicle was skidding before it mounted the 6-inch high gore surface, and left 23- and 47-foot skids on top of the gore surface. These marks stopped 10 feet beyond the sign. Wheel track width was 62.5 inches indicating a large car. The bumper height was estimated at 20.5 inches based on markings on the post. The sign panel bent along the edge of the undamaged post. The damaged sign is shown in Figure 52. No accident reports were ever filed on either of the two above accidents.

Accident at Sunrise Blvd. and Highway 50
