EFFECTS ON A VEHICLE IMPACTING A
CONCRETE SAFETY SHAPE BARRIER AT
A LOW SPEED AND A LARGE ANGLE

The following conclusions are based on the results of an 1860 lb vehicle/27.4 mph/52° impact test, Test 431, into a safety shape concrete barrier.

3.2 Test Results, Test 431 (1860 lbs/27.4 mph/52°)

FIGURE 4 - Data Summary Sheet - Test 431

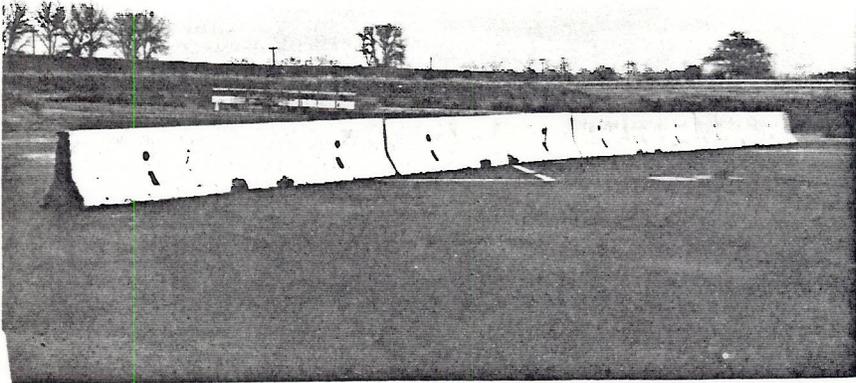
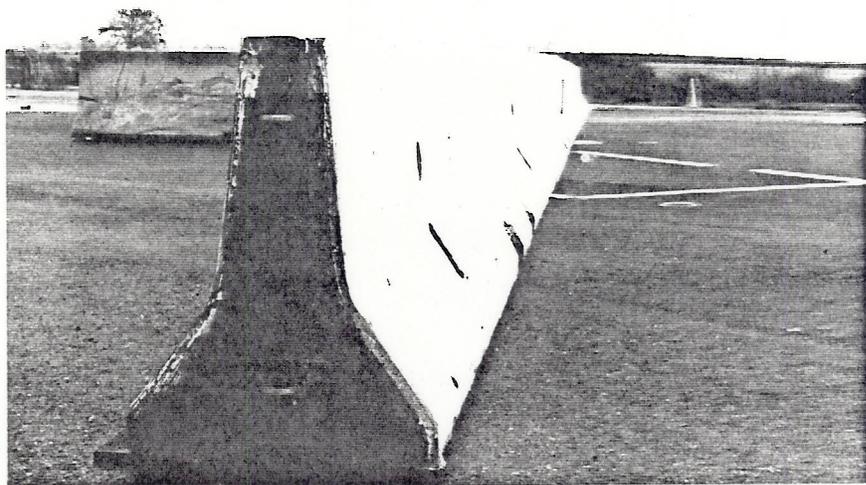
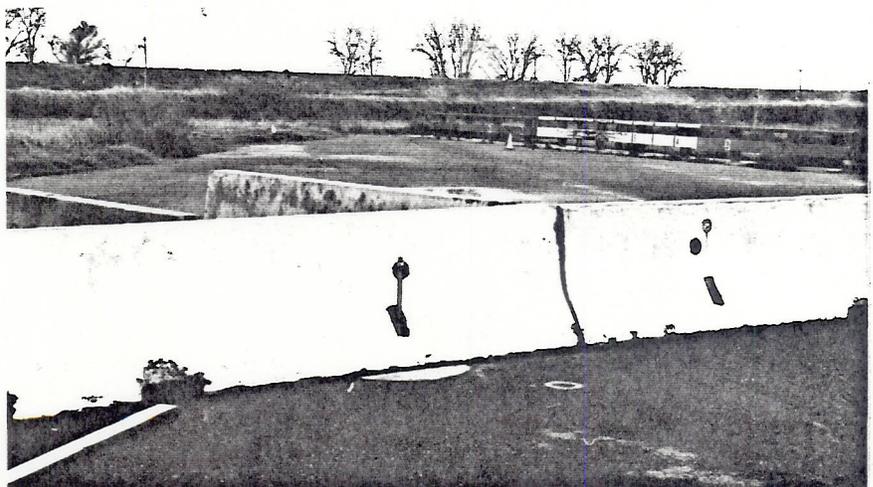
FIGURE 2 - Test Barrier

A former test barrier similar to Caltrans Temporary Railing Type K was used for the test. It was 80 feet long and composed of four 20 foot sections. The barrier had a safety shape (New Jersey) profile identical to the profile of the Caltrans Type 50 Concrete Barrier. It was placed on top of an asphaltic concrete surface. It was bolted to a footing at one point and backed up with two barrier segments, set perpendicular to the test barrier near impact point, to minimize barrier movement. The test barrier is shown in Figures 1 and 2.

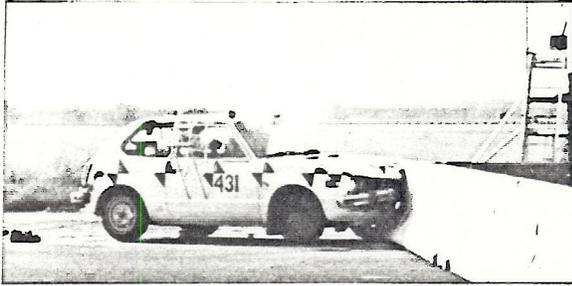
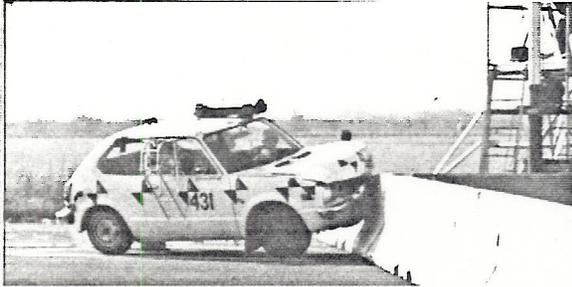
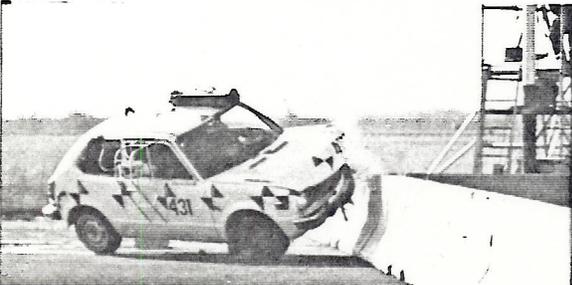
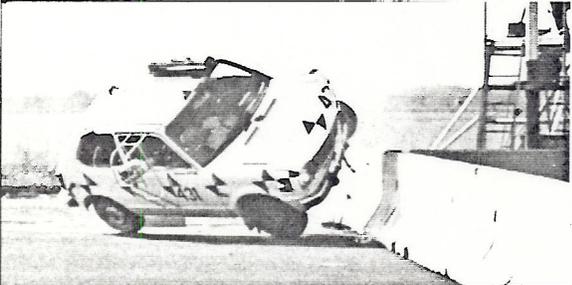
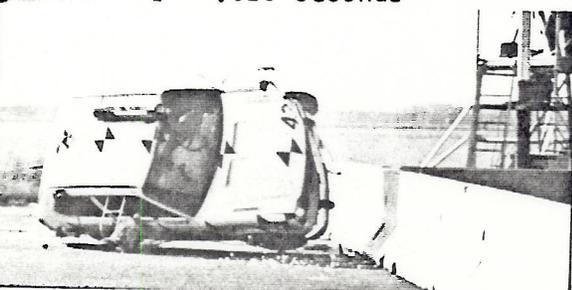
The left front bumper of the test vehicle impacted the 80 foot barrier at 48 feet from the end and 32 feet from the beginning of the barrier. The vehicle body contacted the barrier at initial impact (before the wheel) and then for a distance of 4 feet. The test vehicle rode up the face of the barrier and across the face while rolling clockwise, Figure 6. Maximum wheel climb on the parapet face was 2.25 feet. The vehicle continued off the barrier while rolling over onto its right side where it stopped, lying on the camera rack hung on the right window, Figure 7. The camera rack stopped the vehicle from continuing the rollover, which would possibly have caused more damage to the car and occupant.

HIC 317
 TAD/VDI FL4/11FYEW3
 Max. Roll/Pitch 71°/-2°/-12°
 Yaw

Permanent Barrier 1.75 in. Lateral
 Displacement

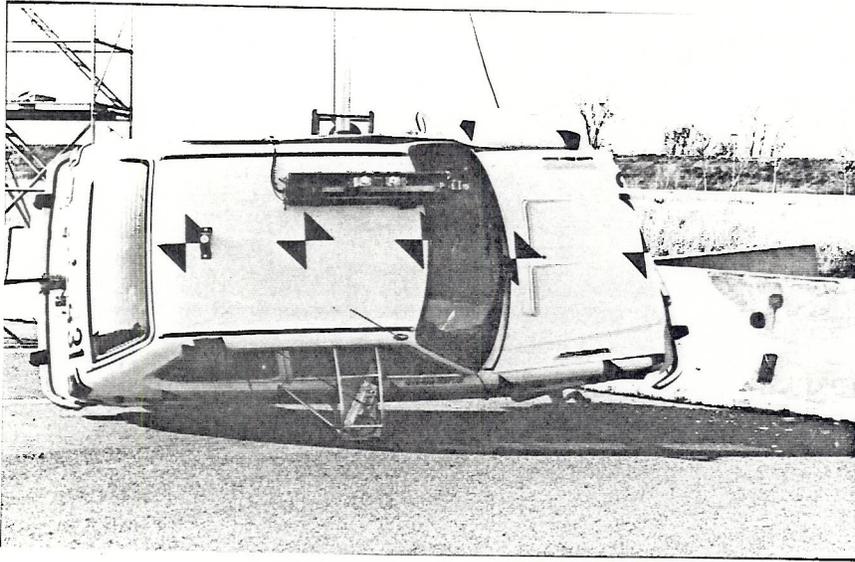
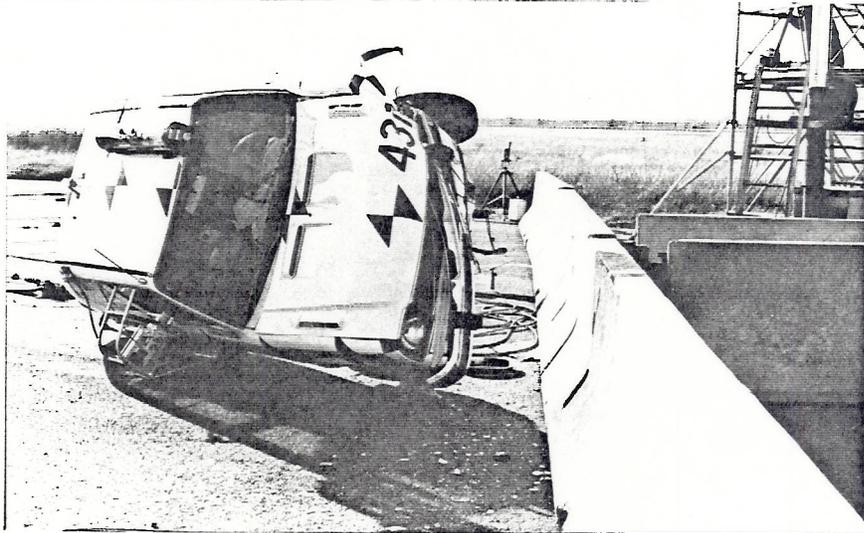
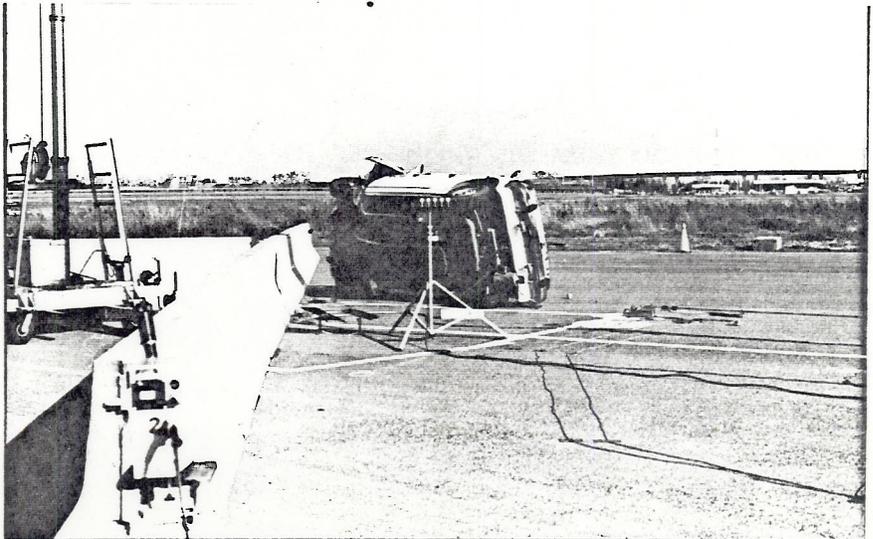
Figure 7 - Car Location With Respect to the Barrier After Impact

In test 431, the final resting position of the test vehicle after impact is shown on the Data Summary Sheet, Figure 4, in the Test Results section of this report and in Figures 6, 7 and 8. The test vehicle rode up the face of the barrier and across the face while rolling steadily clockwise to its right side where it rested, lying on the camera rack hanging on the right window. The vehicle remained on its right side at an angle of 69° with respect to the center line of the barrier. Rollovers do not meet the safety evaluation criteria for highway safety devices according to NCHRP Report 230. Hence, it is clear that this impact was extra hazardous due to the rollover.
