Subject: **San Francisco Bay Area Toll Bridge Seismic Retrofit 2013 First Quarter Project Progress and Financial Update**

Briefing on E2 Anchor Bolts – May 7, 2013

THE SAN FRANCISCO-OAKLAND
BAY BRIDGE
SEISMIC SAFETY PROJECT

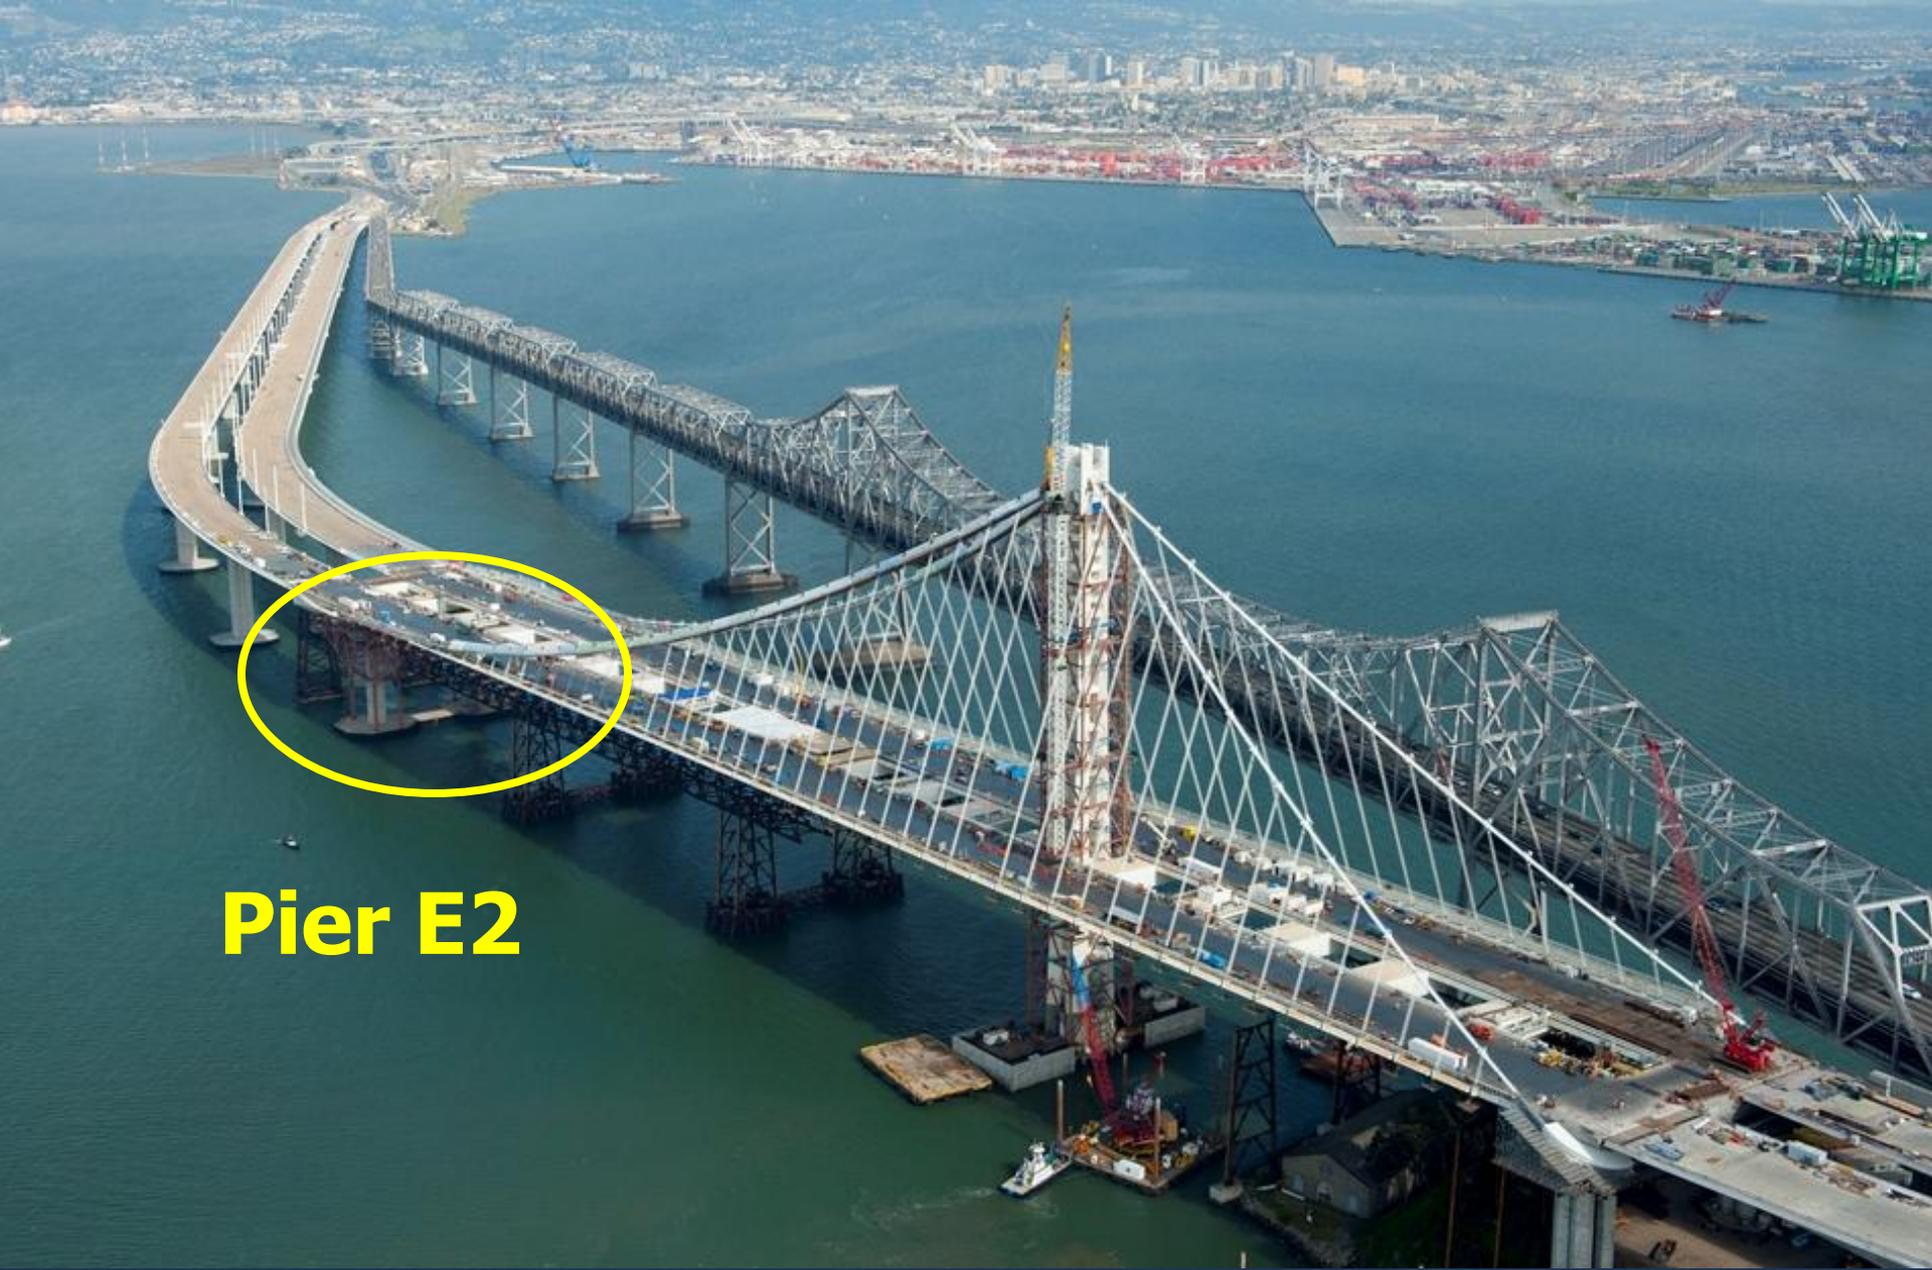
Pier E2

- Bearings and shear keys are secured to E2 by 3 inch diameter anchor bolts, ranging from 9 feet to 24 feet in length.
- 96 bolts manufactured in 2008 shown in red are embedded in the pier.
- 192 bolts manufactured in 2010 shown in blue are not embedded in pier.
