Report on the A354 Grade BD High-Strength
Steel Rods on the New East Span of the
San Francisco-Oakland Bay Bridge
With Findings and Decisions

July 8, 2013

TOLL BRIDGE PROGRAM
OVERSIGHT COMMITTEE

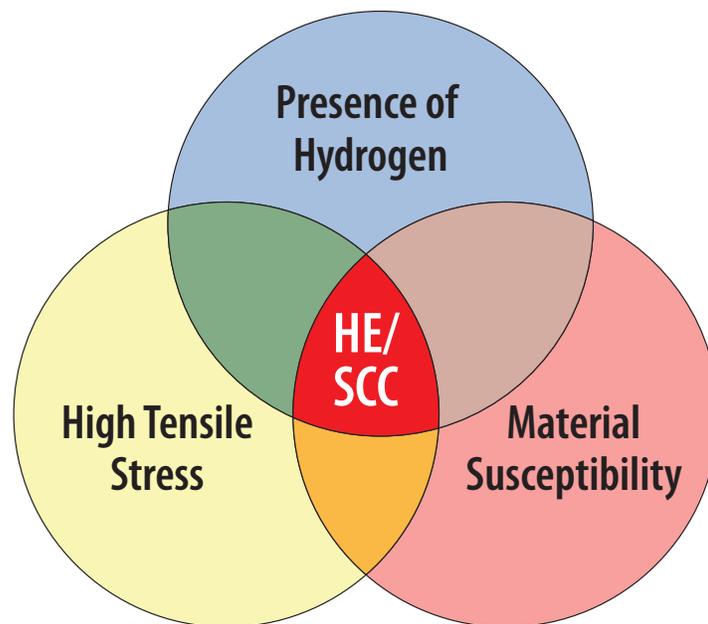
Figure ES-4 Causes of Hydrogen Embrittlement (HE) or Stress Corrosion Cracking (SCC)

Hydrogen embrittlement is the root cause for the failure of the A354 grade BD high-strength steel anchor rods at shear keys S1 and S2 (Item #1 in Table ES-1). As used in this report, hydrogen embrittlement is considered a short-term phenomenon that occurs in metals, including high-strength steel, when three conditions apply: a susceptible material, presence of hydrogen and high tensile stress (as shown in Figure ES-4). To trace what led to the rod failures, this summary calls out each of the three hydrogen embrittlement conditions, and then tracks the events and decisions that either caused or contributed to that condition. In their totality, these events and decisions led to the failure of the 2008 A354 grade BD rods in March 2013.

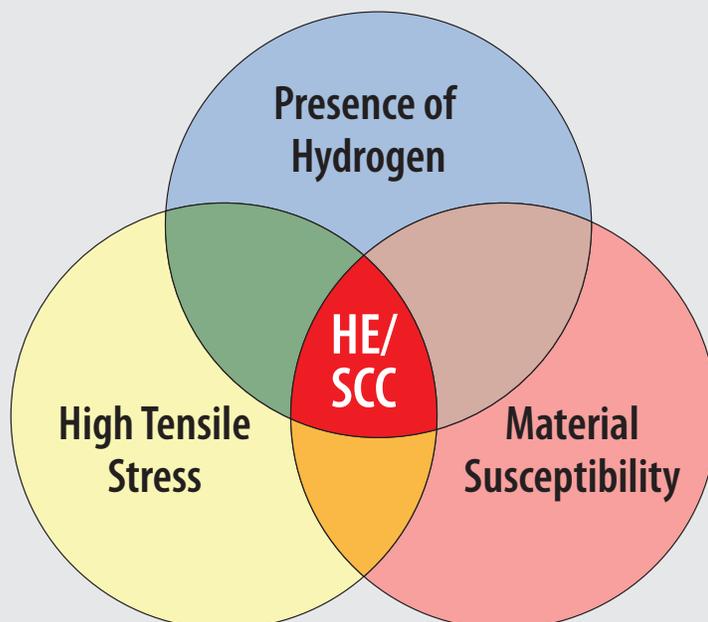
Causes of Hydrogen Embrittlement (HE) or Stress Corrosion Cracking (SCC)

The accompanying Venn diagram shows that when all three conditions apply (i.e., the presence of hydrogen, high tensile stress and a susceptible material), the metallurgical structure of the steel has a higher susceptibility to HE. The diagram also shows that these same conditions can cause a related phenomenon known as Stress Corrosion Cracking (SCC), which will be addressed later in this report.

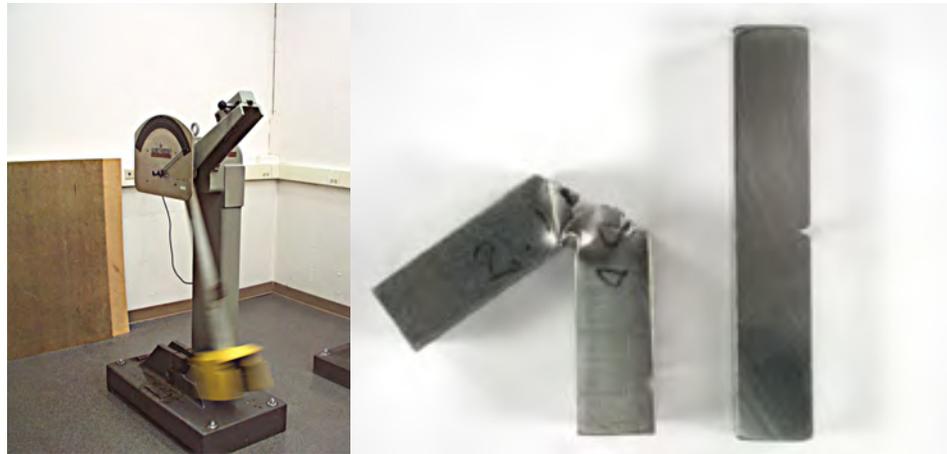
Figure 25 Charpy Toughness Test in Process (left); Tested and Untested Specimens (right)

Test II Test II is to conduct laboratory tests on a selected number of specimens or spares in order to determine a rod's hardness (Rockwell hardness test), toughness (Charpy V-Notch test) and chemical composition (Figure 25). In some locations there are rods installed in the bridge that have an excess or protruding length which, if cut off, could serve as a test specimen in a controlled laboratory environment. There are also some spare rods from the original manufactured lots that are available for laboratory testing.

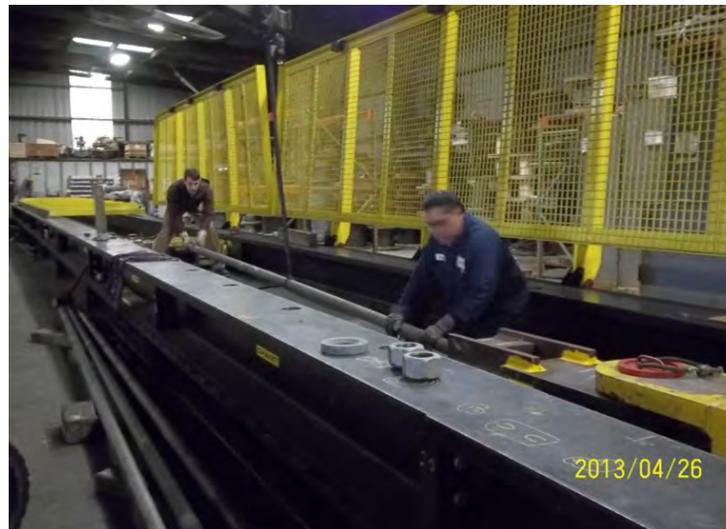
Figure 26 Photograph of Full-Sized Rod Being Placed into Test Rig

Test III Test III is to conduct laboratory testing (full size tension test, coupon tension test, Rockwell C hardness, Charpy, chemistry, fracture analysis) of full-sized rods extracted from the Pier E2 shear key and bearings (Items #2, 3, and 4 in Table 1) and the Tower Anchorage (Item #12 in Table 1). All the other full-sized tests can be performed on spare rods and bolts from the original manufactured lots. Under Test III, rods will be loaded to failure, and the failed rods will be examined and tested to determine their hardness, toughness, mechanical properties, and chemical composition. Figure 26 shows such a full-sized laboratory test underway.

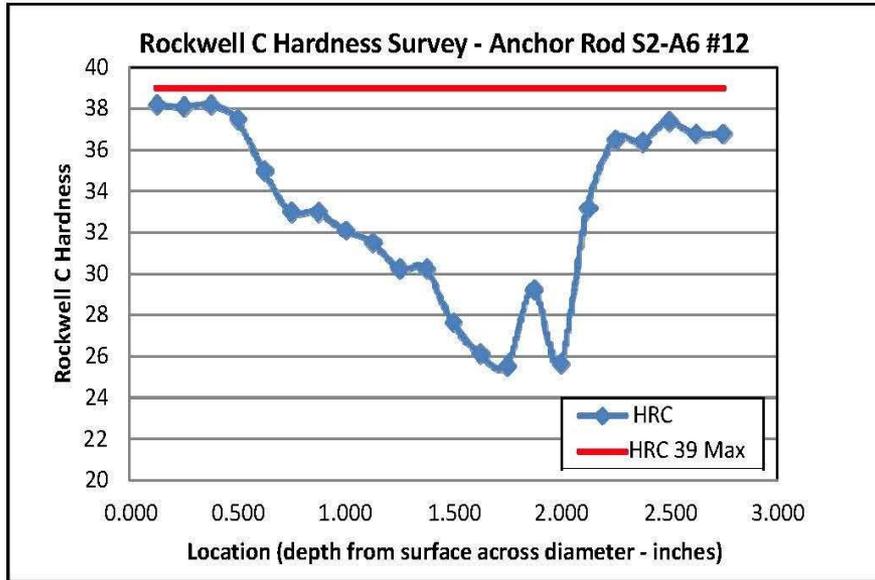
Failed 2008 Rod

- Rods exhibited a material susceptibility to hydrogen embrittlement with a heterogenous structure and high surface hardness.

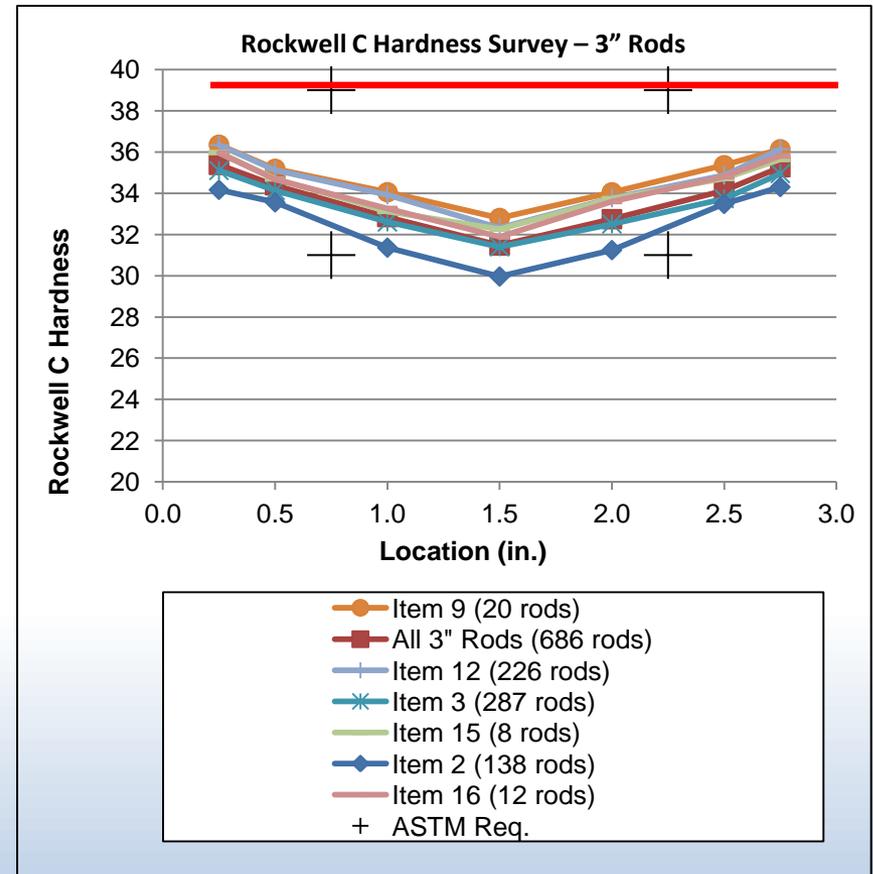
Other 3" Rods

Tests I, II and III for the other rods verified QC/QA test results and confirmed that the rods have low risk for near-term hydrogen embrittlement failures because the rods exhibit better metallurgical uniformity and improved toughness as compared to the failed 2008 rods. As noted earlier, these rods have performed successfully under tension from a minimum of three months to a maximum of nearly four years.
