A Report of an Investigation to Determine Causes for Displacement and Faulting at the Joints in Portland Cement Concrete Pavements

May 1949

F.N. Hveem

State of California  
Division of Highways  
Materials and Research Department

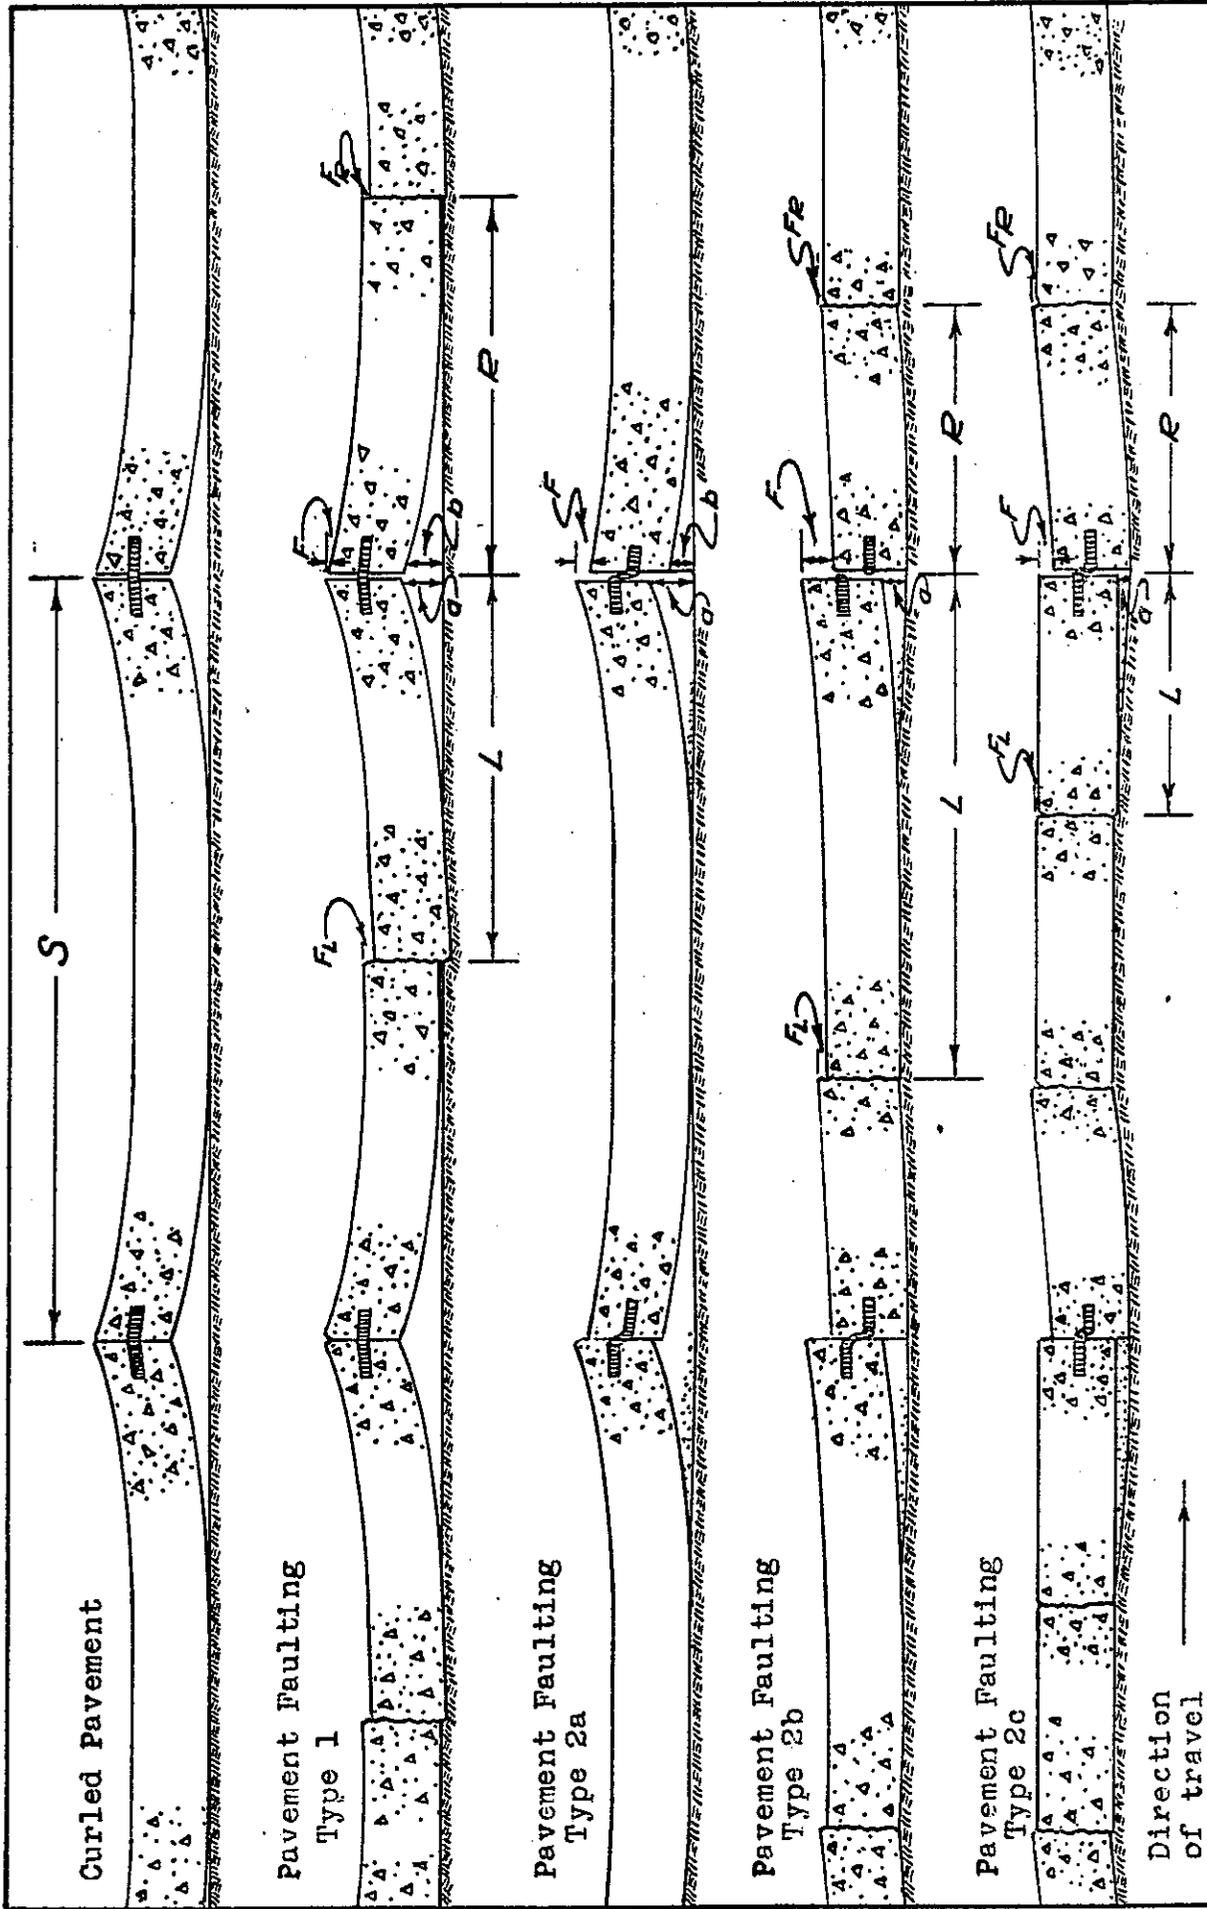
Development of "Joint Troubles" in P.C.C. Pavements.

The accompanying drawing (2) is a diagrammatic sketch showing the progress of a 3-3 truck and trailer unit across a series of curled P.C.C. pavement slabs, each 20 ft. in length. Axle spacings are to scale for one of the many combinations encountered on California highways.

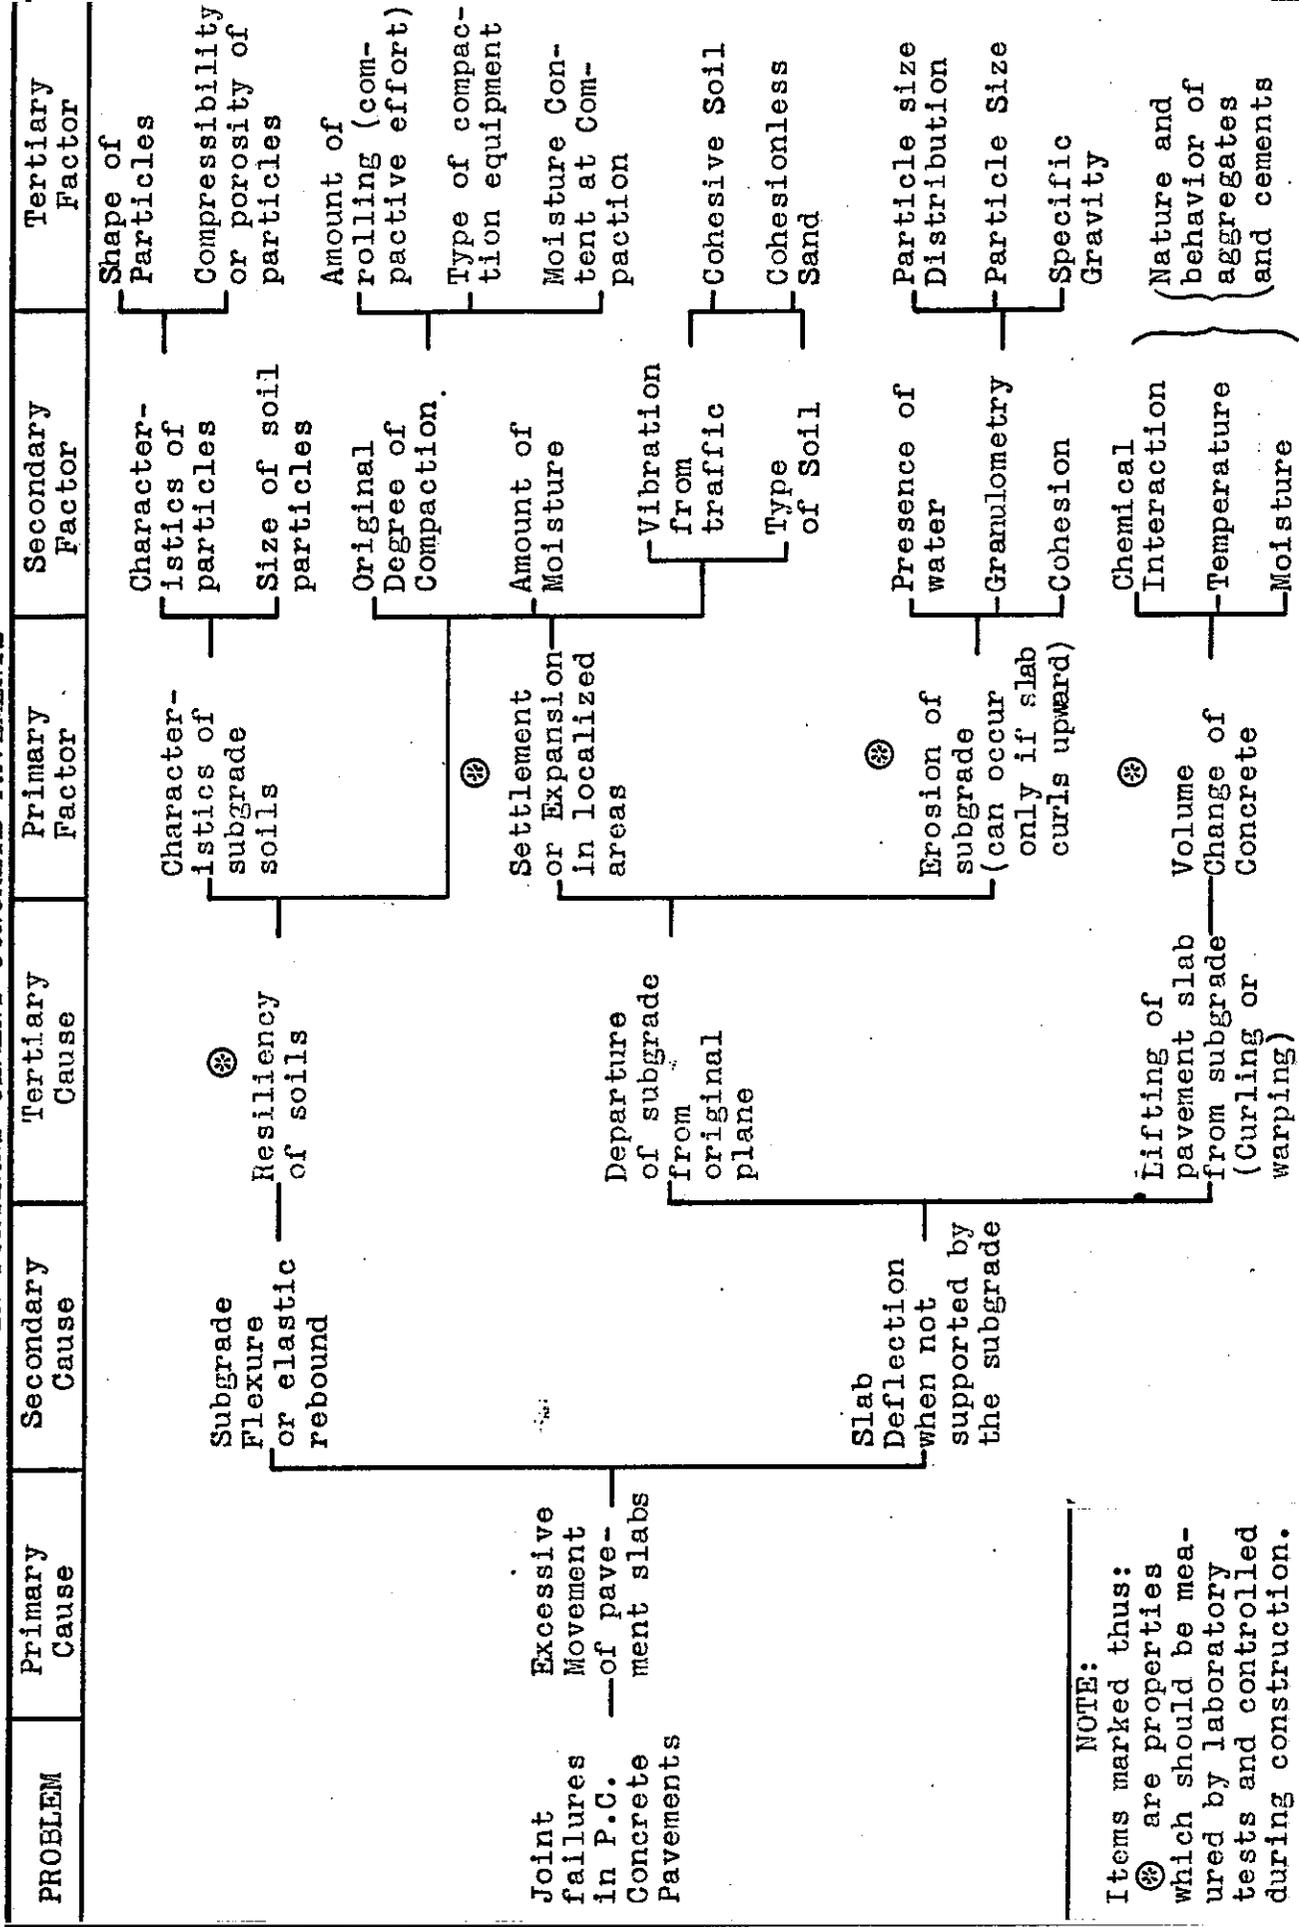
ANALYSIS CHART INDICATING THE CAUSES OF JOINT FAILURES  
 IN PORTLAND CEMENT CONCRETE PAVEMENTS

The Analysis Chart (3) is an attempt to classify the most important causes and factors which contribute to joint failures in concrete pavements. This chart is developed on the principle of subdividing each major item into its primary factors indicating the secondary and tertiary elements or variables that are involved. This chart indicates that for a satisfactory concrete pavement, the following items ought to be limited or controlled by the engineer. These items, marked on the chart by asterisks, are as follows:

1. Volume change of the concrete
2. Erosion and loss of Subgrade Material
3. Consolidation or Settlement in Localized Areas
4. Resilience of the Underlying Soil

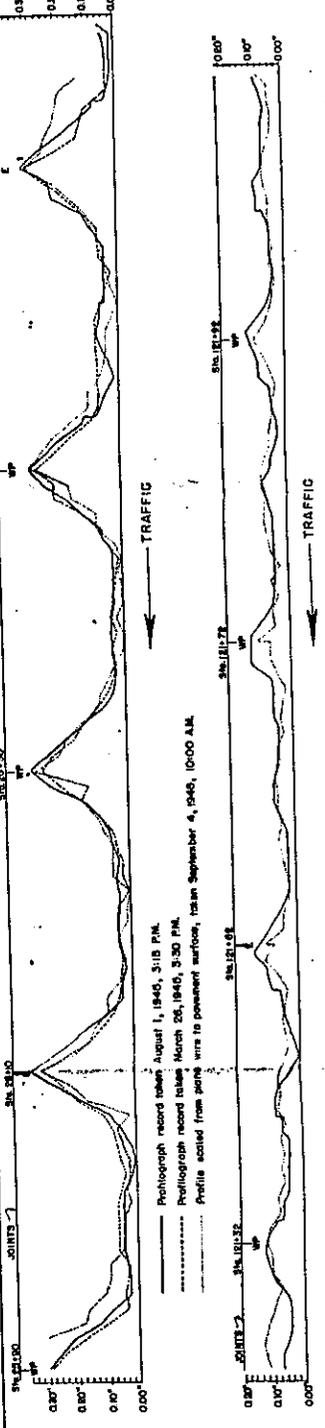
XIV - Ora-171-A - Job Letter (S) - Hampshire Avenue - West Lane

Profiles from different sections of pavement, both placed under Contract No. 07XG3 in 1937. Pavement was smoothest P.C.C. pavement constructed in state in 1937. Surrounding country flooded by heavy rains in early 1958 and pavement curbed soon after. At present (see pavement has no cracks and is still in excellent condition except for permanent cur. Profiles taken 30" west of longitudinal joint.

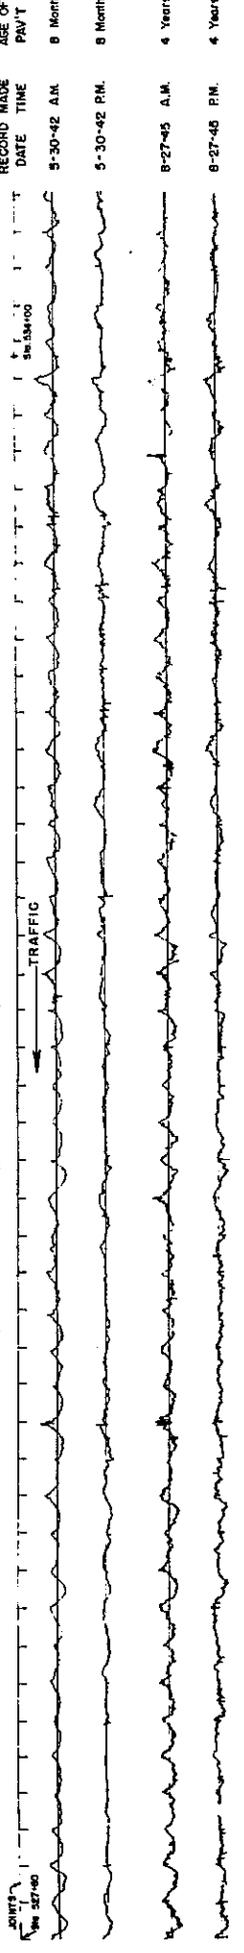
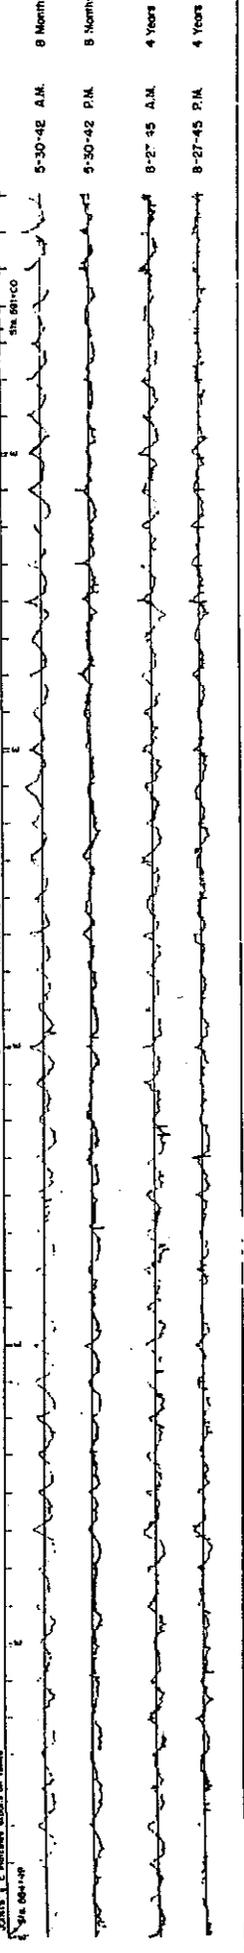
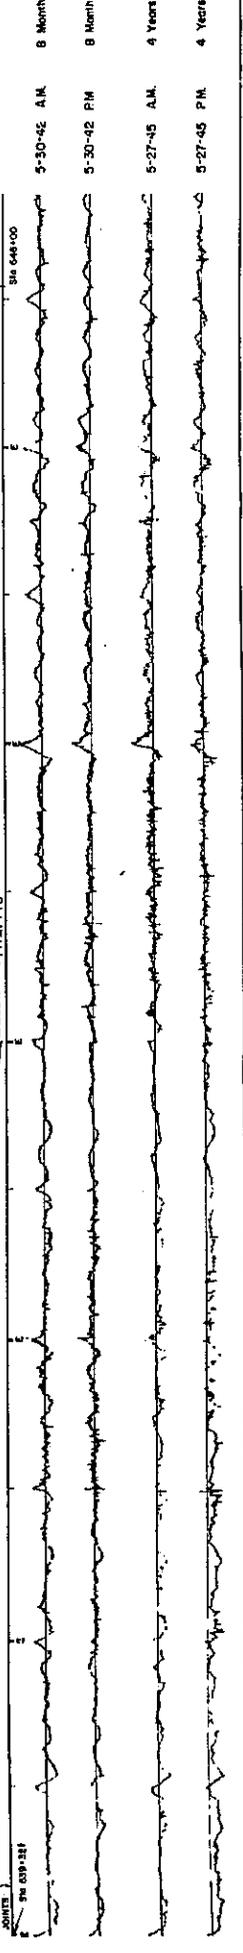
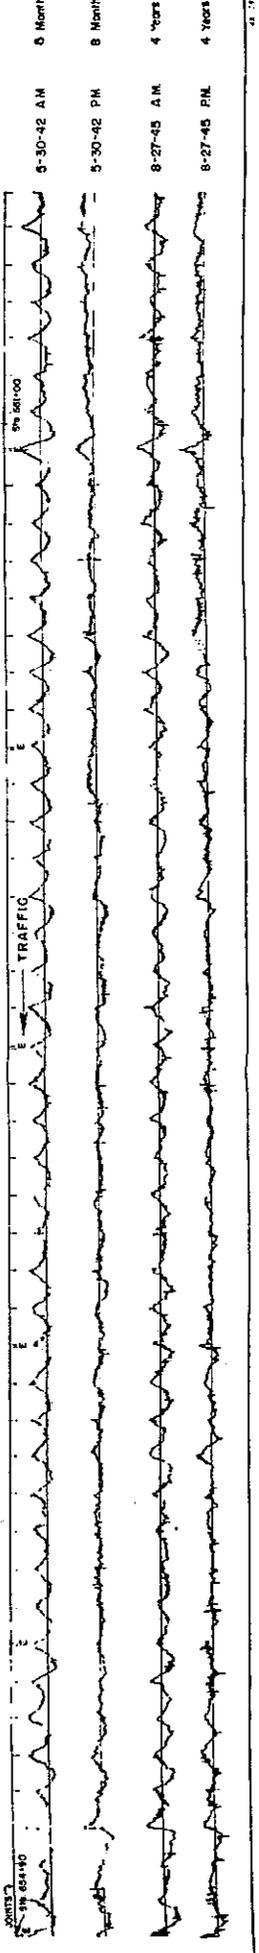
Test Section 1b - North Lane. Expansion joints spaced 5250' apart, weakened plane joints spaced 15' apart. Pavement cross-section 9'-7"-9".

Test Section 4b - North Lane. Expansion joints spaced 120' apart, weakened plane joints spaced 15' apart. Pavement cross-section 9'-7"-9".

Test Section 6b - North Lane. Expansion joints spaced 20' apart, weakened plane joints spaced 60' apart. Pavement cross-section 9'-7"-9" (reinforced)

Test Section 7b - North Lane. Expansion joints spaced 120' apart, weakened plane joints spaced 15' apart. Pavement cross-section 8" uniform thickness.

No cracks of other than planned joints on this project, as of August, 1945.

The conditions noted previously for the second profile sheet are further borne out by the third sheet (9). The sections which have 15 feet and 20 feet spacing between weakened plane joints show curl at every joint regardless of expansion joint spacing. The pavement with longer spacing between joints (30 feet to 60 feet) show curl at each joint and also at most cracks but the spacing of expansion joints seems to have little effect. As noted above, the longer slab length results in a pavement that is smoother over all than is the case with the shorter joint spacing.

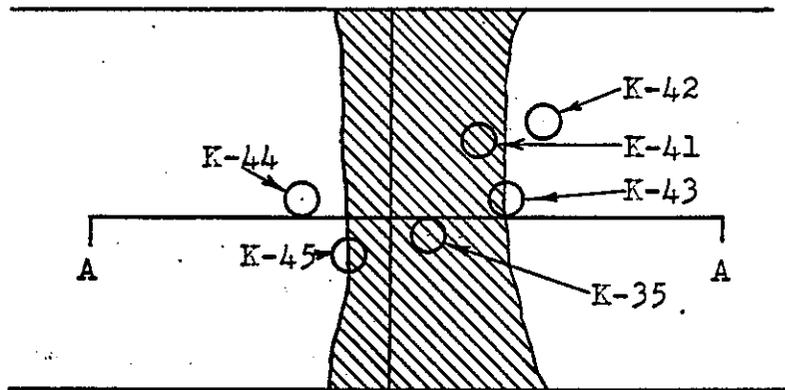
PLAN

Measurement of extent of opening under ends of  
a pavement slab

The sketch which appears opposite (19) is a graphic representation of an attempt to measure the area of opening under the slabs, adjacent to a faulted weakened plane joint.

Cross hatched area  
 corresponds to space  
 filled by plaster

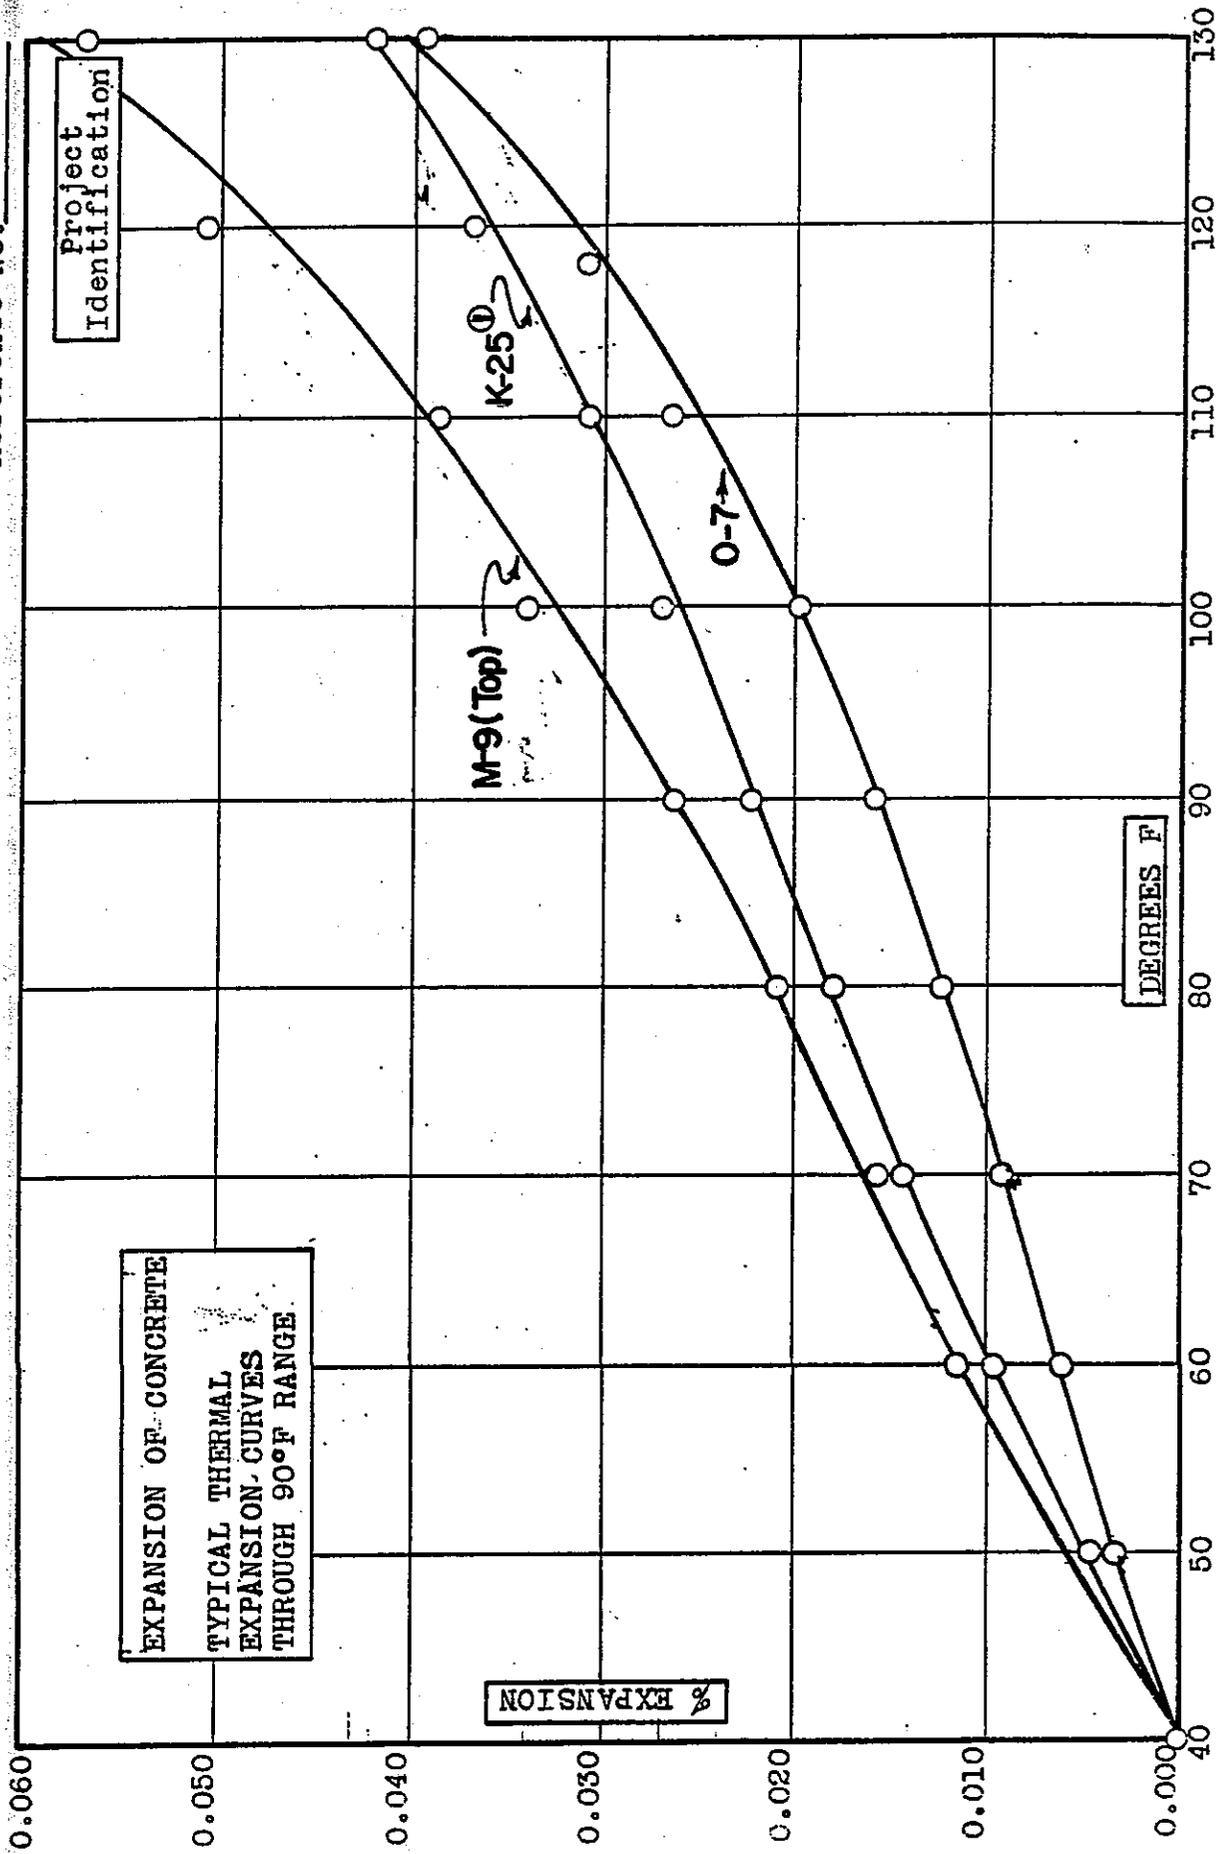
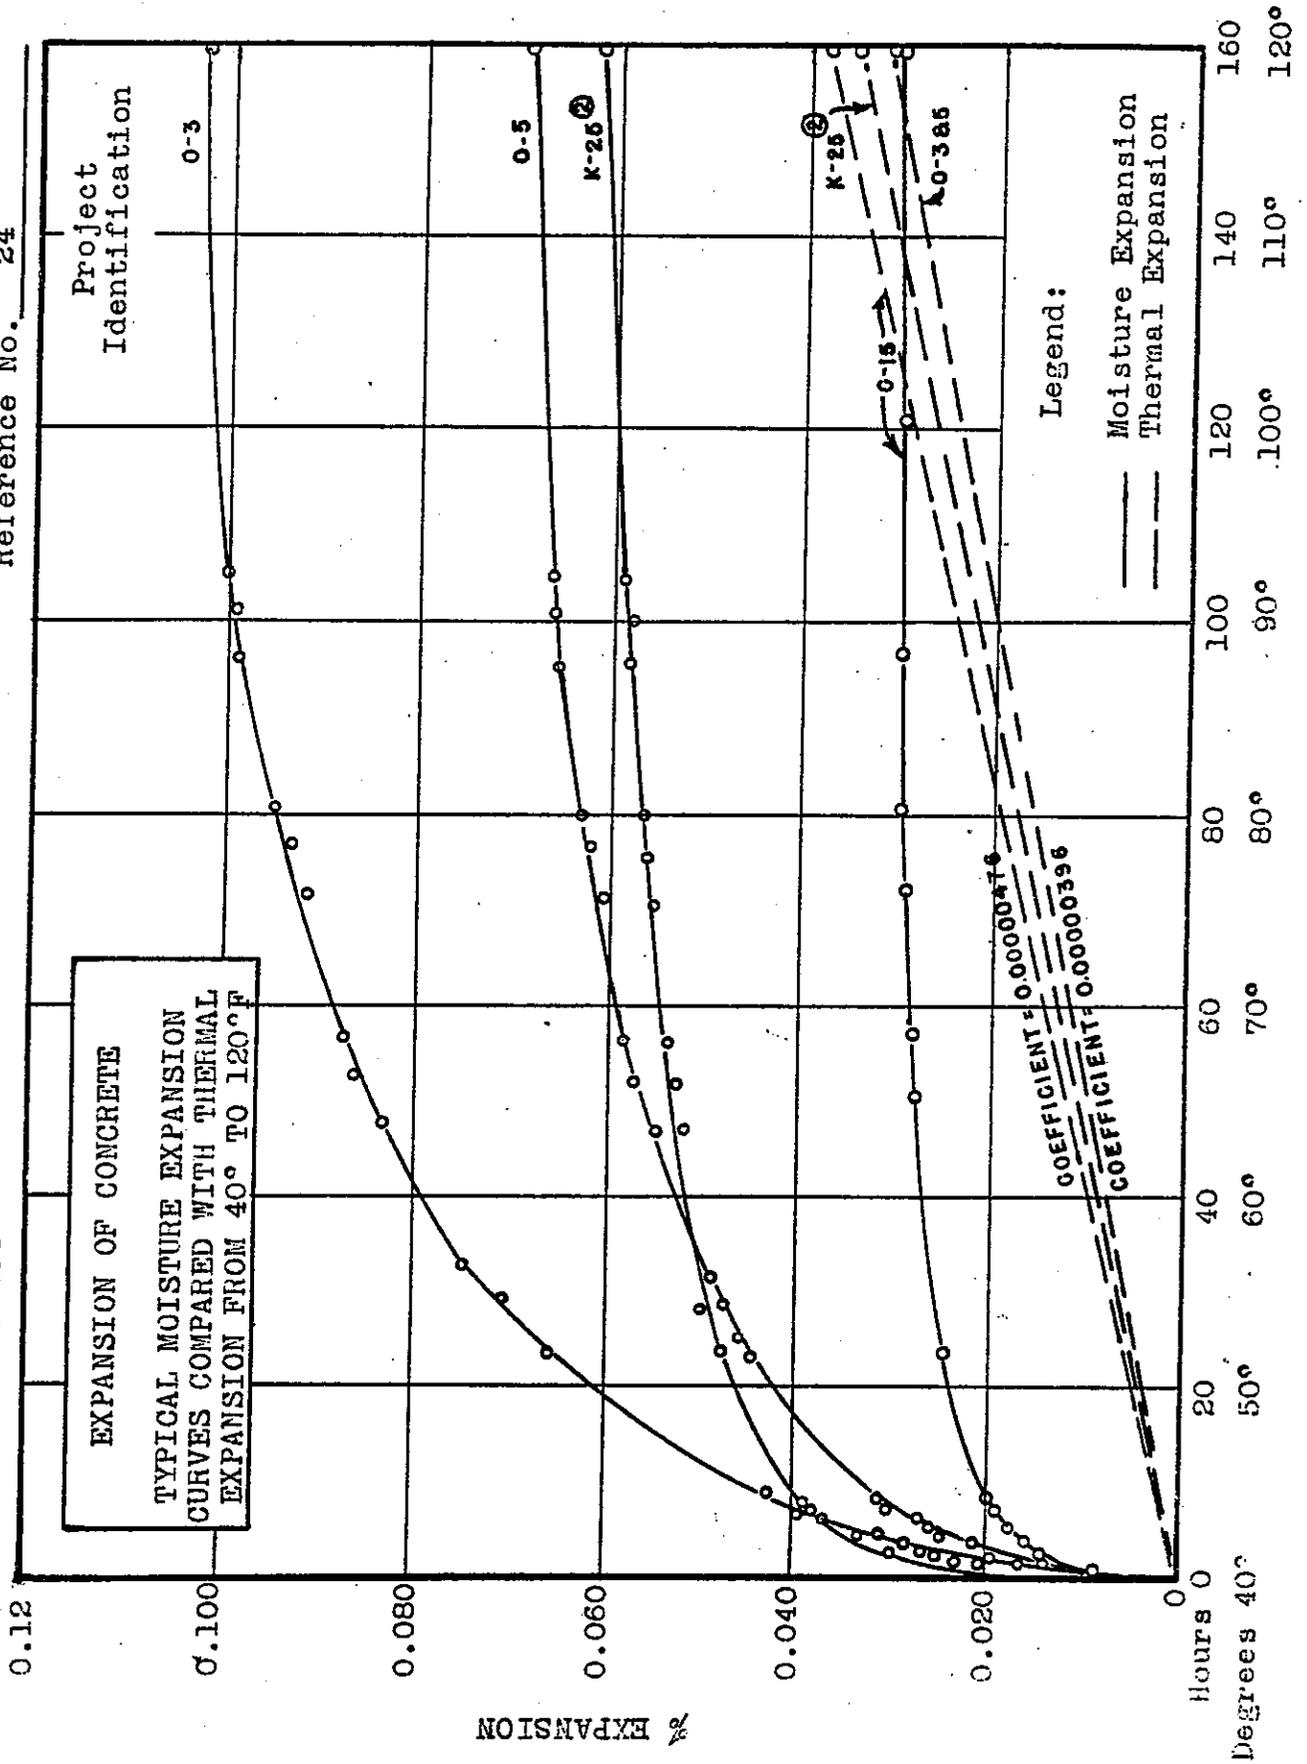
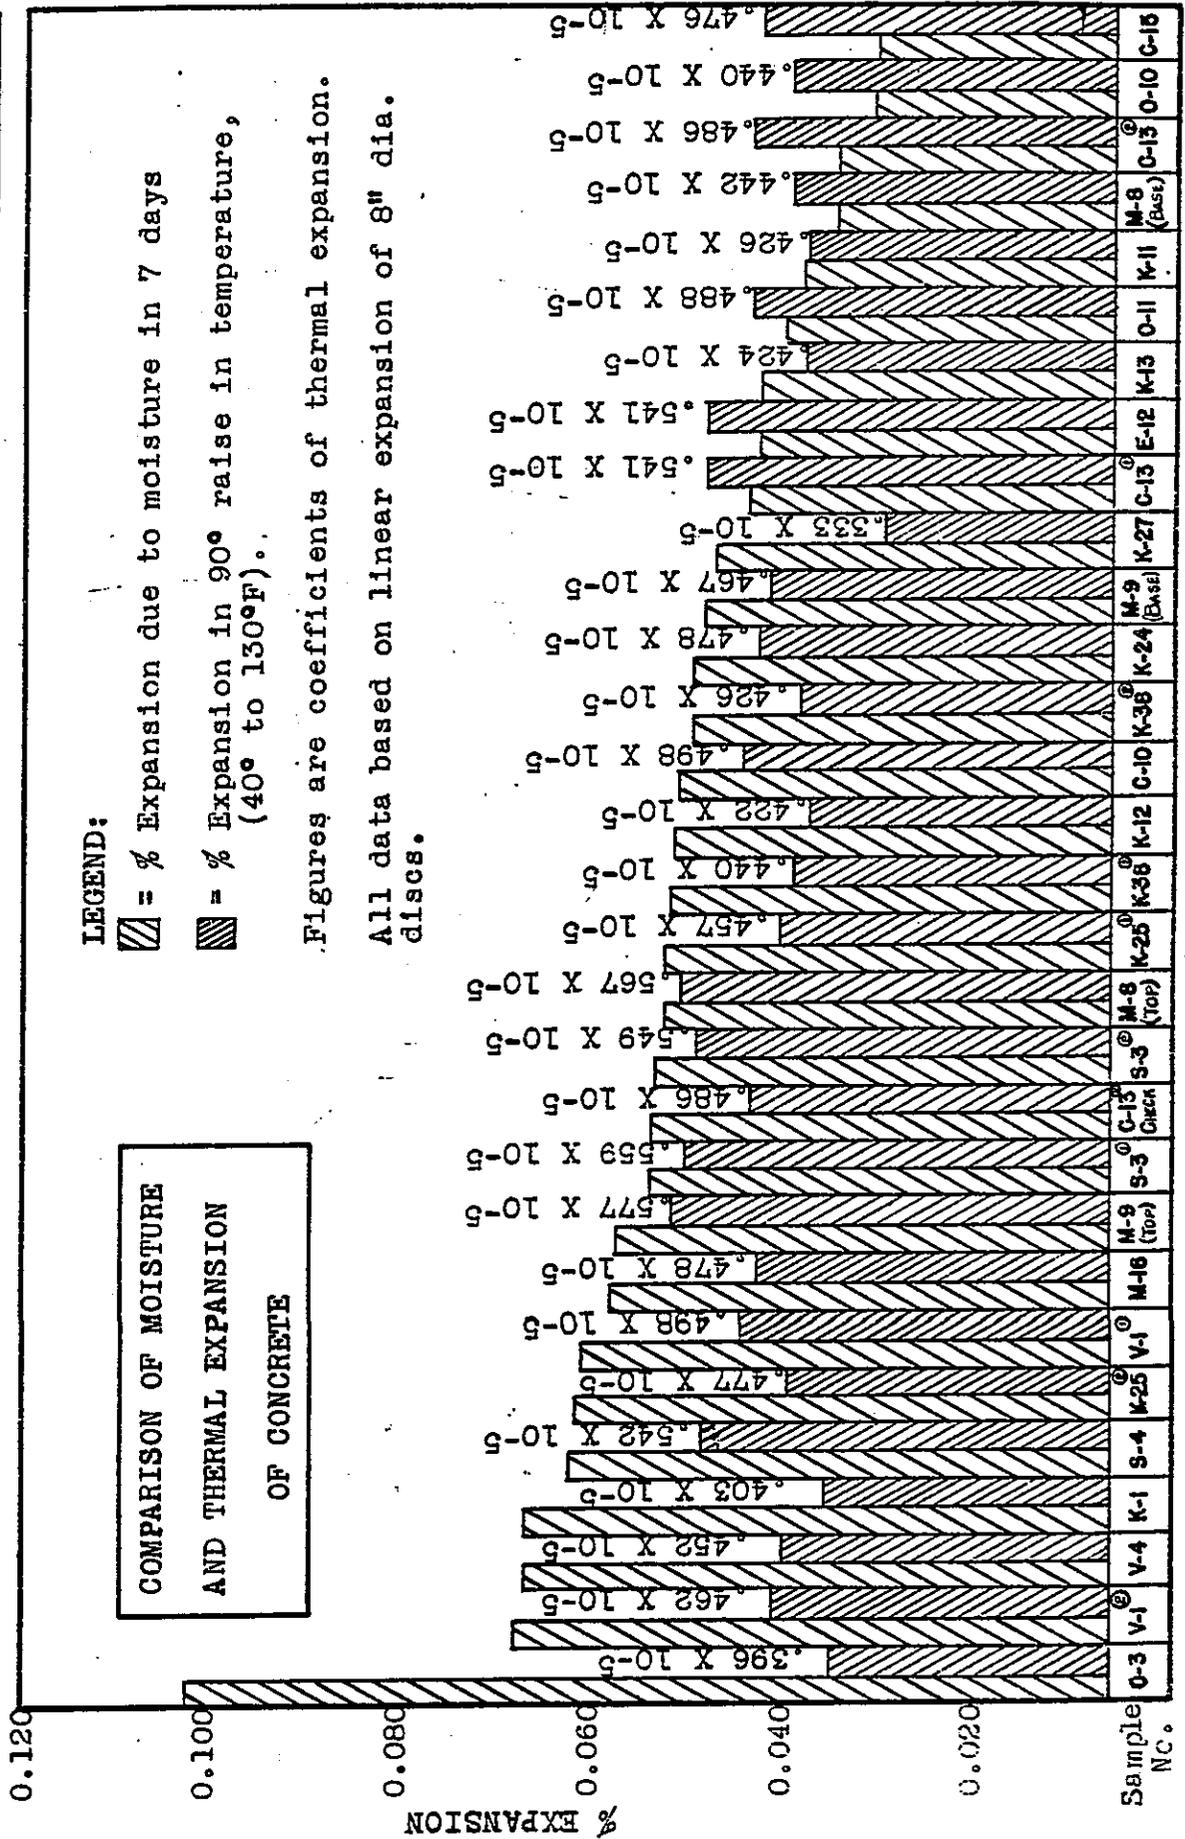
Reference Nos. 23, 24, and 25 are graphic representations of some of the thermal and moisture expansion test results obtained. Note that in Reference 25 with the exception of a very few cases, the expansion due to temperature and that due to moisture are approximately equal. This fact would seem to substantiate the observed conditions of "curled" pavement, namely that the greatest curl occurs in the early morning when expansion due to moisture (lower part of slab) is greatest and expansion due to temperature (upper surface) is least. Conversely, the pavement becomes smoothest in mid-afternoon when the expansion of the upper surface due to temperature is approximately equal to the expansion of the under side due to moisture - the pavement tends to return to the "normal" contour with surfaces again straight.

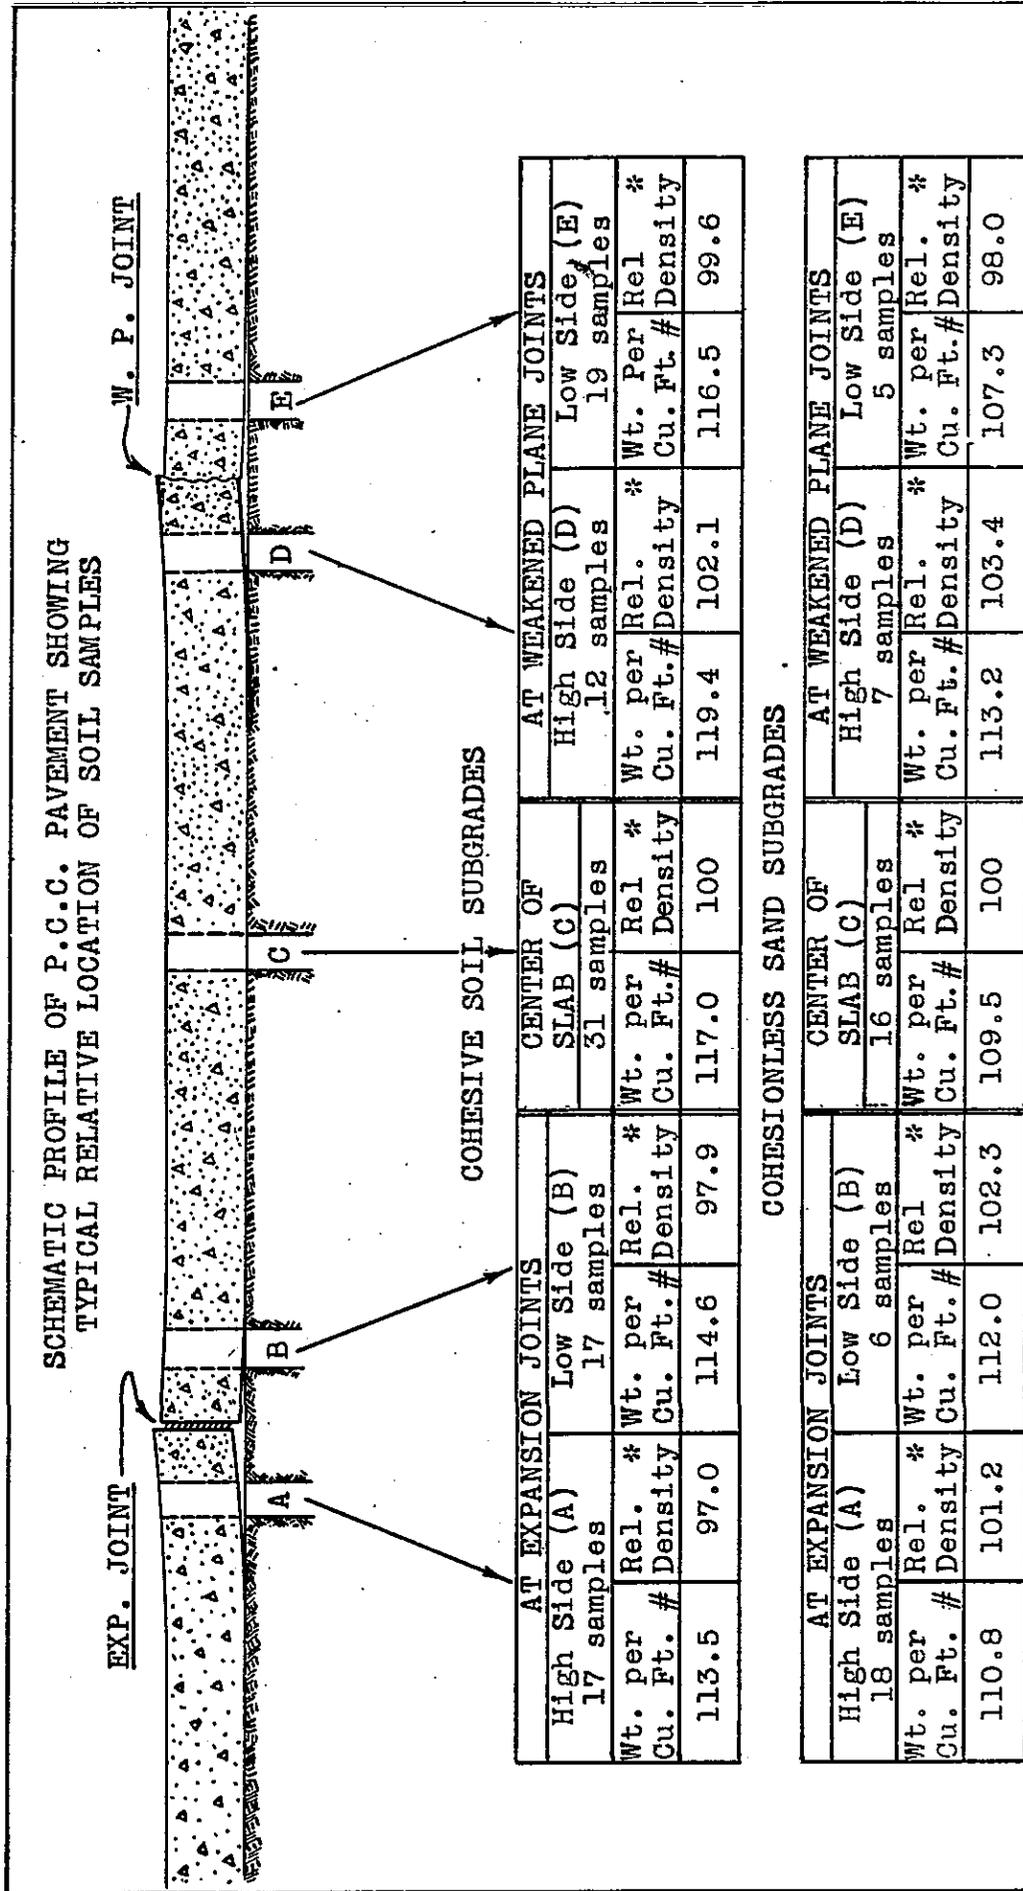
COMPARISON OF SUBGRADE SOIL COMPACTION BENEATH CENTER AND ENDS OF SLABS

The accompanying sketch (34) is a diagrammatic drawing showing the relative positions of subgrade soil samples taken and a tabulation of densities encountered in various types of soil.
