A Survey of the Condition of the Corrugated Metal Culverts in District 1

March 1955

R.F. Stratfull

State of California  
Department of Public Works  
Division of Highways  
Materials & Research Department

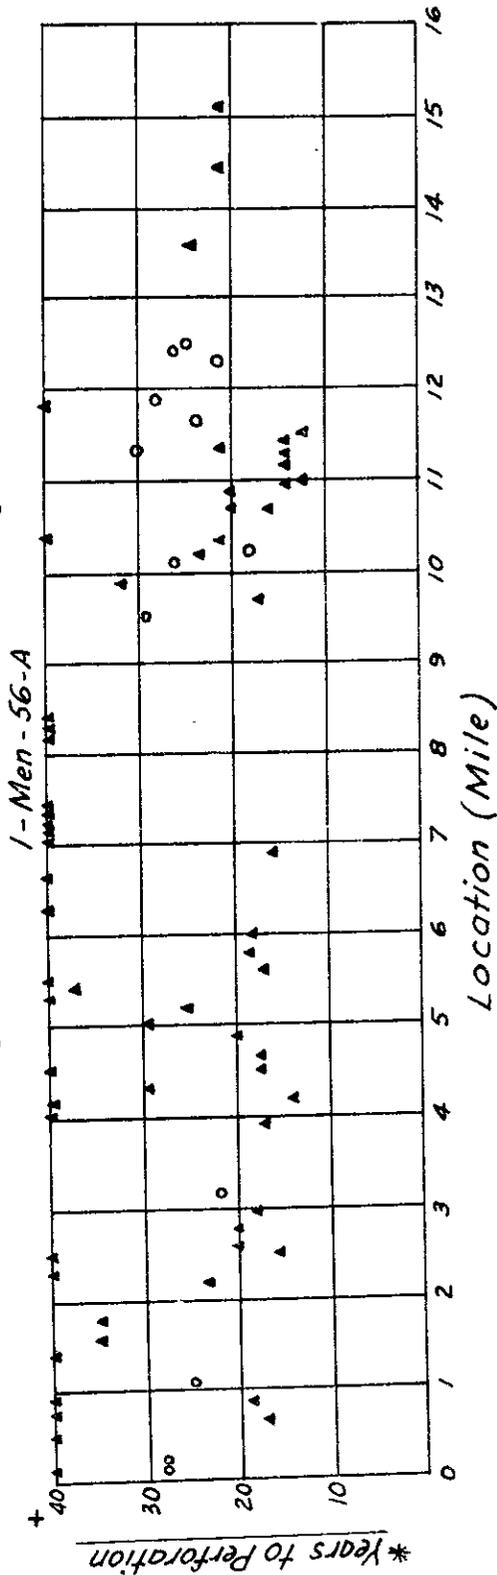
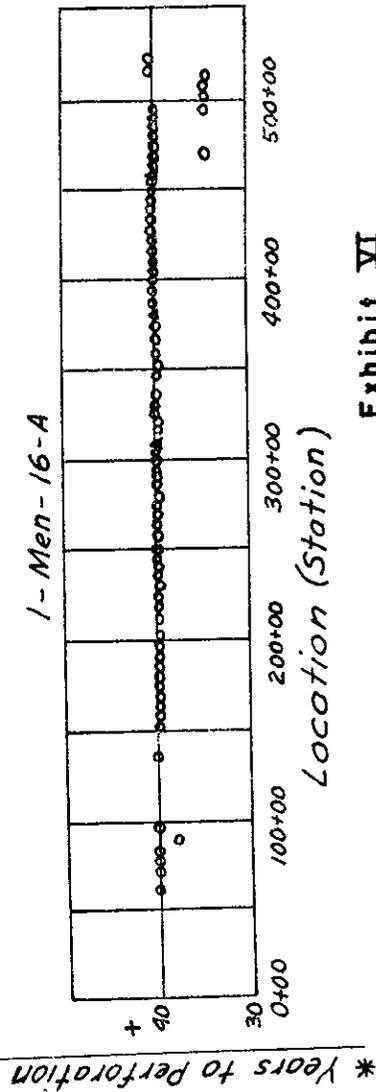
Culvert Corrosion Rates  
A Typical Comparison of Culvert Corrosion Rates  
Used for Corrosion Area Designation

NOTE: No culvert with less than 10 yrs. service was included.
