FHWA/CA/TL-88/07

Vehicle Impact Testing of Lightweight Lighting Standards

October 1988

Office of Transportation Laboratory  
California Department of Transportation  
Sacramento, California 95819

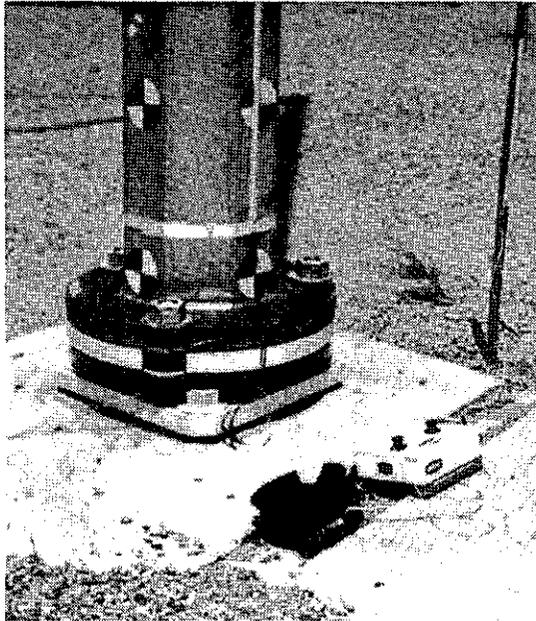
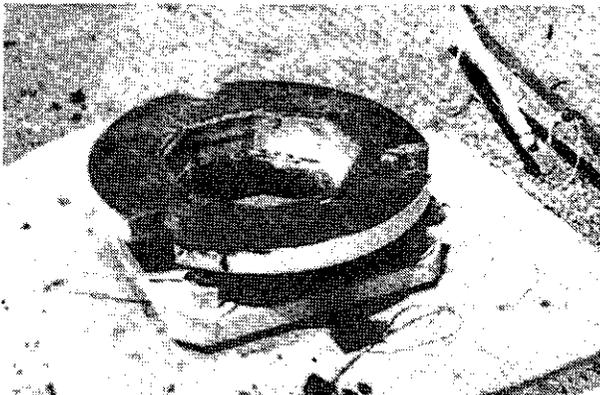
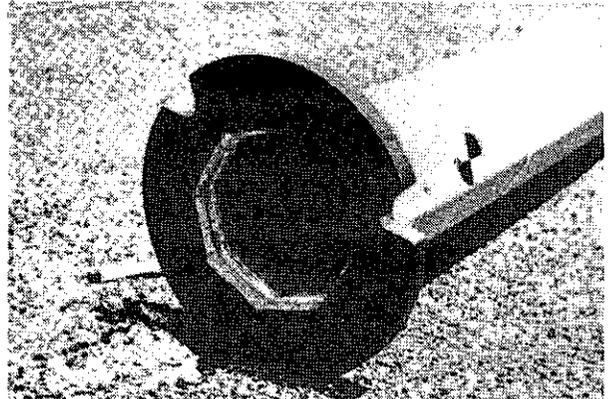
Figure 1. Details of the TTI Slip Base

The TTI slip base consisted of two identical plates which have slots at the apexes of an equilateral triangle (Figure 1). The bottom plate was rigidly attached to the foundation (Figure 1-b), and the top plate was welded to the luminaire support shaft (Figure 1-c). The two plates were clamped together with bolts through the slots (Figure 1-a). The clamping force had to be large enough to prevent slip base separation when the lighting standard is

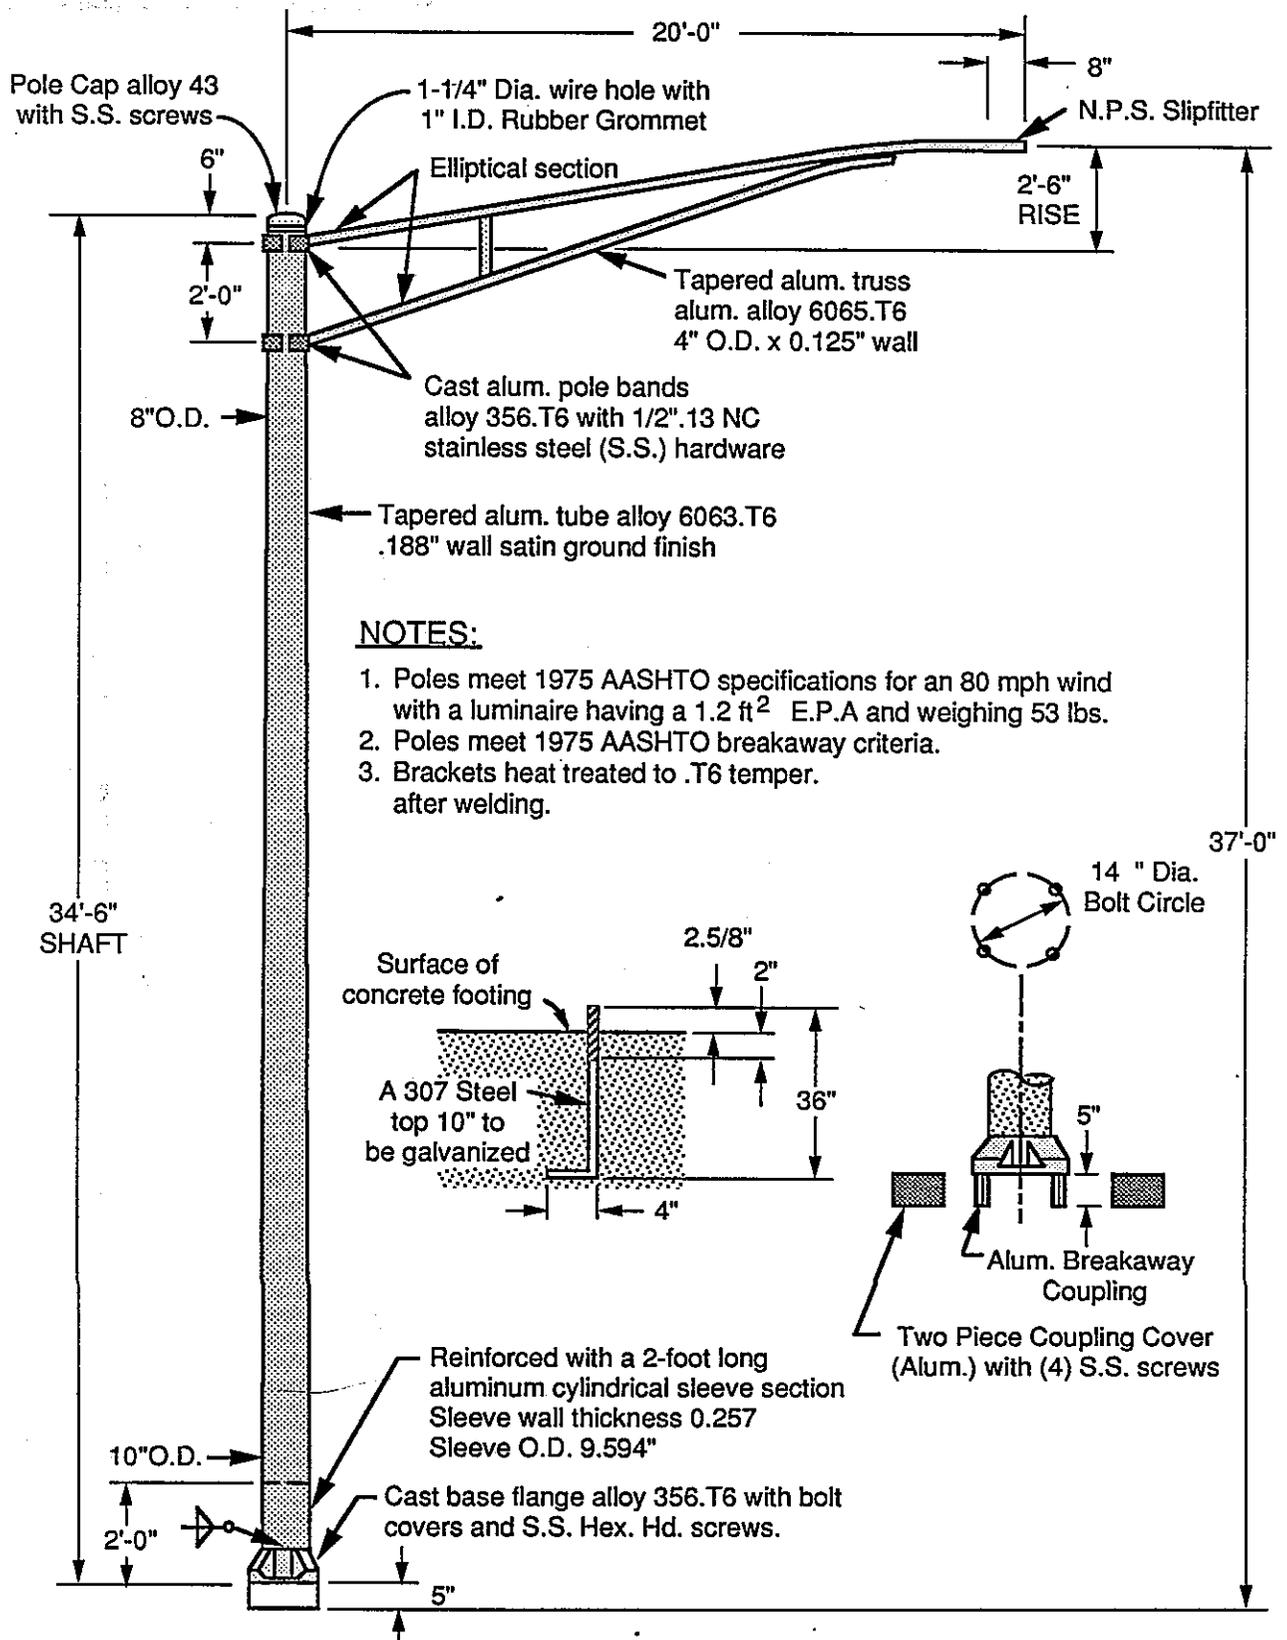
Figure 2. Aluminum Lighting Standard Used in Tests 401 and 402

The aluminum lighting standard (with truss type aluminum mast arm) used in Tests 401 and 402 is shown in Figure 2. It was manufactured by Hapco of Abingdon, Virginia. The pole height installed was 35 ft. The shaft tapered from 10 in. (base OD) to 8 in. (top OD) and the wall thickness was 0.188 in. The pole base was reinforced with a 2-ft-long aluminum cylindrical sleeve section, 0.257-in.-thick, inserted and welded inside the pole to insure that the shaft had sufficient strength to resist crushing or denting in the vehicle contact area. This also insure a quick transfer of impacting force to the breakaway support causing optimal performance of the breakaway base.

A 4-bolt base flange was used to correspond to the aluminum couplings which were used as the breakaway device for Tests 401 and 402. To minimize weight and excessive luminaire deflection, the 20-ft-long mast arm was built as a truss. The mast arm had a 30 in. rise. A GE 400 watt high pressure sodium luminaire weighing 48 lb was installed at the end of the mast arm. To simulate the actual

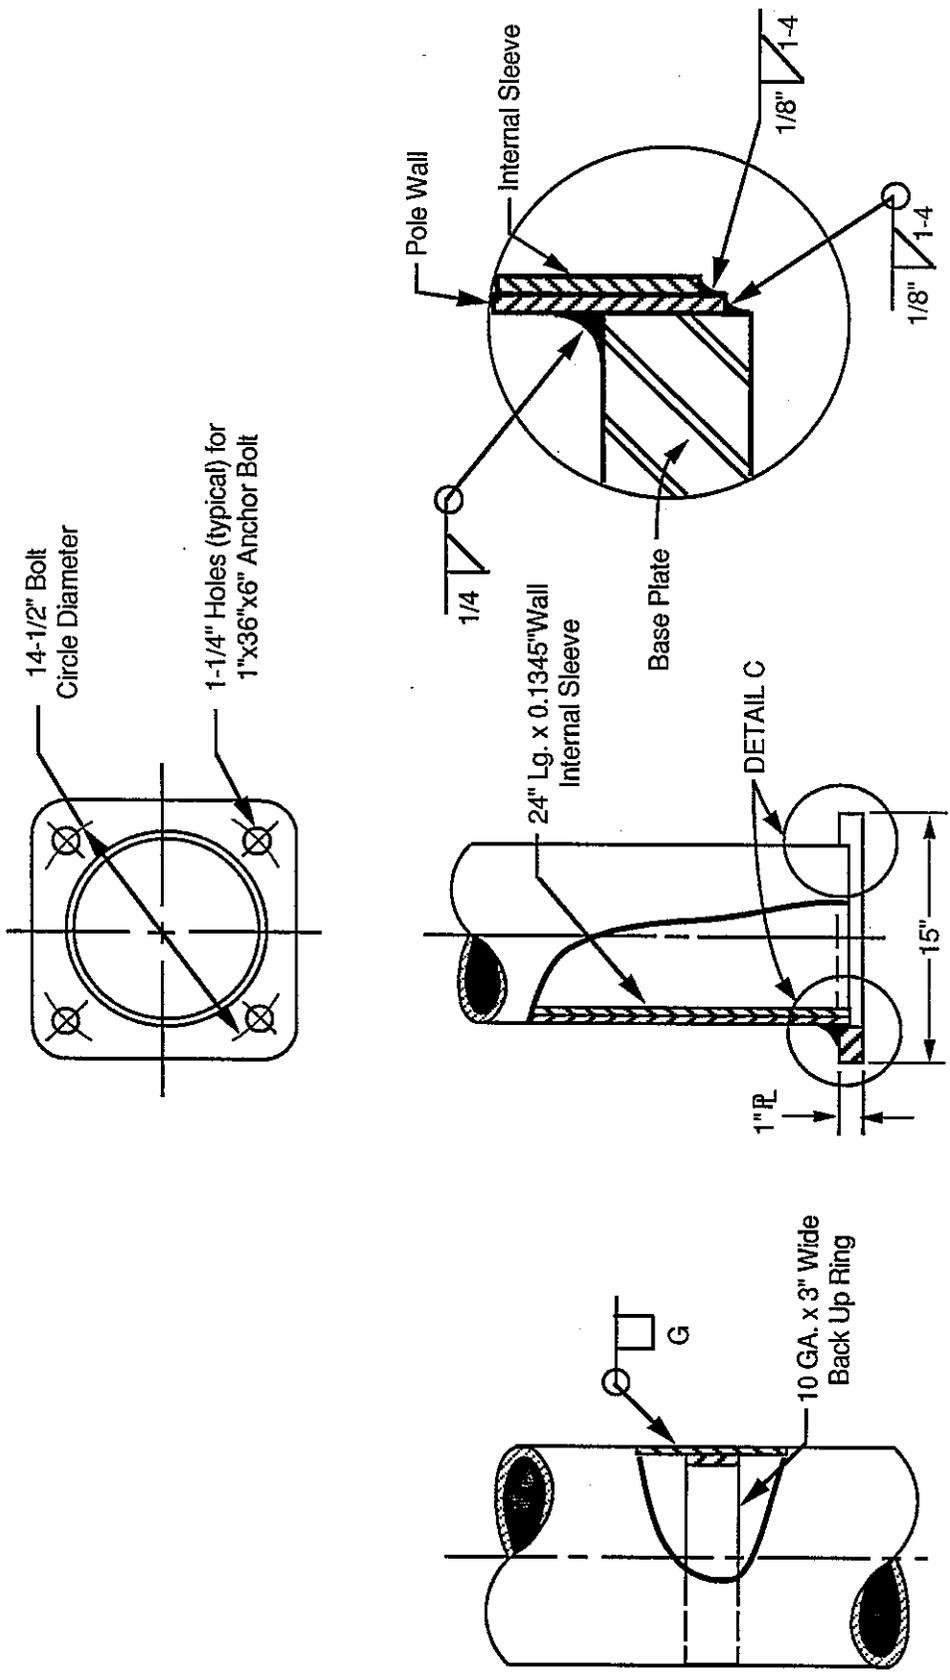
DETAIL A - BASE DETAIL

The lighting standard used for Test 403 was manufactured by Ameron Pole Products, Division of Oakland, California (Figure 3). The tapered shaft (35'-0" X 10-1/16" OD X 5-3/8" OD) weighed 461 lb. The shaft was reinforced at the bottom with a 2-ft-long x 10 gage (0.1345-in.-thick) steel cylindrical sleeve section, inserted inside the shaft and welded to the base plate. A 4-bolt base plate was used to correspond to the aluminum couplings which were used as the breakaway device for Test 403. The 20-ft-long mast arm (20'-0" X 5-1/4" OD, X 2-3/8 " OD) was manufactured from 10 gage (0.1345-in.-thick) steel and weighed 132 lb. The luminaire used was an ITT 400 watt fixture with a high pressure sodium lamp weighing 48 lb. To simulate the real condition, the luminaire was wired

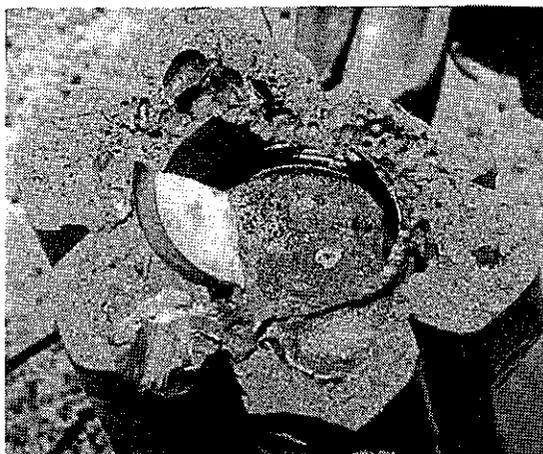
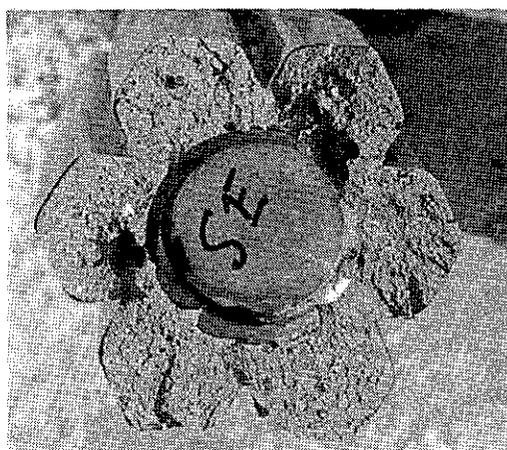
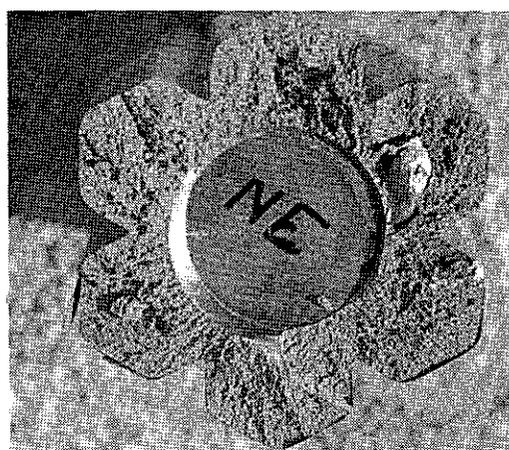
The eight couplings used in Tests 401 and 402 had been randomly selected from the 20 die-cast aluminum couplings obtained from Transpo Industries, Inc. No tensile or shear strength or chemical properties of the couplings had been determined prior to using them in crash Tests 401 and 402. Following the second crash test (Test 402), all pieces of the broken couplings were visually inspected. It was noted that five of the eight couplings had severe porosity defects (1/4" or larger holes) on the fractured surfaces, where coupling failure had occurred, Figure 8. It was also found that cases of Transpo coupling failures in the states of Utah and Wyoming had also been attributed to excessive porosity.

Figure 8. Fractured Surfaces of Transpo Die-Cast Aluminum Couplings Used in Tests 401 and 402

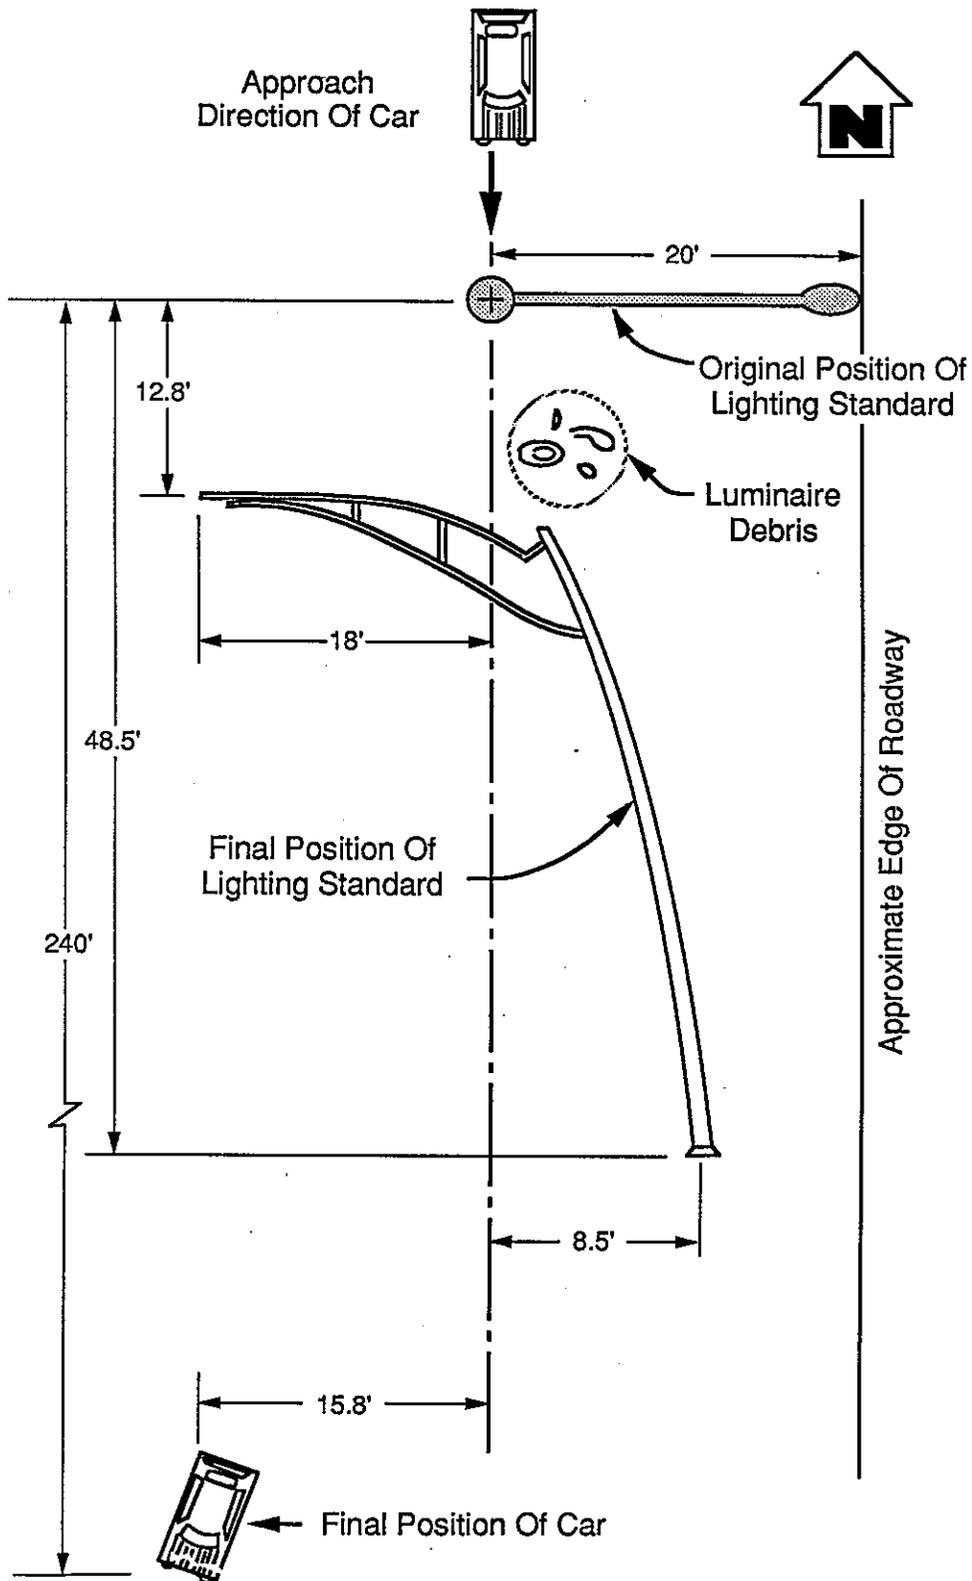
Figure 23. Final Location of the Lighting Standard and the Car After Collision - Test 401

of 15 in. to the right of centerline) at 58.6 mph. The couplings sheared off as intended, and the vehicle pushed the pole base up and passed under the pole as it decelerated in a fairly straight line without significant yaw. The final position of the vehicle after it was braked remotely (240 ft downstream from the foundation) and the final location of the lighting standard are shown in Figure 23.

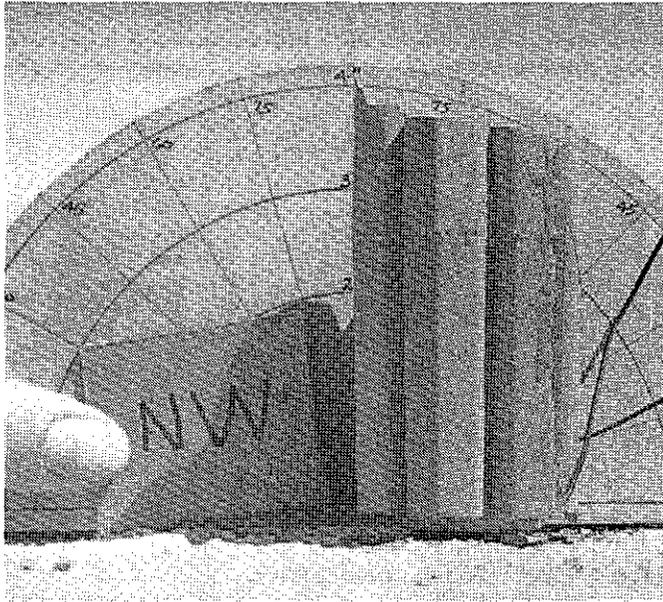
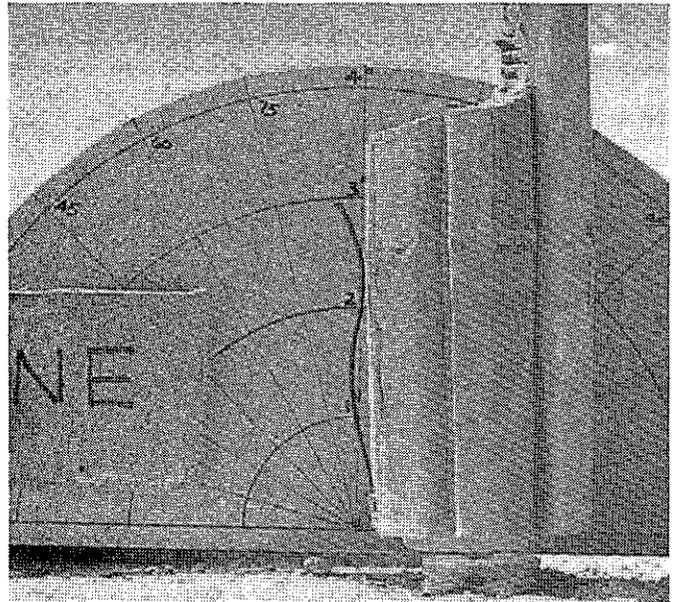
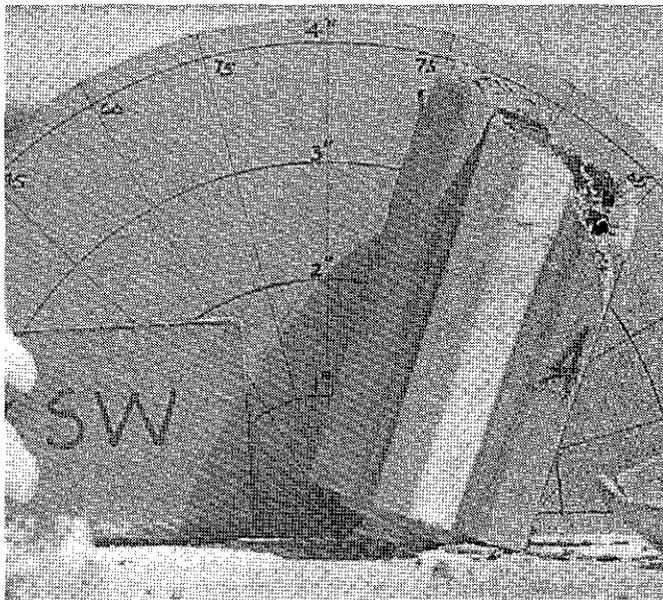
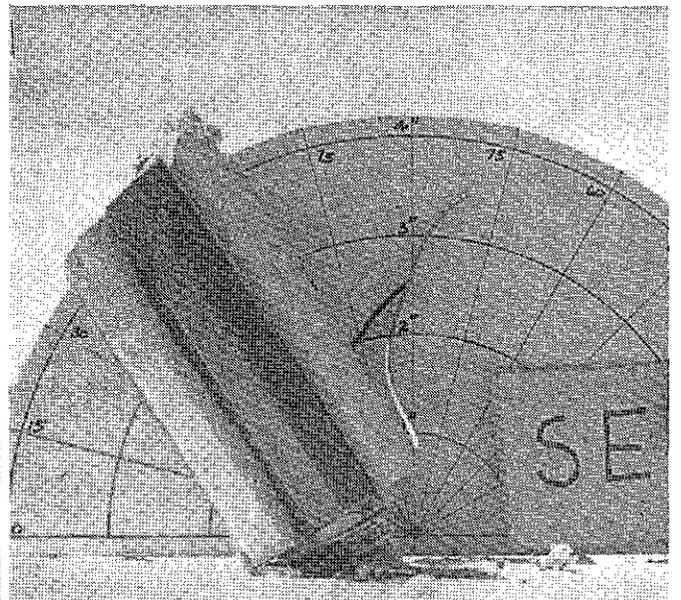
Figure 24. Die-Cast Aluminum Couplings After Impact - Test 401

The couplings fractured as expected, with the bottom two thirds of the couplings remaining intact on the anchor bar studs as shown in Figure 24. Cracks in the couplings initiated in the root of the "V" notches at the top of the coupling and progressed downward until they reached a location near the base of the top stainless steel stud. The two stainless studs on the upstream side of the lighting standard, which remained in the holes in the base plate at the bottom of the aluminum pole, impacted and bent the two downstream anchor bar stubs which were directly in their path. Figure 25 shows the schematic of the vehicle approach direction and the anchor bar stubs after the impact. This vehicle approach direction offers the highest shear resistance as required by NCHRP Report 230. This condition would not normally be present because of the typically skewed approach angle of an errant vehicle. No relative movement between the concrete foundation and the surrounding asphalt concrete occurred due to the impact.

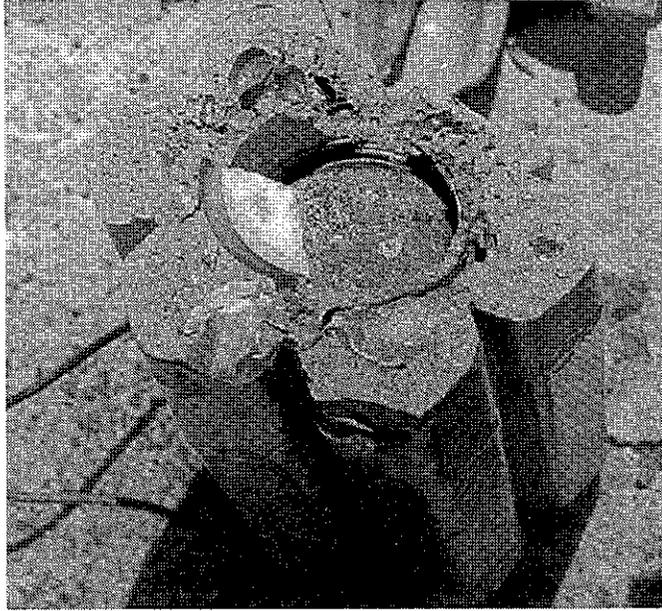
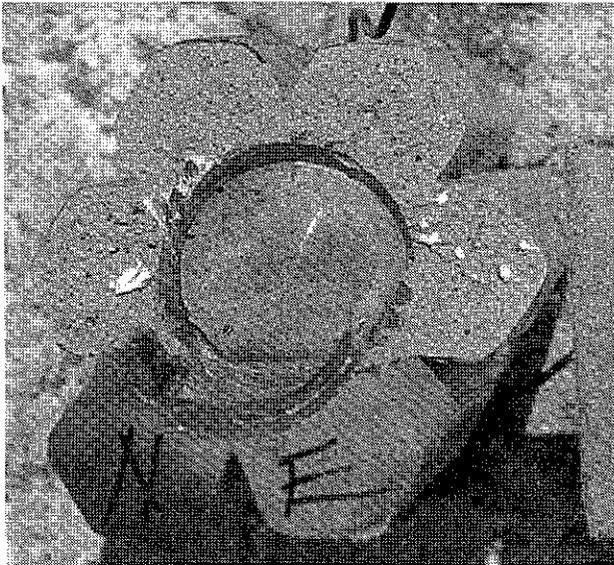
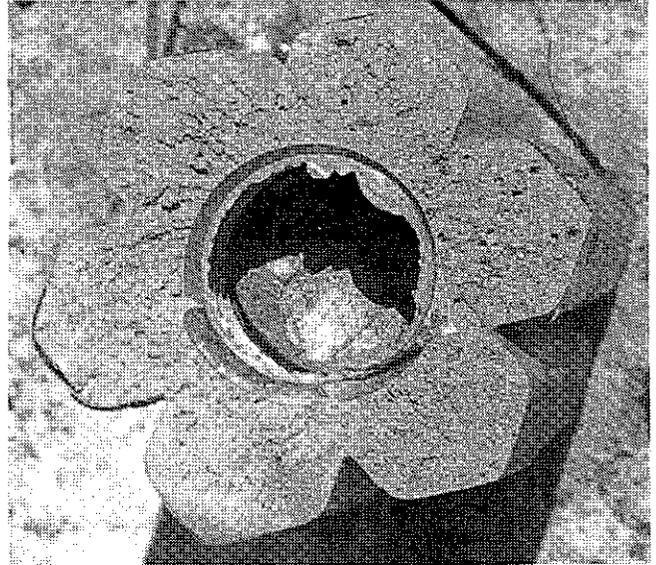
Figure 26. Fractured Surfaces of Die-Cast Aluminum Couplings - Test 401

Excessive porosity was noted on the fractured surfaces of the broken couplings as shown in Figure 26.

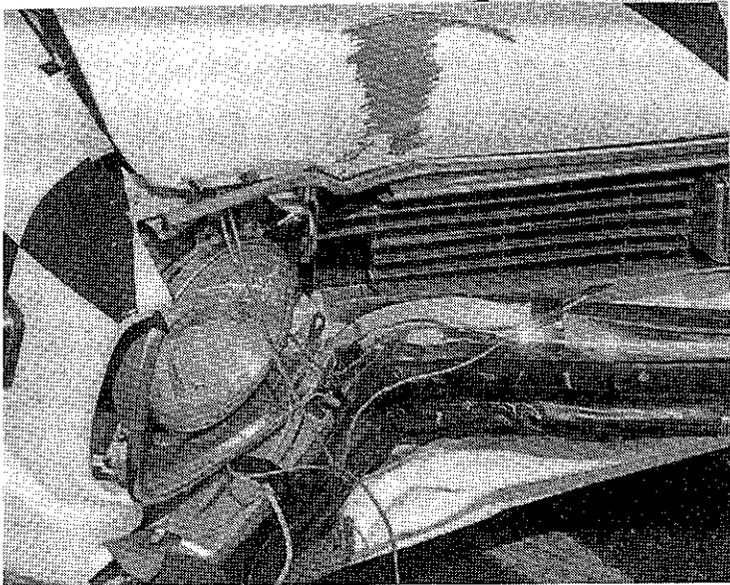
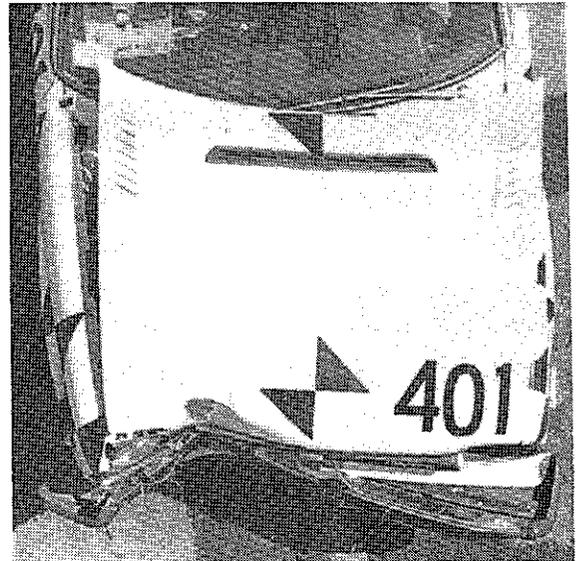
Figure 28. Test Vehicle After Impact - Test 401

Figure 28 shows the test vehicle after the impact. The front crush profiles of the vehicle (measured in horizontal planes at different heights) are shown in Figure 29. Maximum crush of the bumper was 11.25 in. at the impact point.

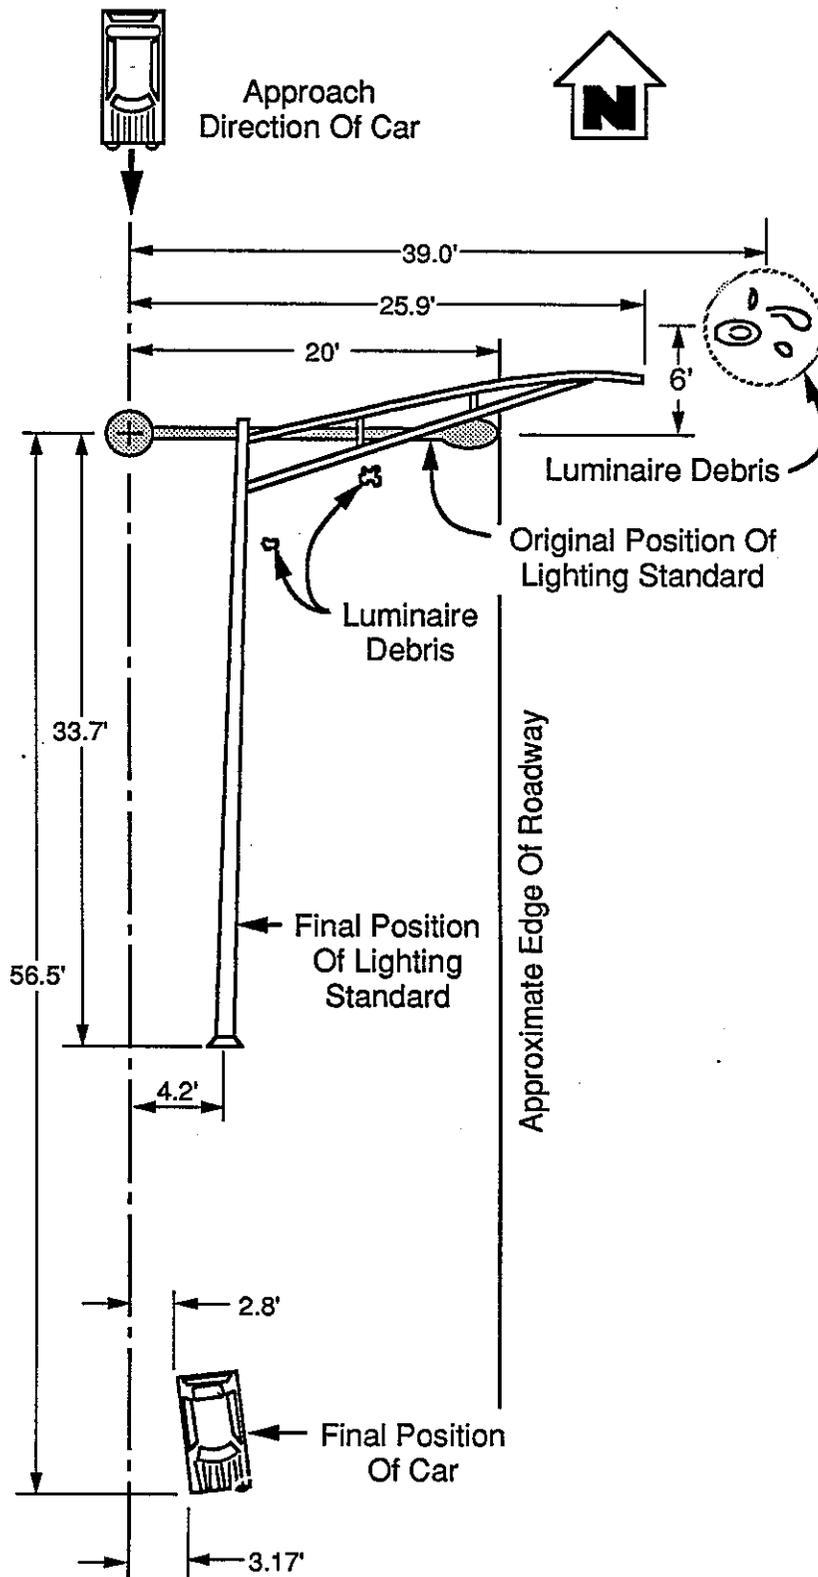
Figure 31. Final Location of the Lighting Standard and the Car After Collision - Test 402

The 1979 Honda Civic test vehicle impacted the aluminum pole at the center of the front bumper at 19.6 mph. Upon impact, the couplings sheared off and the vehicle pushed and bumped the pole along in front of the decelerating auto. The pole was pushed over slowly and it rolled on the roof as the car barely passed under the pole base plate. The vehicle traveled in an almost straight line after impact, drifting slightly to the left with virtually no yaw. The final position of the vehicle after the brake had been applied was 56.5 ft from the foundation as shown in Figure 31.

The luminaire broke into many pieces that were scattered over a large area (well into the imaginary traffic lanes). The largest pieces were lying about 39 ft east of the concrete foundation (Figure 31).

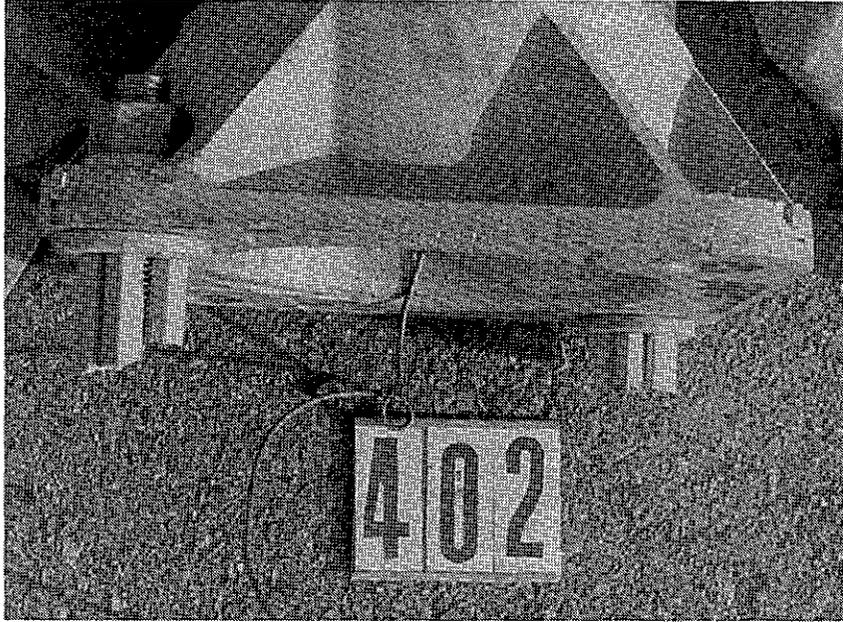
Figure 32. Aluminum Lighting Standard Shoe Base  
After Impact - Test 402

lighting standard shoe base, Figure 32, impacted the broken aluminum coupling stubs (still intact on the anchor bar stubs) and bent the two downstream anchor bars as occurred in Test 401. Figure 33 shows the couplings and the anchor bars after the impact. The schematic of the vehicle approach direction and the anchor bar stubs after the impact are shown in Figure 34. As mentioned before, this vehicle approach direction offers the highest shear resistance as required by NCHRP Report 230; however, the approach of an errant car is typically skewed. No relative movement between the concrete foundation and the surrounding asphalt concrete occurred due to the impact.

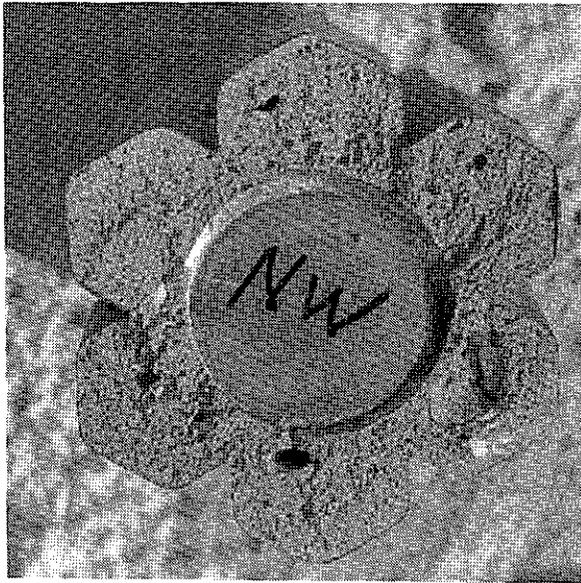
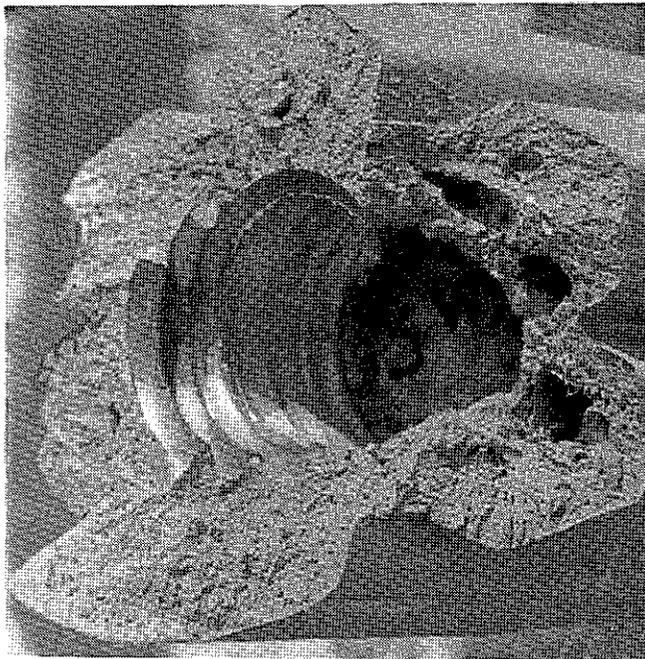
Figure 35. Fractured Surfaces of Die-Cast Aluminum Couplings - Test 402

Figure 35 shows the excessive amount of porosity observed on the fractured surfaces of the broken couplings. This is similar to what had been observed in Test 401. As explained before (section 5.1.2.2,1), because of this excessive amount of porosity, the remaining couplings were x rayed and only those with an acceptable amount of porosity were used in the next test, Test 403.

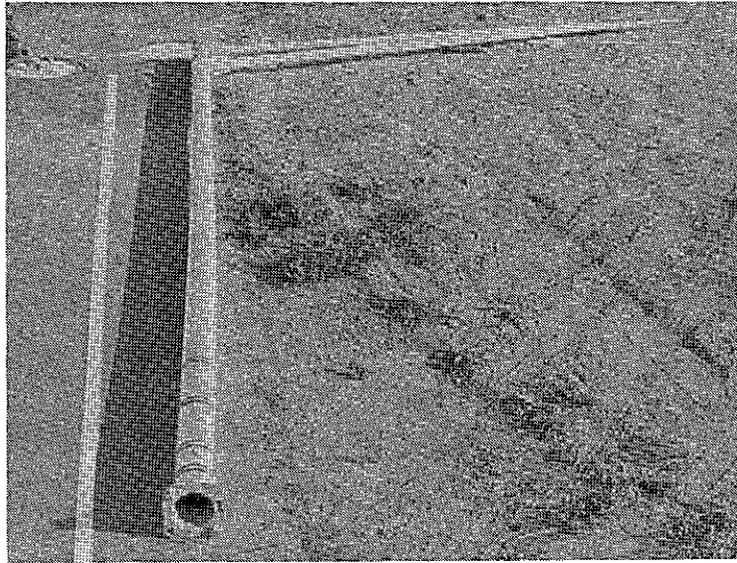
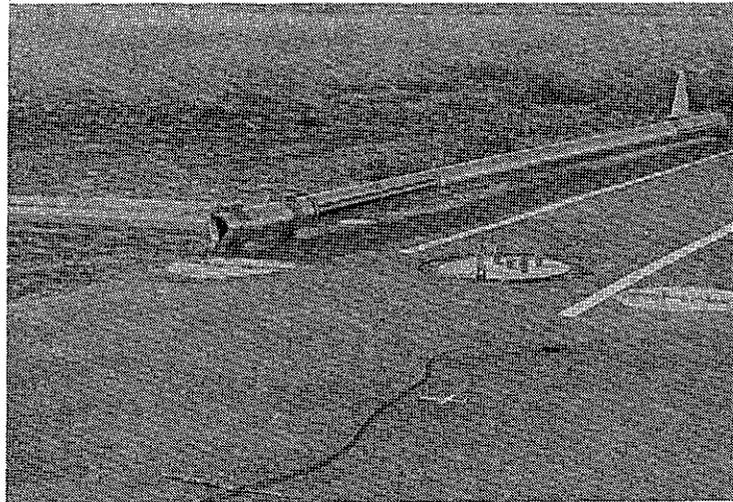
Figure 36. Lighting Standard Damage - Test 402

As in Test 401, the aluminum pole sustained no damage from the impact of the vehicle's front bumper. The top of the pole; however, swung down and impacted the asphalt pavement, damaging the end cap and top edge of the pole and causing the upper cast aluminum mast arm clamping band to fracture, Figure 36. The mast arm, however, did not buckle as it did in Test 401.

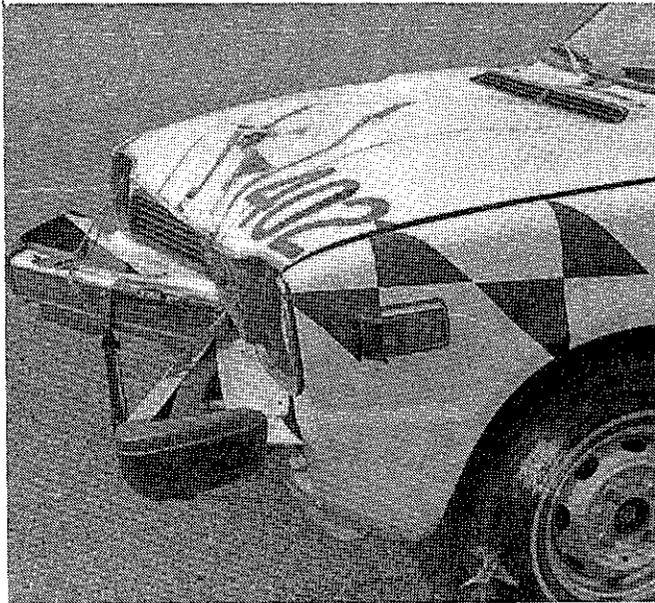
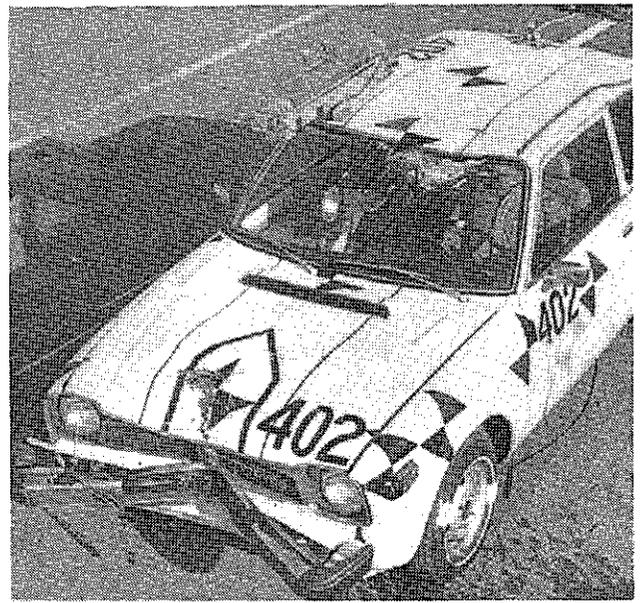
Figure 37. Test Vehicle After Impact - Test 402

Figure 37 shows the test vehicle after the impact. The front crush profiles of the vehicle measured horizontally at different heights are shown in Figure 38. A maximum crush of 11.25 in. was measured at the center of the bumper. The top front edge of the car's roof was dented 1.25 in. and the windshield was cracked as the pole contacted the roof of the auto about 8 ft up from the base plate after the impact. The rear quarter panel on the driver's side of the vehicle also had a small dent caused by the base plate barely clipping the rear quarter panel of the vehicle.

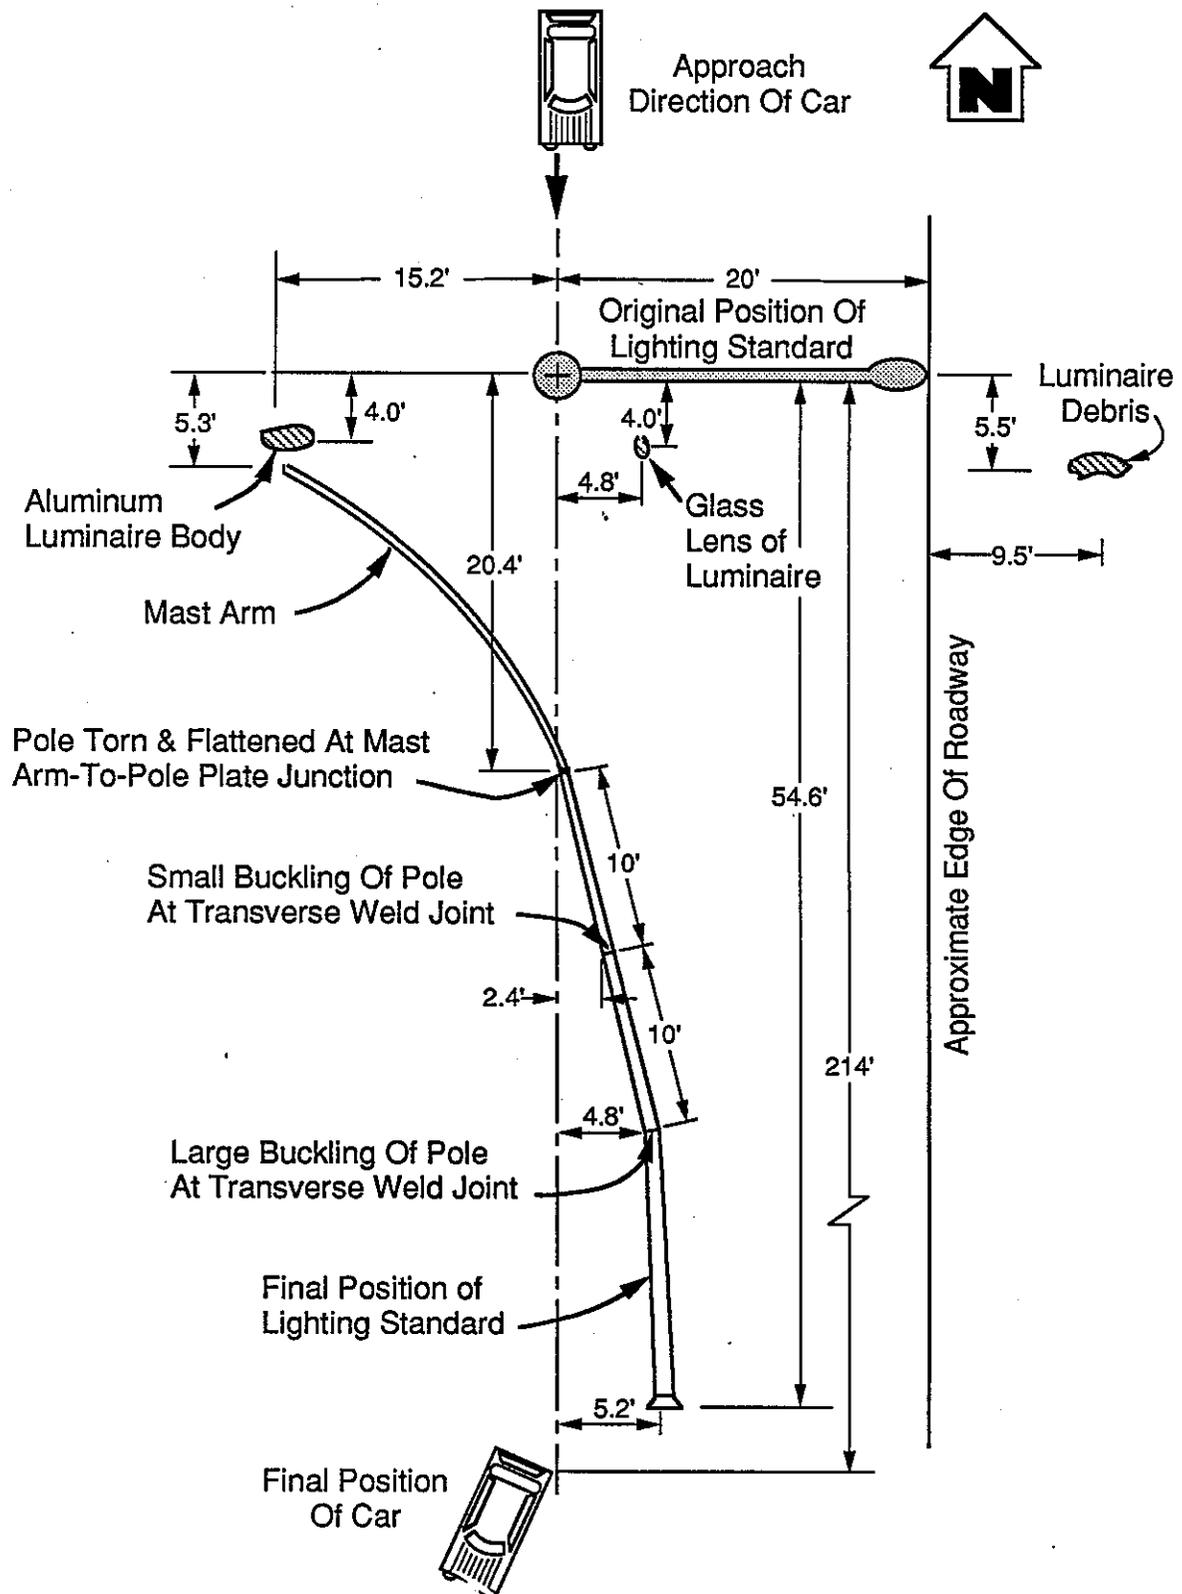
Figure 40. Final Location of the Lighting Standard and the Car After Collision - Test 403

The lighting standard came to rest downstream from the pole foundation (Figure 40), with the pole base plate 54.6 ft downstream (south) and 5.2 ft east of the foundation. The tip of the pole was 20.4 ft south of the foundation. The mast arm, still undamaged and attached to the pole, rotated 180 degree from its original direction with its tip 15.2 ft west and 5.3 ft south of the pole foundation.

The luminaire was totally demolished and slipped completely off the mast arm. The luminaire body landed 4 ft south of and 15.2 ft west of the pole foundation, away from traffic. The lens which was heavily taped before installation (to contain glass fragments) landed 4 ft south (downstream) and 4.8 ft east of the foundation, Figure 40. One piece of the cast aluminum cover landed 5.5 ft south of and 29.5 ft east of the pole foundation. Although this small piece would have landed in the traveled way, it probably would have caused little or no damage to cars in the outside lane.

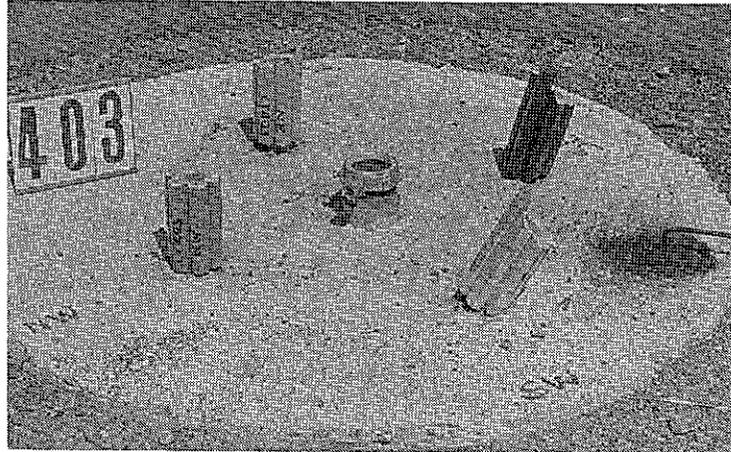
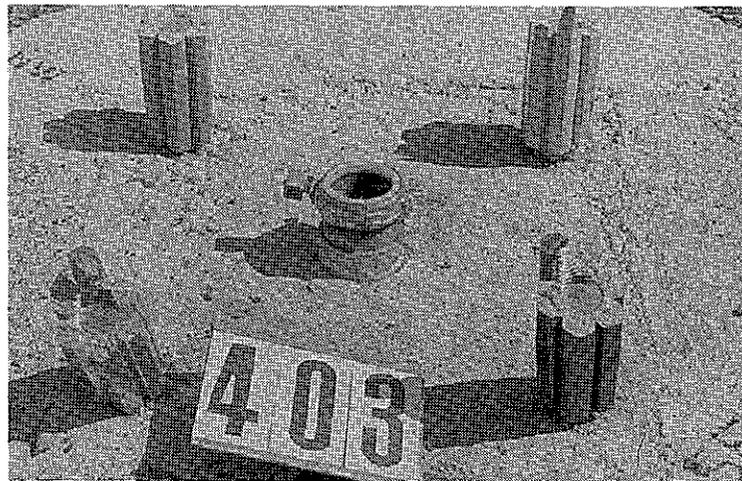
Figure 41. Die-cast Aluminum Couplings After Impact-Test 403

As mentioned in section 5.1.2.2, 1, the aluminum couplings used in this test were chosen after they had been x rayed. Those selected had level 2 porosity defects according to the ASTM E505 reference radiographs.

Upon impact, all four couplings sheared relatively cleanly just at the bases of the top stainless steel studs as shown in Figure 41. The remaining bottom portions of the two upstream couplings (marked NW and NE on Figure 41), still screwed onto the anchor bars, were approximately equal in height and projected 3-3/4 in. above the foundation surface. The stub marked NE had a sharp jagged spike on the upstream side. The two downstream stubs each had one flute intact on the upstream side which projected above the stud shear plane with the remainder of the top portion of the coupling sheared at the base of the stainless steel stud pocket. A couple of small porosity voids were noted; however, the cast aluminum material in these handpicked couplings was, on the whole, sound and nearly solid, and of much better quality than that of those used in

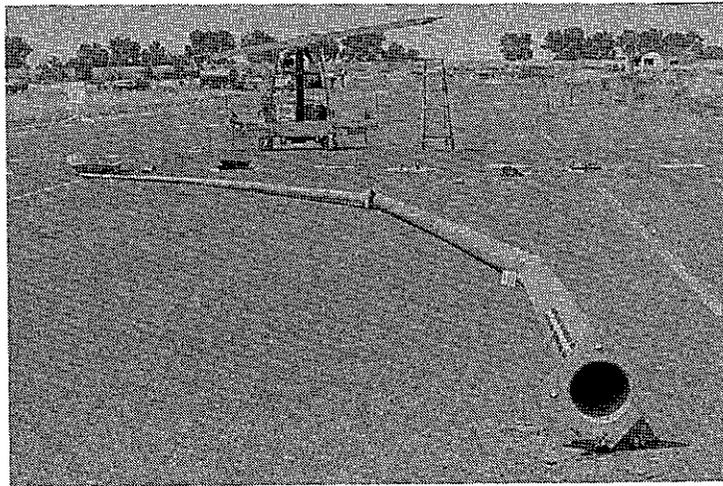
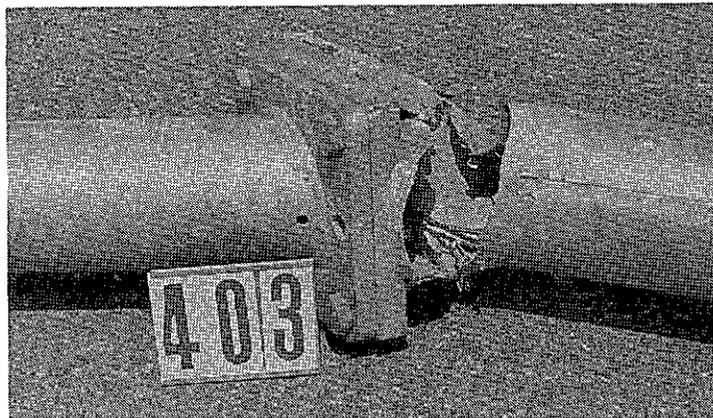
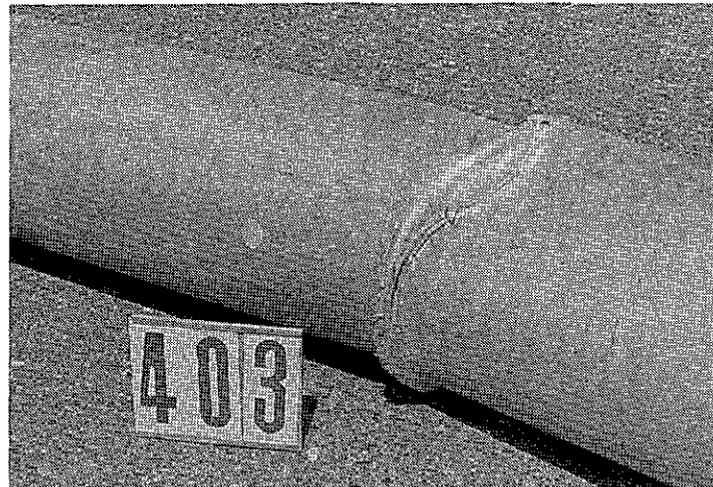
Figure 42. Lighting Standard Damage - Test 403

As shown in Figures 40 and 42, the 11 gage (0.1196 in. thick) steel pole was severely damaged. Upon impact, the pole buckled at the transverse weld joint 20 ft down from the top of the pole. No buckling occurred at the bottom transverse weld joint. In addition, as the mast arm and top of the pole impacted the ground, the pole buckled 10 ft down from the top of the pole. It appears as though the heat-affected zones of the transverse welds reduced the yield strength of the steel. In addition, the slight reduction of wall thickness of the pole in these areas, where the transverse welds

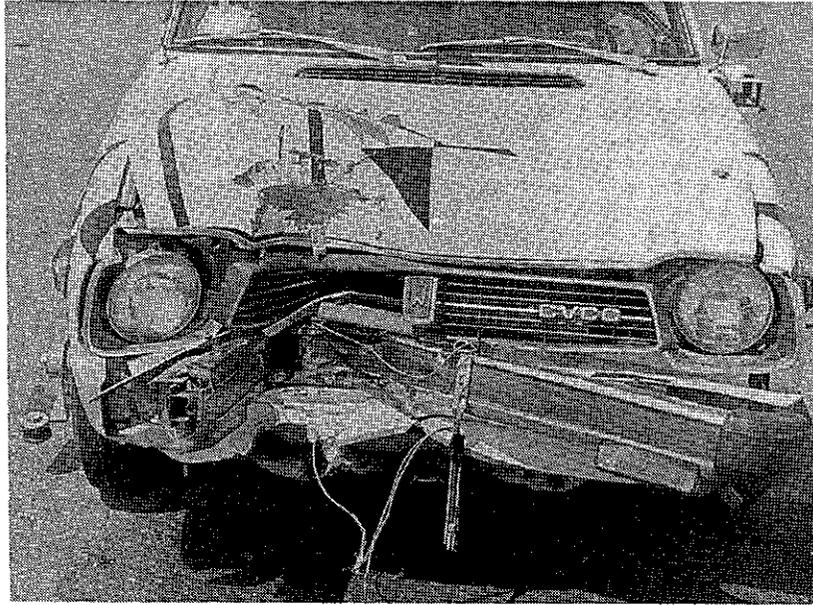
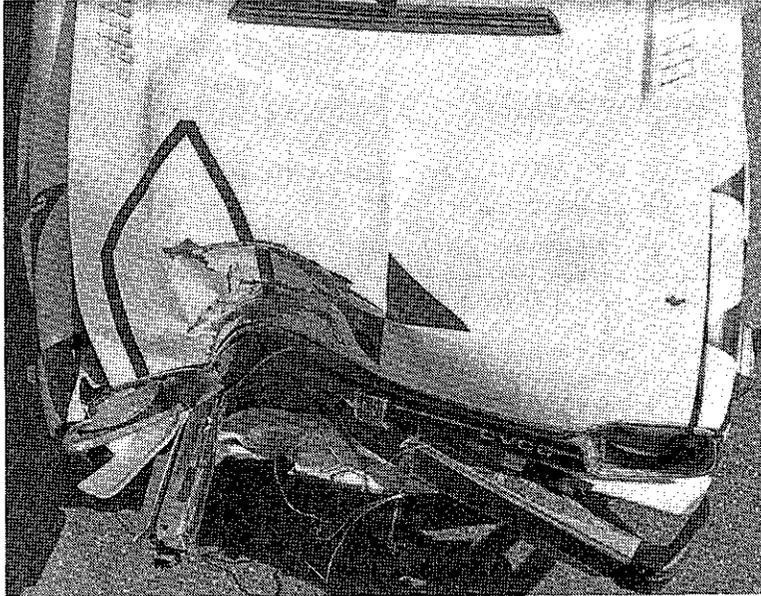
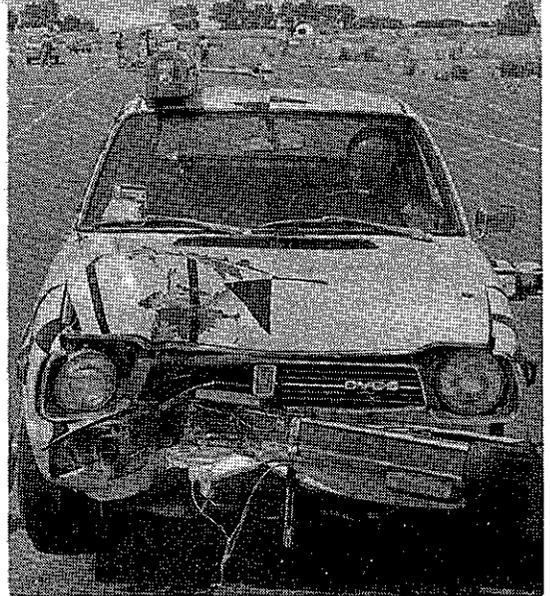
Figure 43. Test Vehicle After Impact - Test 403

Figure 43 shows the test vehicle after the impact. The crush profiles of the vehicle (measured in horizontal planes at different
