FHWA/CA/TL-88/07

Vehicle Impact Testing of Lightweight Lighting Standards

October 1988

Office of Transportation Laboratory  
California Department of Transportation  
Sacramento, California 95819

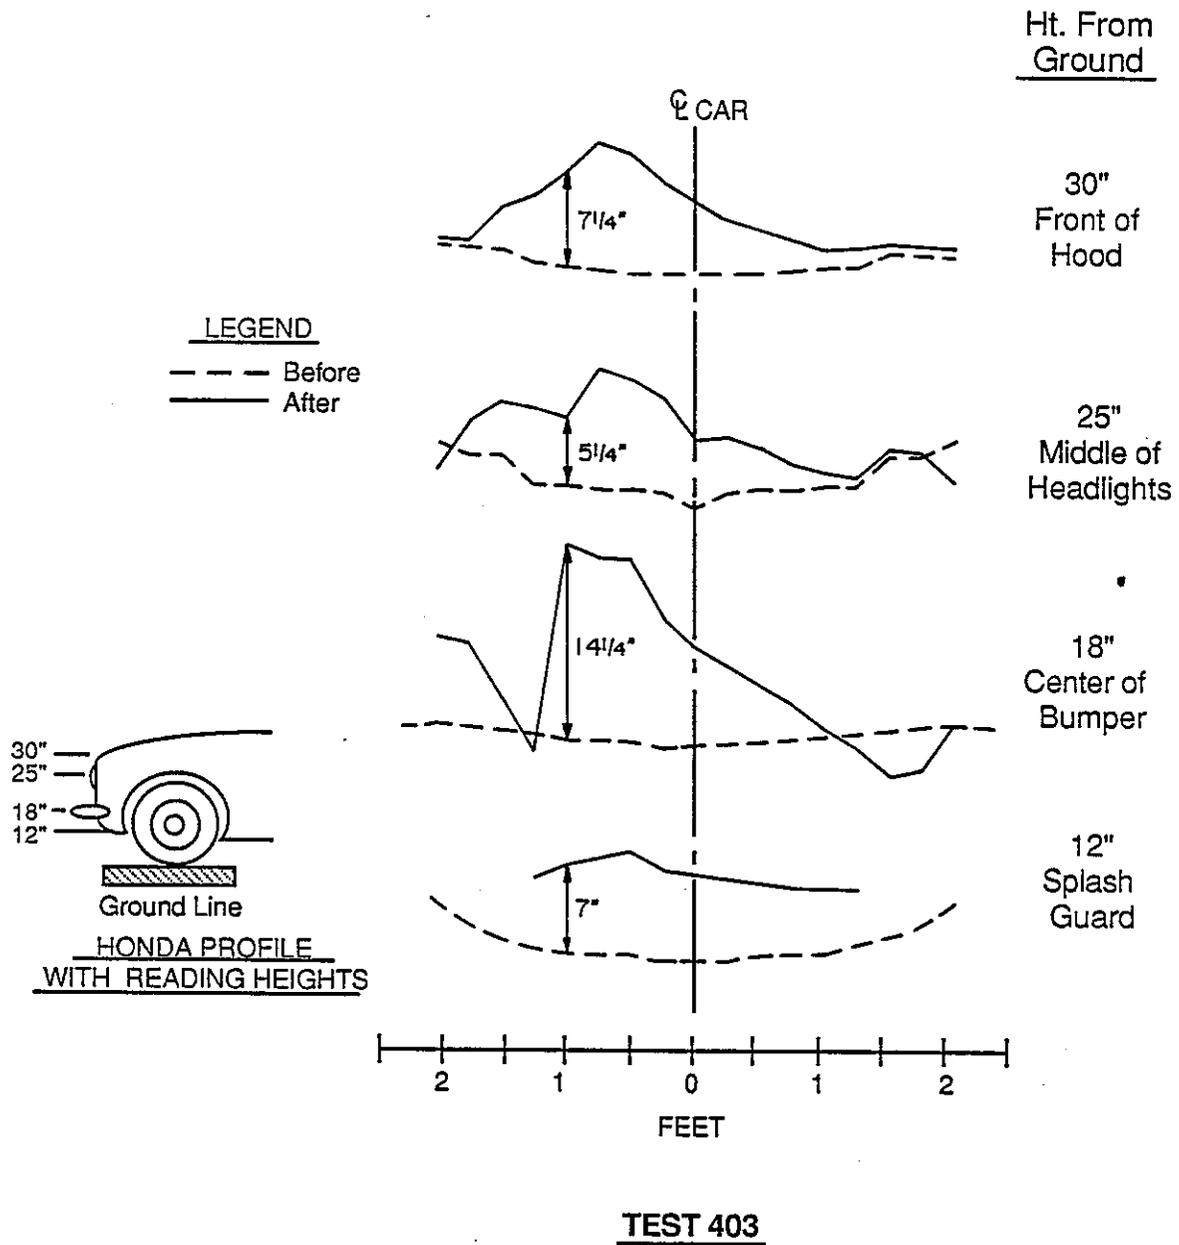
Figure 44. Crush Profiles of the Front End of Test Vehicle - Test 403

heights) are shown in Figure 44. The maximum crush of the bumper was 14.25 in.

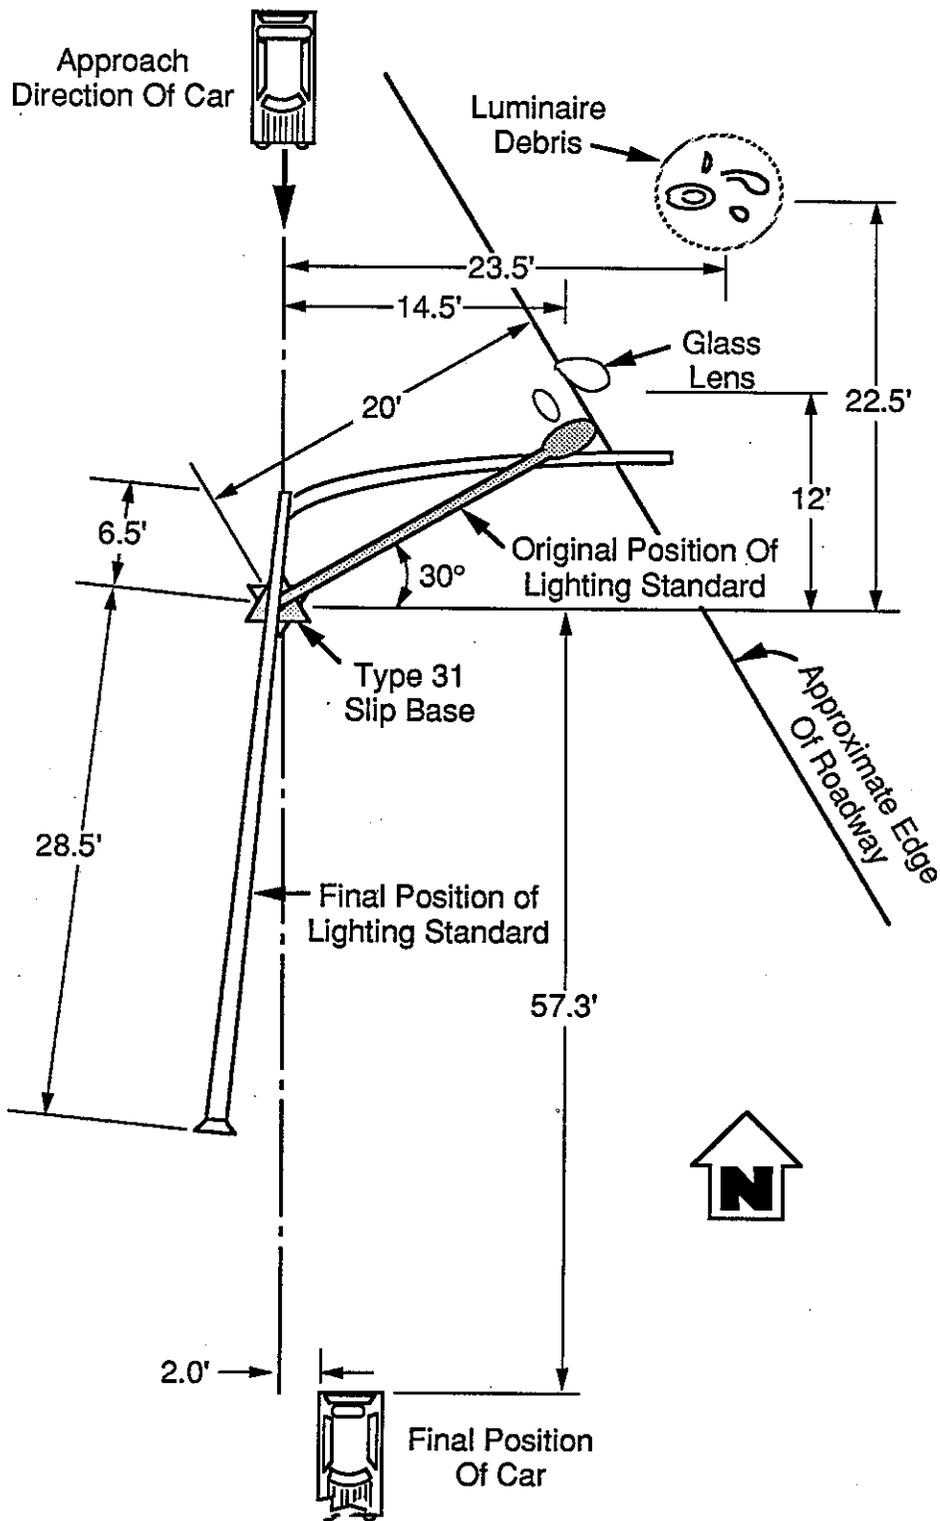
Figure 46. Final Location of the Lighting Standard and the Car After Collision - Test 404

After impact, the pole did not rotate and came to rest on top of the bottom slip base plate with its top 6.5 ft north of the concrete foundation (Figure 46). The tip of the mast arm projected about 1 ft into the outside traffic lane. Upon impact, the keeper plate which was installed at the slip plane, ripped open at two corners, and was carried downstream approximately 14 ft, still retaining one of the clamping bolts. The other two clamping bolts were nearby. No relative movement between the concrete foundation and the surrounding soil backfill was evident.

ft north of the original foundation as shown in Figure 46.

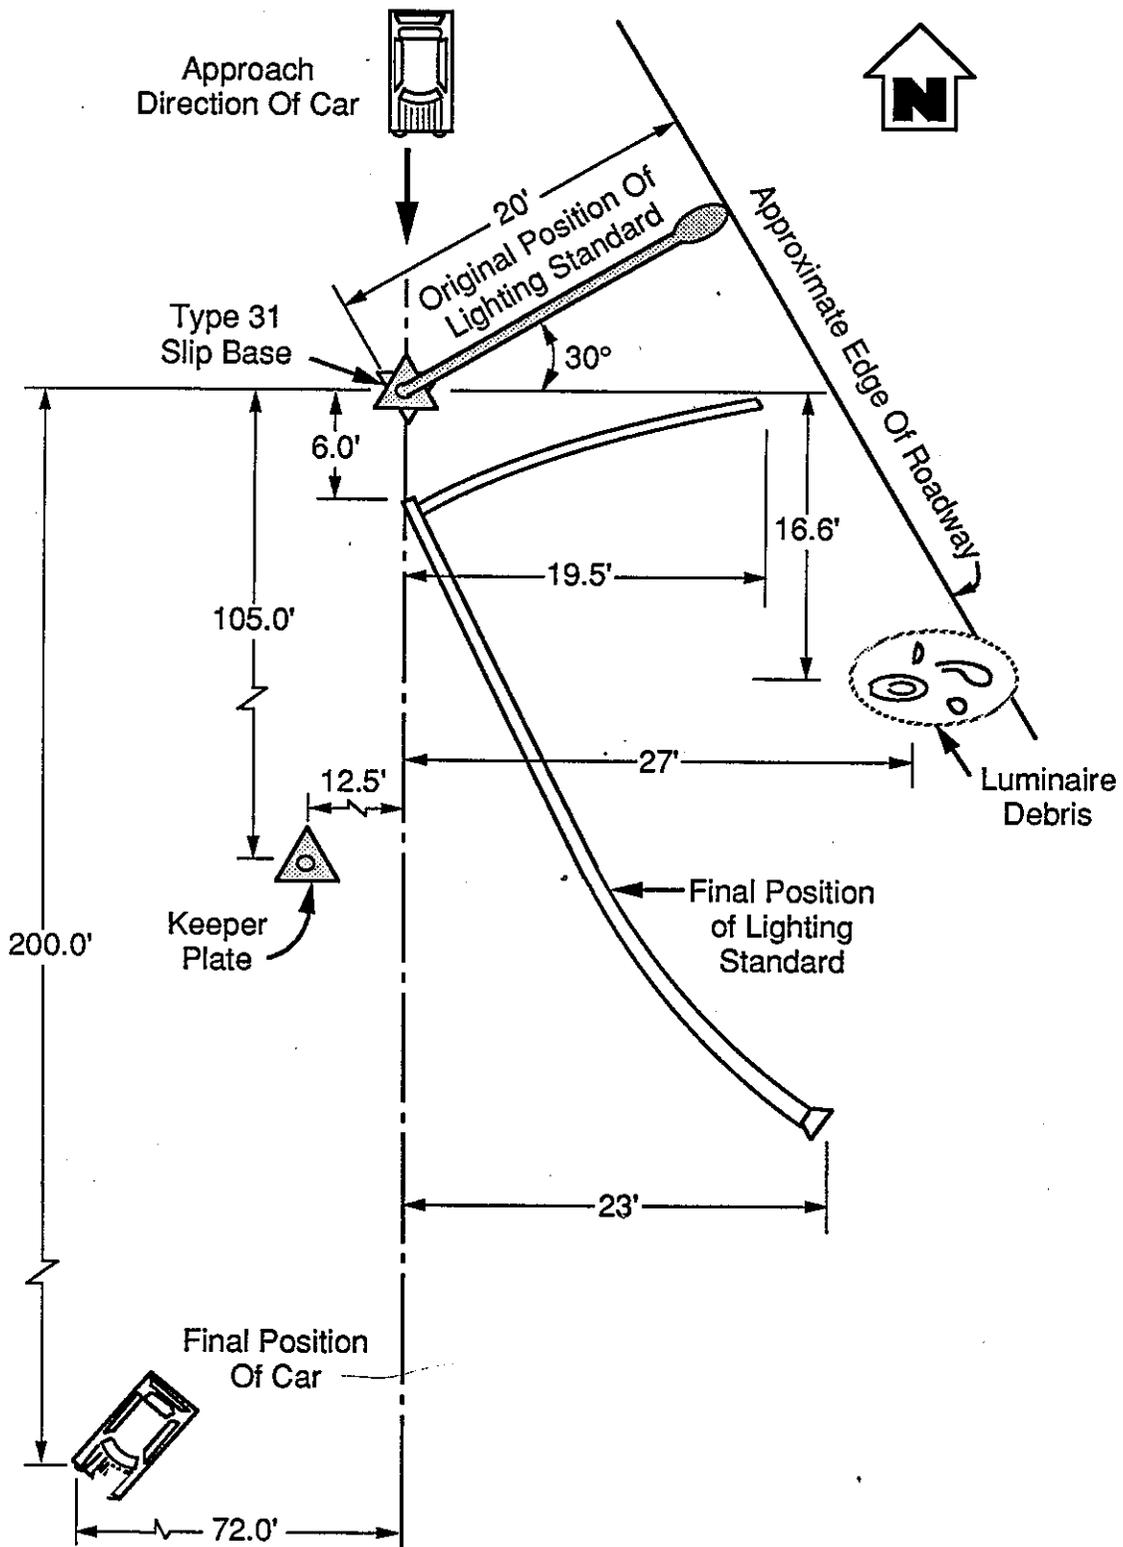
Figure 51. Final Location of the Lighting Standard and the Car After Collision - Test 405

The 1979 Honda test vehicle first impacted the base of the pole 13-5/8 in. to the right of center line of the vehicle's front bumper (1-3/8 in. to the left of the desired quarter point location). The impact speed was 53.9 mph (an impact speed of 60 mph was desired). Since the initial impact was offset from the Honda's c.g., the car yawed immediately after impact, and both the right front and the right rear tires ran over the foundation and bottom slip base plate assembly which was bolted to the foundation. Running over the foundation caused the whole right side of the Honda to vault into the air. After the initial 40 degree clockwise yaw, the car proceeded southwest in a fairly straight line until coming to rest 200 ft south and 72 ft west of the pole foundation as shown in Figure 51.

Figure 51 is the schematic representation of the lighting standard damage and final location. As shown, the top of the pole came to rest 6 ft downstream from the concrete foundation. The tip of the mast arm came to rest 19.5 ft due east of the foundation, pointing toward the traffic lanes. Upon impact, the keeper plate which was installed at the slip plane ripped open at the front corner as designed, and was carried downstream, retaining the two rear clamping bolts. It came to rest approximately 12.5 ft west and 105 ft south of the foundation. The pole end cap and portions of the luminaire housing landed about 27 ft east of the foundation. No relative movement between the concrete foundation and the surrounding soil backfill was evident.

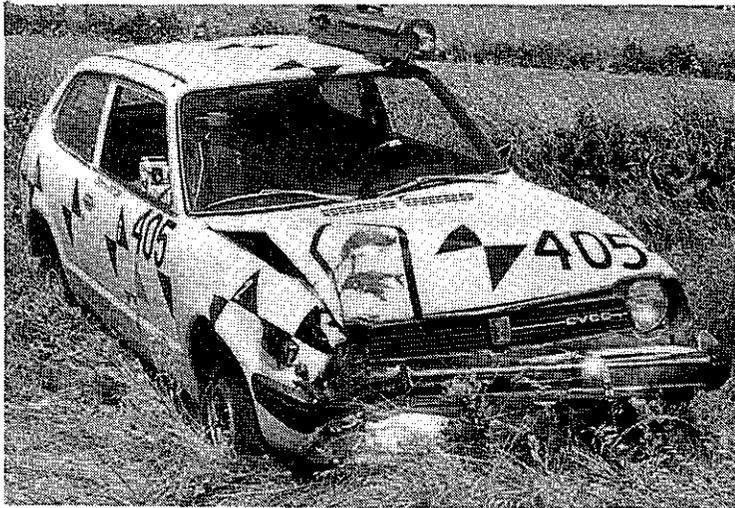
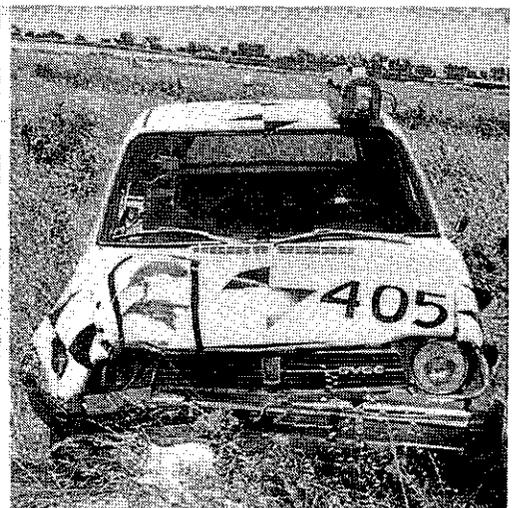
Figure 53. Test Vehicle After Impact - Test 405

Figure 53 shows the test vehicle after the impact. The front crush profiles of the vehicle (measured in horizontal planes at different heights) are shown in Figure 54. The maximum crush of the bumper was 13-5/8 in.

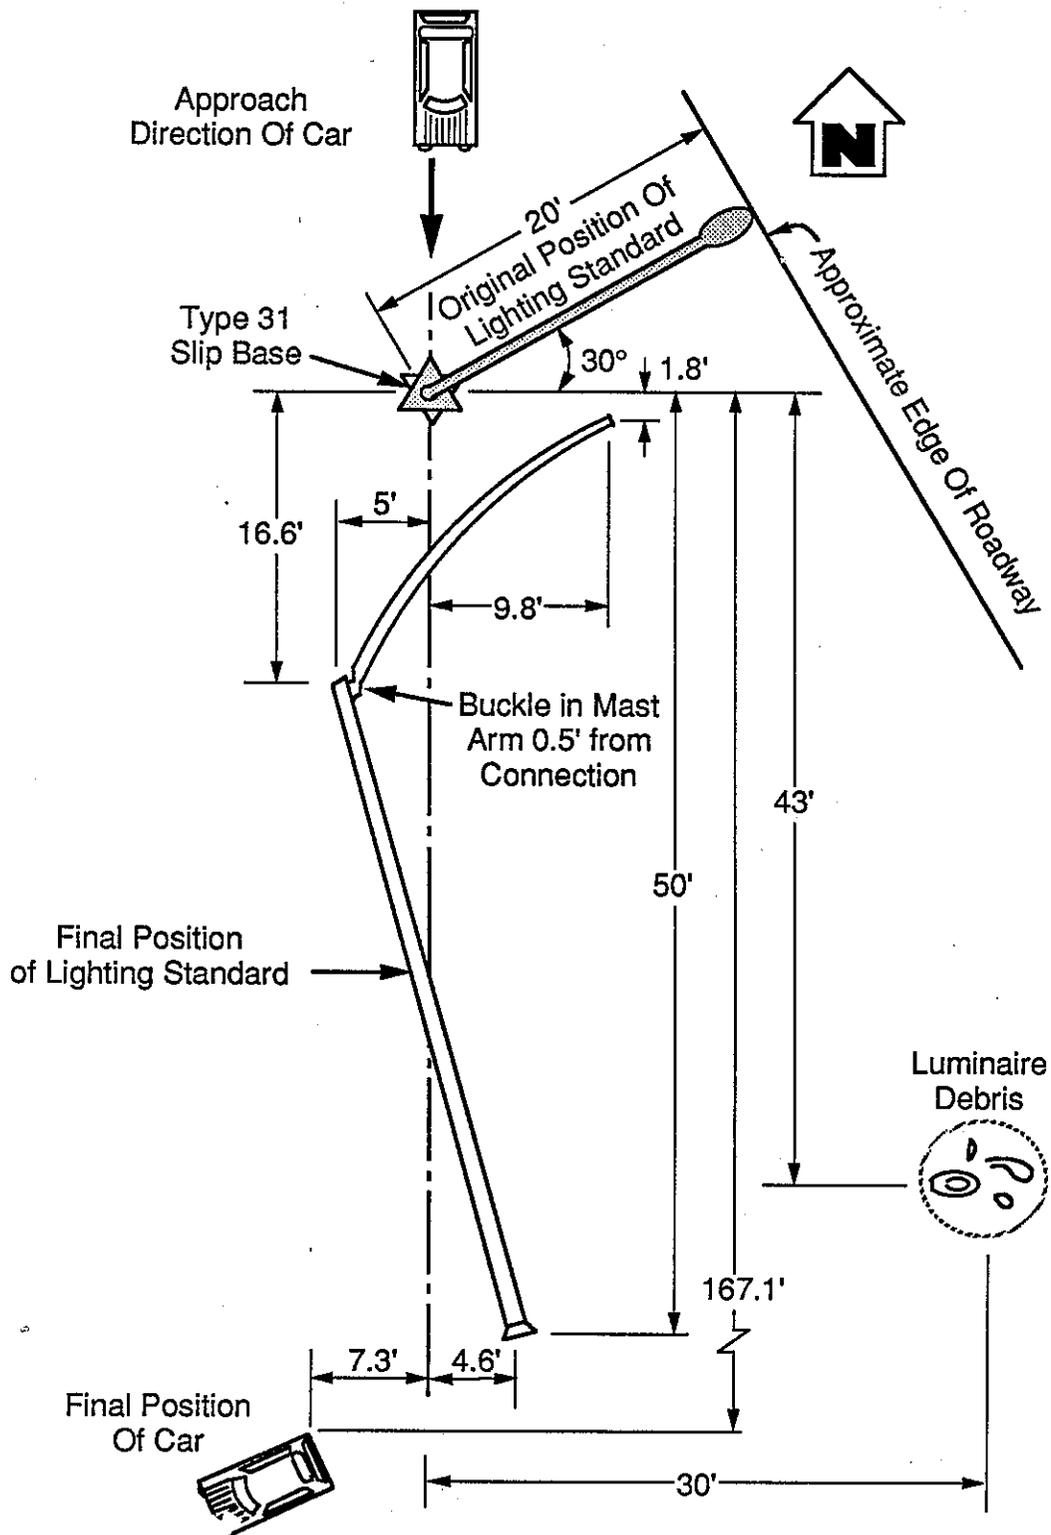
Figure 56. Final Location of the Lighting Standard and the Car After Collision - Test 406

skidding and yawing to the left in the opposite direction, and finally came to rest pointing almost due west, 167.1 ft downstream from and 7.3 ft to the west of the foundation as shown in Figure 56.

The base of the pole was carried downstream and came to rest 50 ft from the foundation, as shown on Figure 56. The tip of the mast arm came to rest approximately 10 ft east and 1.8 ft south of the foundation and was pointed northeast, toward traffic lanes. The keeper plate was found 205 ft downstream (south) of the foundation with each of the three corners ripped open. No relative movement between the concrete foundation and the surrounding soil backfill was evident.

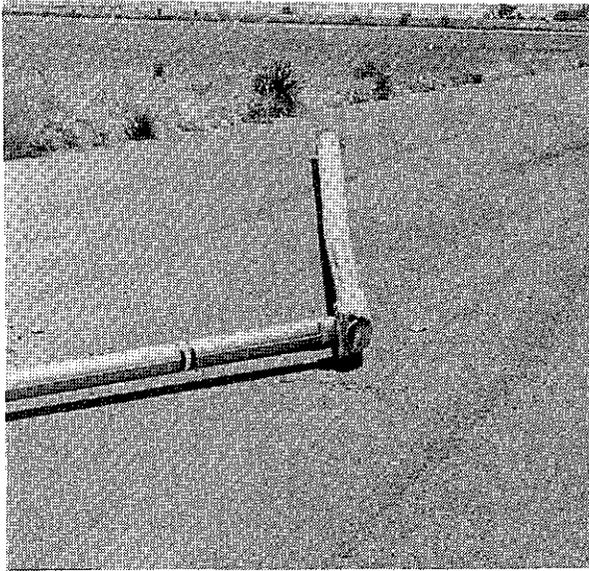
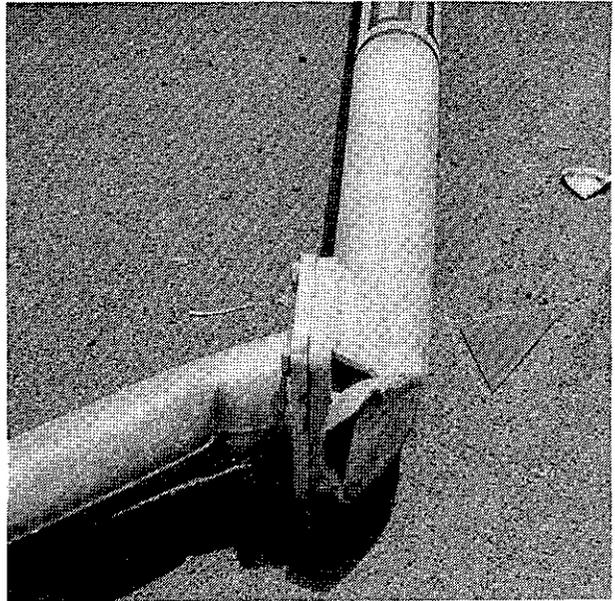
Figure 57. Lightning Standard Damage - Test 406

The surface of the pole where initial bumper impact occurred (18 in. from the ground to the center of the front bumper) was not dented or deformed. The lower section of the galvanized steel pole sustained no significant damage from the impact of the vehicle bumper and front end. After impact, the pole tip and the mast arm swung down and impacted the asphalt concrete pavement, breaking the end cap and flattening the back edge of the pole top. The mast arm buckled approximately 6 in. from the mast arm-to-pole end plate (Figure 57) and the pole had a slight permanent bow about 15 ft from its tip.

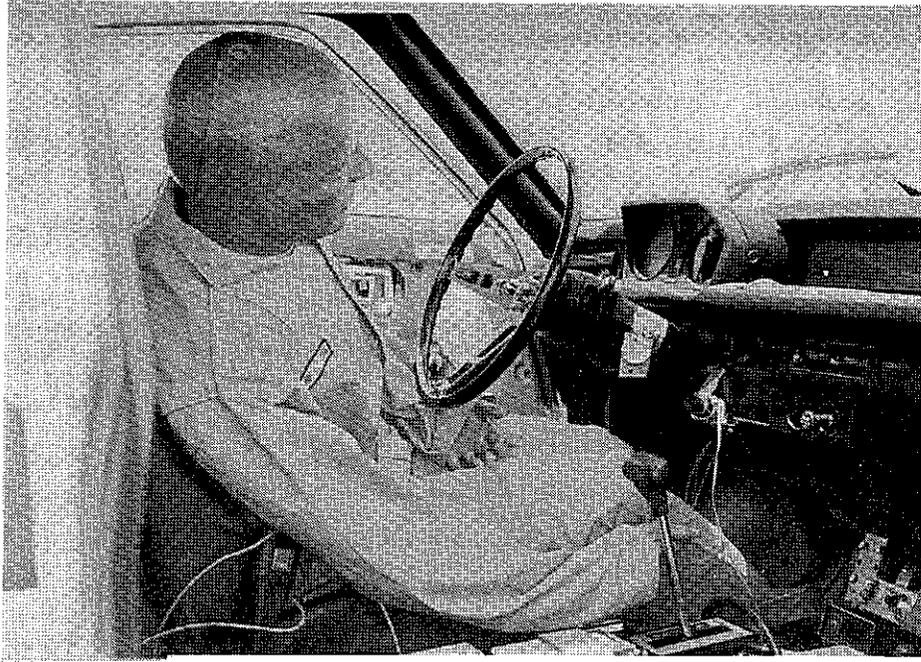
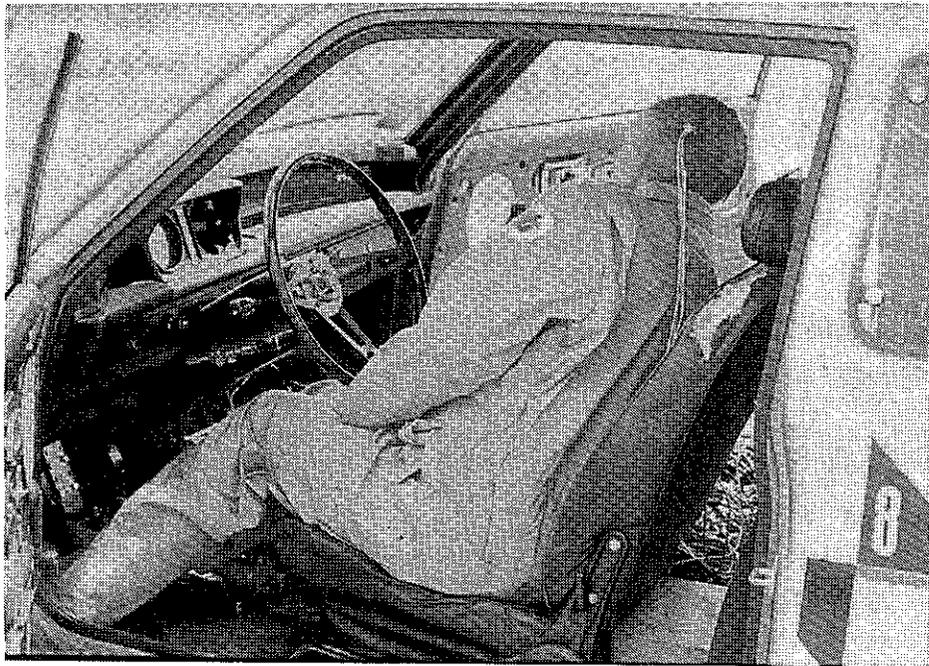
Figure 60. Dummy's Position After Impact - Test 406

The test dummy, positioned in the driver's seat was unrestrained. There was no internal camera coverage for the dummy due to a shortage of high-speed cameras. Upon initial impact, the dummy bent at the waist and the shoulders and head were thrown forward. The dummy's head hit the steering wheel. Figure 60 shows the dummy's position after the impact.

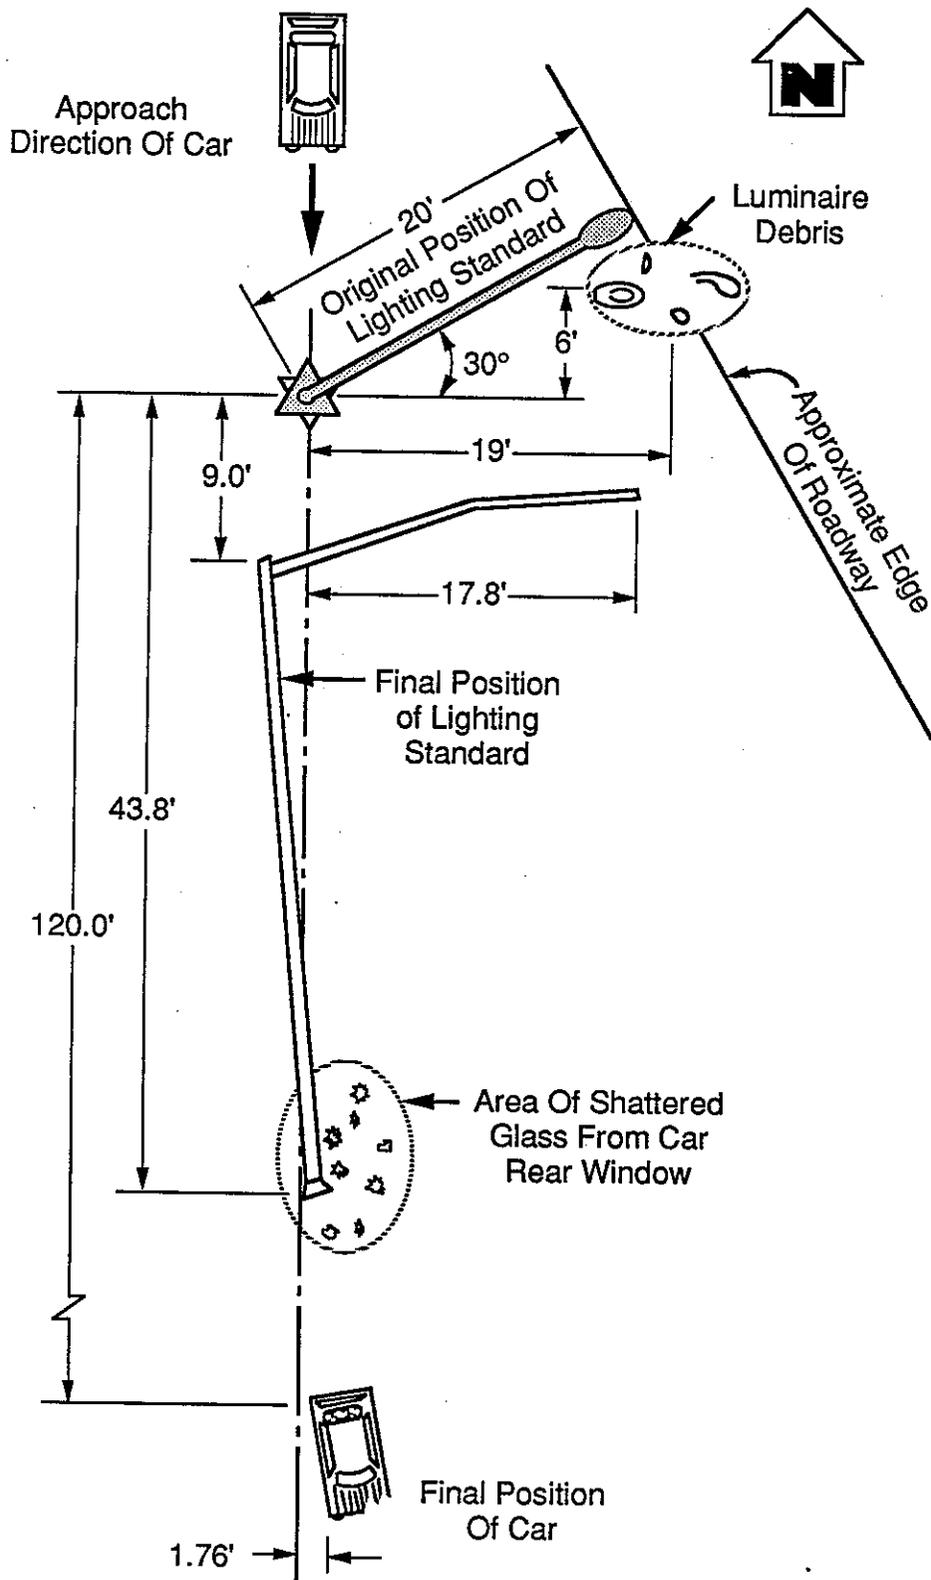
Figure 62. Final Location of the Lighting Standard and the Car After Collision - Test 407

The test vehicle impacted the base of the pole 3 in. to the right of the center of the front bumper. The impact speed was 23.7 mph, though the desired impact speed was 20 mph. Just after the test vehicle impacted the pole, the car pushed the pole base plate off the bottom slip base plate and gently pushed the pole in front of the front bumper. After impact, the pole base plate hooked under the front bumper and lifted the front end of the car slightly. The pole did not kick over the car, but rolled on the hood and roof of the car, and finally hooked and shattered the rear window. After impacting the pole, the vehicle decelerated without yaw while traveling southward in a straight line. The car finally came to a halt 120 ft downstream, due south of the foundation as shown in Figure 62.

Figure 62 shows the schematic of the lighting standard damage and its final location. As shown, the base of the pole came to rest 43.8 ft south of the foundation. The tip of the mast arm came to rest approximately 18 ft due east of the foundation and was pointed due east, toward traffic lanes. The keeper plate landed 9 ft downstream (south) of the foundation with two of the three corners ripped open. No relative movement between the concrete foundation and the surrounding soil backfill was evident.

The luminaire broke into pieces and remnants of the luminaire housing landed from 16 to 22 ft east of the foundation (shown in Figure 62)

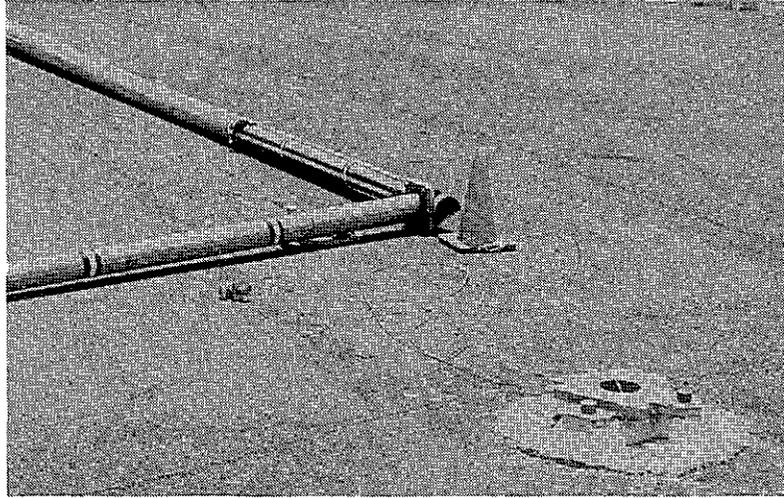
Figure 63. Lighting Standard Damage - Test 407

The surface of the pole where initial bumper impact occurred (18 in. from the ground to the center of the front bumper) was not dented or deformed. After impact, the pole base plate hooked under the front bumper. The pole was nudged ahead slowly by the car bumper and was not kicked up as in higher speed tests, but rolled on the hood and top of the car and, finally, hooked on rear window trim and shattered the window glass. The tip of the pole and the luminaire arm swung down and impacted the asphalt concrete pavement flattening the pole tip and cracking the end cap, Figure 63.

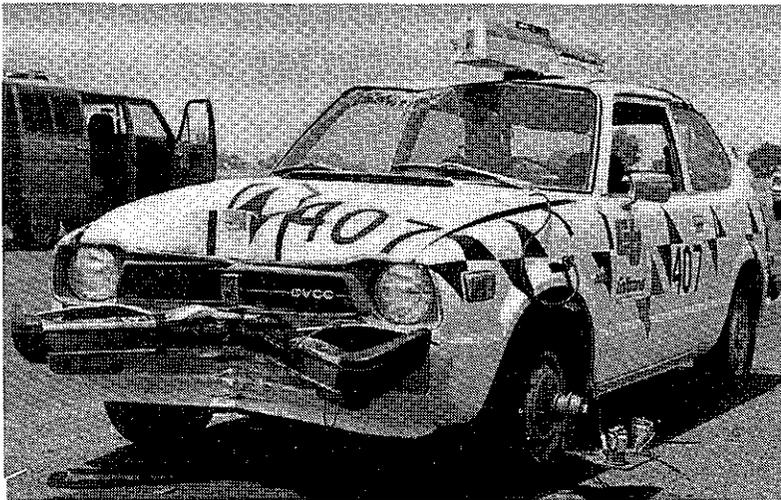
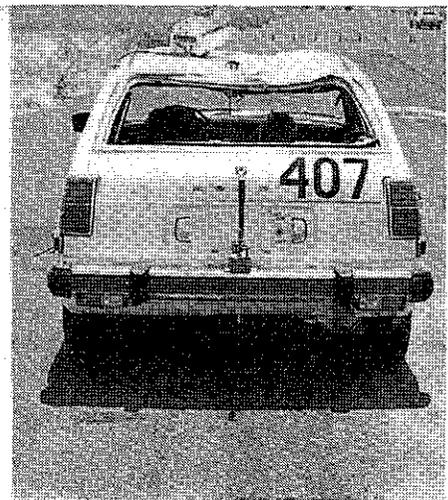
Figure 64. Test Vehicle After Impact - Test 407

Figure 64 show the test vehicle after the impact. The crush profiles of the front end of the vehicle (measured in horizontal

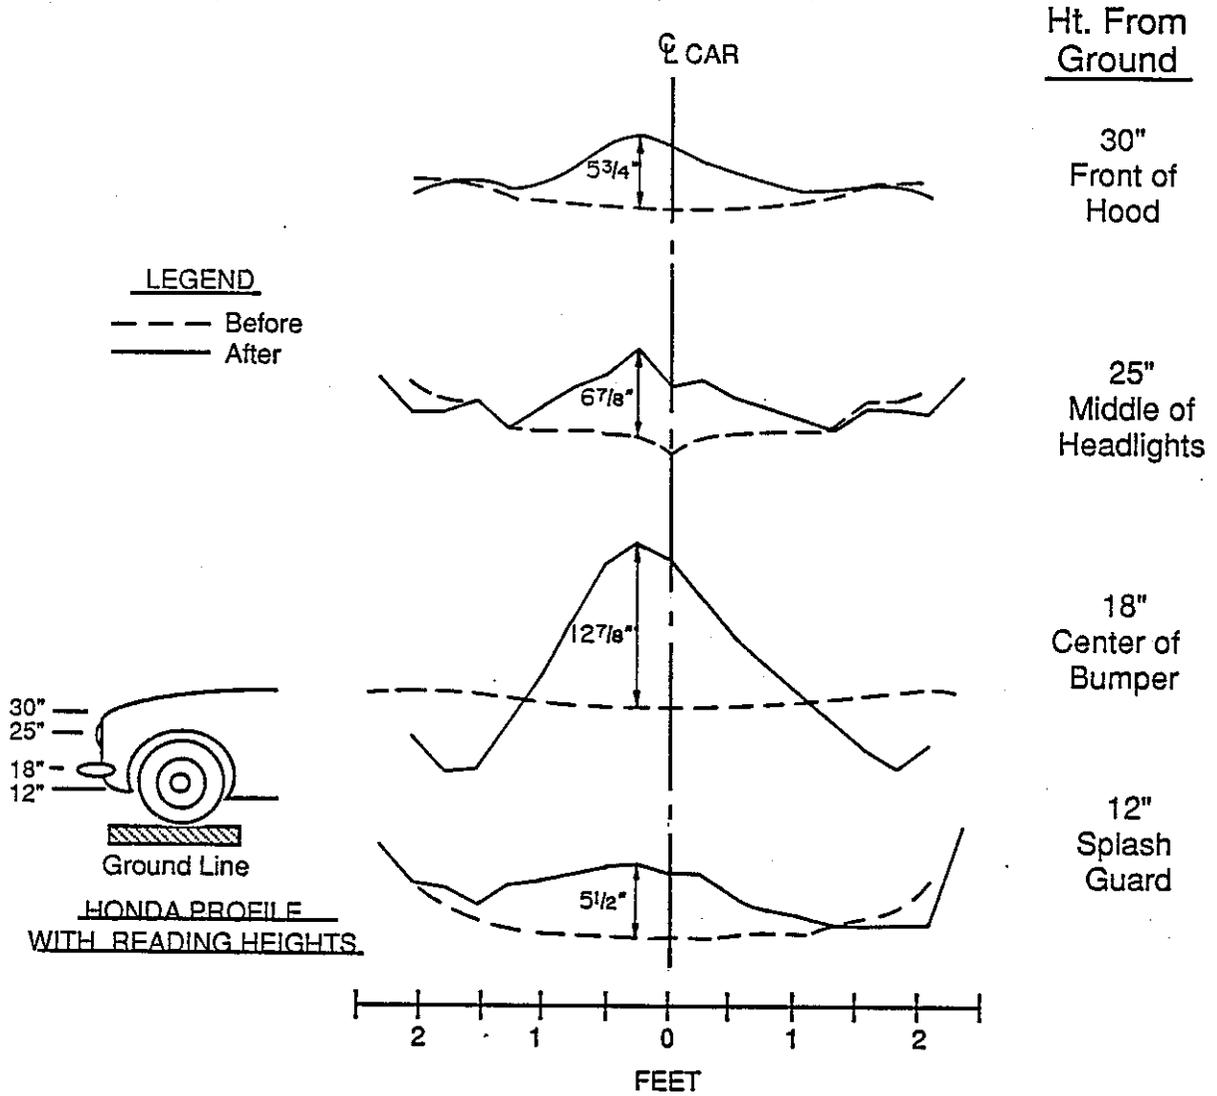
Figure 65. Crush Profiles of the Front End of Test Vehicle - Test 407

planes at different heights) are shown in Figure 65. The maximum crush of the front bumper was 12-7/8 in.

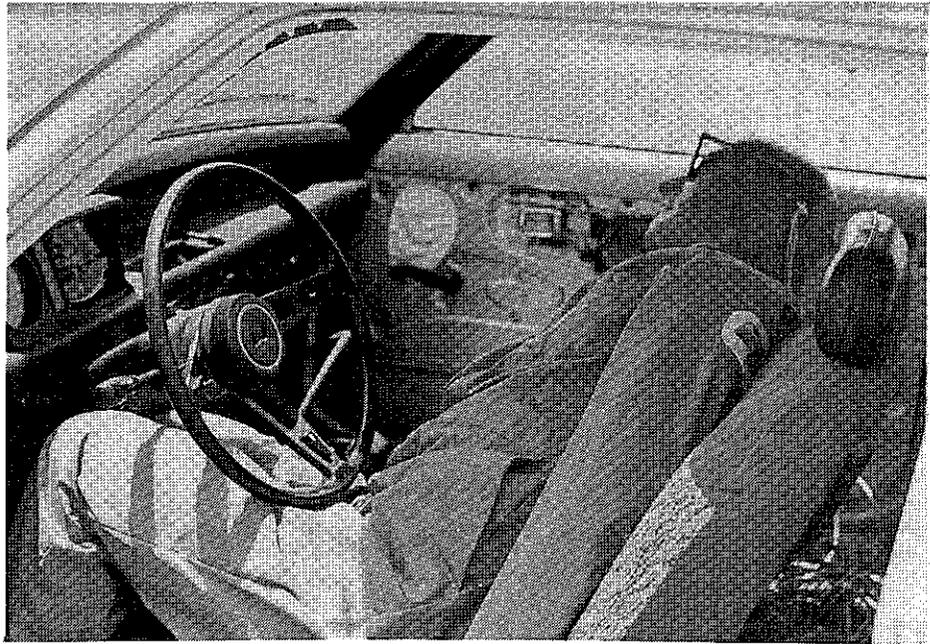
Figure 66. Dummy's Position After Impact - Test 407

The test dummy, positioned in the driver's seat during the impact, was unrestrained. There was no internal camera coverage for the dummy due to a shortage of high-speed cameras. Upon impact, the dummy leaned forward slightly but did not hit the steering wheel. Figure 66 shows the dummy's position after the impact.
