CONSTRUCTION EVALUATED  
RESEARCH REPORT:

CATHODIC PROTECTION SYSTEMS  
INSTALLED ON SUBSTRUCTURE SURFACES

CA-92-02  
03-NEV-80 PM 59.44  
03-377601  
Yuba Pass Overhead and Separation  
Bridge No. 17-23L/R

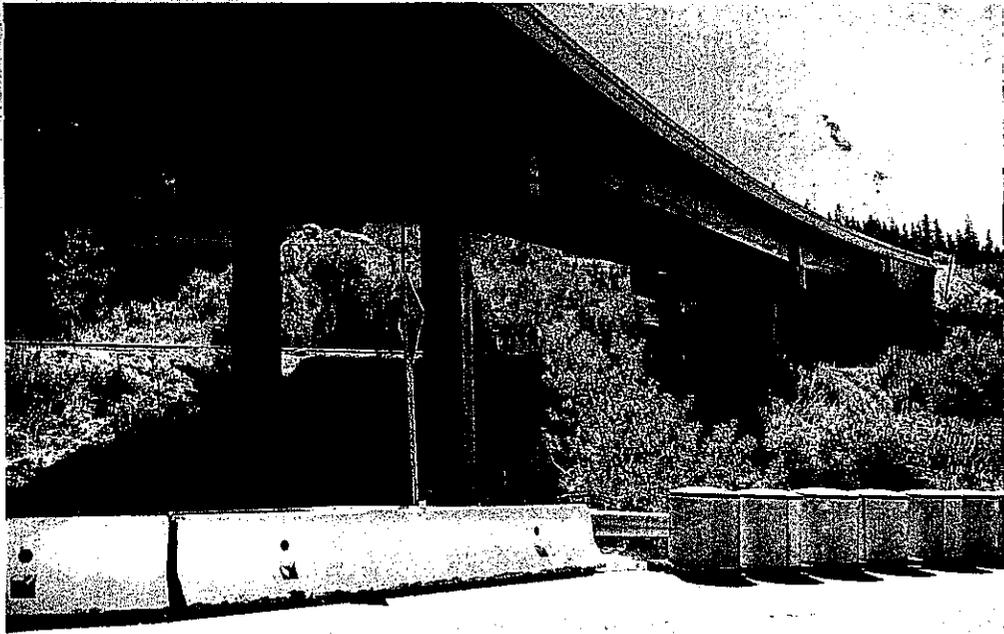
Figure 3. Yuba Pass Overhead and Separation (Bridges 17-23L/R). View facing Southeast. The left bridge is in the foreground.

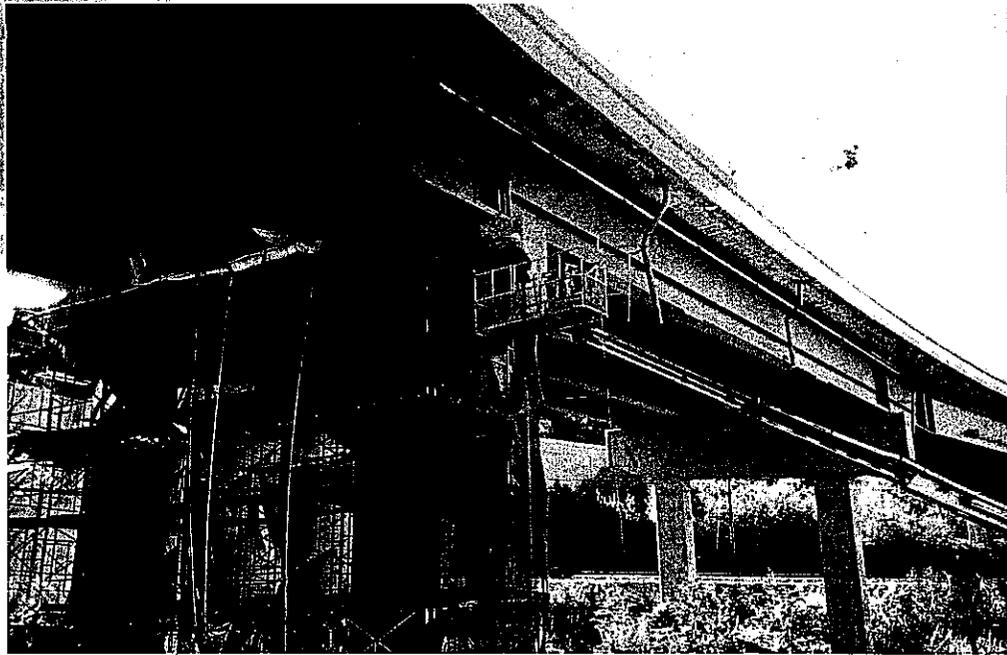
Figure 5. View of Bent 4L showing netting in-place to prevent construction debris from entering the roadway and creek.

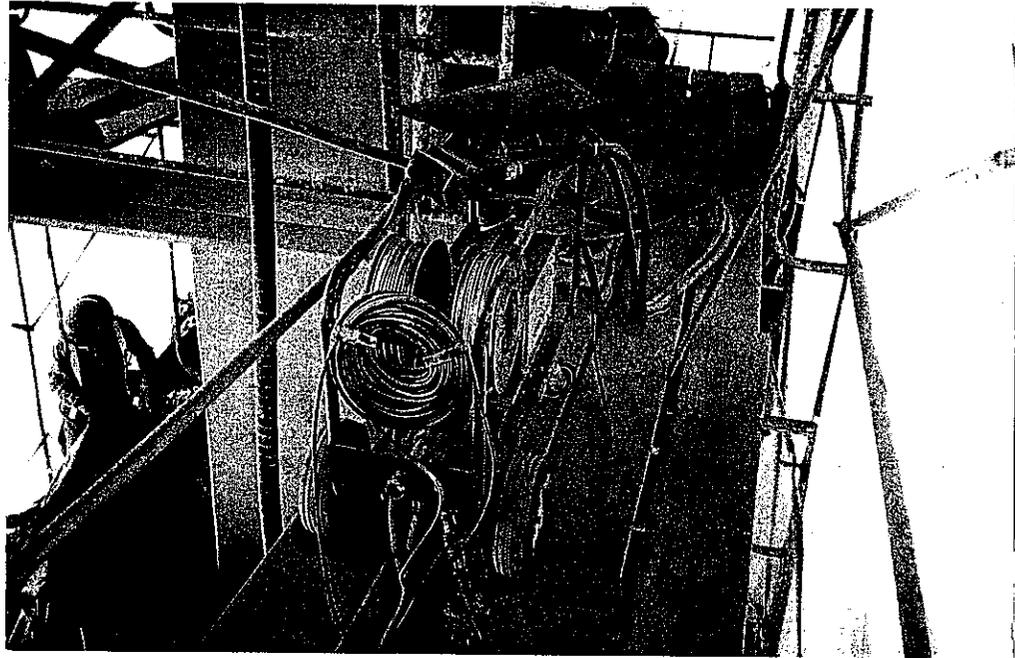
Figure 11. Photograph showing the metallizing equipment. Metallizing was performed with an electric arc gun.

The metallized zinc was applied using an arc spray system. This equipment consisted of an arc spray gun, an air compressor, an electric power unit, and an electrical short detection device. The electrical short detection device was used to monitor the electrical resistance between the metallized zinc and the reinforcing steel (embedded in the concrete). The metallizing process was automatically interrupted if a direct electrical connection was made between the metallized zinc and the reinforcing steel. Figures 11 through 13 show the zinc metallizing equipment, the metallizing operation, and a view of the metallized concrete surface. Figures 14 and 15 show the brass anode pads before and after zinc metallizing was applied.

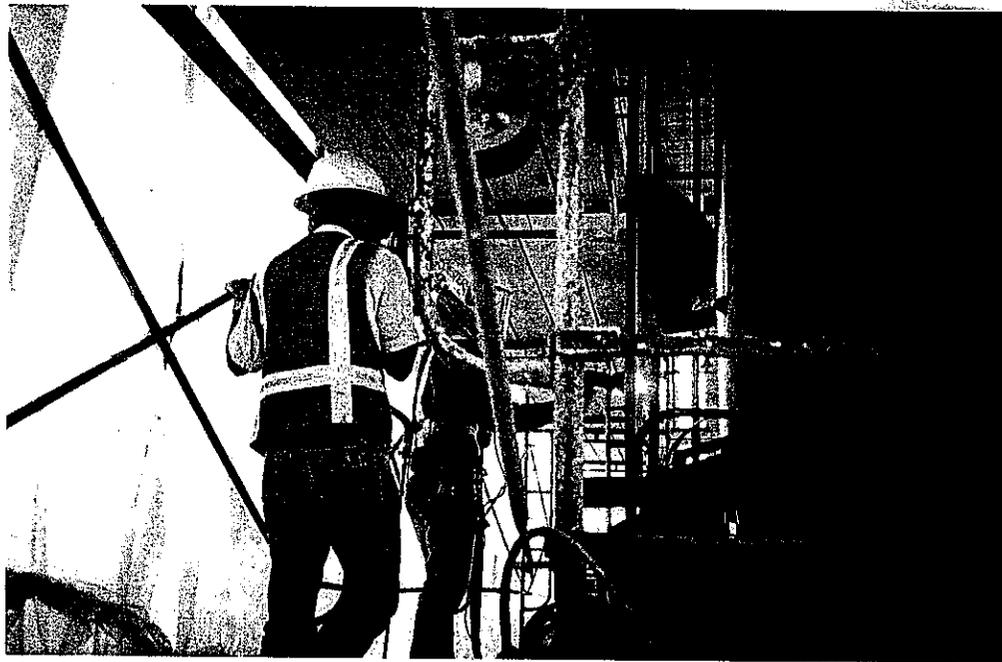
Figure 12. Photograph showing the metallizing operation.

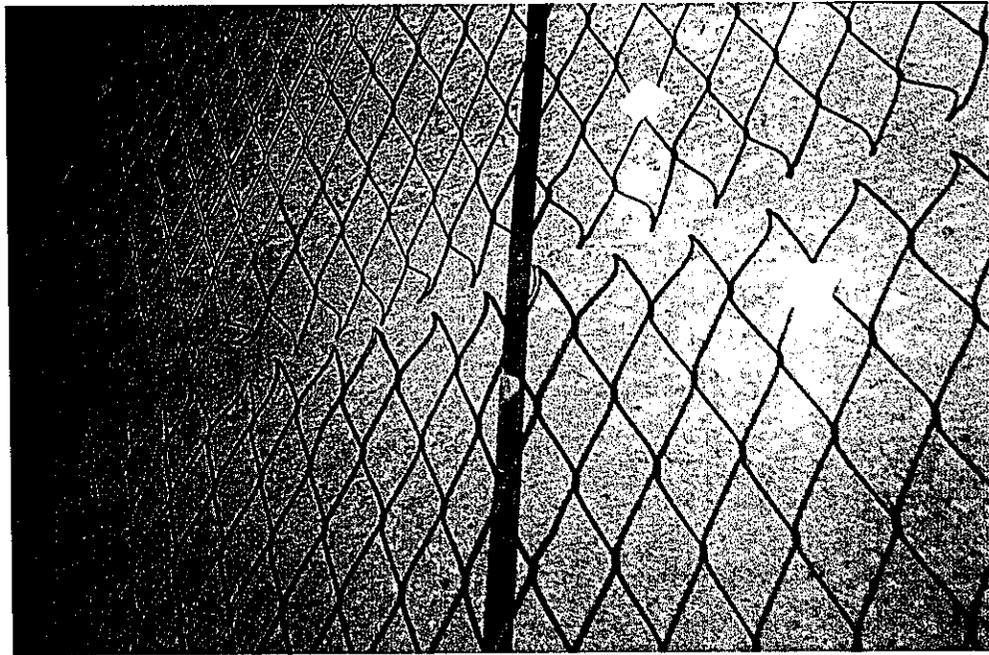
Figure 17. Close-up view of the Elgard mesh at Bent 4L. The CP rectifier for this system has its primary connection to the vertical strip shown in the photograph.

The Elgard CP system consists of a constant voltage DC rectifier to supply the protective CP current, titanium alloy strips (primary connections wired to the CP rectifier), and a titanium alloy mesh (Elgard 210 mesh) to distribute the protective CP current to the concrete. The titanium alloy strips were placed along the northeast and southwest faces of the bent cap and columns and were resistance welded to the mesh anode. Figures 16 and 17 show details of the Elgard anode mesh and a primary anode strip.

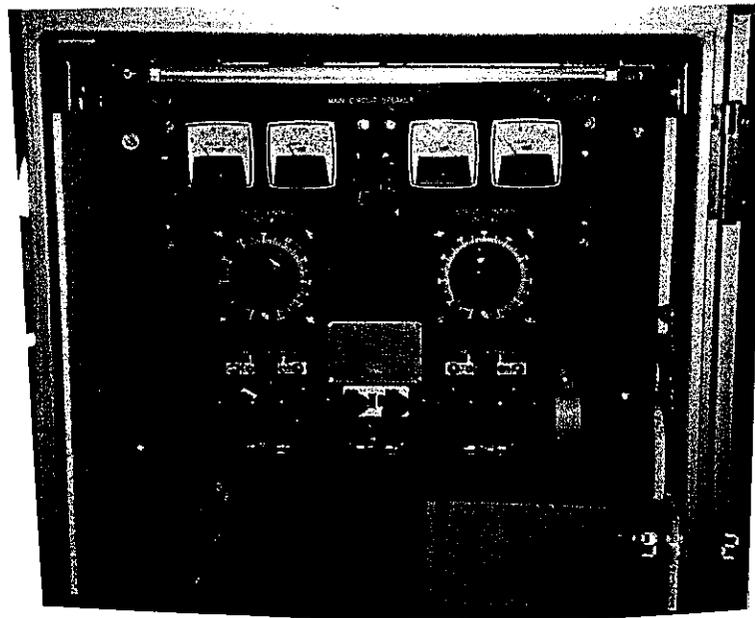
Figure 18. View of the CP control rectifiers. The rectifiers are mounted inside a standard traffic control cabinet. The cabinet contains the CP rectifiers, remote datalogger, and cellular telephone unit. The cabinet is located at Abutment 5 of bridge 17-23L.

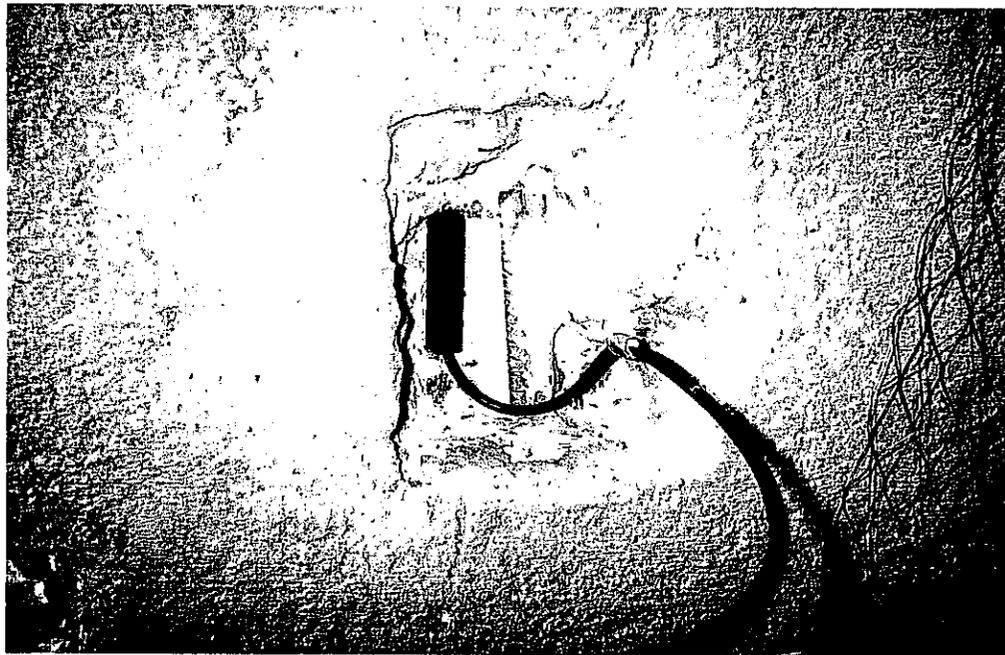
Figure 20. View of a graphite reference cell. The reference cells were grouted in-place next to the reinforcing steel. The reference cells will be used to monitor the electrical potential of the reinforcing steel. This will give an indication of the level of protection provided to the steel.

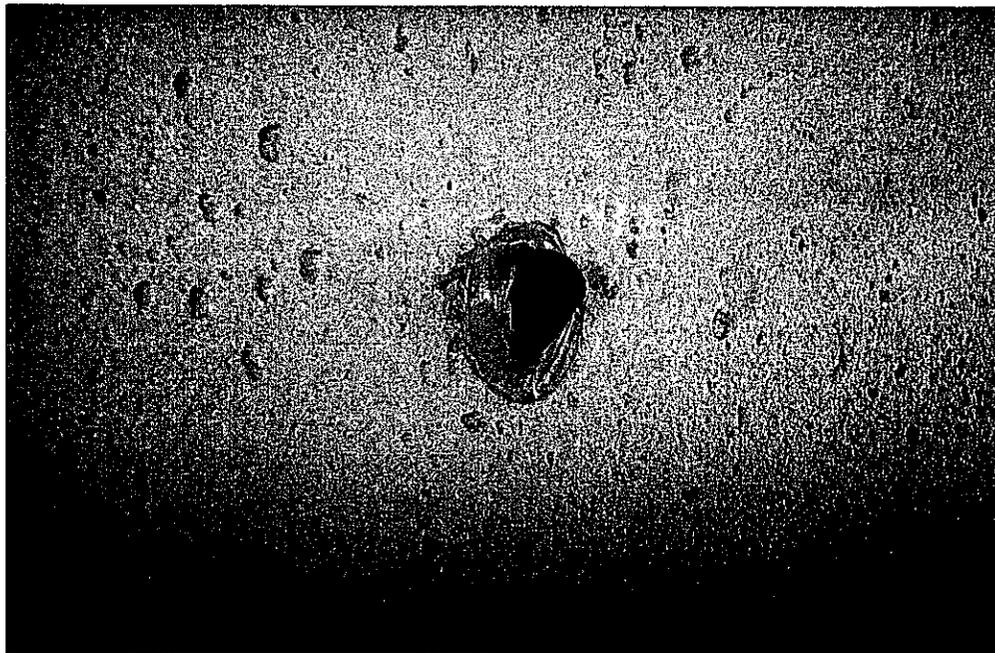
Figure 22 View of an external half cell port. The PVC cup is epoxied to the concrete surface and will hold an external copper/copper sulfate half cell to monitor the electrical potential of the reinforcing steel. A portion of the metallized zinc was removed prior to epoxying the PVC cup to facilitate direct contact of the half cell with the concrete.

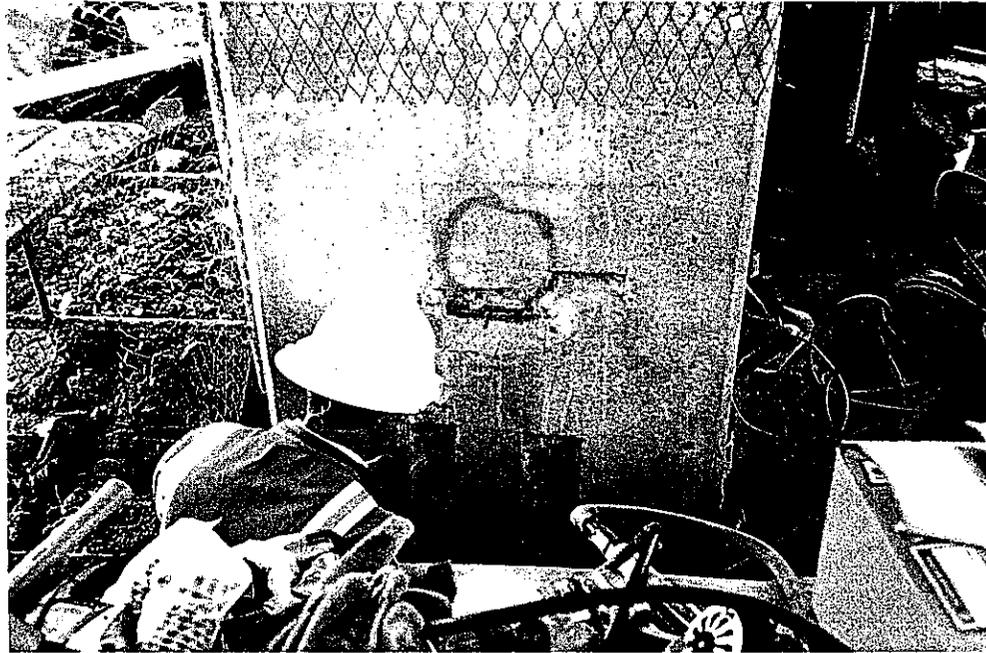
Figure 23. Worker installing a corrosion null probe. The corrosion null probe is an experimental Strategic Highway Research Program (SHRP) product. The probe can be used to monitor the amount of CP current delivered to the probe location.

In addition to the graphite reference cells, four corrosion null probes were installed at the most corrosive areas (two probes per CP system, installed as a contract change order). Corrosion null probes are an experimental Strategic Highway Research Program (SHRP) product used to evaluate the effectiveness of reinforced concrete CP systems. The null probes are segments of existing reinforcing steel (located in one of the most anodic locations) that are cut to isolate them from the rest of the reinforcing steel (Figure 23). CP current can be monitored through a resistor connected to the probe and adjoining reinforcing steel. By knowing the location and surface area of the probe, the current density (amount of CP current per steel surface area) for a particular location can be calculated. The two corrosion null probes at Bent 4R were constructed from separate segments of No. 4 confinement steel. One corrosion null probe at Bent 4L was constructed from a segment of No. 4 confinement steel, and the second probe was constructed from a segment of No. 5 rebar located in the bent cap.

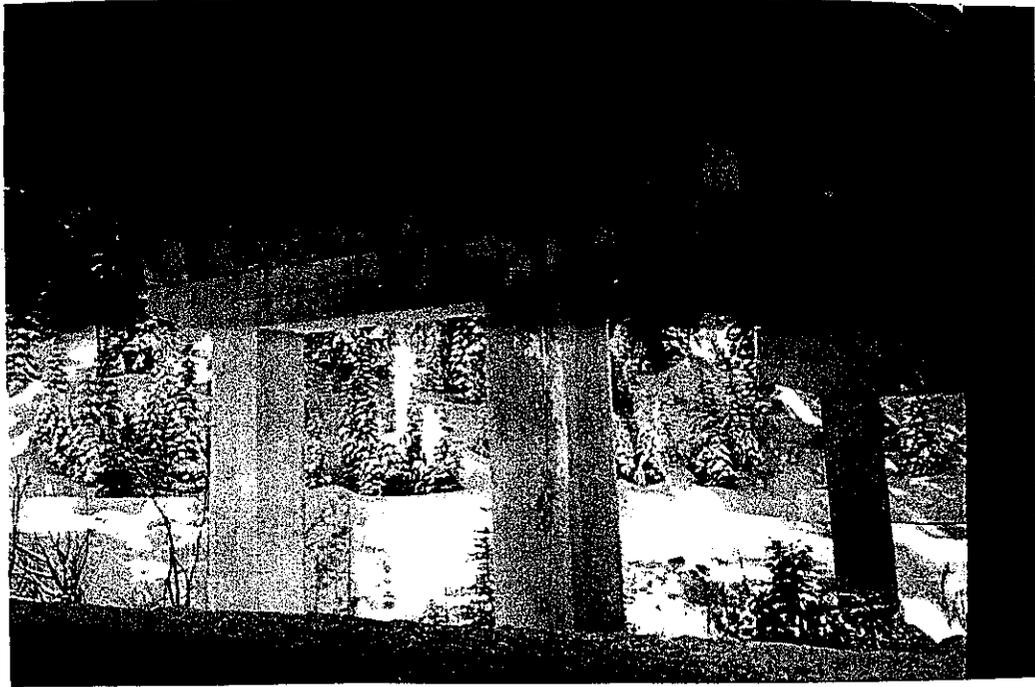
Figure 25. View looking Southeast showing the completed project. Bent 4R (Metallized Zinc CP system) is in the foreground.

By February, 1994, all work was completed and the CP systems were operating satisfactorily. No contractor claims were filed against Caltrans for this project. Figures 25 and 26 show the completed project.
