FHWA/CA/TL-93/09

Effects of Corrosion on the Bare Weathering Steel in the Antioch Bridge

June 1992

Division of New Technology
Materials and Research
California Department of Transportation
Sacramento, CA 95819

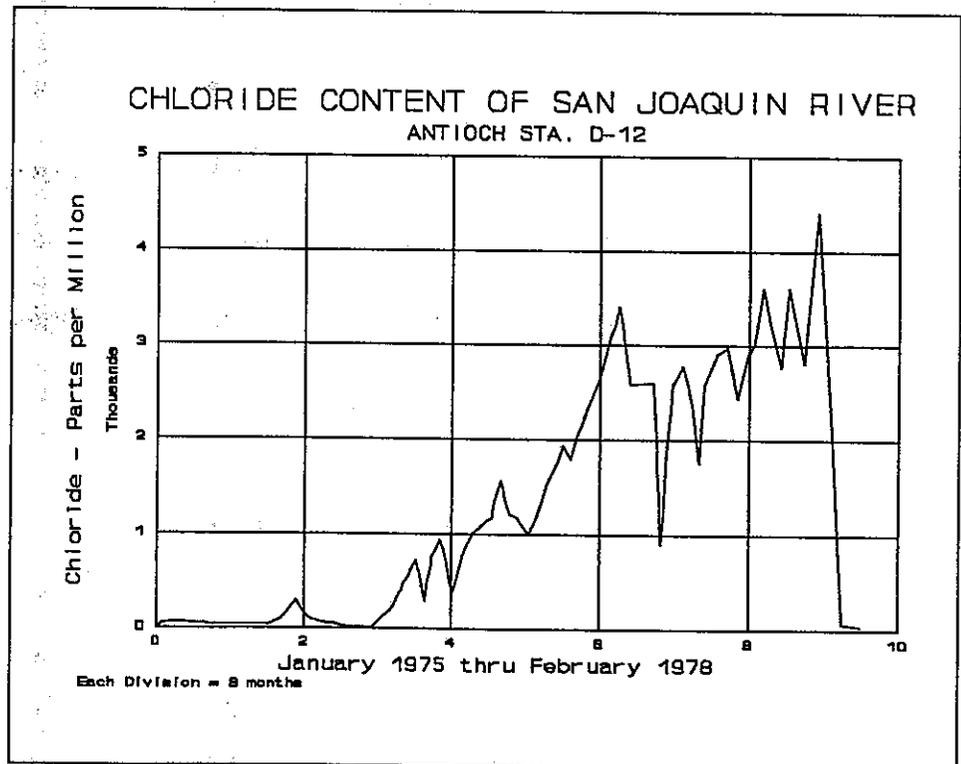
Graph A

The chloride content of seawater is approximately 19,000 mg/l. This graph shows that the chloride content of the river at the time of erection was approximately 25% that of seawater.

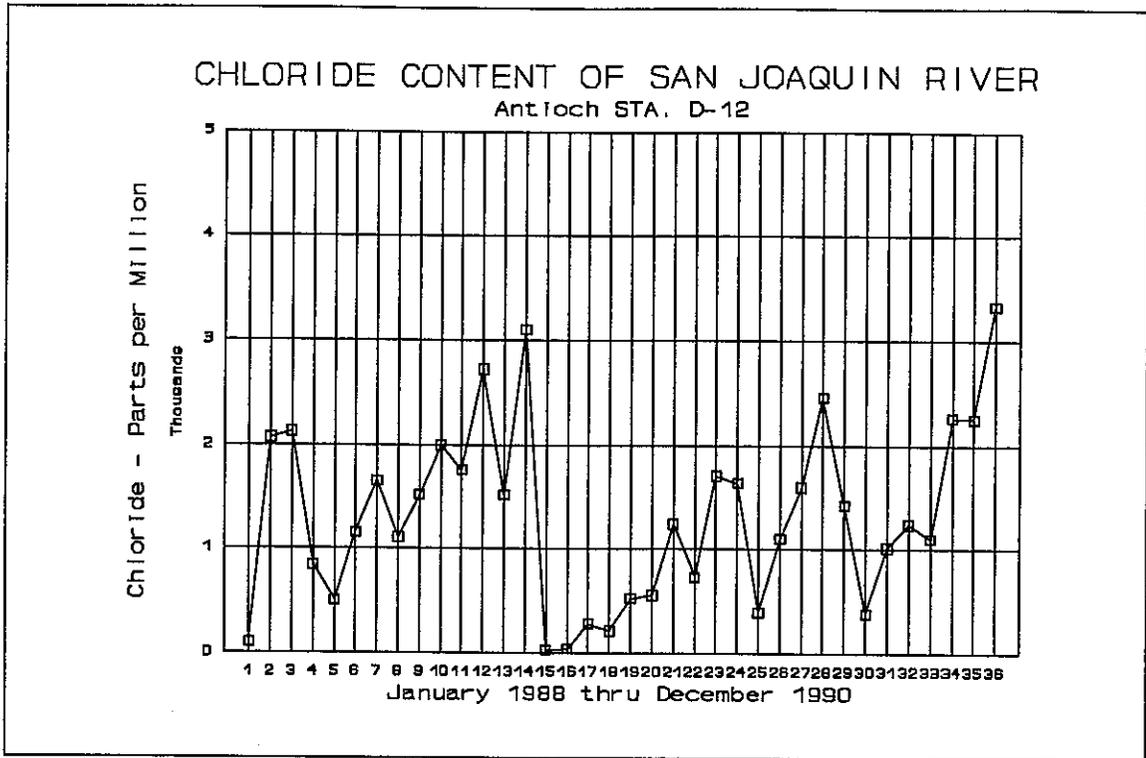
Graph B

California is presently in a period of drought of several years duration and the following graph of river salinity shows that during drought periods, the salinity increases significantly during low fresh water flow in winter months.

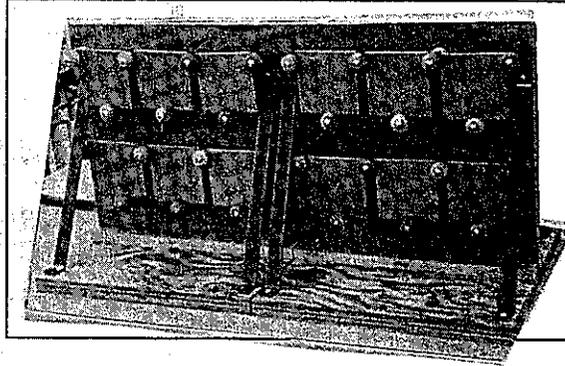
Figure 2

Racks With ASTM A588 Steel Samples

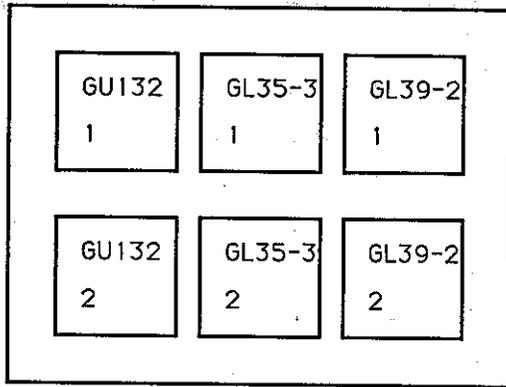
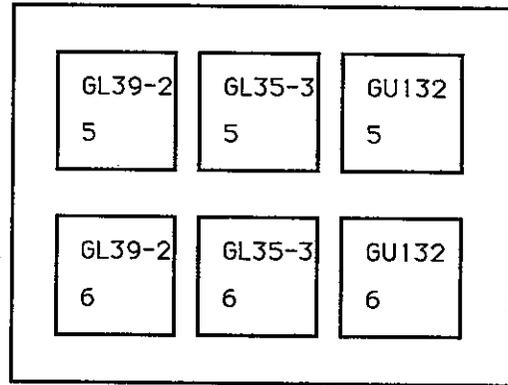
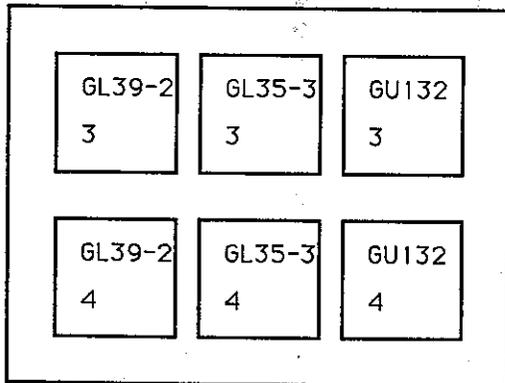
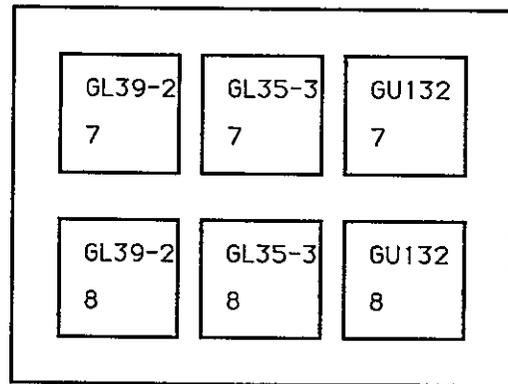
Figure 3

Plaque layout on the racks and bridge location is shown in figure 3. The remaining plaques on pier 2 are available for future evaluation. The remaining plaques on pier 8 were destroyed by vandals.
