COMPLIANCE CRASH TESTING OF THE
TYPE 60K CONCRETE BARRIER USED IN
SEMI-PERMANENT INSTALLATIONS
FINAL REPORT # **FHWA/CA/TL-2001/08**
CALTRANS STUDY # F99TL36

STATE OF CALIFORNIA
DEPARTMENT OF TRANSPORTATION
DIVISION OF NEW TECHNOLOGY,
MATERIALS AND RESEARCH

**COMPLIANCE CRASH TESTING
OF THE TYPE 60K CONCRETE
BARRIER USED IN SEMI-
PERMANENT INSTALLATIONS**

1. REPORT NO.	2. GOVERNMENT ACCESSION NO.	3. RECIPIENT'S CATALOG NO.	
4. TITLE AND SUBTITLE COMPLIANCE CRASH TESTING OF THE TYPE 60K CONCRETE BARRIER USED IN SEMI-PERMANENT INSTALLATIONS		5. REPORT DATE August 9, 2001

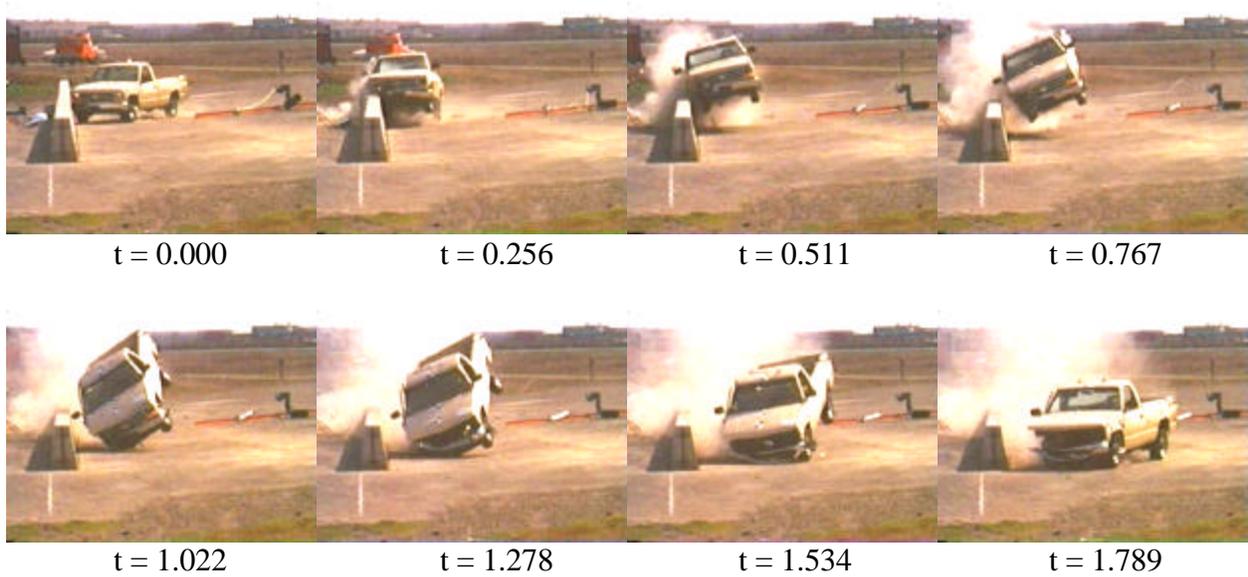
Figure 2-5 - Test 562 Data Summary Sheet

Barrier Damage: There was no damage to the concrete trough. Several of the segments spalled along the bottom edges.

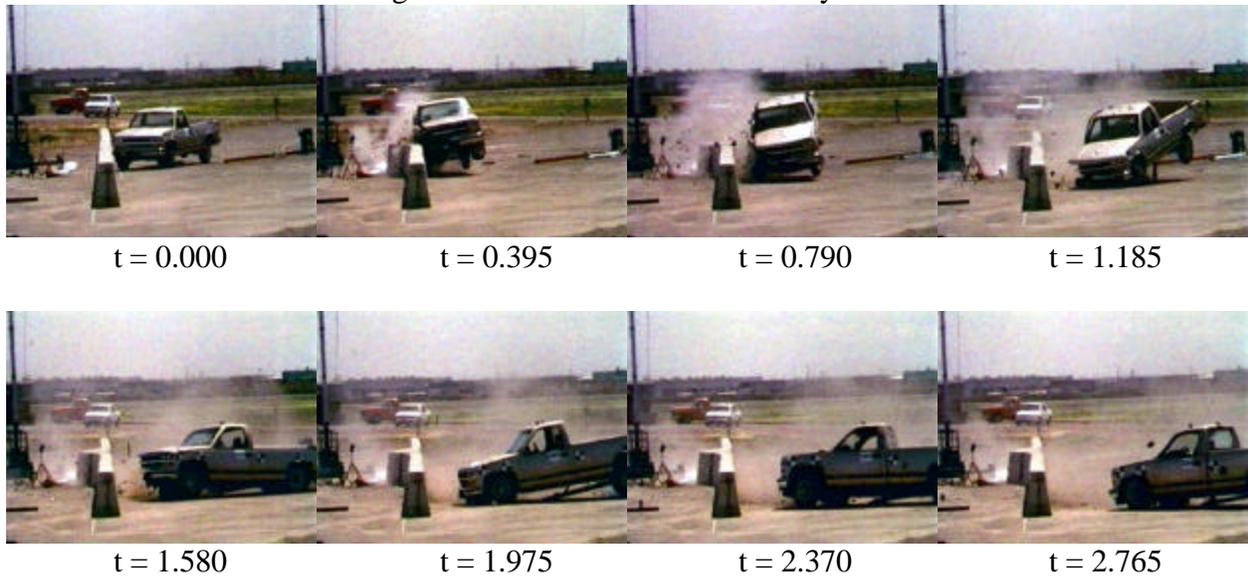
Figure 2-11 - Test 564 Data Summary Sheet

Damage to the barrier was limited to barrier deflection, two of the connection pins being pulled out of the pavement, and some minor concrete spalling. The maximum, permanent barrier deflection was 725 mm at the joint between segments 8 and 9 (see Figure 2-8). The barrier deflections led to the pins at joints 8-9 and 9-10 being pulled out of the pavement. Concrete spalling was limited to the leading edges of segments 8 and 10 where the vehicle snagged the barrier. All of the barrier segments were reusable.

Barrier Damage: Minor concrete spalling, moderate lateral displacement, and bent connecting pins.

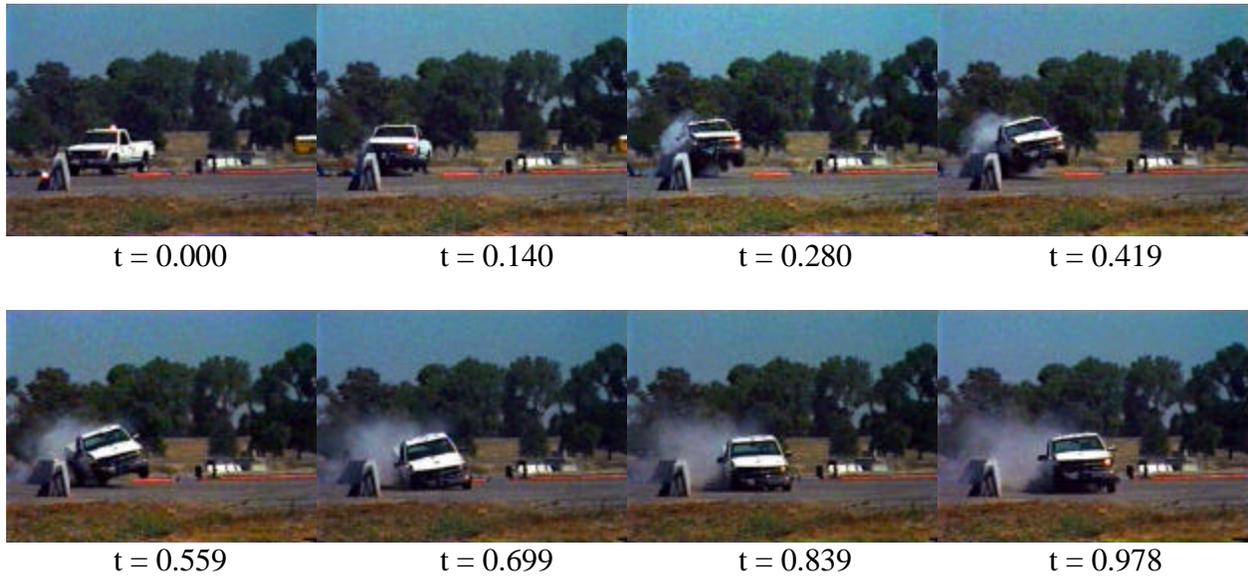
Figure 2-17 - Test 565 Data Summary Sheet

Barrier Damage: Minor concrete spalling,
 moderate lateral displacement, and bent connecting
 pins.

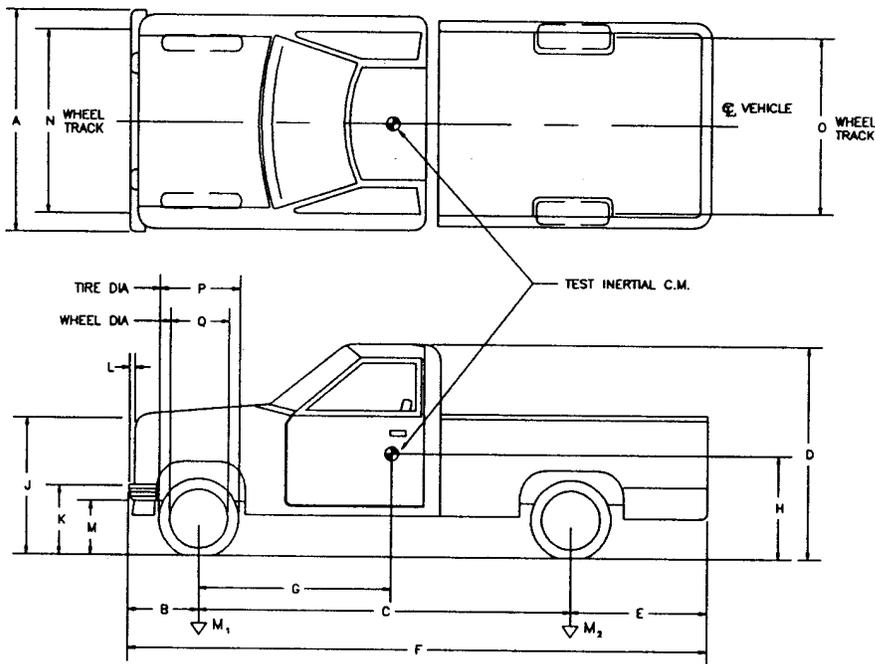
DESCRIBE ANY DAMAGE TO VEHICLE PRIOR TO TEST: Right door, lower rear corner has a shallow dent. The right side of the bed has a long shallow dent in front of the rear wheel.
