Vehicle Crash Tests of the Aesthetic, See-Through Concrete Bridge Rail with Sidewalk, Type 80 SW

August 1998, revised 8/99

Robert Meline, John Jewell, Rich Peter

Materials Engineering and Testing Services  
California Department of Transportation  
5900 Folsom Blvd.  
Sacramento, CA. 95819

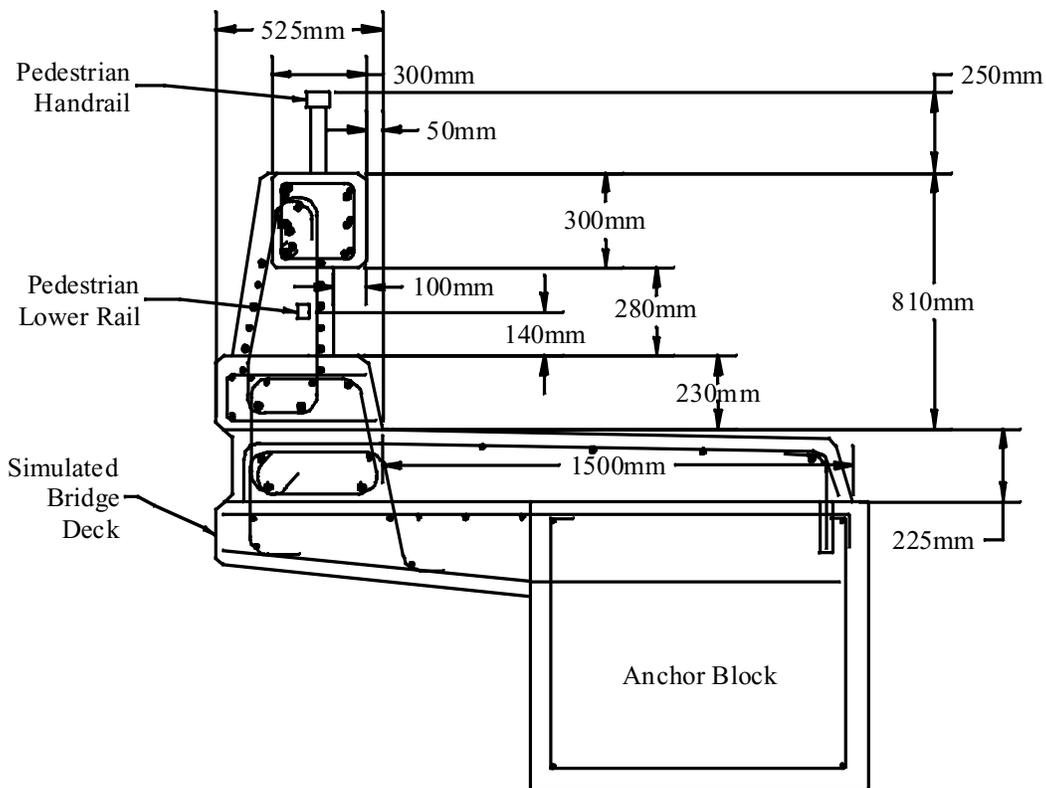
Figure 2-1 - Type 80SW

The design configuration for the Type 80SW includes viewing spaces 310 mm high by 1620 mm long, chosen to meet structural and safety requirements. A structural cross-section is shown in Figure 2-1. The space height was later reduced to 280 mm due to evidence of potential wheel snagging from Test 541. The reinforcing steel is covered with a minimum of 25 mm of concrete and all longitudinal reinforcing is terminated in 90 degree hooks. The 810 mm-high design was used in the tests as the shortest configuration to be placed in service. This provided a more conservative test configuration for the evaluation. Additional as-built drawings for the Type 80SW can be found in Appendix 7.5. Caltrans, Office of Structures Design should be contacted to obtain the most current and complete plans for future construction projects.

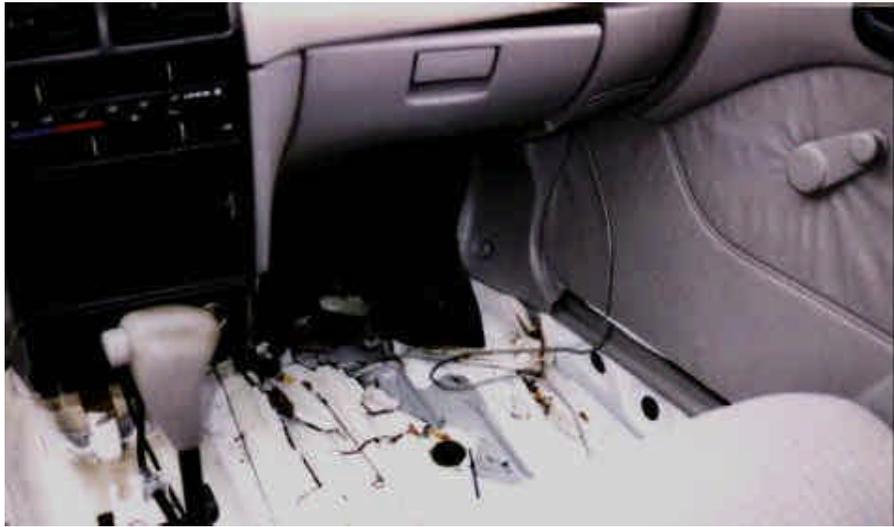
Figure 2-19 -  
Post Impact  
Passenger  
Floorboard  
Damage,  
Vehicle 541

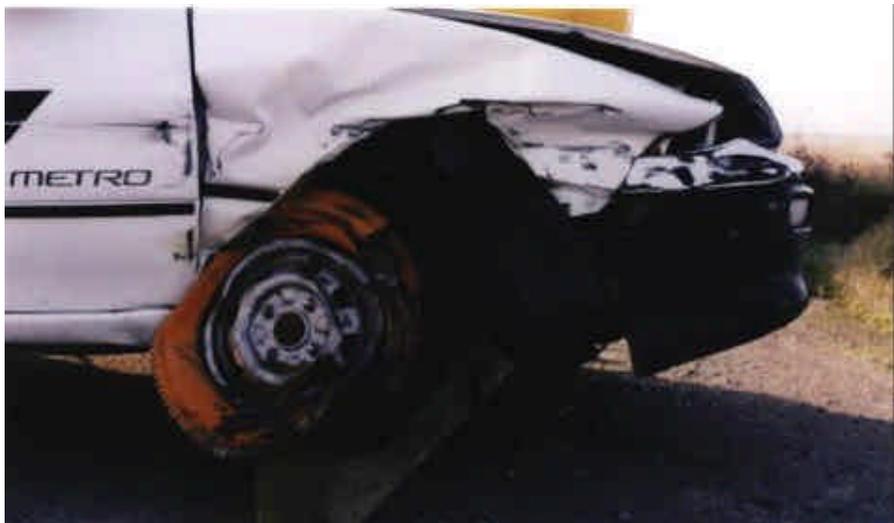
Figure 2-21 -  
Close up of  
Passenger Side  
Front Damage,  
Vehicle 541

The right front section of the vehicle sustained crushing of the bumper and minor unibody frame deformation, damage to the suspension and a flat tire. Initial right front wheel damage occurred on impact with the sidewalk 0.38 m from the beginning of the bridge rail installation. The sidewalk contact caused deformation of the wheel and tire deflation. Other tires experienced minor deformation on impact with the sidewalk but remained inflated. After contacting the bridge rail the right front wheel was pushed back, forcing the wheel well area to deform (Figure 2-21).

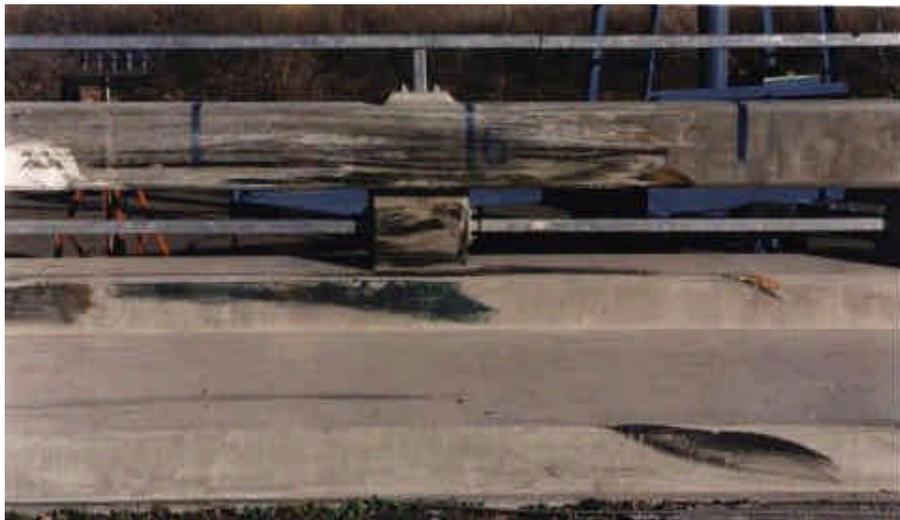
Figure 2-24 -  
Post Impact  
Bridge Rail  
Scuff Marks Test  
541

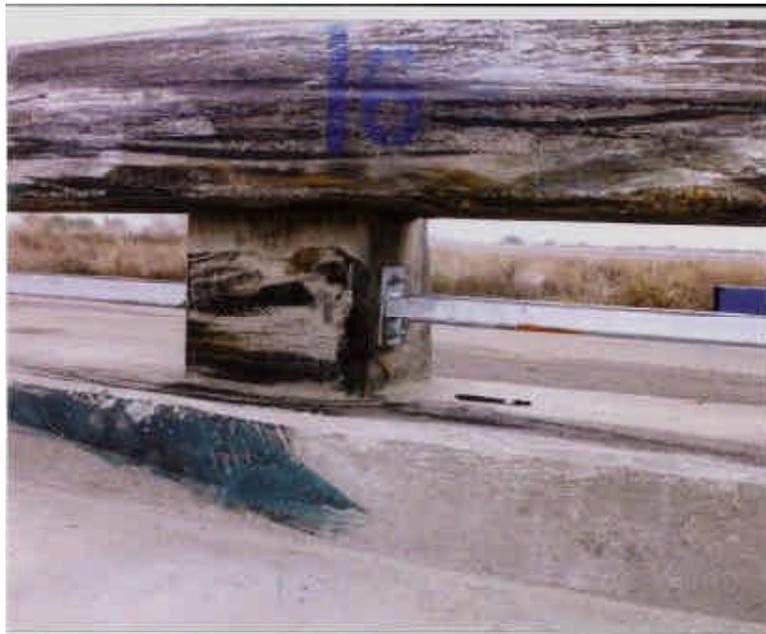
Figure 2-25 -  
Close up of Post  
Impact Bridge  
Rail Scuff Marks

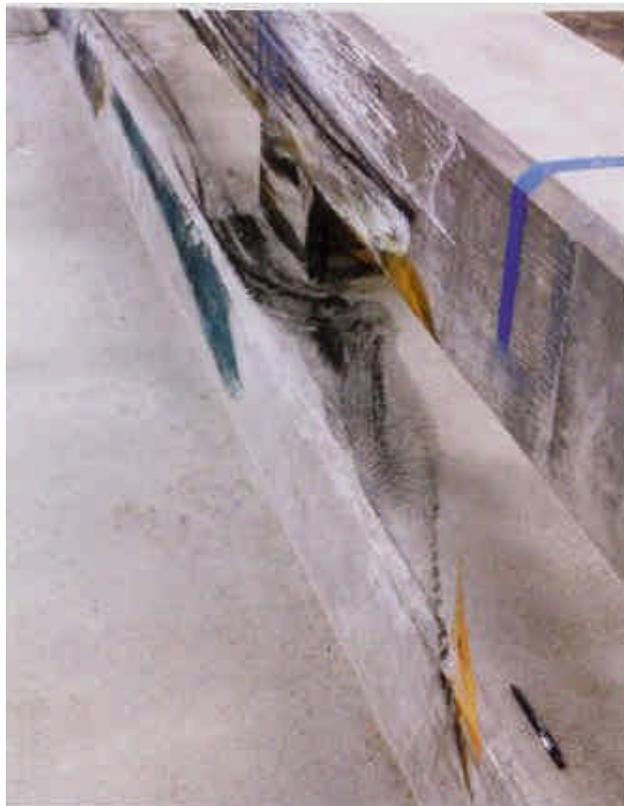
Figure 2-26 -  
Wheel Rotation  
Marks Around  
Bridge Rail Post

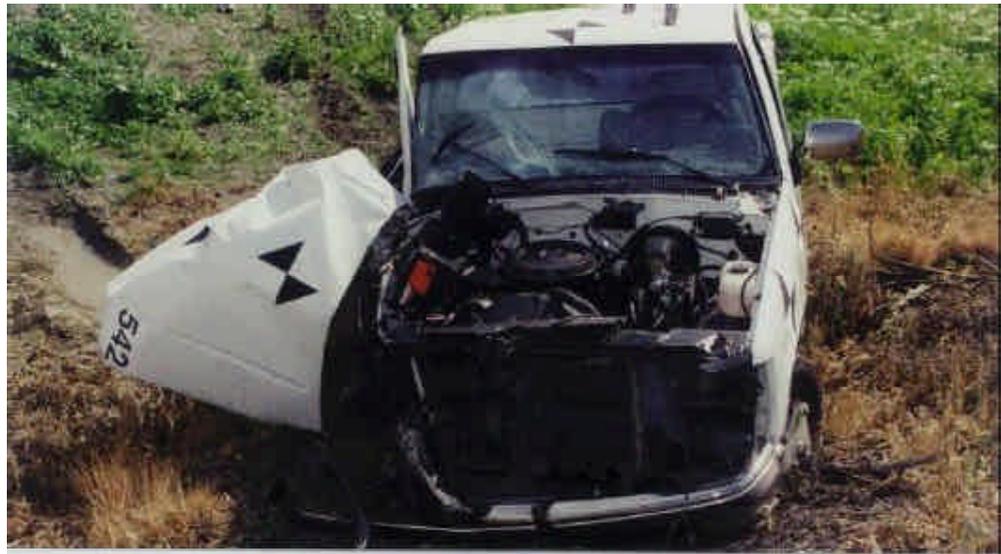
Figure 2-34 -  
Final Position  
Of Test  
Vehicle 542

The vehicle stayed in contact with the rail for approximately 6.5 m. The exit angle and speed were 7° and 77 km/h respectively. The vehicle remained upright throughout and after the collision. Brakes were applied 0.75 s after initial contact with the rail and the stopping point for the vehicle was approximately 34 m from the point of last contact with the barrier. Figure 2-34 shows the vehicle in its final resting position.

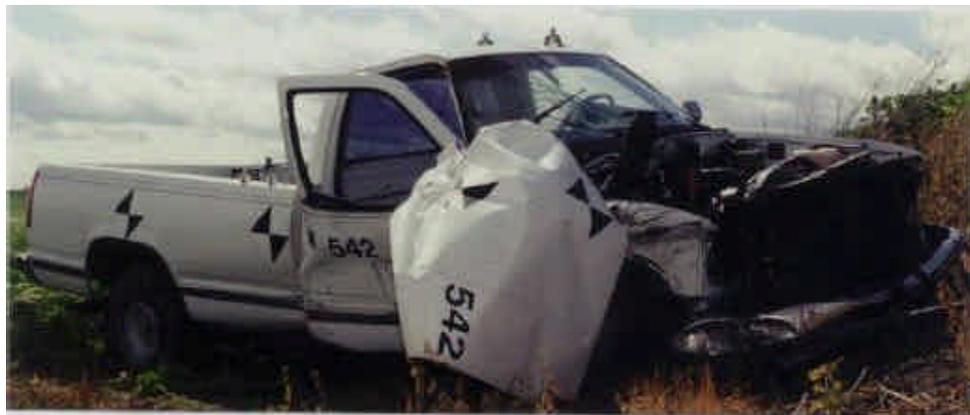
Figure 2-36 -  
Close-up of  
Impacting  
Corner Of  
Tested  
Vehicle 542

The extra speed of the vehicle, 10.2 km/h over target, undoubtedly contributed to higher deformation of the impacting right corner of the vehicle than would have otherwise occurred. Figure 2-36 shows the right front wheel pushed back into the wheel well, caused by impact with the rail curb and beam face. All of the wheels stayed connected to the vehicle throughout the test. The front right shock absorber, stabilizer bar and upper and lower control arms were bent but still attached. The rear and left front suspension components were intact and appeared undamaged. There was minor deformation of the right front frame.

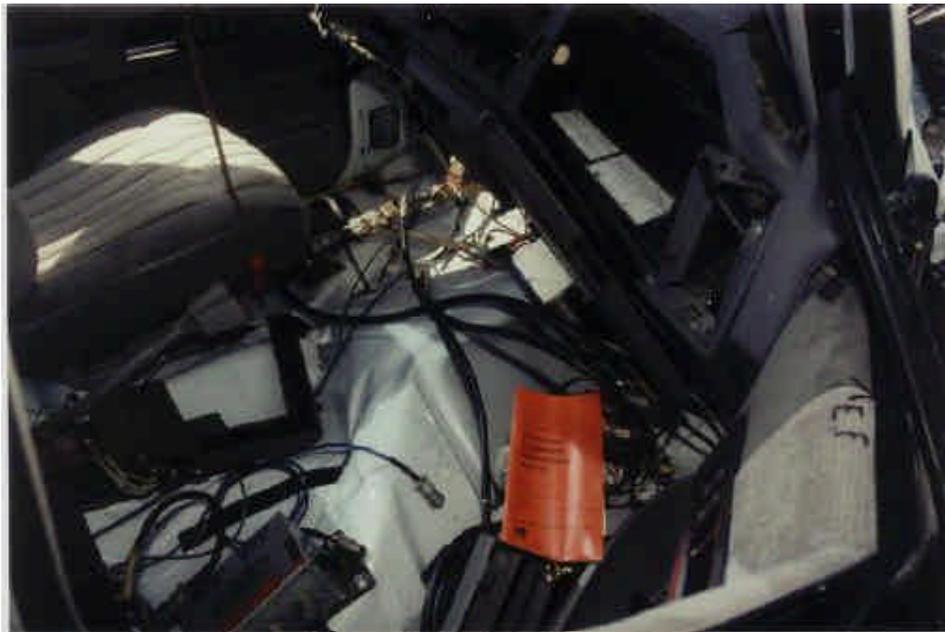
Figure 2-38 - Floor board of Vehicle 542

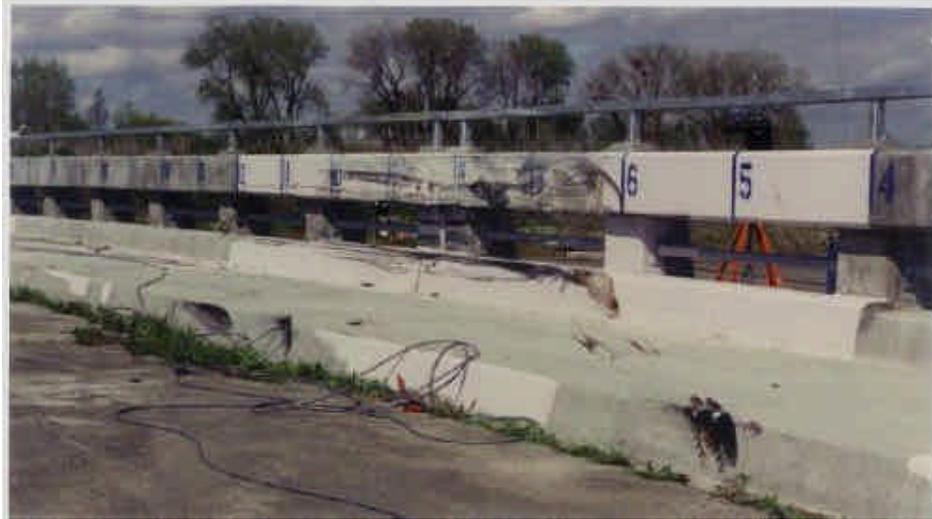
Figure 2-39 -  
Bridge Rail  
after Test  
542-View  
from  
Upstream

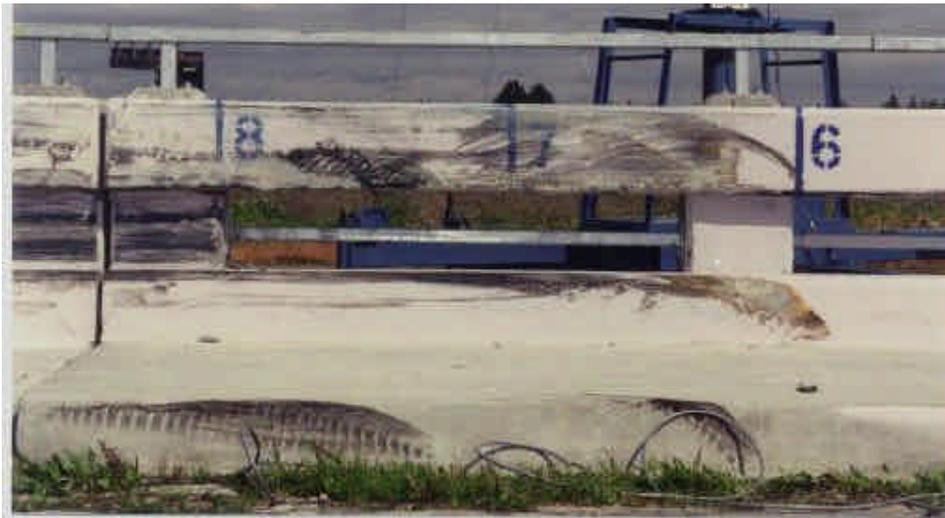
Figure 2-40 -  
View  
Perpendicu  
r to Point of  
Impact

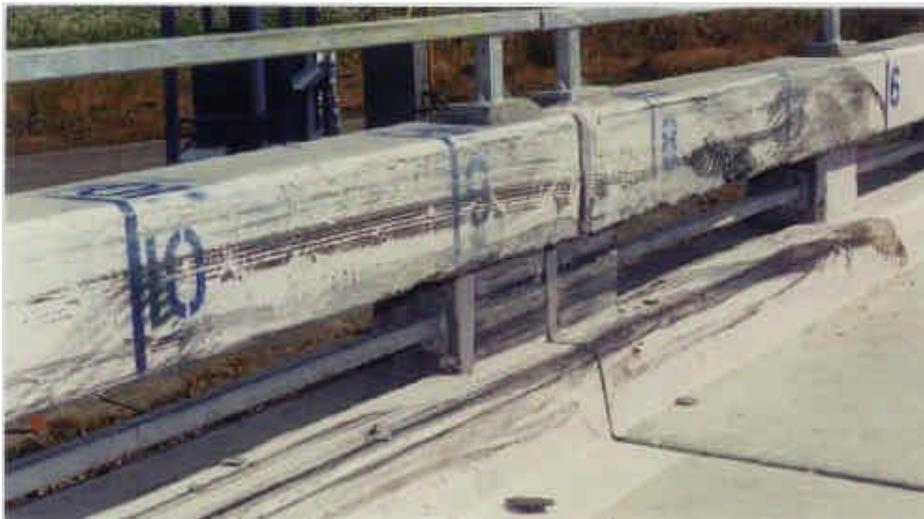
Figure 2-41 -  
Impact Area  
and Expansion  
Joint

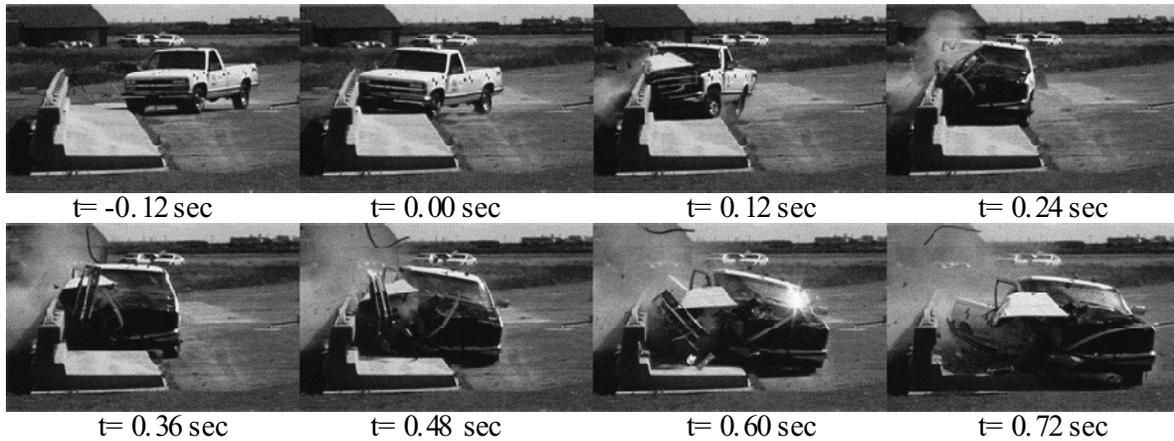
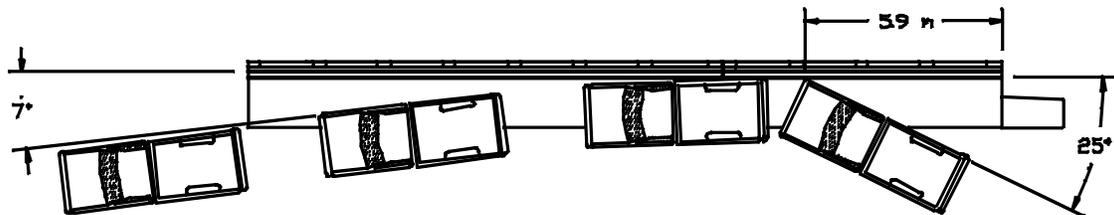
Figure 2-42 - Test 542 Data Summary Sheet

The barrier sustained minor spalls from the point of impact to roughly 4 m downstream. Other barrier damage was cosmetic only, consisting of scrapes and tire marks.

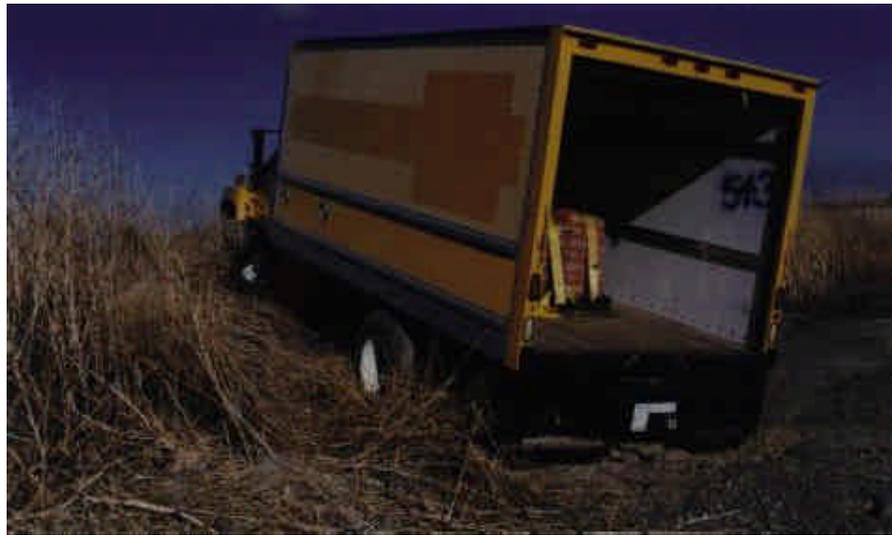
Figure 2-49 -  
Impact Side  
View of Vehicle  
543 after Impact

The 2918 kg of ballast, comprised of two separate pallets of sand bags strapped down to the cargo floor. The pallets were constrained by 150 mm angle iron and the sand bags were held down by 100 mm trucking straps as shown in Figure 2-47. The sand was allowed to shift slightly but is unlikely to have affected the test. None of the sand bags broke loose during the test (Figure 2-49).

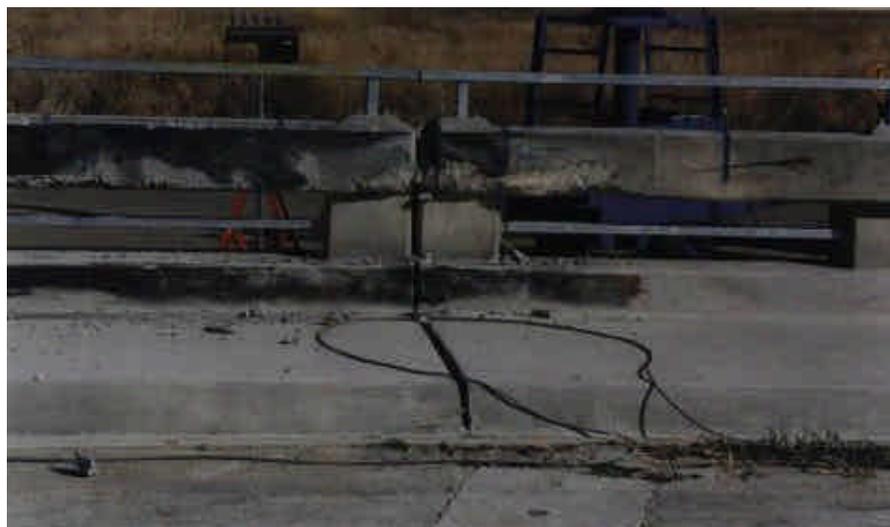
Figure 2-54 -  
Impact Area for  
Test 543

The barrier was scraped along the face and edges over a 3 m length. There was also spalling on the underside of the beam caused by the downward force of the rotating right front wheel lug nuts. The tire marks along the barrier were only a little longer than the scraping along the face. A concrete spall at the expansion joint was 80 mm to 100 mm deep and extended to the back face of the rail, shown in Figure 2-55 and Figure 2-56. The spall exposed the end of a piece of rebar but no structural damage was evident. The bridge rail withstood the impact from vehicle 543 well with only spall repairs necessary before subsequent tests.

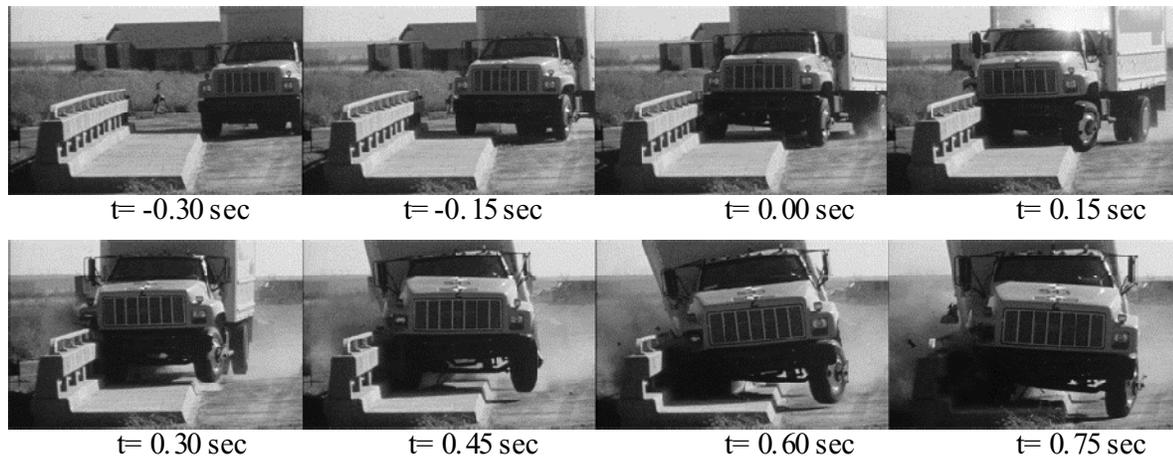
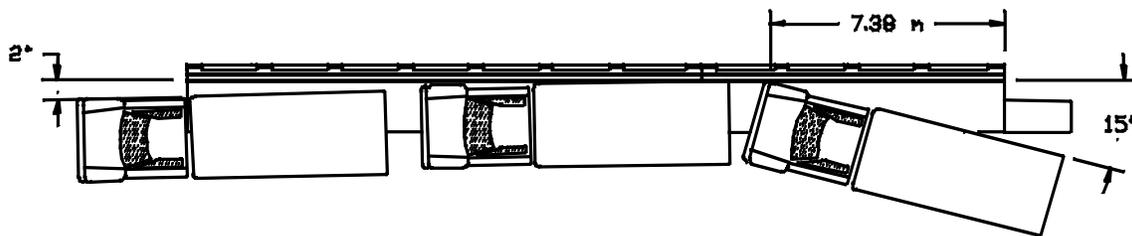
Figure 2-57 - Test 543 Data Summary Sheet

The barrier was scraped along the face and edges over a 3 m length. There was also spalling on the underside of the beam and at the expansion joint with no structural damage.

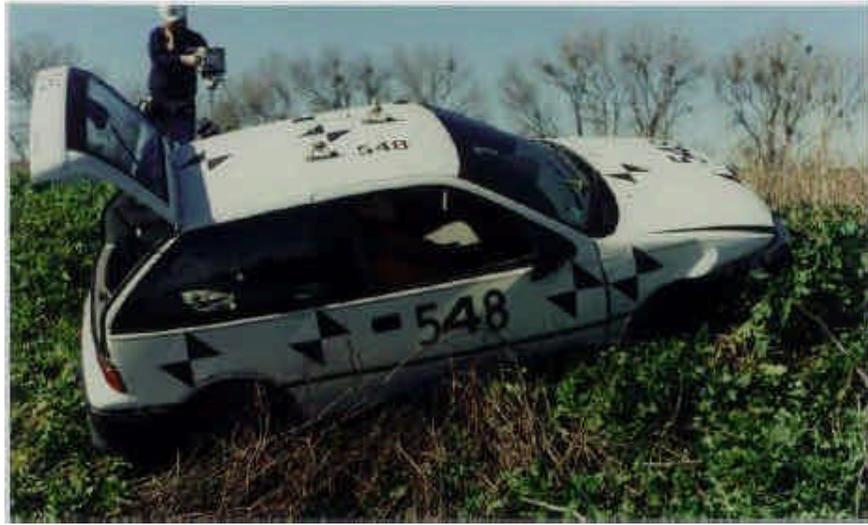
Figure 2-64 -  
Final Resting  
Position of  
Vehicle 548

The exit speed and angle were approximately 62 km/h and 4°, respectively. The maximum roll of -14.3° occurred during the initial contact with the bridge rail and a maximum pitch of 5° was obtained as the vehicle's side came into contact with the beam section. The vehicle remained upright throughout and after the collision. Brakes were not applied and the stopping point for the vehicle was approximately 37 m from the point of last contact with the barrier. Figure 2-64 and Figure 2-67 show the vehicle in its resting position.

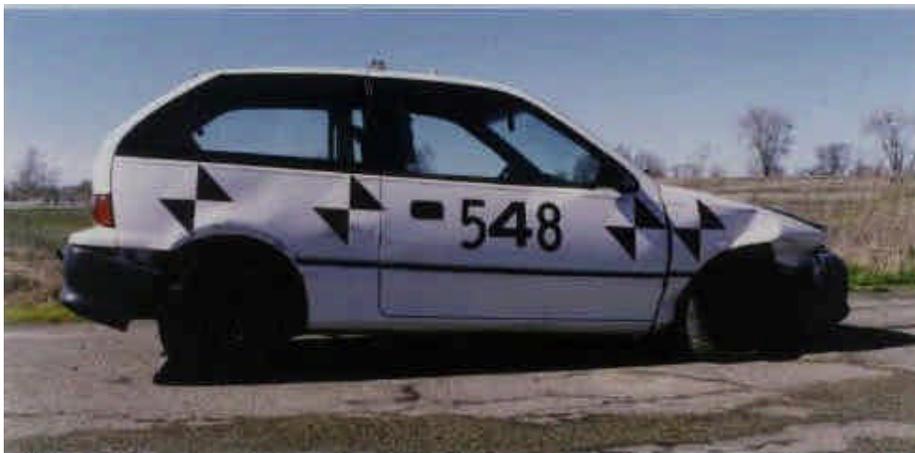
Figure 2-65 -  
Right Side of  
Vehicle 548  
after Impact

The right front section of the vehicle sustained crushing of the bumper and right front quarter panel, damage to the suspension and a flat tire. Initial right front wheel damage occurred on impact with the sidewalk 0.4 m from the beginning of the bridge rail. The sidewalk contact caused deformation of the wheel and tire deflation. Wheel damage is shown in Figure 2-66. Other wheels were slightly deformed upon impact with the sidewalk, but the tires remained inflated. The vehicle first contacted the bridge rail on the curb section below the beam approximately 5.1 m from the beginning of the rail. After contacting the bridge rail, the right front wheel was pushed back, forcing the wheel well area to deform (Figure 2-65). The strut and axle for the right front wheel were bent, but remained attached.
