EVALUATION OF ABRASION RESISTANCE OF PIPE AND PIPE LINING MATERIALS

Final Report

FHWA/CA/TL – CA01-0173

September, 2007

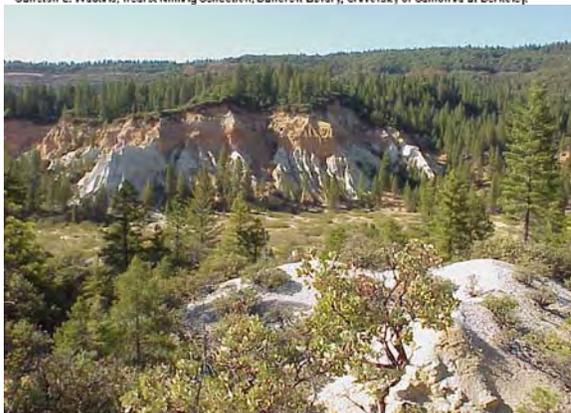
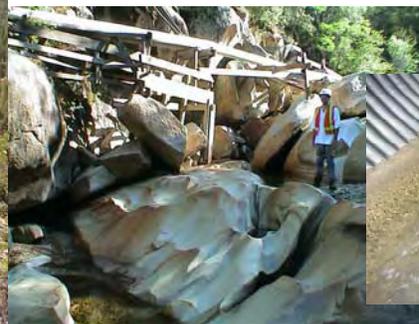
Top left: Shady Creek 1 mile upstream. Top right: Channel downstream of test site. Middle (left): Malakoff Diggings (late 1800's) - World's largest Hydraulic mine located in adjacent basin to upper Shady Creek watershed. Middle (right): Bedload. Bottom (left): Malakoff Diggings today. Bottom (center): wear pattern on granite boulders 500 feet upstream. Bottom (right): severely worn concrete invert lining after two years inside culvert prior to placing steel plate invert protection.

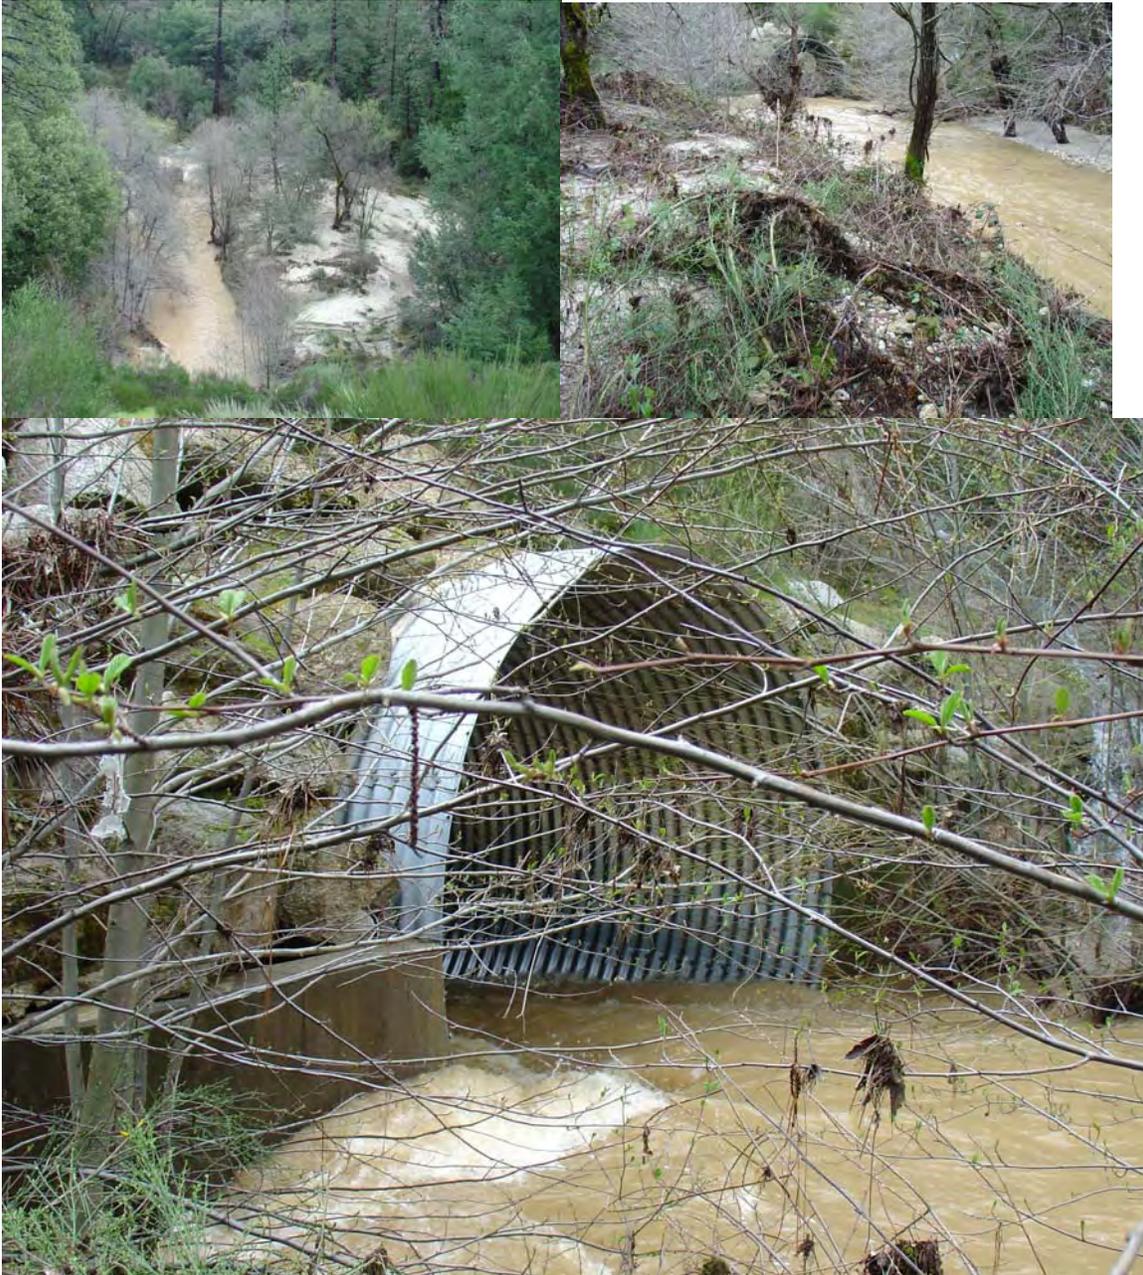
The approach channel immediately upstream of the culvert entrance is skewed approximately 20 degrees. During winter flow events, as water enters the pipe, a large eddy current (vortex) several feet in diameter forms around the headwall on the left side and continues several feet into the pipe, which is invert-lined with a flat, 102 inch wide steel plate. See approach channel and culvert entrance pictures and notes below them:

Top left: Aerial view upstream of approach channel. Top right: Approach channel showing skew angle with culvert entrance. Bottom: Culvert entrance and vortex around left headwall. Note turbidity of water. It was speculated the vortex caused a significant reduction of sediment entering the left side of the culvert and over the concrete test pad at the outlet (see pictures on previous page).

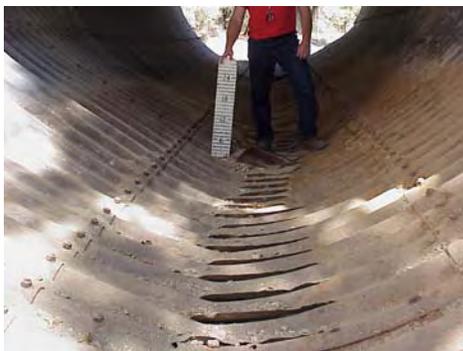
A 180-inch, 1 gage SSPP was originally placed at this site in 1976. It was chronically perforated in the invert after less than 20 years and structurally deformed. See cover photo and pictures below.

Invert perforations in original culvert

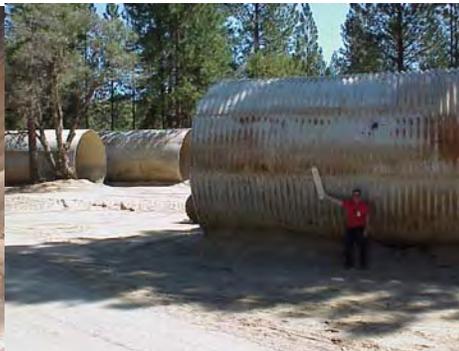
Sections of original culvert

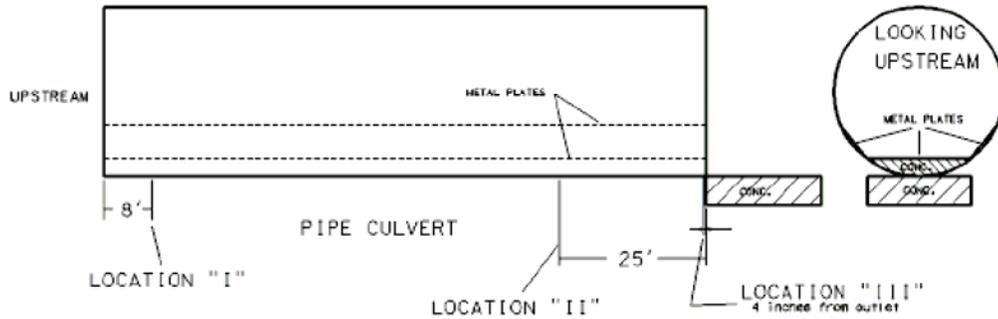
FIGURE "A"

0.375 inch Thick A572 Grade 50 Steel Plate Invert Measurement
Reference Points (see below)

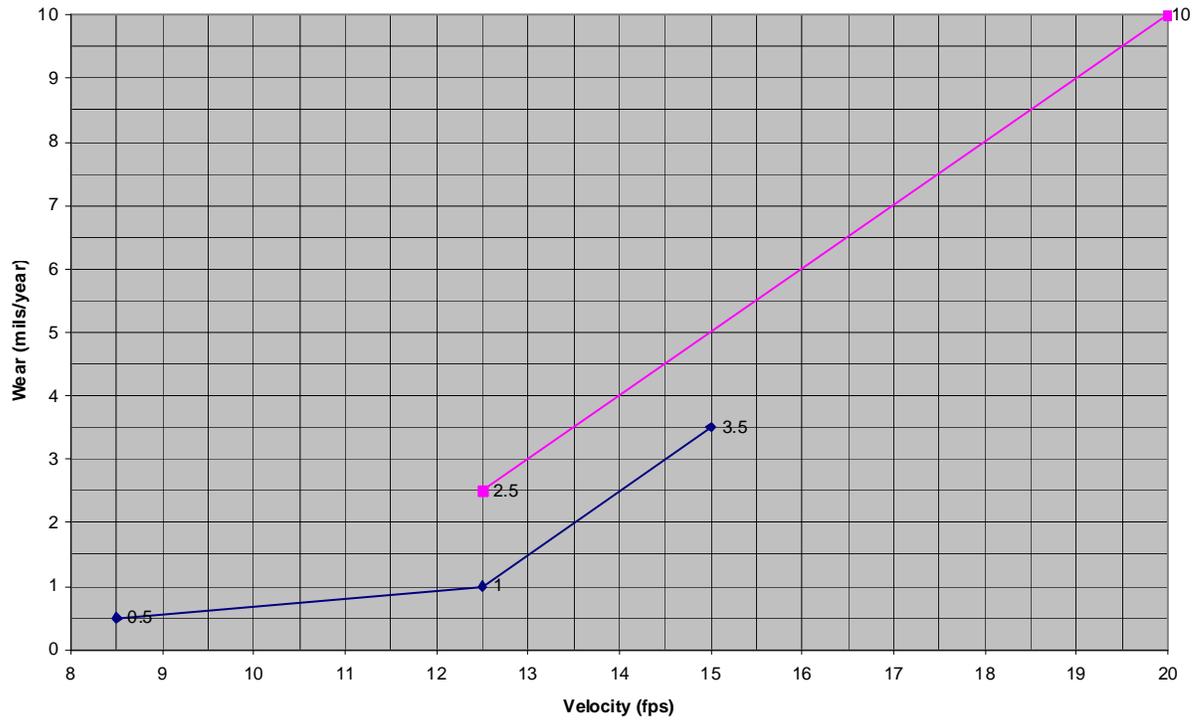
Anticipated additional wear (in mils/year) to steel pipe for abrasion levels 4 through 6

No additional wear for abrasion levels 1 through 3. See HDM Figure 854.3C for estimating years to perforation.

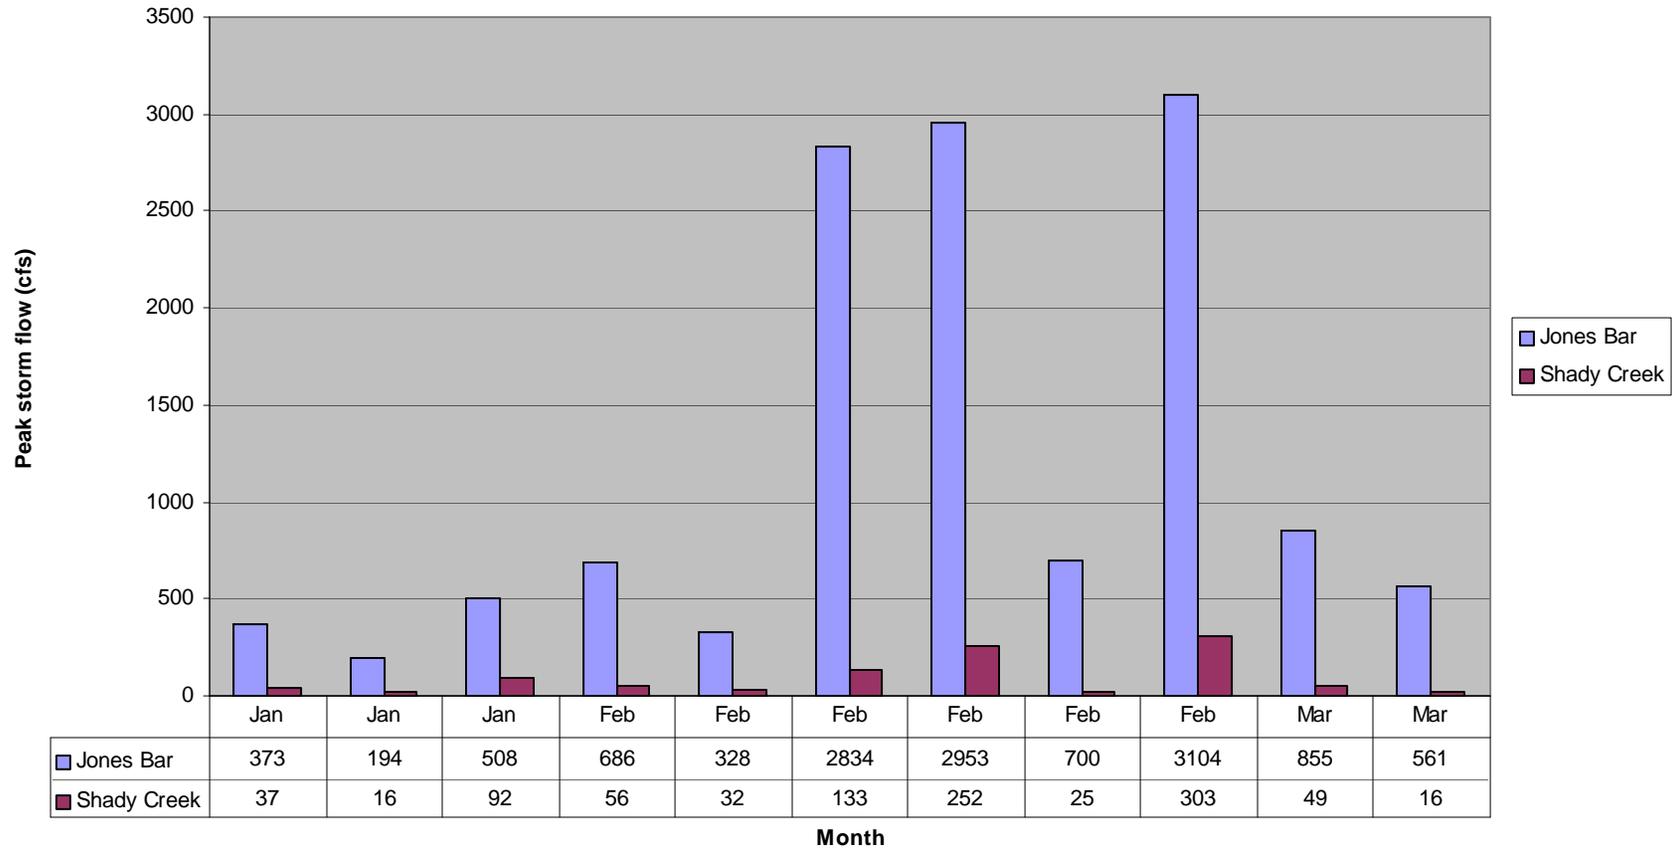
Jones Bar (S Fk Yuba River) and Shady Creek Gage Comparison (1/1-3/31 2004)

Rainfall	0.6"	0.37"	1.65"	1.3"	0.4"	1.2"	1.6"	0.3"	1.5"	0.75"	0.6"
Bedload Tons/Day	18	1.5	150	40	15	180	700	8	1050	40	1.5
