Job Stamp:
04-SF-80-13.2/13.9 04-0120F4
SFOBB SAS
San Francisco Co. in San Francisco
Fm 0.6 km to 1.3 km East of Yerba Buena
Tunnel East Portal

ASSISTANT RESIDENT ENGINEER'S DAILY BRIDGE REPORT

| Location: W2 Cap Beam | 7-day const. cal.: 520 | Weather: clear |

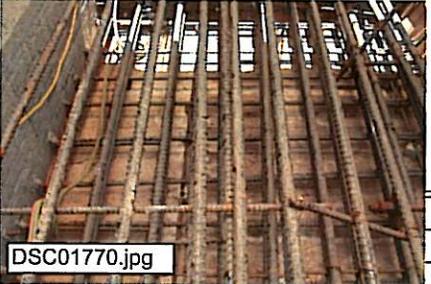
With the Hinge K assembly raised in the air and the hot temperatures we received this week, it looks like the denso paste from the Macalloy rods have been melting and dripping on the rebar below (DSC01770). This denso paste application is primarily for debonding of the rods from the concrete pour. In this case, the steel reinforcement will be debonded from the concrete in which it will be encased. A remedy may be required to remove this paste on the reinforcement.
 RPS has continued to place duct in the south column cage area - grades have not been checked.
