Job Stamp 04-0120F4 SFOBB SAS

Assistant Structure Rep.'s Daily Report

Location & Description of Operation	SAS-Temporary towers, Tower A & B Erection
Weather	HI: 67 F Low: 57 F Partly cloudy

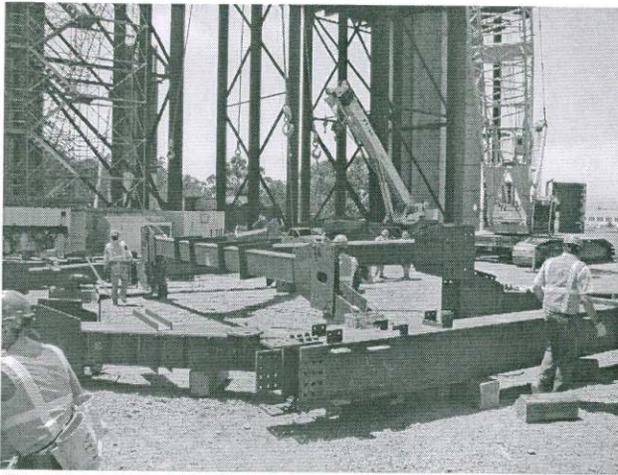
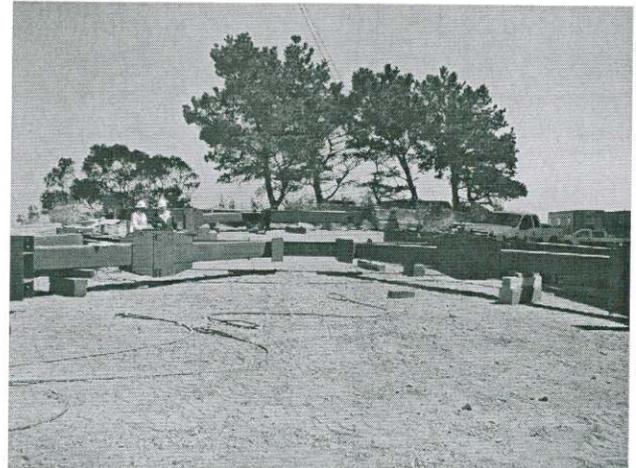
Figs 1 and 2. ABF crews started to assemble the first section which has vertical members, one link beam and one strut member.
