Job Stamp 04-0120F4 SFOBB SAS

Assistant Structure Rep.'s Daily Report

Location & Description of Operation	SAS-Temporary towers, Tower A & B Erection
Weather	HI: 74 F Low: 54 F Partly cloudy

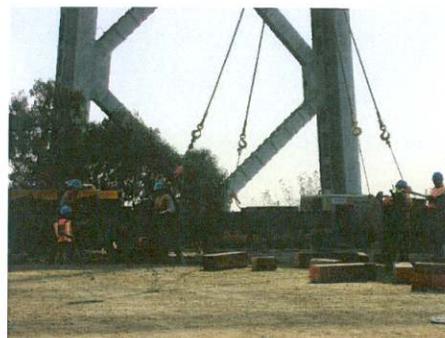
Fig 8

- Note
 - ABF increased the bolt size (from 4inch to 4 ¼ inch) at the brace splice zones of the tower BE to avoid that the shear plane is located at either run out or thread regions. See blue circles of Fig. 8. The bolt size is 4 inch at the same locations of the tower BW.
 - Superintendent Dan is on site from 06:30 to 06:45, 09:00 to 10:30 and 12:00 to 12:30.
 - Mark and Art checked the thickness of the diagonal bracing and confirmed that it is within tolerance.
