| DEPARTMENT OF TRANSPORTATION | SFOBB SAS | Project Work Day No. | Day No. 930 |
| Form HC-10A (Rev. 6/80) | 04-0120F4 | Date | 12/2/2008 |

Erect Temporary Towers: North Node Tower F Driving Frame Assembly & TTF South Retap

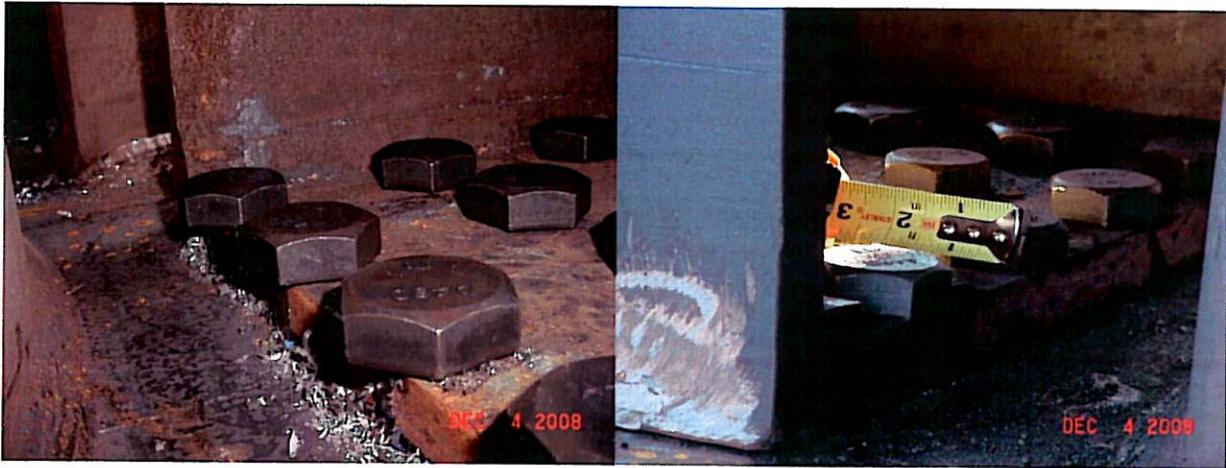
The crew of the Big Digger is continuing to assemble the North node of the Tower F driving frame at pier 7. See the attached drawing for locations of the frame that were worked on today. A brief description of the progress thus far is as follows. For the bottom elevation of 1.5 meter, the northeast corner has been drilled and torqued as of yesterday. The southeast corner was drilled and about 80% of it was torqued yesterday, so this morning the rest of the bolts were torqued. These same workers moved over to the southwest corner to continue the drilling of these connection. It is at this corner that the diagonal is a little short, between 50 and 100 mm short. At the northwest corner there is a worker continuing to drill holes. This is the location where there is a misaligned chord on the West side of the connection. The same thing was on the South node and the designer gave the "OK" to drill another row of bolt holes and bolt them up.

On the top of the frame, elevation 5.5 meter, the diagonal is in on the northwest side, and toward the end of the day a couple workers were drilling holes all around that location, in the diagonal and in the chords.

In the 1:30 pm meeting with ABF, Bill O'Sullivan was there to talk about the diagonal being too short on the southwest corner. He said there was going to be an RFI generated and sent to Kohn Crippen Berger regarding this situation. After the meeting John Denis and I went to take a look at the diagonal and John saw that some of the field drilled holes looked to be too close to the edge of the box section on the North side of the frame. It appeared that on the northeast corner of the field drilled connections between the 8-sleeve piece and the 1-sleeve piece are approaching 35 – 40 mm, when the plans call for 50 mm minimum. This same situation happened on the South frame and is noted in Thanh Les diary on October 13, 2008. Bill O'Sullivan and Sean Heydan came out after John and I left the site, and I met with them to show them the areas of concern. They measured these locations and agreed that some are less than 50 mm, and that they will be included in the RFI that will be sent to KCB.
