DEPARTMENT OF TRANSPORTATION

Contract #: 04-0120F4Cty: SF/ALA Rte: 80 PM: 13.2/13.9File #: 69.15**SOURCE INSPECTION REPORT****Resident Engineer:** Pursell, Gary**Address:** 333 Burma Road**City:** Oakland, CA 94607**Report No:** SIR-002525**Date Inspected:** 22-Jul-2010**Project Name:** SAS Superstructure**OSM Arrival Time:** 700**Prime Contractor:** American Bridge/Fluor Enterprises, a JV**OSM Departure Time:** 1900**Contractor:** Zhenhua Port Machinery Company, Ltd (ZPMC), Changxing Island **Location:** Shanghai, China**Quality Control Contact:** Mr. Don Walton**Quality Control Present:** Yes No**Material transfer:** Yes No N/A**Sampled Items:** Yes No N/A**Stock Transfer:** Yes No N/A**OK to Cut:** Yes No N/A**Rebar Test Witness:** Yes No N/A**Delayed/Cancelled:** Yes No N/A**Other:** Coating Inspection**Bridge No:** 34-0006**Component:** See Below**Bid Item:** 77, 78, 79**Lot No:** B #204**Summary of Items Observed:**

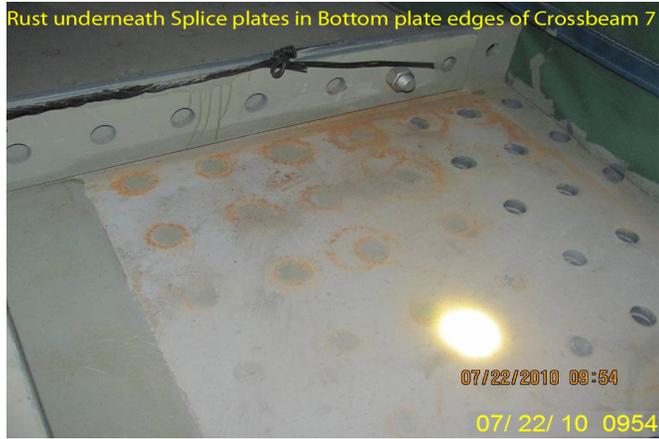
2. An inspection was requested on the OBG Cross beam CB7 and CB9 for DFT check and final acceptance of internal bottom plate, vide request no. 3779 at Ship no.9, Heavy Dock Jetty. This QA inspector observed, ABF inspectors Mr. Turtle, Mr. Hong and Mr. David performing the said inspection. This QA inspector observed, ABF inspectors rejected CB7 bottom plate for mud crack, over blast and Rust in faying surfaces. It was found some of the splice plate holes need touch up with Interzinc 52 which was pointed out to ABF and ZPMC inspectors. This QA Inspector observed, Rust in Edge splice plate bottom where Drilled holes have been plugged.

The attached photo shows clearly the rust formation. This QA inspector observed, CB9 bottom plate has been accepted by ABF Inspectors. International protective coatings technical service representative Mr. Lou Qian Chuan. was found present during the coarse of this inspection process.
