**DEPARTMENT OF TRANSPORTATION**

Contract #: 04-0120F4Cty: SF/ALA Rte: 80 PM: 13.2/13.9File #: 69.28**WELDING INSPECTION REPORT****Resident Engineer:** Siegenthaler, Peter**Address:** 333 Burma Road**City:** Oakland, CA 94607**Report No:** WIR-021445**Date Inspected:** 01-Mar-2011**Project Name:** SAS Superstructure**OSM Arrival Time:** 700**Prime Contractor:** American Bridge/Fluor Enterprises, a JV**OSM Departure Time:** 1900**Contractor:** Zhenhua Port Machinery Company, Ltd (ZPMC), Changxing Island **Location:** Shanghai, China**CWI Name:** Lv Li Qing Xi/Geng Wei**CWI Present:** Yes No**Inspected CWI report:** Yes No N/A**Rod Oven in Use:** Yes No N/A**Electrode to specification:** Yes No N/A**Weld Procedures Followed:** Yes No N/A**Qualified Welders:** Yes No N/A**Verified Joint Fit-up:** Yes No N/A**Approved Drawings:** Yes No N/A**Approved WPS:** Yes No N/A**Delayed / Cancelled:** Yes No N/A**Bridge No:** 34-0006**Component:** OBG**Summary of Items Observed:**

## WELDING INSPECTION REPORT

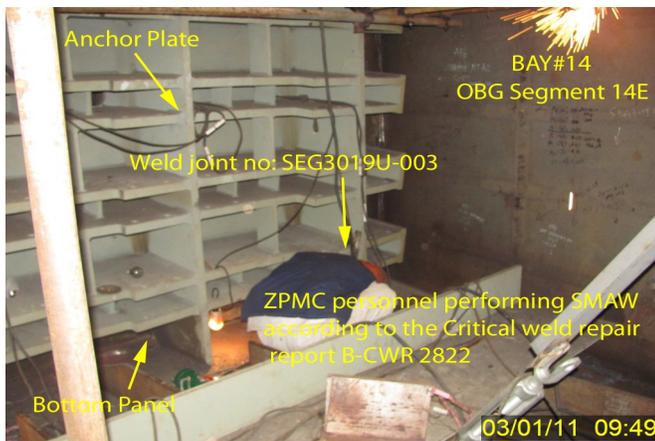
SMAW welding of weld joint no: SEG3019U-003 located on OBG Segment 14E Anchor Plate to Bottom Panel. Welder is identified as #066268. ZPMC CWI is identified as Mr. Geng Wei. Welding was performed according to the Critical weld repair report B-CWR2822 .The welding variables recorded by QC appeared to comply with the WPS-345-SMAW-2G(2F)-FCM-Repair-1. Please see the attached picture.
