Contract #: 04-0120F4Cty: SF/ALA Rte: 80 PM: 13.2/13.9File #: 69.25B**QUALITY ASSURANCE -- NON-CONFORMANCE REPORT****Location:** Changxing Island, Shanghai, PRC**Report No:** NCR-000092**Prime Contractor:** American Bridge/Fluor Enterprises, a JV**Date:** 20-Mar-2008**Submitting Contractor:** Zhenhua Port Machinery Company, Ltd (ZPMC), Changxing Island**NCR #:** ZPMC-0090**Type of problem:**

Job Name: SAS Superstructure

Subject: NCR No. ZPMC-0090

Reference Description: Tower Diaphragm 28/38 Meter / Heat Straightening - Active Force Applied

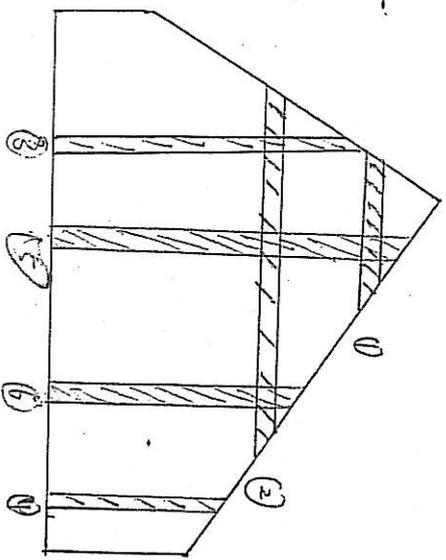
Cause原因 Mill induced distortion 钢厂造成的变形

Type of Defect缺陷类型 Mill distortion 出厂变形

缺陷去除方法(Defect Removal Method): Flame Straightening by natural gas

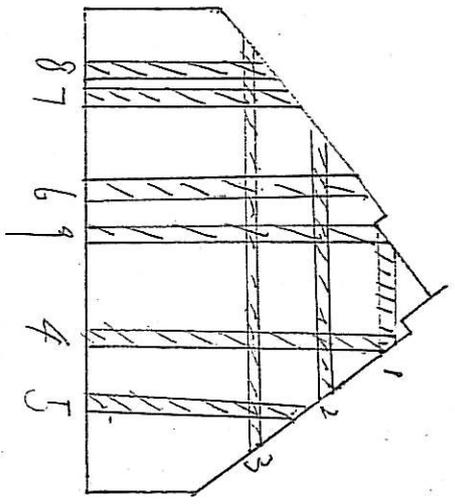
The serial no. of project: RP06-787 The drawing no.: SA277 (5) Part name:

平整度/翘曲垂直度是否合格: ACC
 Heat straightening result: ACC
 校核工影响焊接, 请填写以下项目
 Fill the following items if the straightening affects the weld
