Contract #: 04-0120F4Cty: SF/ALA Rte: 80 PM: 13.2/13.9File #: 69.25B**QUALITY ASSURANCE -- NON-CONFORMANCE REPORT****Location:** Changxing Island, Shanghai, PRC**Report No:** NCR-000173**Prime Contractor:** American Bridge/Fluor Enterprises, a JV**Date:** 08-Aug-2008**Submitting Contractor:** Zhenhua Port Machinery Company, Ltd (ZPMC), Changxing Island**NCR #:** ZPMC-0157**Type of problem:****Welding****Concrete****Other****Welding****Curing****Procedural****Bridge No:** 34-0006**Joint fit-up****Coating****Other****Component:** Tower Type 3B Diaphragm**Procedural****Procedural****Descriptor:** Tower Diaphragm ESD1-SA316 B/B**Reference Description:** 04-0120F4 Special Provisions**Description of Non-Conformance:**

Job Name: SAS Superstructure

Subject: NCR No. ZPMC-0157

Reference Description: Failure to follow Approved Procedure / Weld Sequence / Tower Diaphragm Assembly

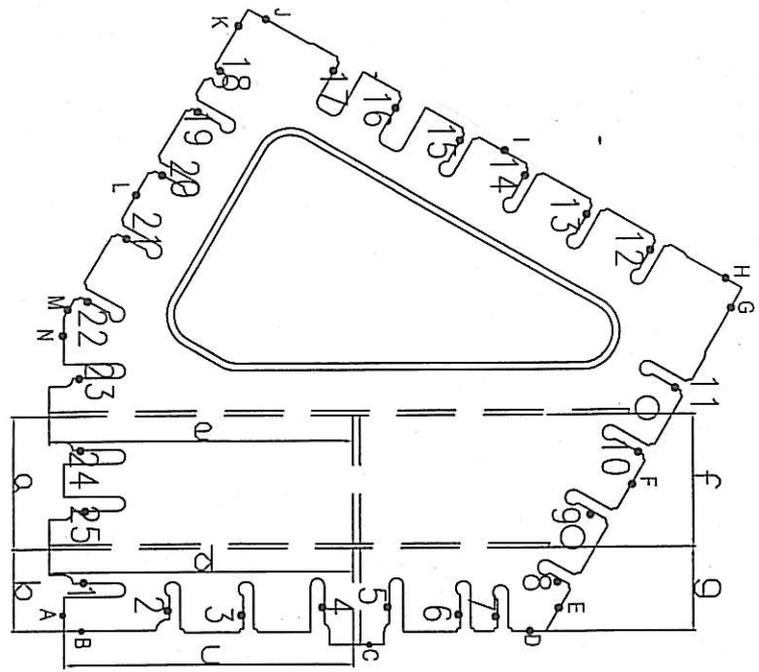
槽口带边量 groove edge offsetting (mm)

测量点 Checking point:	1	2	3	4	5	6	7	8	9	10	11	12	13
测量值 Measure result:	-1	2	3	4	5	6	7	8	9	10	11	12	13
测量点 Checking point:	14	15	16	17	18	19	20	21	22	23	24	25	26
测量值 Measure result:	1	0.5	0	0.5	0.5	0.5	3.2	1.6	1.8	19.5	1.9	1.5	1
测量点 Checking point:	1	2	3	4	5	6	7	8	9	10	11	12	13
测量值 Measure result:	1	0.5	1	0.5	21.5	0.5	0.5	1	1	1	1.5	1

五处角带边量 edge offsetting (mm)

测量点 Checking point:	A	B	C	D	E	F	G	H	I	J	K	L	M	N
测量值 Measure result:	21.5	0.5	2	1	31	31.5	32.5	20.5	2.5	21.5	1.5	2	1.5	1.5
